## INSPECTION REPORT BY MAGNIFY INSPECTIONS

1234 Main Street  
Edmonton, AB T5J 3R8

Buyer Name  
04/30/2025 9:00AM

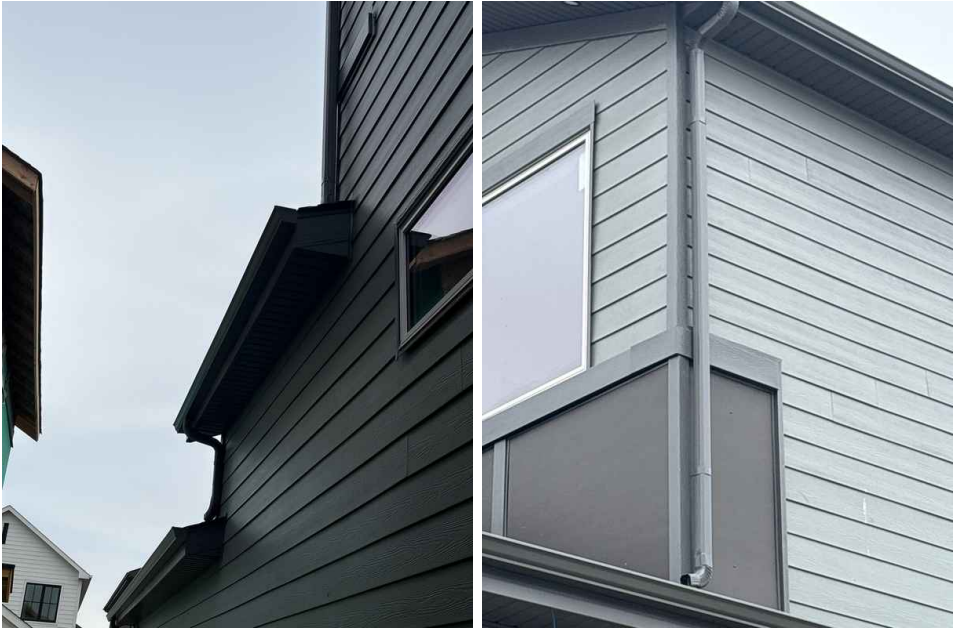
-   2.6.1 Roof - Gutters & Downspouts: Downspout from higher roof drains on lower roof. Requires extension to gutter
-   2.6.2 Roof - Gutters & Downspouts: Recommend downspout extension

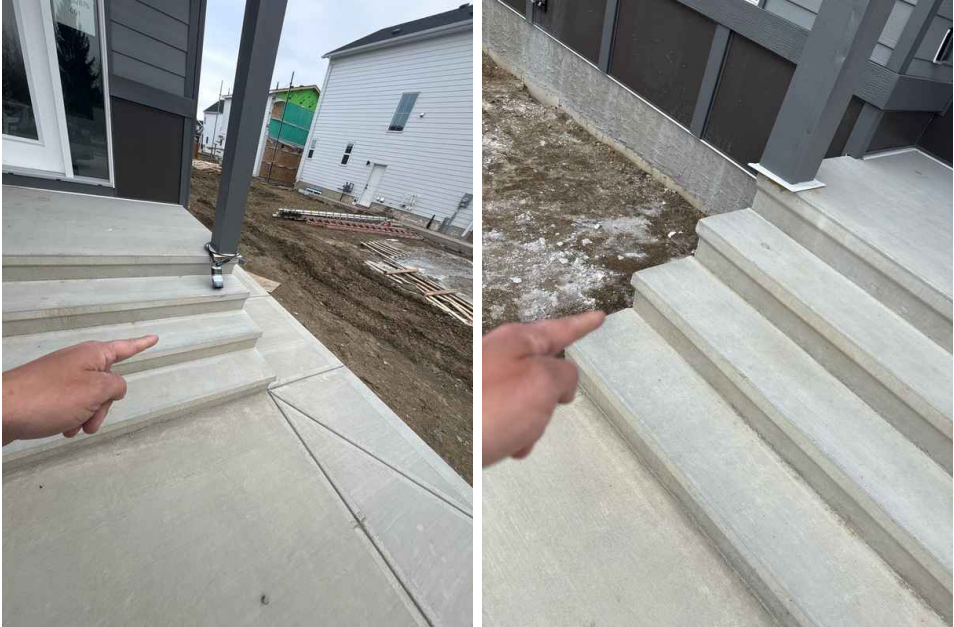
3.4.1 Railings, Guards & Handrails

**MISSING HANDRAIL**

I observed a missing handrail.  
There is more than one step here, and I recommend installing a handrail for safety.  
Recommendation  
Contact a qualified professional.

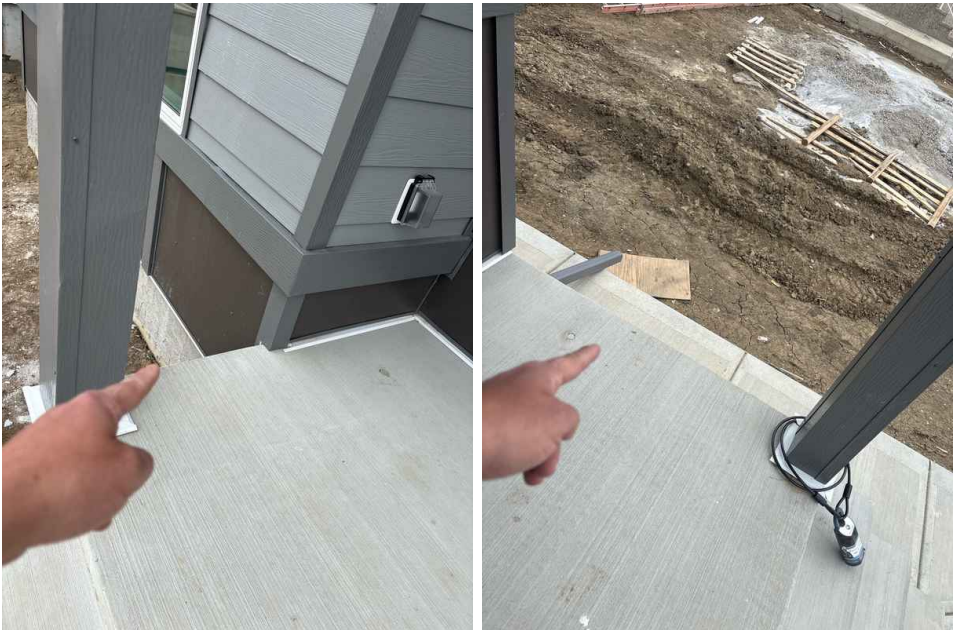
3.4.2 Railings, Guards & Handrails

**MISSING GUARDRAILS**

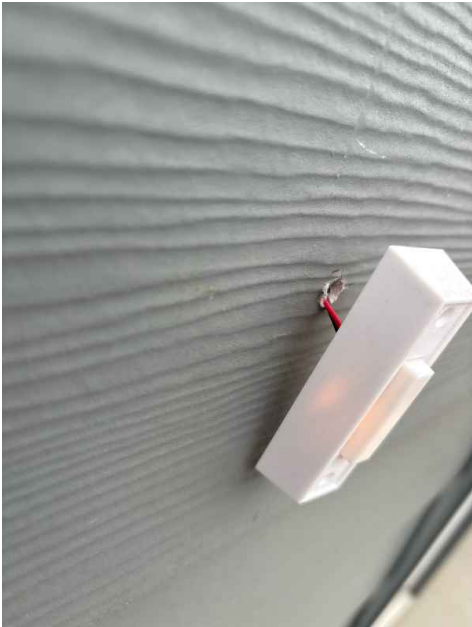
3.11.1 Exterior Electrical

**DOOR BELL NEED SECURING TO WALL**

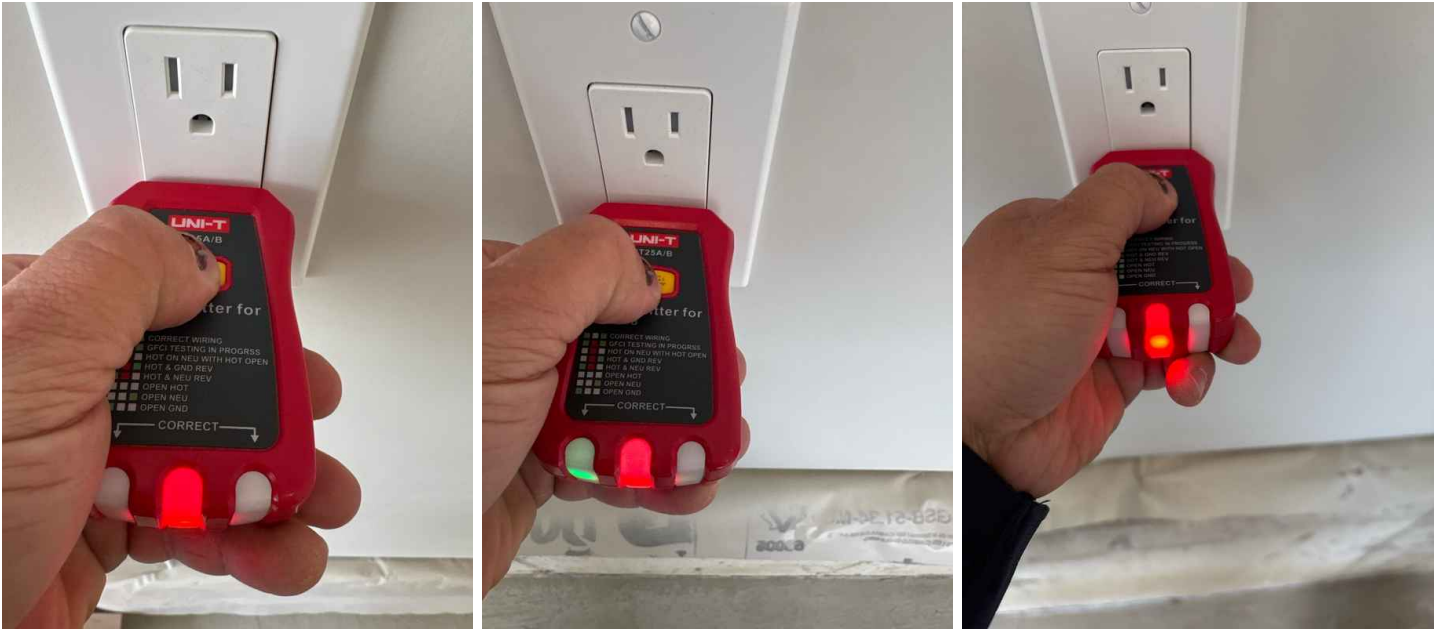
4.4.1 Electric in Garage

MISSING GFCI-PROTECTION IN GARAGE

I observed a receptacle in the attached garage without GFCI (or ground fault circuit interrupter) protection.

Contact a qualified electrical contractor.

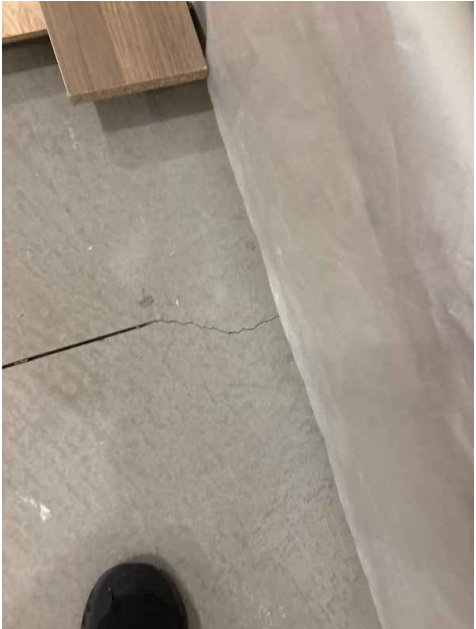
4.6.1 Garage Floor

**MINOR CRACKING OBSERVED IN FLOOR OF GARAGE.**

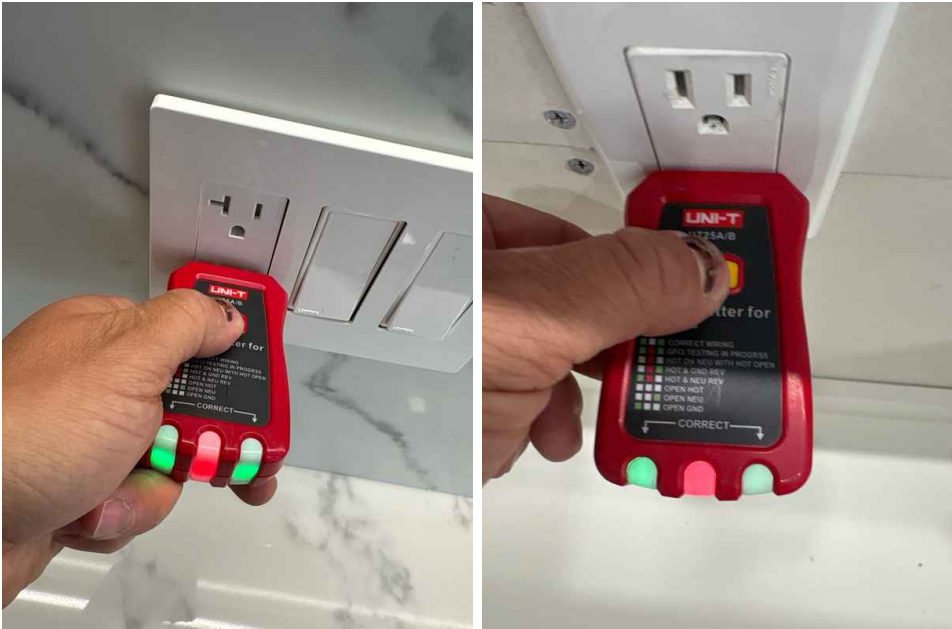
MISSING GFCI PROTECTION

I observed indications of missing GFCI protection in the kitchen. All kitchen counter receptacles are required to be GFCI protected.

Contact a qualified electrical contractor.

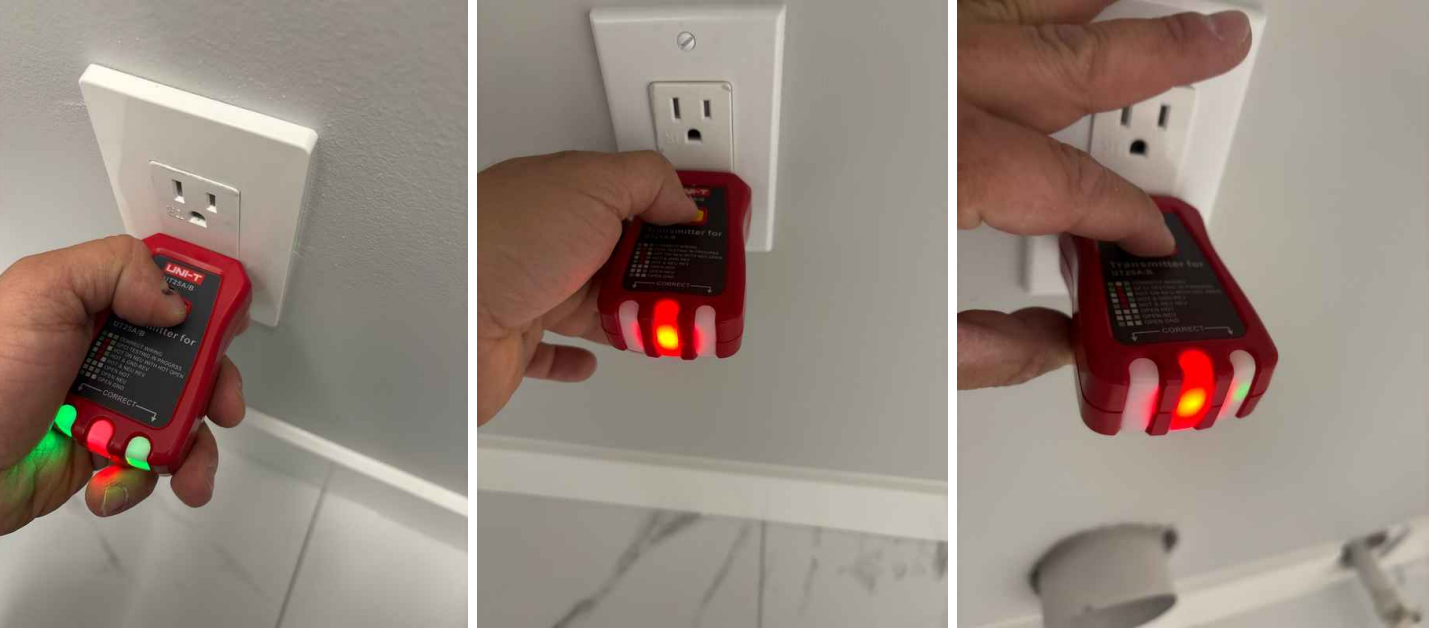
I observed that there is missing GFCI protection at the receptacles in the laundry room.  
All 120-volt, 15- and 20-amp outlets in laundry rooms must be AFCI and GFCI protected. 2014 NEC 210.8(A) (10) & 210.12(A)

Recommendation  
Contact a qualified electrical contractor.
