Overview

The HydroTrek-WCSRA is a leading ML-based software for determining the defect locations in sewer CCTV using Artificial Intelligence Computer Vision (CV). In addition, it uses Machine Learning (ML) to predict the defect locations in un-inspected assets with high accuracy. The reduction in business risk based on the CV/ML results can 1) prevent catastrophic failures ,2) reduce I&I and 3) improve network performance. The platform has been successfully tested in multiple utilities located in North America. The CV models can be used for QA/QC of existing inspected reports or to create inspection reports from new videos. The ML model can be used to schedule new inspections. These models were developed using the Supercomputing Cluster at the University of British Columbia.

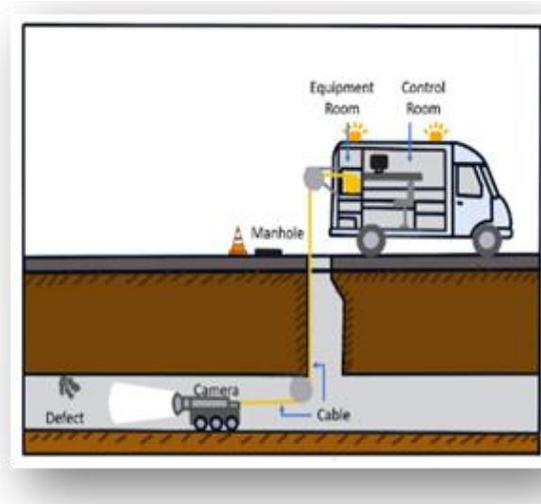
Figure 1. Sewer CCTV Inspection

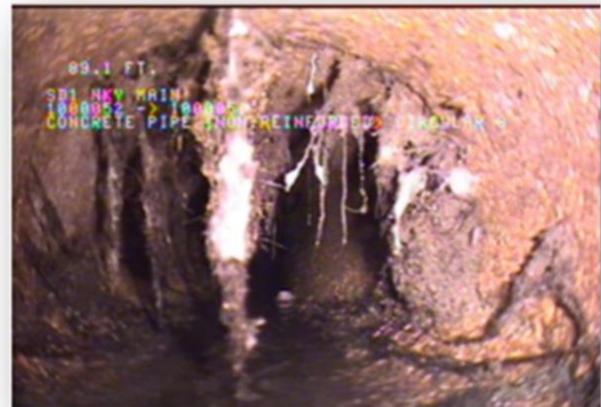
Figure 2. The CV model predicted Pipe Collapse (XP) and Root Fine Joint (RFJ) defects that were missed by humans

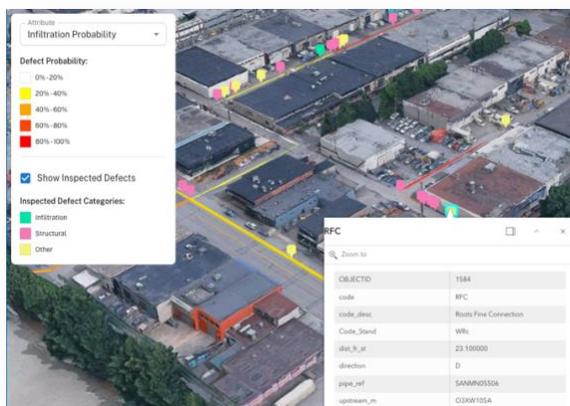
Figure 3. Potential I&I Defects Visualization
