Property Inspection Report

45693 Prairievista Pl, Quartz Hill, CA 93536
Inspection prepared for: Larry Jones
Date of Inspection: 12/20/2024 Time: 10:00 am
Weather: Sunny

Pool Inspection

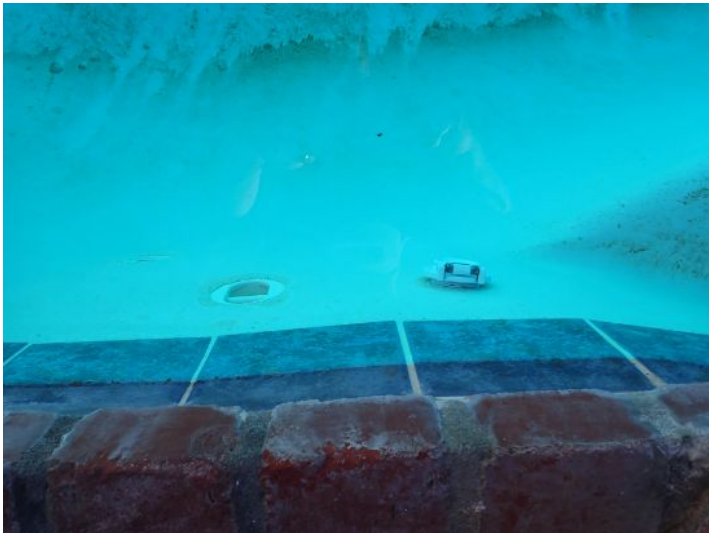
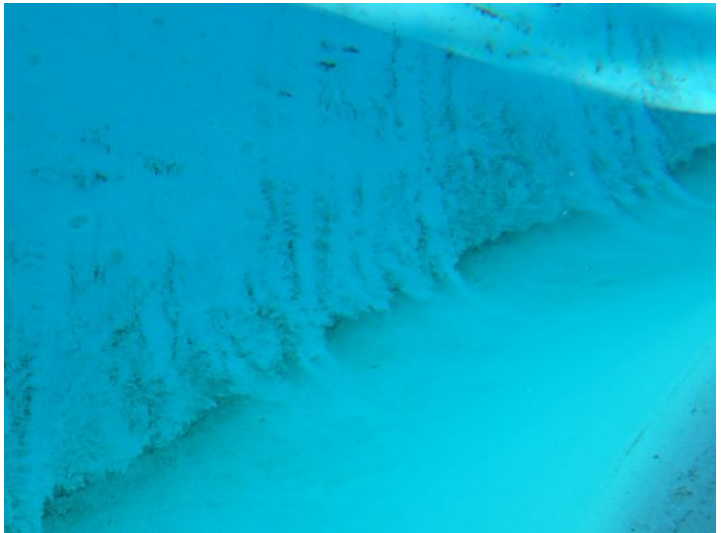
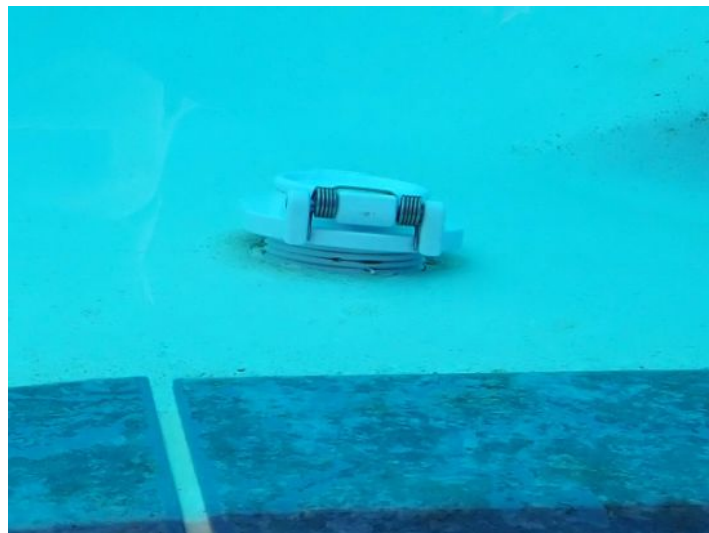
2. Pool Structure

- The visible portions of the pool structure are in good condition.
- Some stained or dirty areas noted, recommend cleaning.
- Some calcium deposits noted, recommend cleaning.
- Inlet is not flush with pool surface.
- Depth markers are not installed.
- The inspector can not determine if the pool or spa is free of leakage. If further review is desired, we recommend contacting a licensed pool company.

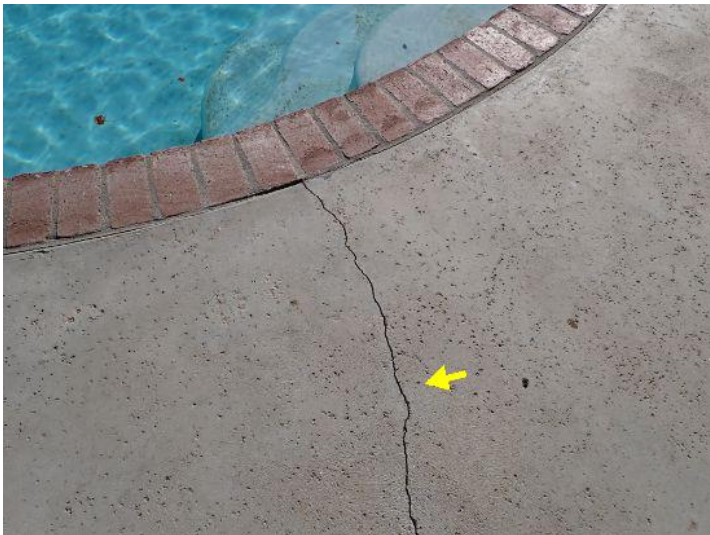
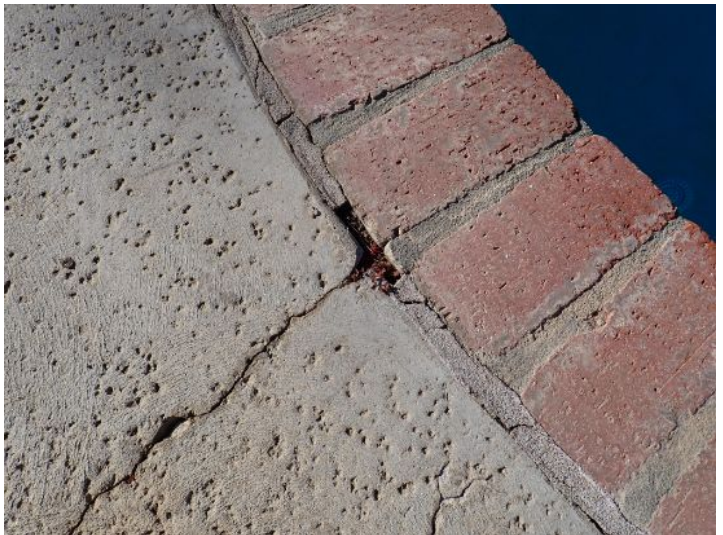
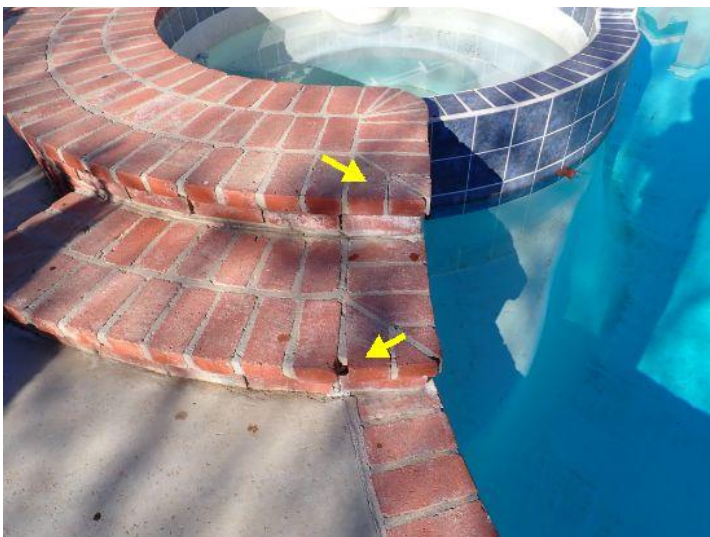
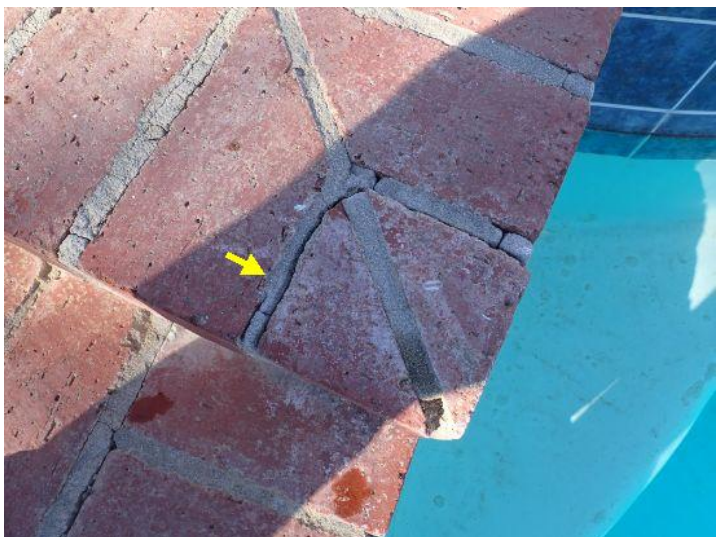
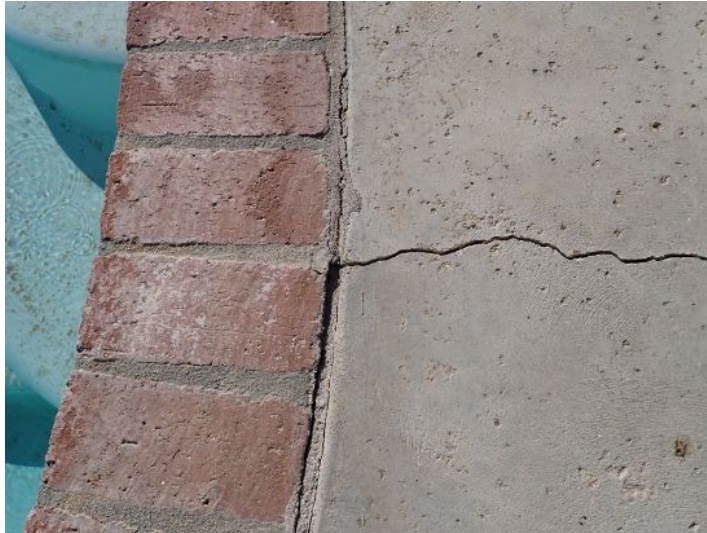
3. Deck Surface

- Concrete cracks noted, recommend repair by a licensed concrete contractor.

Damaged and cracked mortar noted, recommend repair by a licensed pool or mason contractor.

Evidence of repairs noted, unable to determine the effectiveness of these repairs.

- Damaged and cracked mortar noted, recommend repair by a licensed pool or mason contractor.

- Evidence of repairs noted, unable to determine the effectiveness of these repairs.

- Damaged and missing deck seal noted, recommend repair by a licensed pool.

- A number of deck drains were noted on property at time of inspection.

Maintenance tip; Check and clean deck drains to make sure they are free of debris and draining properly.

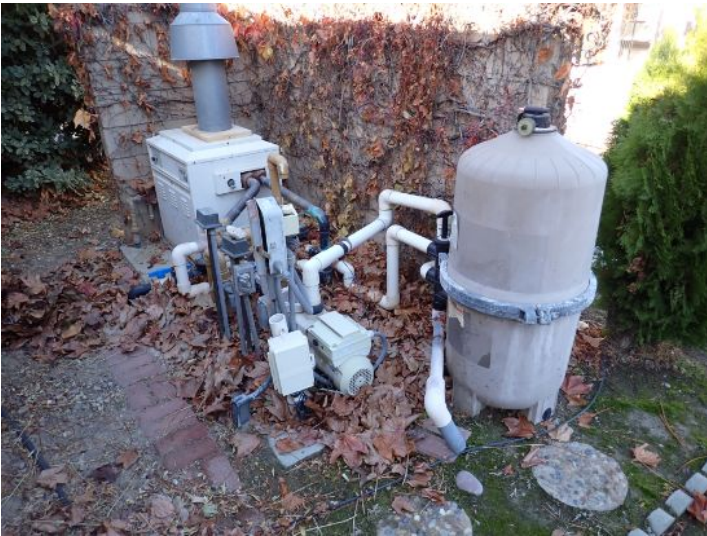
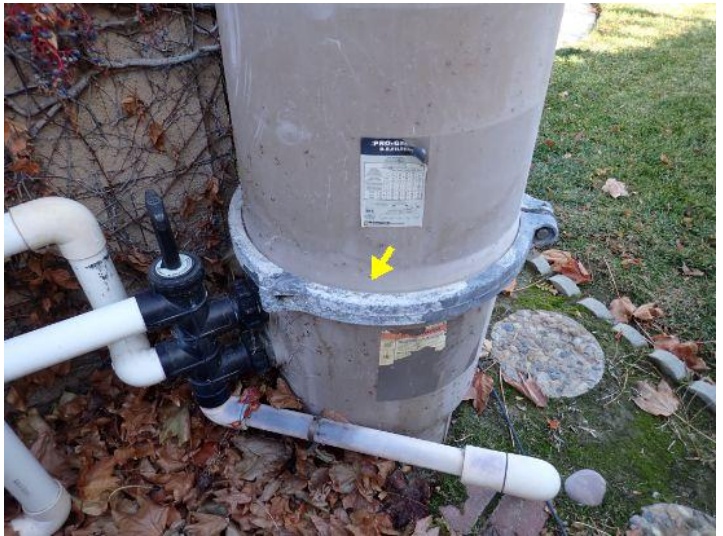
4. Equipment

- Pump and filter are in working condition.
- Note; Limited visibility due to leaf debris.
- ****Pump Motor****
- Pump motor should be protected by a ground fault circuit interrupter, recommend repair by a licensed pool or electrical company.
- ****Filter System****
- Some deterioration or corrosion, recommend review by a licensed pool company.

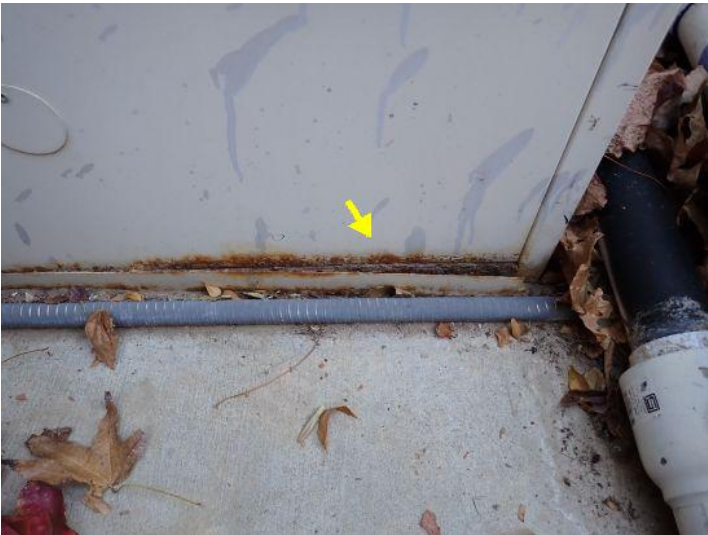
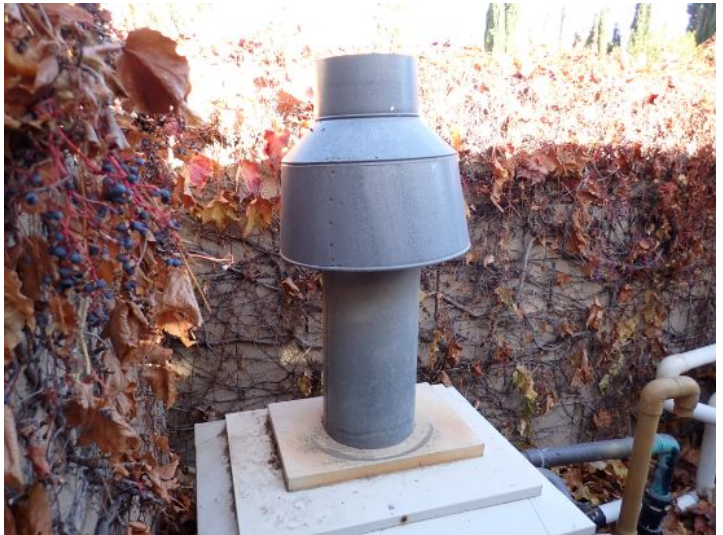
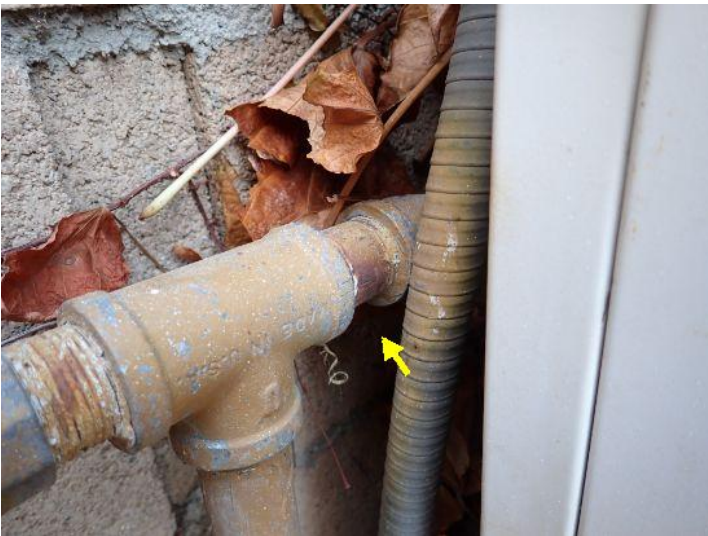
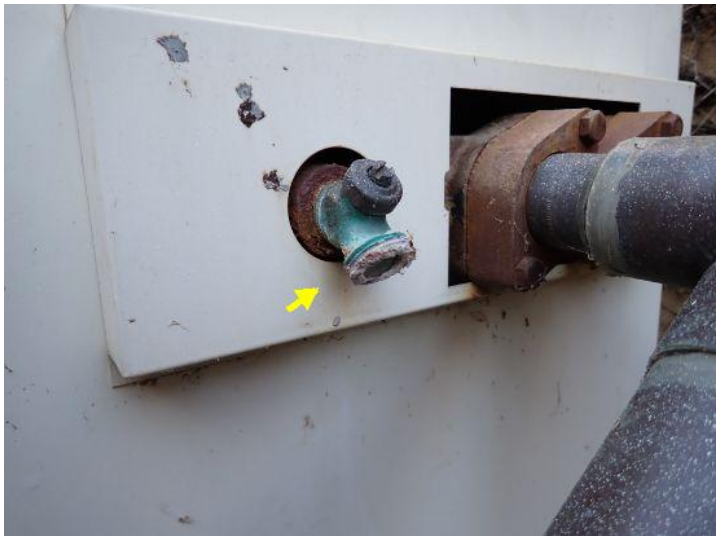
5. Heating System

- Damaged parts and rust noted at heater, recommend review and repair by a licensed pool company.
- Loose vent at heater, recommend securing.
- Corrosion noted at hose bib.
- Gas line is showing signs of rust, recommend painting.
- Note; Heater was not tested at time of inspection.

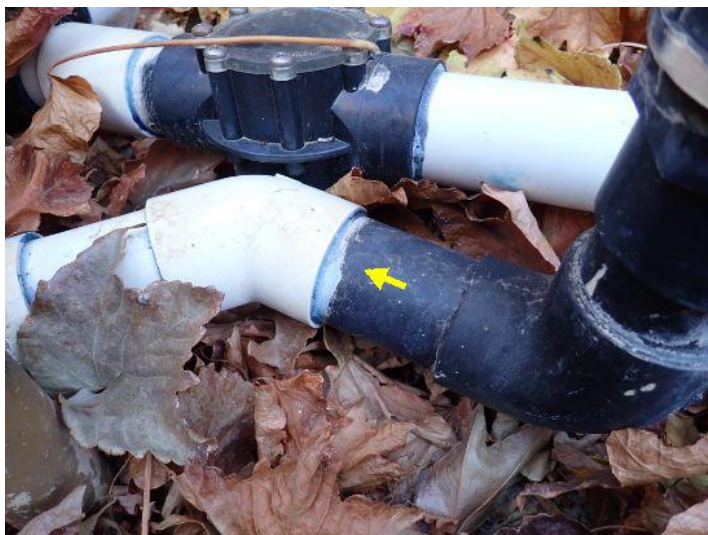
6. Plumbing

- No plumbing leaks noted at time of inspection.
- Recommend painting plumbing pipes to protect from ultraviolet rays.
- Note; Limited visibility due to leaf debris.

- Copper pipe, Polyvinyl Chloride (**PVC**) pipe and Black (**ABS**) Acrylonitrile Butadiene Styrene pipe is present.
- Note; Wrong glue used at ABS and PVC pipe joints, recommend review by a licensed plumber or pool company.

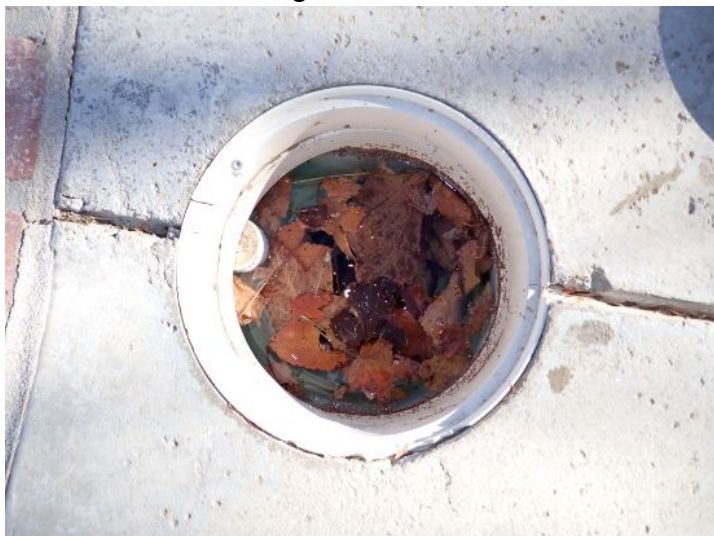
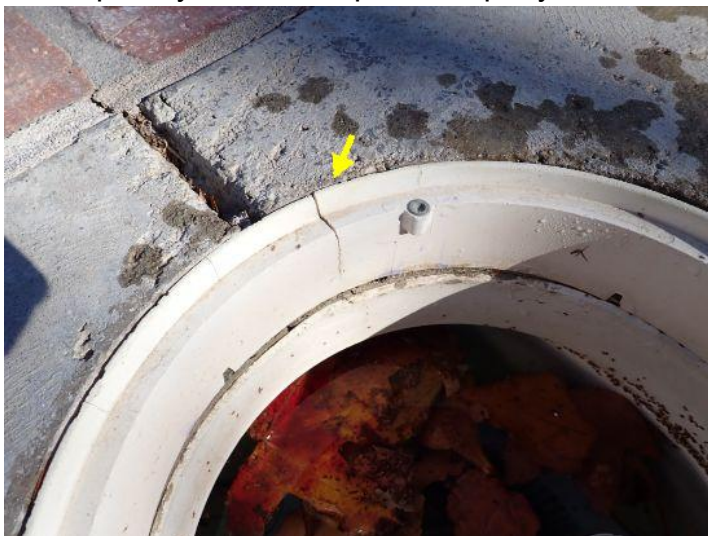
7. Skimmer

- Skimmer was full of debris at time of inspection.
- Cracked plastic at skimmer basket area, recommend repair by a licensed pool company.
- The weir is missing at skimmer location, recommend repair by a licensed pool company.

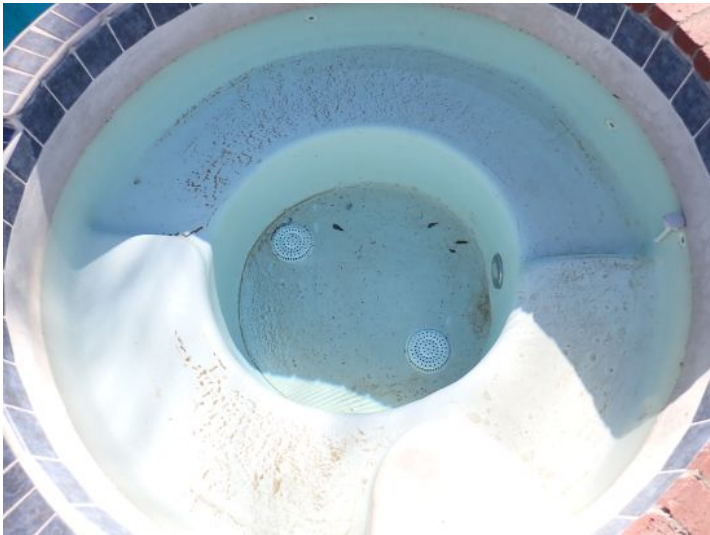
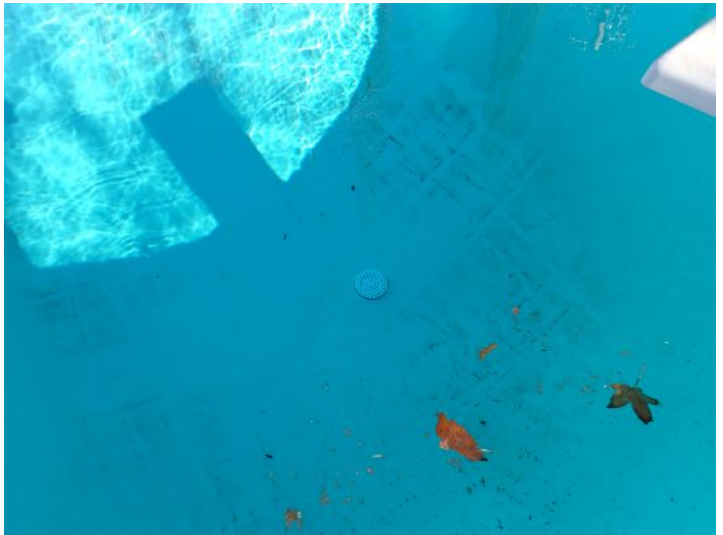
8. Drain Covers

- Drain covers are present, inspector could not determine if covers are in compliance with the state standards. We recommend further evaluation by a licensed pool company.

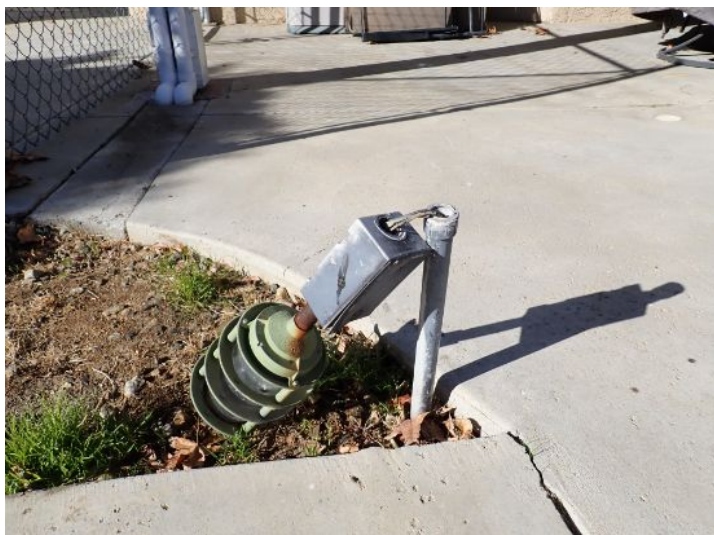
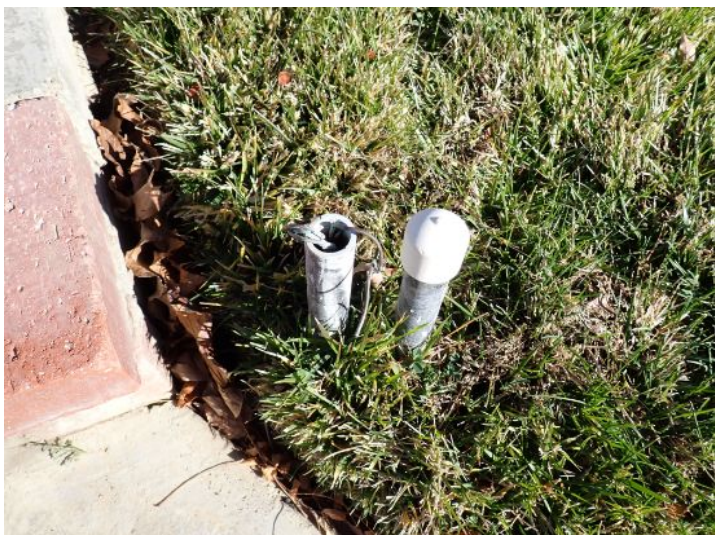
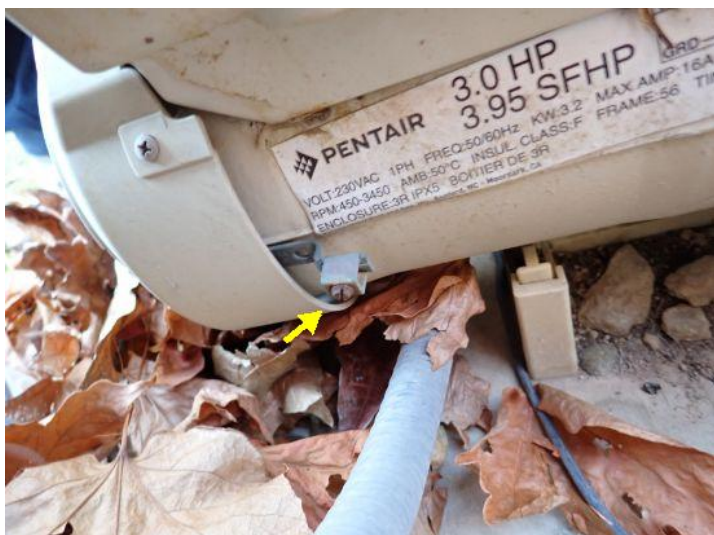
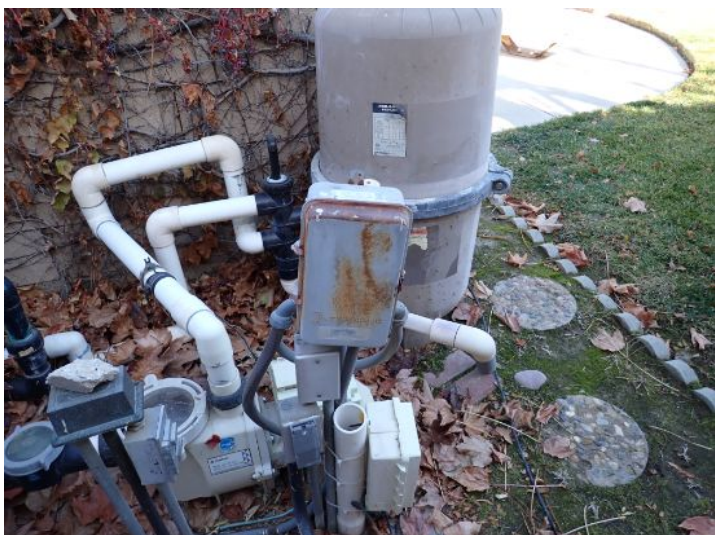
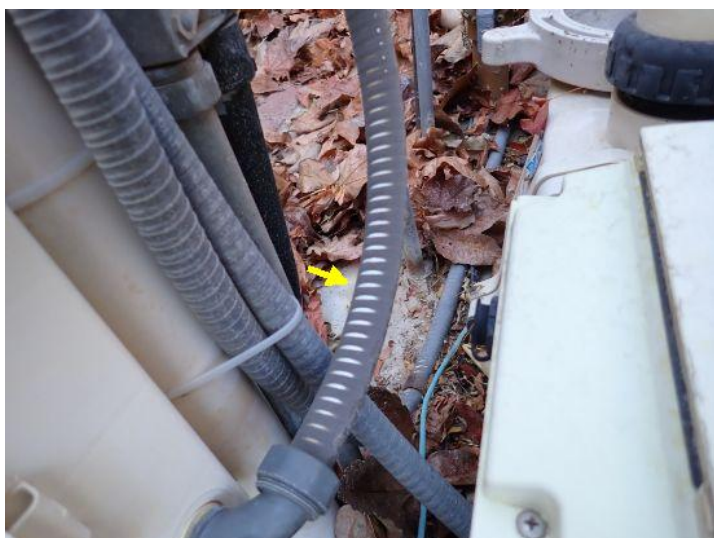
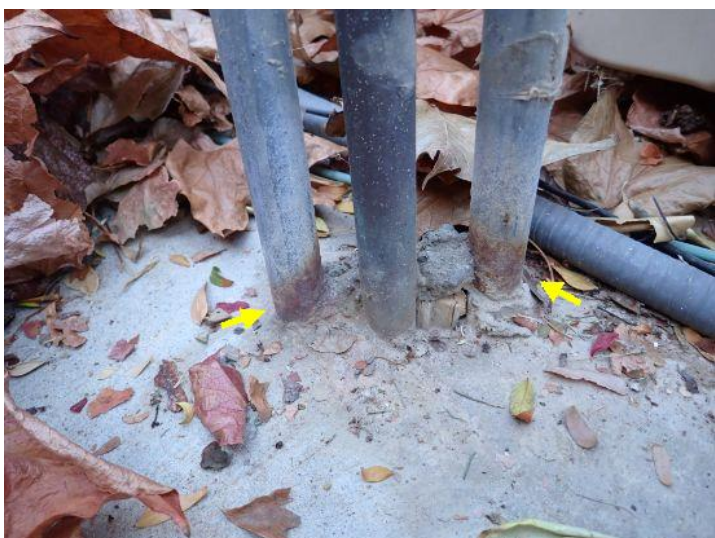
10. Electrical/Bonding

- ****Pump Motor****
 - Pump motor was not bonded, recommend repairing to ensure safety.
- ****Pool & Spa Lights****
 - Two lights noted at time of inspection, lights are in working condition.
- ****Safety Hazard****
 - Exposed wires, missing and damaged lights noted, recommend repair by a licensed pool or electrical company.
- ****Conduit****
 - Conduit showing signs of wear and rust, recommend review by a licensed pool or electrical company.
- ****Control Box****
 - Control box is showing signs of wear and rust, recommend review by a licensed pool or electrical company.
 - Plastic sheathing appears to be damaged at a number of wires, recommend review by a licensed electrical contractor.
 - Protective cover for wires is missing, recommend installing to ensure safety.
