# *TH Inspection Services*

## Property Inspection Report

42263 50th St. West, Quartz Hill, CA 93536  
Inspection prepared for: Larry Watson  
Date of Inspection: 3/14/2021 Time: 10:00 am  
Age of Home: 32 yrs. Size: 2205 sqf.  
Weather: Partly cloudy

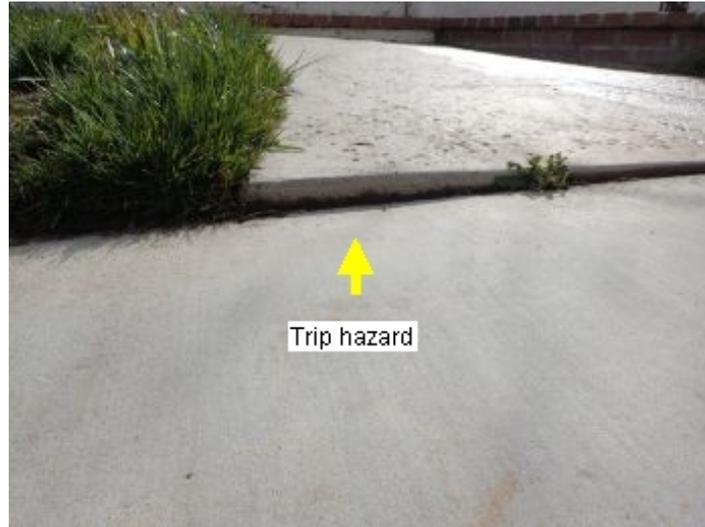
### 1. Driveway and Walkway Condition

- Operational at time of inspection.
- Concrete cracking noted, recommend sealing cracks if possible to extend life of concrete surface.
- **\*\*Walkway\*\***
- Trip hazard noted at walkway, recommend repairing to ensure safety.

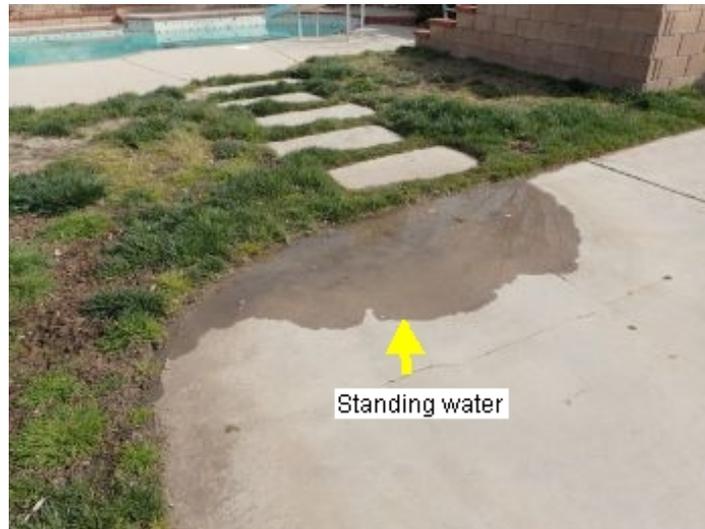
- Operational at time of inspection.
- Concrete cracking noted, recommend sealing cracks if possible to extend life of concrete surface.
- Water will collect in a number of areas, recommend establishing positive drainage to exit water from property.
- Today's building standards require a minimum 2 inch clearance between concrete surface and stucco weep screed, without this clearance moisture can enter the structure.
- **\*\*Rear Yard\*\***
- Standing water noted at time of inspection.

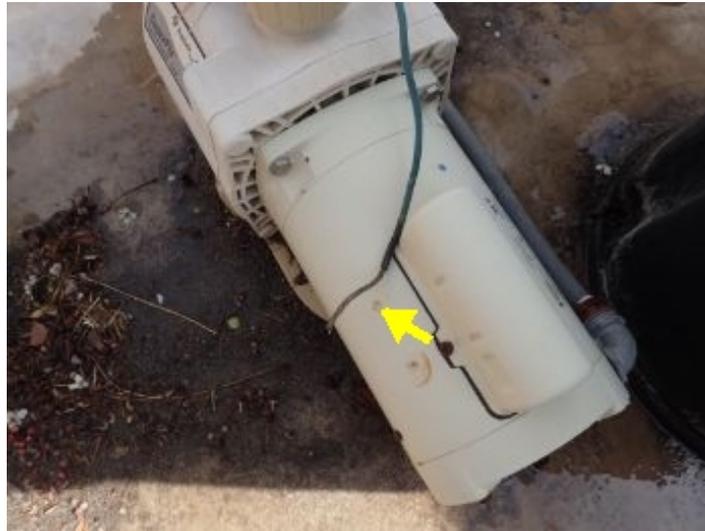
Pool equipment

- Additional electrical is added to property, recommend review by a licensed electrical contractor to ensure safe and adequate service.
- Secure loose junction box and conduit at side of house, recommend repair by a licensed electrical contractor.
- Light fixture by garage service door did not operate due to missing bulb.
- **\*\*Exterior Outlets\*\***
- Operational at time of inspection.
- **\*\*Exterior Light Fixtures\*\***
- A number of light fixtures did not operate due to missing bulbs.
- Recommend caulking all exterior light fixtures to house.
- **\*\*Pool Equipment\*\***
- Pump motor is not bonded, recommend repair by a licensed pool contractor to ensure safety.

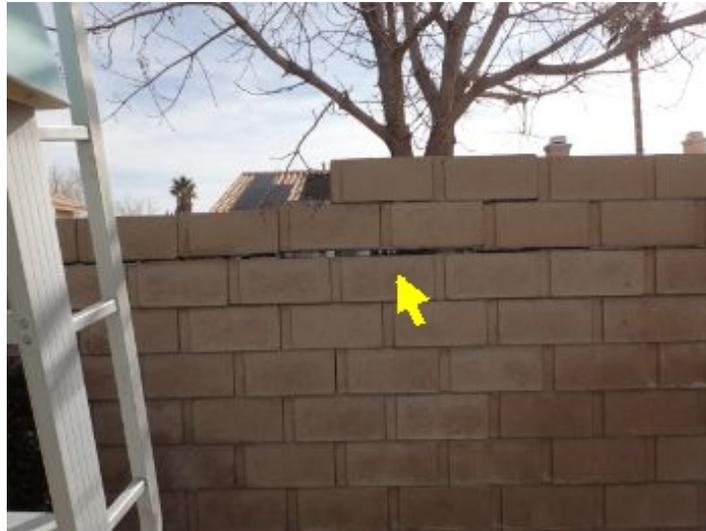
### 16. Fence Condition

- Some wall damage noted, recommend repair by a licensed masonry contractor.
- **A number of loose wall caps noted, recommend repairing to ensure safety.**

Grounds		
Page 11 Item: 16	Fence Condition	<ul style="list-style-type: none"> <li>• A number of loose wall caps noted, recommend repairing to ensure safety.</li> </ul>
Page 14 Item: 19	Water Features	<ul style="list-style-type: none"> <li>• <b>**Drowning Hazard**</b></li> <li>• No enclosure installed around pool, immediate repair is needed to ensure safety. Recommend contacting a licensed fence contractor to repair, fence contractor needs to be professionally trained in pool safety and also adhere to the (ASTM) standards.</li> </ul>
Attic		
Page 22 Item: 9	Chimney	<ul style="list-style-type: none"> <li>• Chimney double wall vent pipe should maintain a minimum 1 inch clearance to combustible materials.</li> <li>• Fire stop is not installed properly at chimney pipe, recommend repair by a licensed fireplace contractor to ensure safety.</li> </ul>
Garage		
Page 25 Item: 7	Exterior Door	<ul style="list-style-type: none"> <li>• No door alarm present, doors leading to a pool area are required to have alarms installed. Recommend installing to ensure safety.</li> </ul>

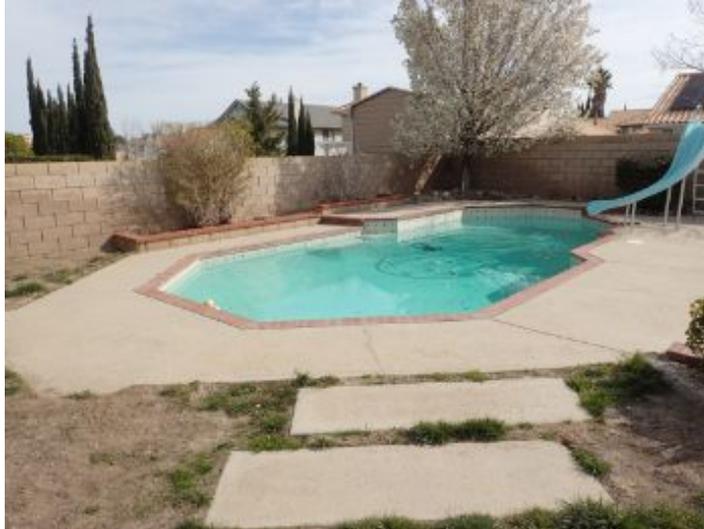
- **\*\*Drowning Hazard\*\***
- No enclosure installed around pool, immediate repair is needed to ensure safety. Recommend contacting a licensed fence contractor to repair, fence contractor needs to be professionally trained in pool safety and also adhere to the (ASTM) standards.

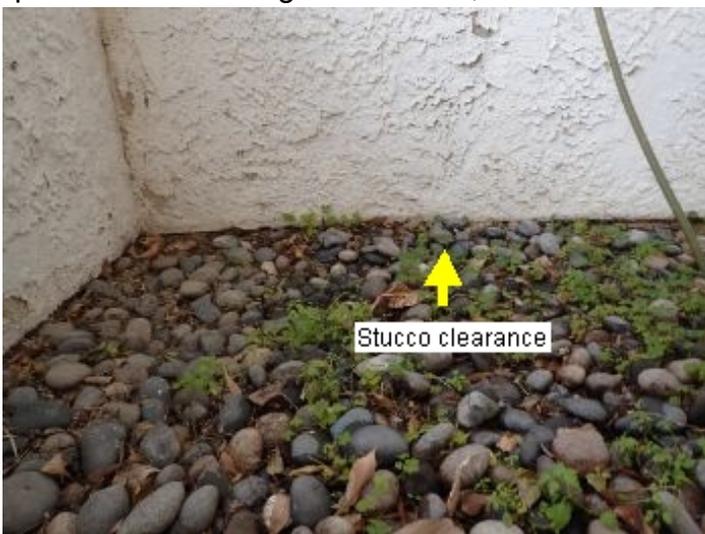
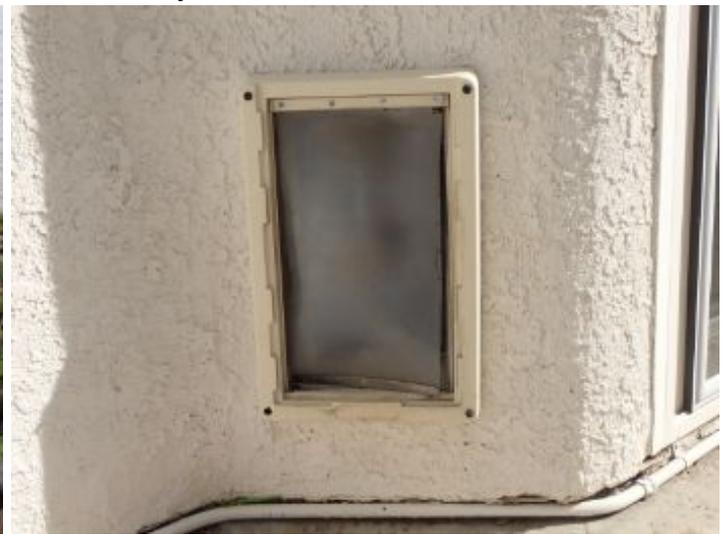
- Some stucco deterioration noted, recommend patching to minimize water intrusion.
- A number of small holes noted in stucco, recommend patching to minimize water intrusion.

- Stucco weep screed is rusted in a number of areas, this is normally caused by too much moisture.
- Seal all stucco penetrations to minimize water intrusion.

- Today's building standards require a minimum 2 inch clearance between concrete surface and stucco weep screed, without this clearance moisture can enter the structure.

- Today's building standards require a minimum 4 inch clearance between soil and bottom of stucco weep screed, without this clearance moisture can enter the structure.

- **\*\*Side Elevation\*\***
- Previous owner penetrated the stucco water proofing due to adding a pet door. This area may possible leak during a rain event, recommend further review by a licensed stucco contractor.

- Peeling paint noted, suggest scraping and painting as necessary.
- All repairs should be done by a licensed stucco contractor to ensure a water tight seal.

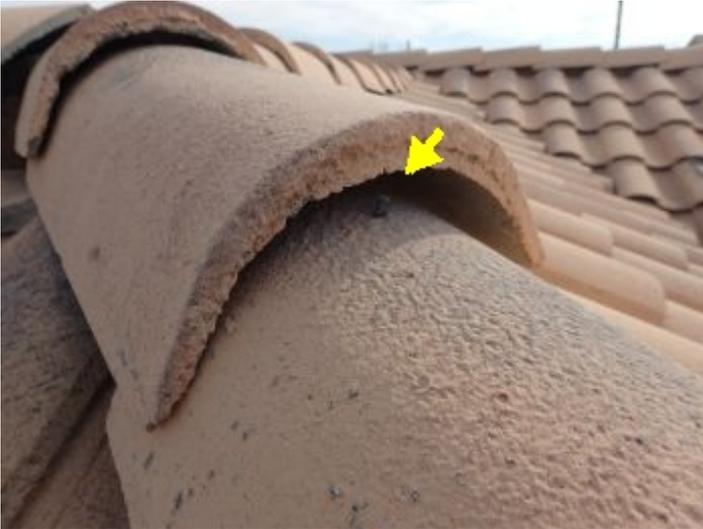
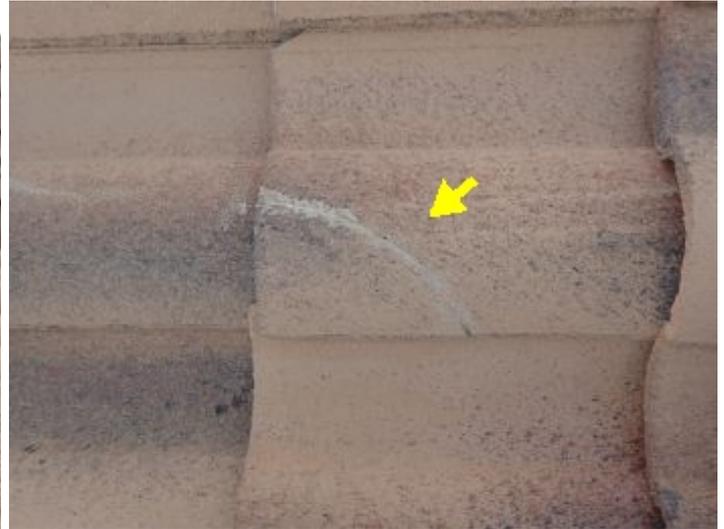
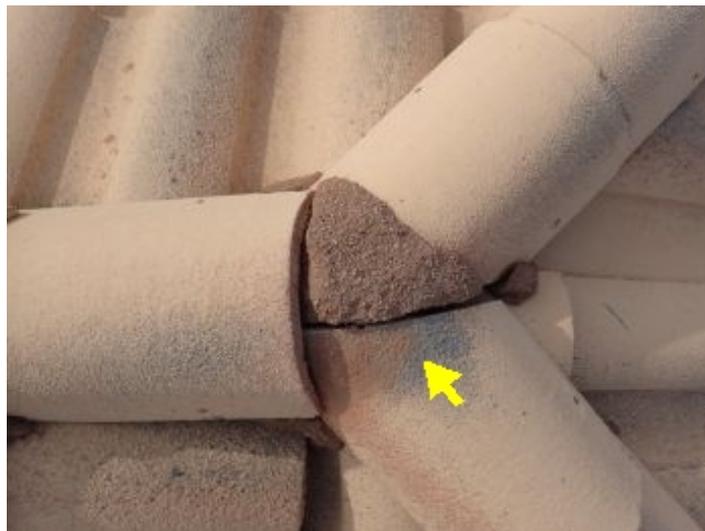
## 1. Roof Condition

- A number of broken and loose roof tile noted at time of inspection.
- Roof tile has slipped out of place in a number of areas.
- Open areas noted on roof surface at time of inspection, possible water intrusion can occur.

- Roof tile does not have the proper tile lap or coverage in a number of areas, possible roof leaks can occur.
- A number of exposed fasteners noted on roofing material.

- Evidence of repairs noted, unable to determine the effectiveness of these repairs.
- Recommend cleaning all debris off roof surface.
- No leak or water test was performed at this inspection.

- Recommend review and repair by a licensed roofing contractor.
- Recommend a roof certification by a licensed roofing specialist.
- Disclaimer; This is a visible inspection and opinion of the current roof condition. The inspector can not warrant or certify that roof systems, coverings or components are free from leakage.

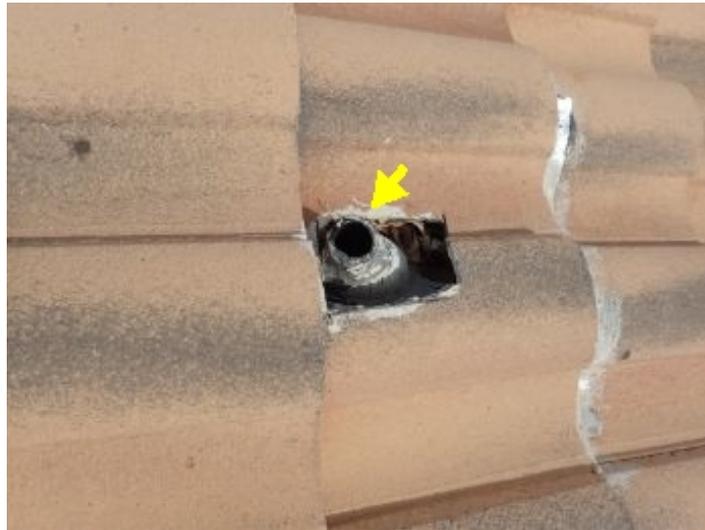
## 2. Flashing

- **\*\*Plumbing Vents\*\***
- A number of flashings have deteriorated sealant, recommend repair by a licensed roofing contractor.
- Plumbing vent pipes should be a minimum of 6 inches above roof surface, recommend review by a licensed plumbing contractor.

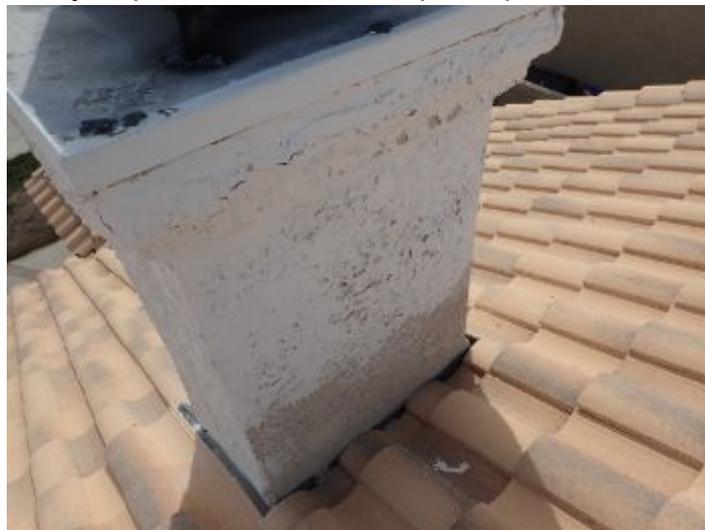
## 3. Chimney

- Peeling paint noted, suggest scraping and painting as necessary.
- **\*\*Chimney Cap\*\***
- Recommend primer and paint at exposed flashings to protect from corrosion and weather.
- Note; Our chimney review is limited to visible accessible components only. If further review is desired, we suggest review by a qualified licensed fireplace professional.

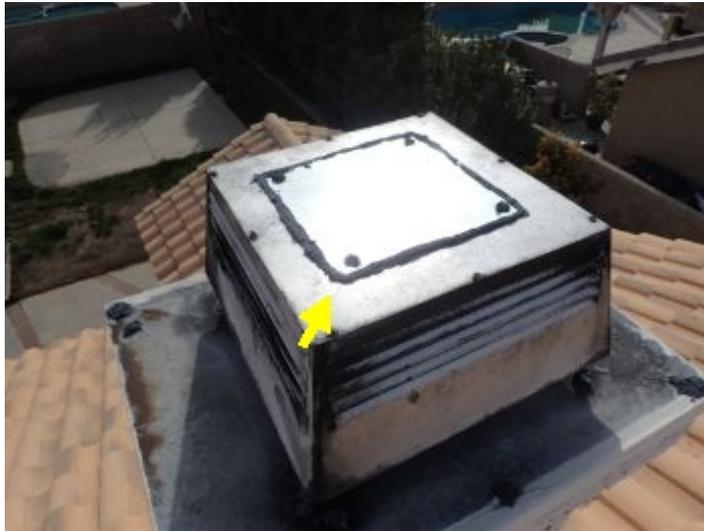
## 4. Spark Arrestor

- Present at time of inspection.
- Evidence of repairs noted, recommend review by a licensed fireplace contractor.

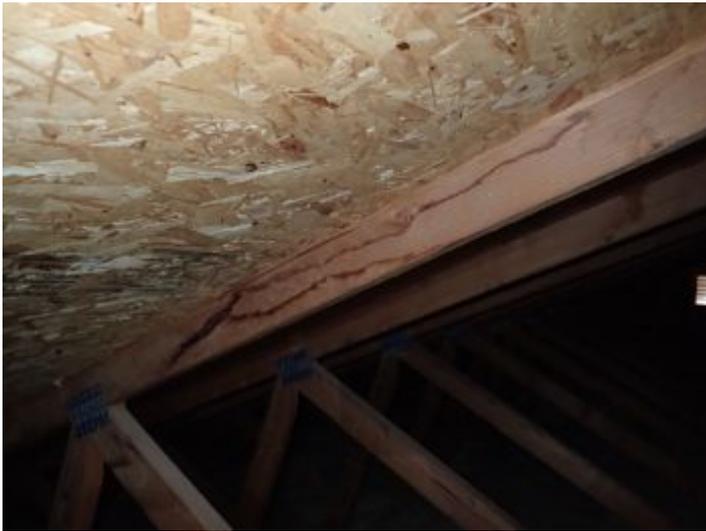
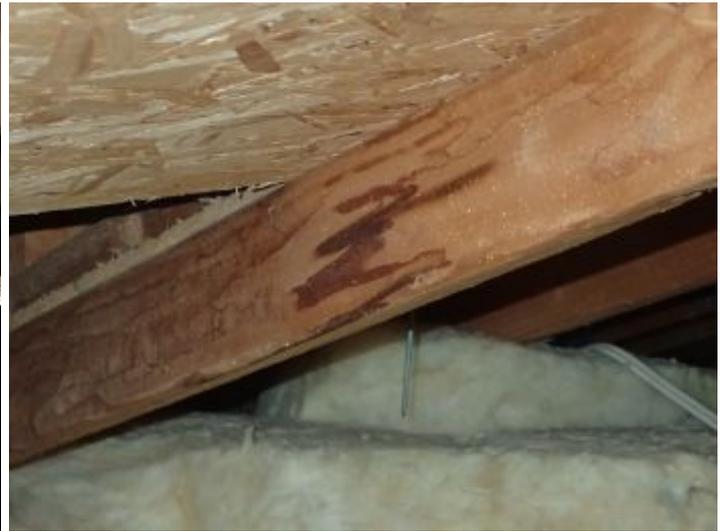
- Engineered wood truss framing noted.
- Evidence of past leaking noted at a number of locations, recommend review and repair by a licensed roofing contractor.
- Note; Limited review of structure due to attic design, inspector could not access all areas of the attic.

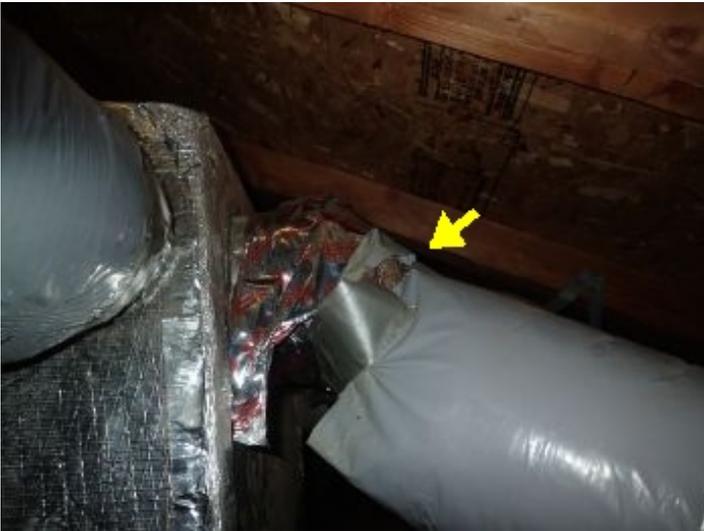
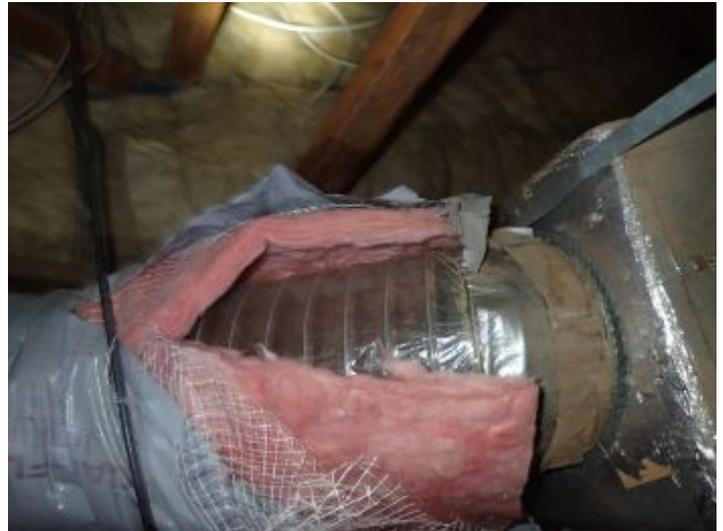
- Duct work (air supply) is separated in a number of locations, recommend review and repair by a licensed HVAC contractor.
- Evidence of repairs noted, recommend review by a licensed HVAC contractor.
- \*\*Hallway Bathroom\*\*
- Low air flow noted at register, recommend review by a licensed HVAC company.

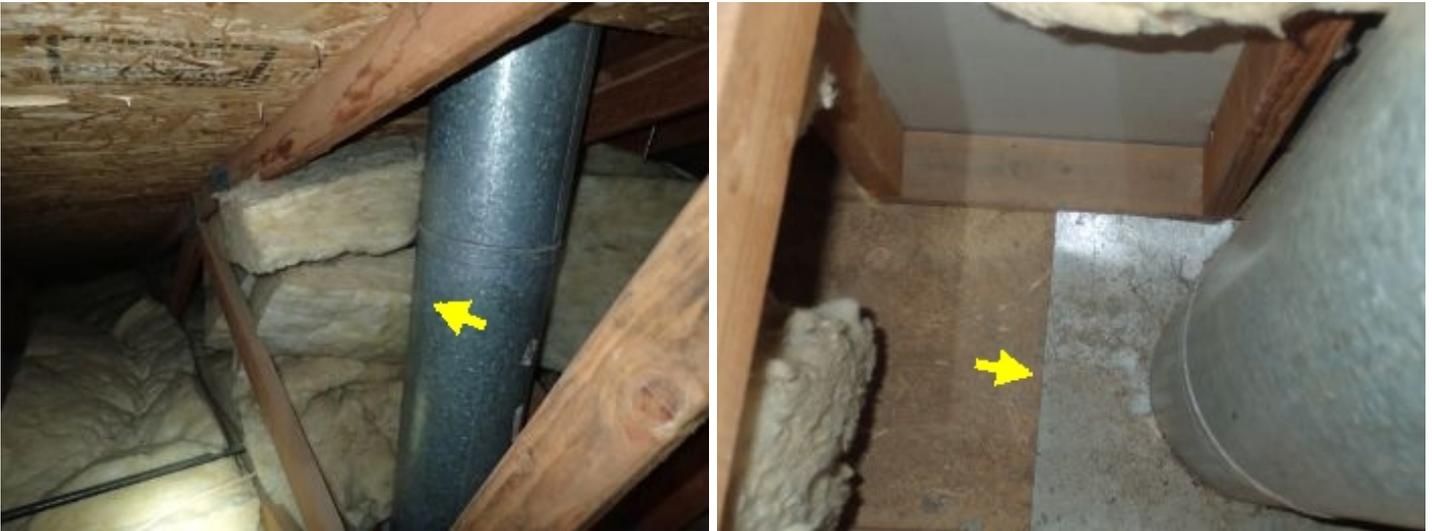
- Evidence of past leaking noted, recommend review by a licensed roofing contractor.
- Note; Our chimney review is limited to visible accessible components only. If further review is desired, we suggest review by a licensed fireplace professional.
- Chimney double wall vent pipe should maintain a minimum 1 inch clearance to combustible materials.
- Fire stop is not installed properly at chimney pipe, recommend repair by a licensed fireplace contractor to ensure safety.

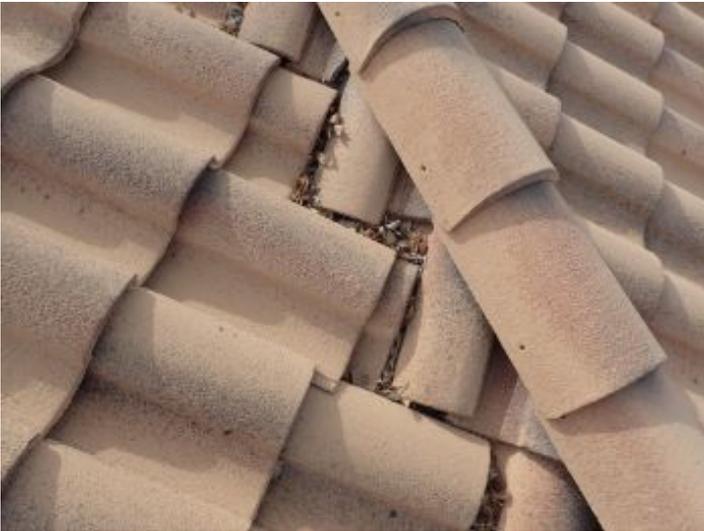
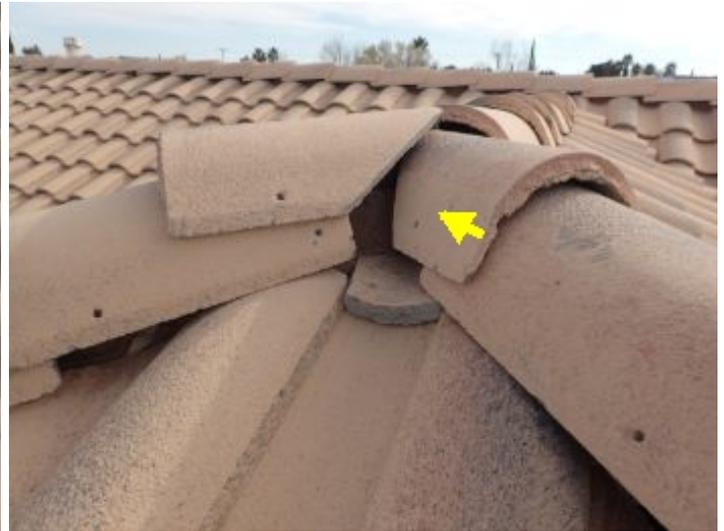
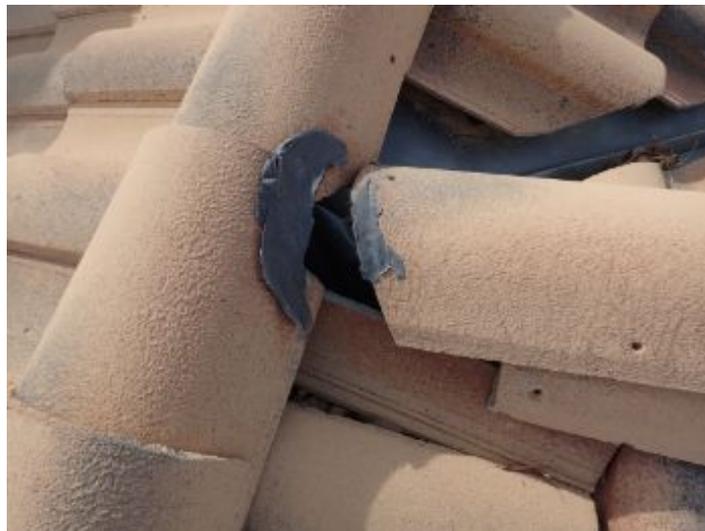
## 1. Roof Condition

- Roof tile have slipped out of place in a number of areas.
- Roof tile does not have the proper tile lap or coverage in a number of areas, possible roof leaks can occur.
- Open areas noted on roof surface at time of inspection, possible water intrusion can occur.
- Tile end caps are missing or showing wear, recommend repairing or replacing.
- Recommend cleaning all debris off roof surface.
- No leak or water test was performed at this inspection.
- Recommend review and repair by a licensed roofing contractor.
- Recommend a roof certification by a licensed roofing specialist.
- Disclaimer; This is a visible inspection and opinion of the current roof condition. The inspector can not warrant or certify that roof systems, coverings or components are free from leakage.

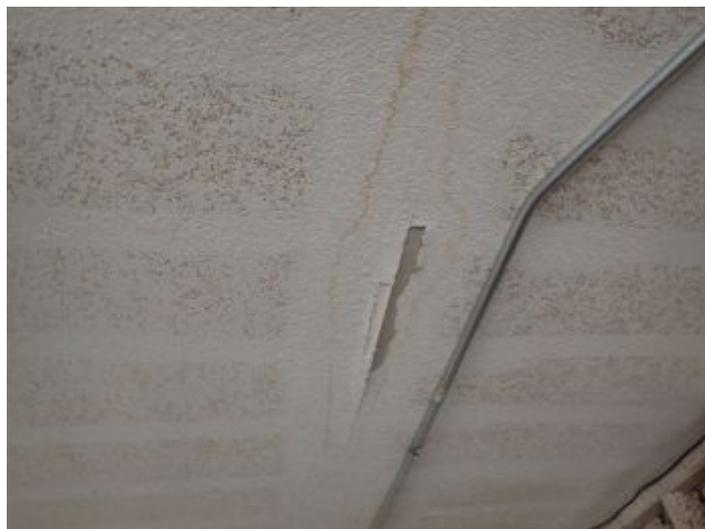
#### 19. Ceiling Condition

- Staining and damage noted from past leaking, recommend review by a licensed roofing contractor.

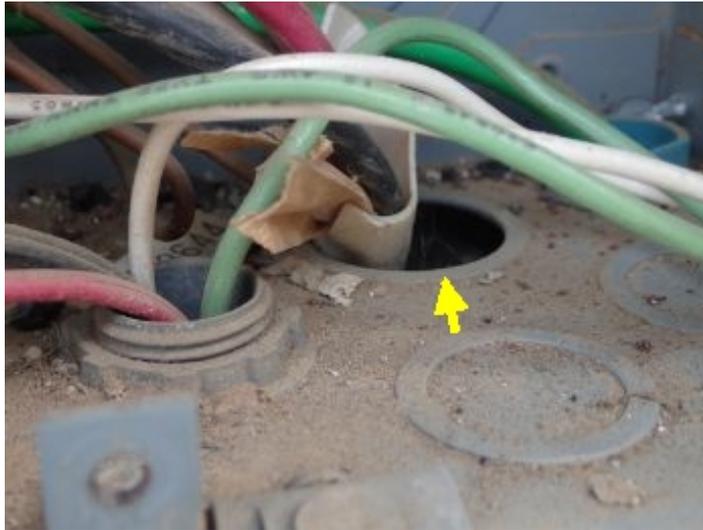
- Additional electrical added to panel, recommend review by a licensed electrical contractor to ensure safe and adequate service.
- Wire clamp is missing at electrical panel, recommend repair by a licensed electrical contractor.

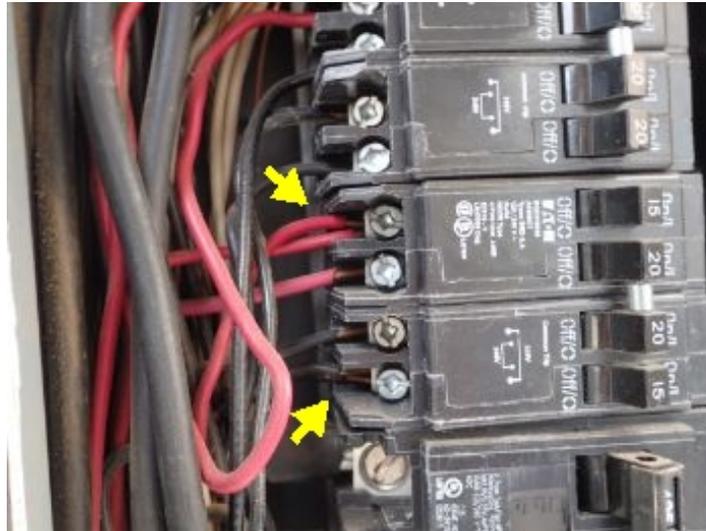
- Double tapping noted, (2 wires on a single pole breaker) this can add to the load of the circuit causing a possible overload and tripping of breakers.
- Note; Additional electrical added to panel, recommend review by a licensed electrical contractor to ensure safe and adequate service.
- **\*\*Arc Fault Protection\*\***
- No arc fault circuit interrupters present.
- Today's building standards require arc fault circuit interrupter breakers for interior circuits, recommend repair by a licensed electrical contractor to ensure safety.

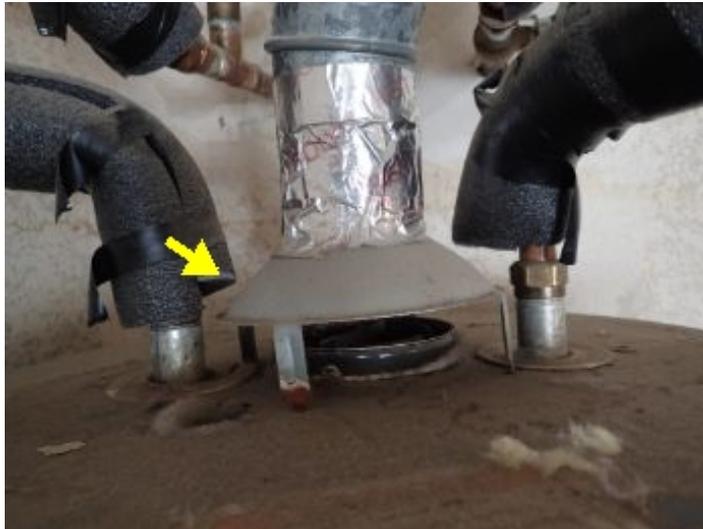
- Some rust noted, recommend review by a licensed plumbing contractor.
- Minimum 3 screws at each vent pipe connection, recommend repair by a licensed plumbing contractor.
- **The water heater vent pipe and draft hood is loose, recommend repair by a licensed plumbing contractor to ensure safety.**

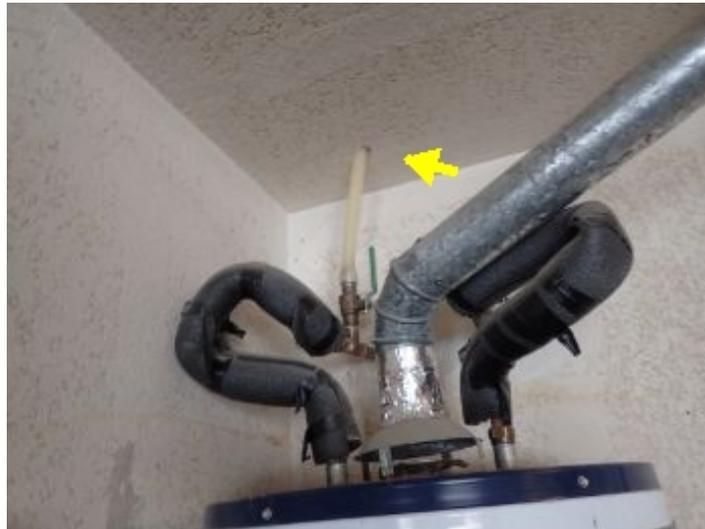
- Operational at time of inspection.
- Insulation is recommended on pipes at unheated areas.
- Note; Water line penetrates ceiling area, recommend installing copper pipe or a 26 gauge metal sleeve.

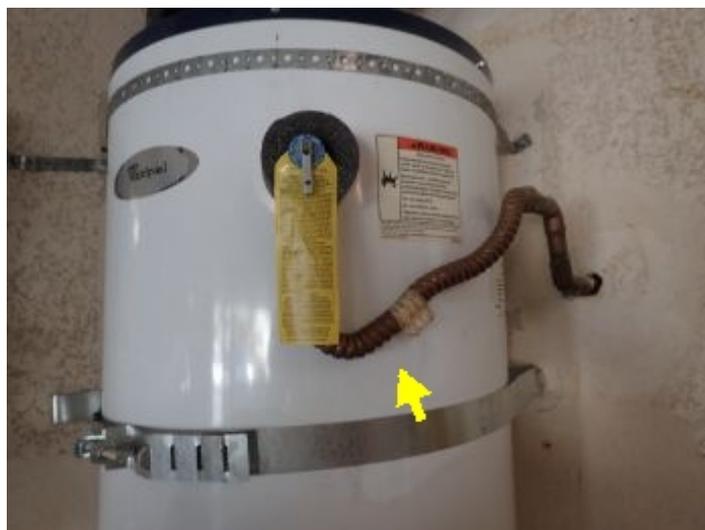
## 10. Overflow Condition

- Overflow line needs to have gravity fall, recommend review and repair by a licensed plumbing contractor.

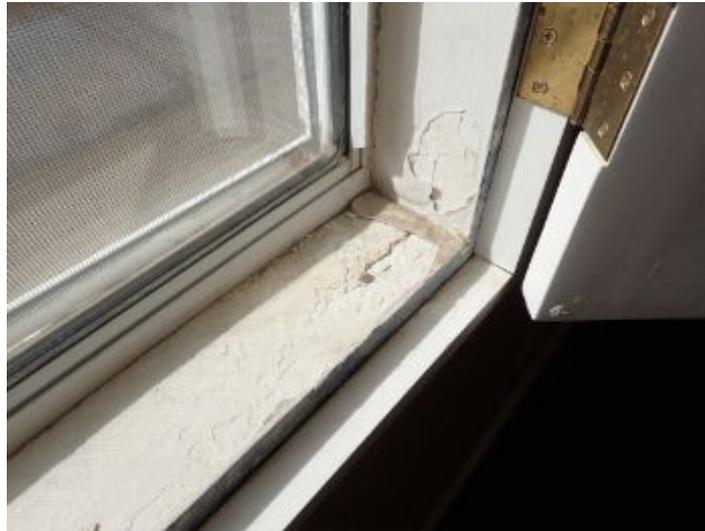
- Note; Water intrusion noted at a number of windows, recommend review by a licensed window company for repair options.
- **No window alarms present, windows leading to a pool area are required to have alarms installed. Recommend installing to ensure safety.**

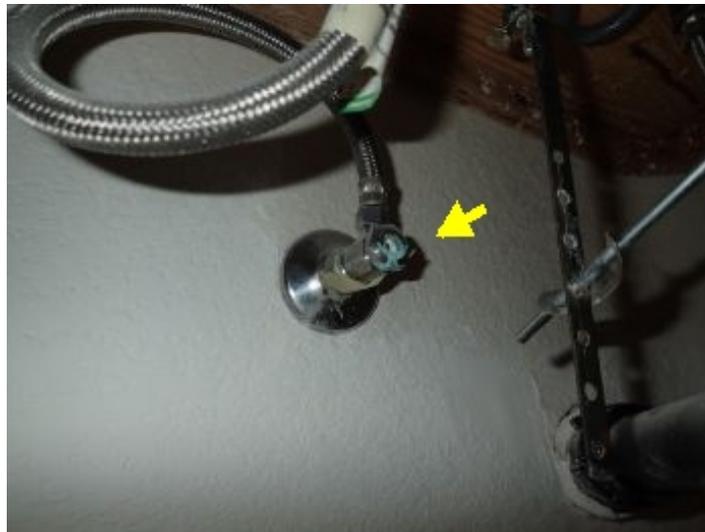
Main bathroom

- **\*\*Hallway Bathroom\*\***
- Operational at time of inspection.
- **\*\*Main Bathroom\*\***
- Missing handel at shut off valve, recommend repair by a licensed plumbing contractor.
- **\*\*Master Bathroom\*\***
- Water was not tested due to main sewer line backing up at time of inspection.

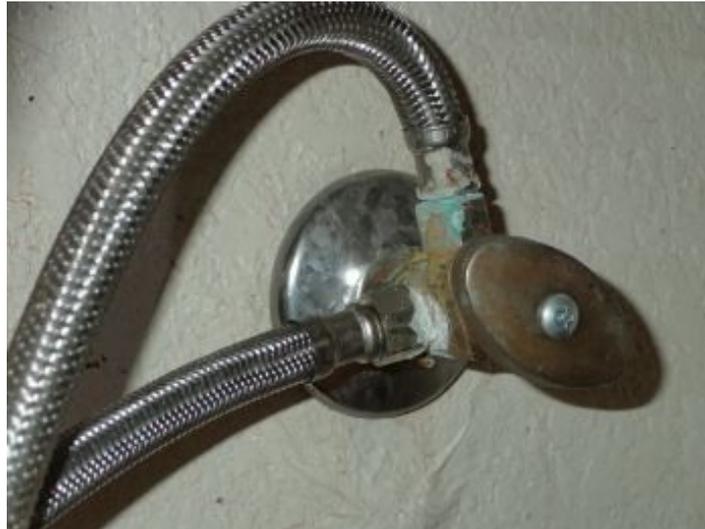
- Operational at time of inspection.
- Some corrosion noted at shut off valves, recommend review by a licensed plumbing contractor.

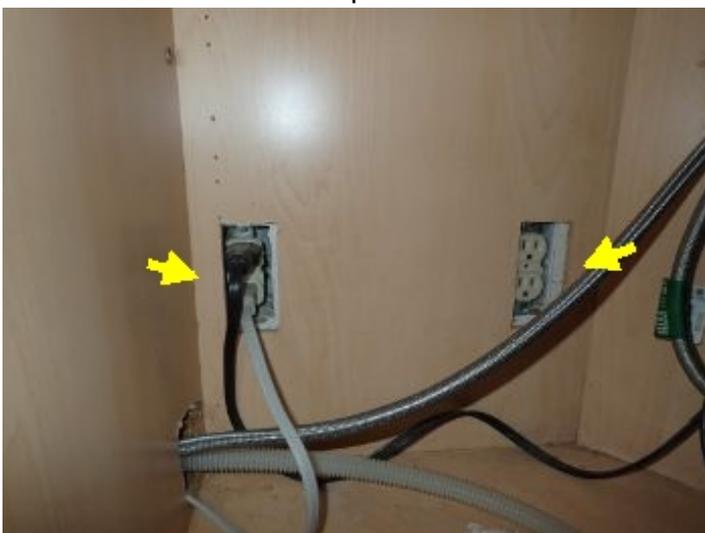
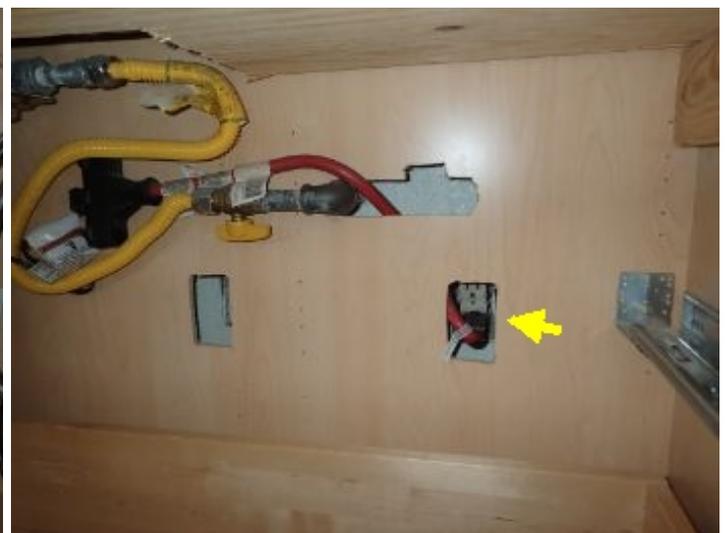
## 14. Electrical

- A number of missing covers and loose outlets noted, recommend repairing to ensure safety.
- Missing and burned out light bulbs noted.
- Extension cord wiring noted, recommend review by a licensed electrical contractor to ensure safety.
- Note; Additional electrical added to kitchen, recommend review by a licensed electrical contractor to ensure safe and adequate service.

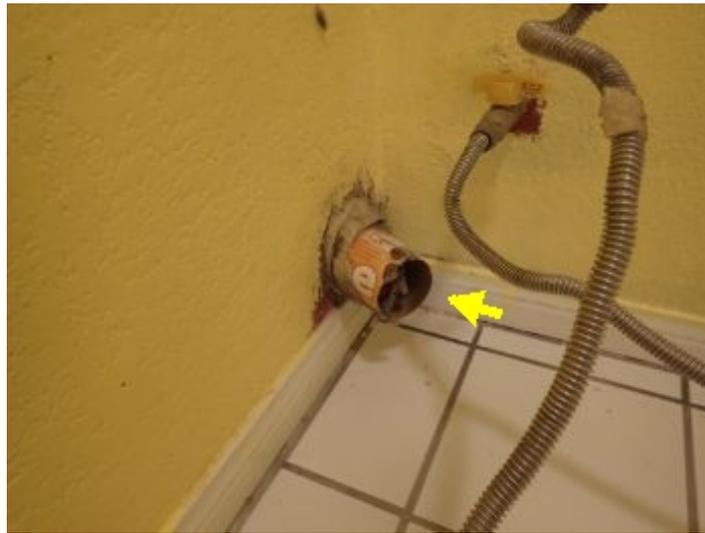
- Dryer vent is damaged, recommend repairing.
- Recommend installing ridged metal pipe in garage area.
