TH Inspection Services

Property Inspection Report

42263 50th St. West, Lancaster, CA 93536
Inspection prepared for: Larry Williams
Date of Inspection: 12/12/2018 Time: 10:00 am
Age of Home: 27 yrs. Size: 1600 sqf.
Weather: Partly cloudy

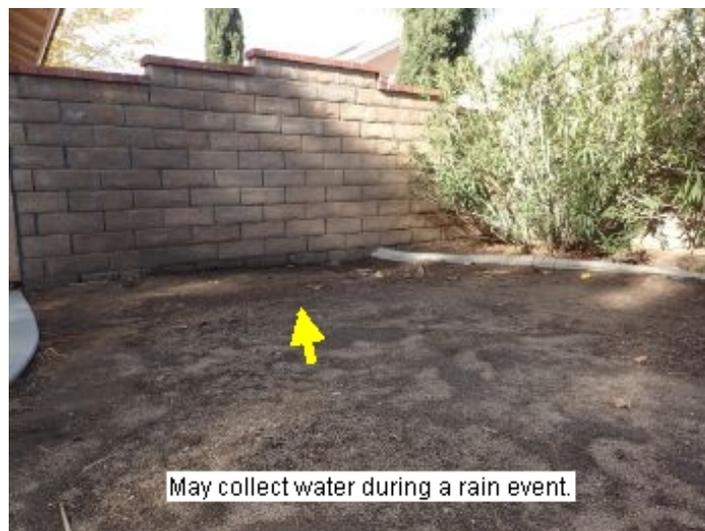
- ****Block Wall Drainage****
- Block walls should have a drainage hole at bottom of wall to allow water to drain from rear yard.
- Back yard may trap water during a rain event due to configuration of yard drainage.

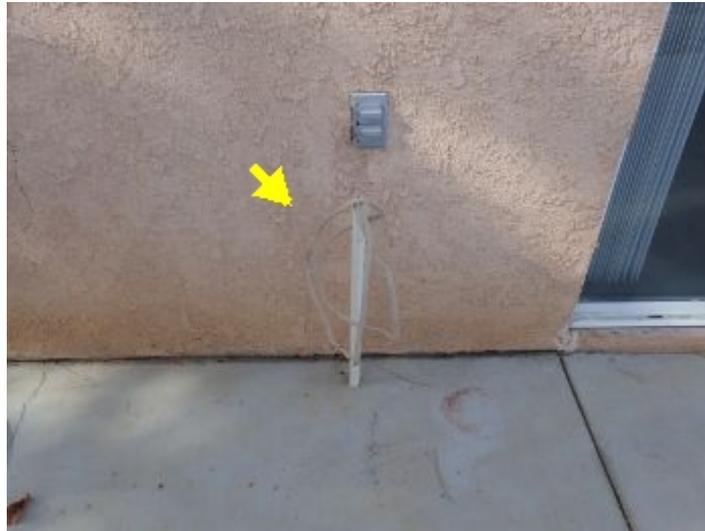
- Additional electrical is added to property, recommend review by a licensed electrical contractor to ensure safe and adequate service.
- Recommend securing loose boxes and conduit to ensure safety.
- ****Exterior Outlets****
- Appeared to be in operational condition.
- ****Exterior Light Fixtures****
- Recommend adding protective covers on bare bulb light fixtures.
- A number of missing light bulbs, recommend installing to ensure safety.
- **Exposed wires noted at rear patio area, recommend repair by a licensed electrical contractor.**

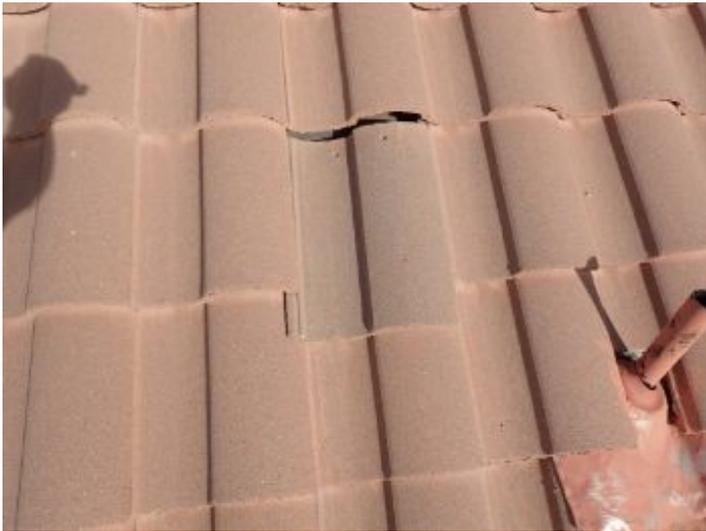
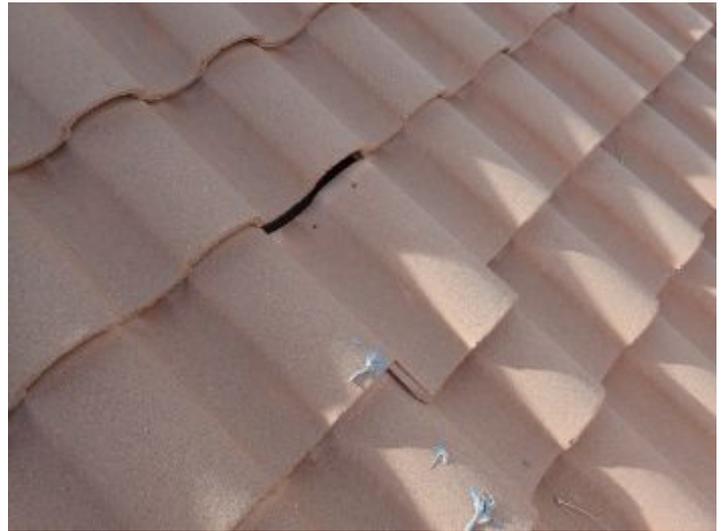
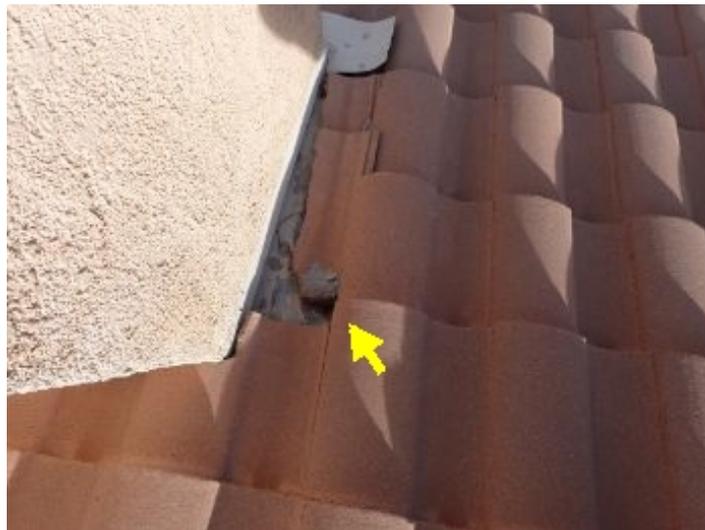
1. Roof Condition

- A number of broken roof tiles were noted at time of inspection.
- Roof tile has slipped out of place in a number of areas.
- Open areas noted on roof surface at time of inspection, possible water intrusion can occur.
- Exposed roofing felt noted at time of inspection.
- Concrete end caps are showing wear, recommend repairing or replacing.
- No leak or water test was performed at this inspection.
- Recommend review and repair by a licensed roofing contractor.
- Recommend a roof certification by a licensed roofing specialist.

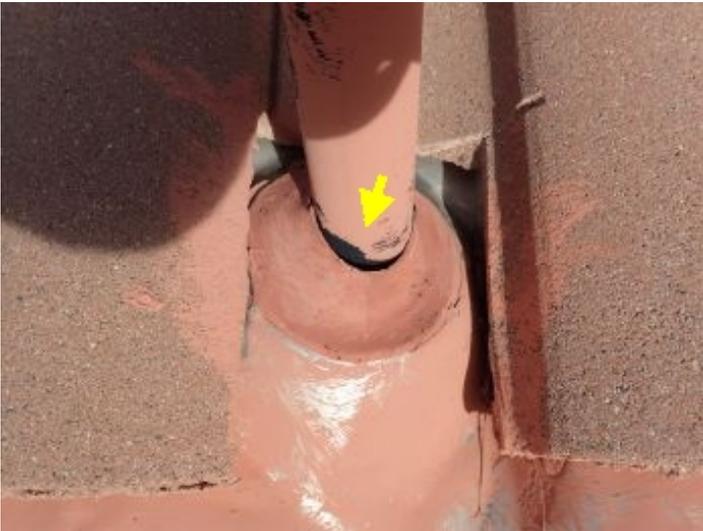
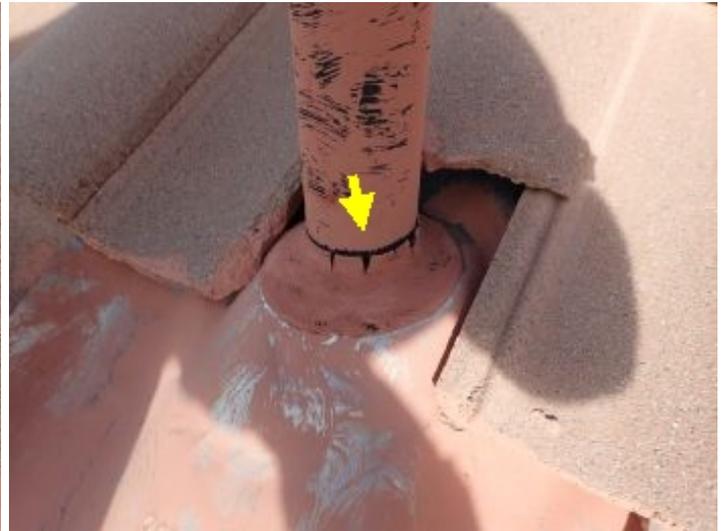
2. Flashing

- ****Plumbing Vents****
- Deteriorated rubber boot seals noted at plumbing vent pipes, recommend review and repair by a licensed roofing contractor.

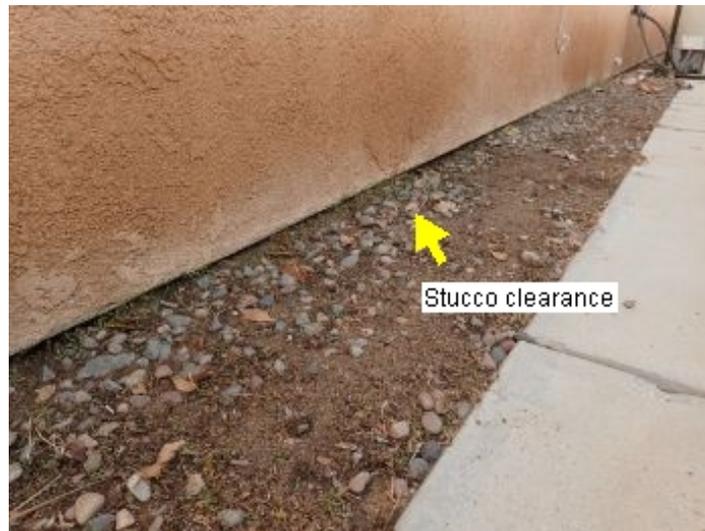
- Some stucco deterioration noted, recommend patching to minimize water intrusion.
- Patched areas noted, unable to verify if repairs were done properly.

- Stucco weep screed is rusted in a number of areas, this is normally caused by too much moisture.
- Seal all stucco penetrations to minimize water intrusion.

- Stucco is stained in a number of areas, stucco is also paintable.
- All repairs should be done by a licensed stucco contractor to ensure a water tight seal.

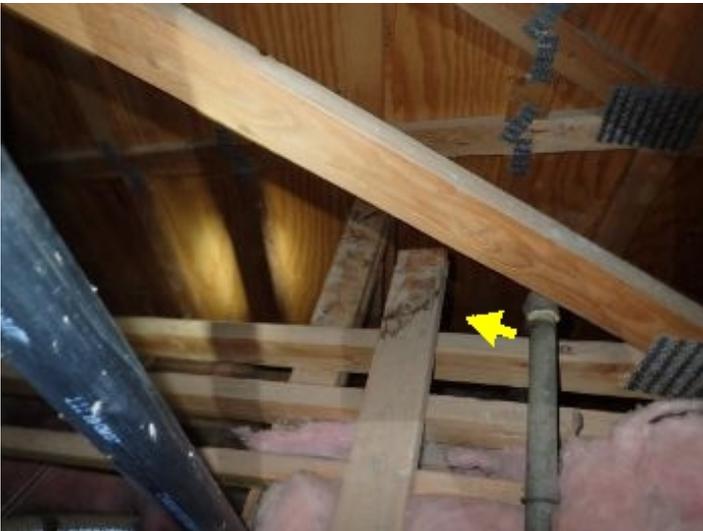
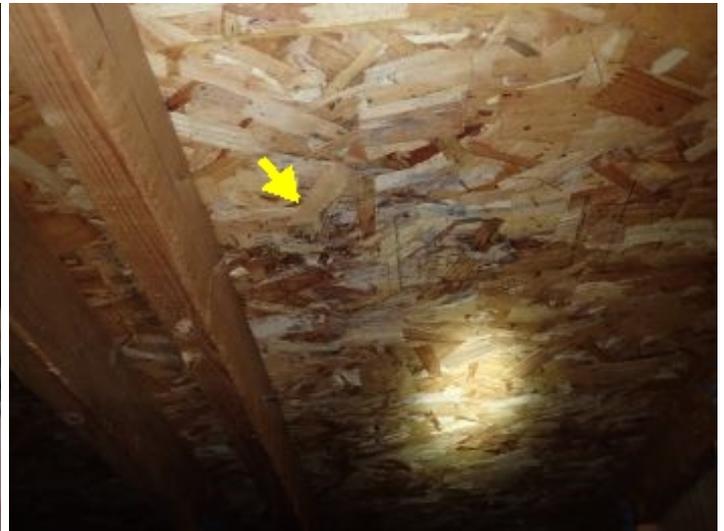
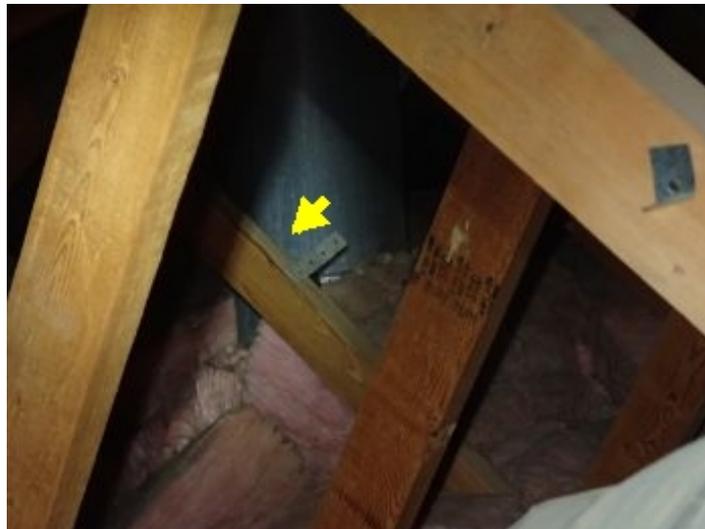
- Engineered wood truss framing noted.
- Evidence of past leaking noted at a number of locations, recommend review and repair by a licensed roofing contractor.
- Possible organic substance noted, if further testing is needed recommend contacting a licensed lab.
- Note; Limited review of structure due to attic design and air ducts. Inspector could not access all areas of the attic.

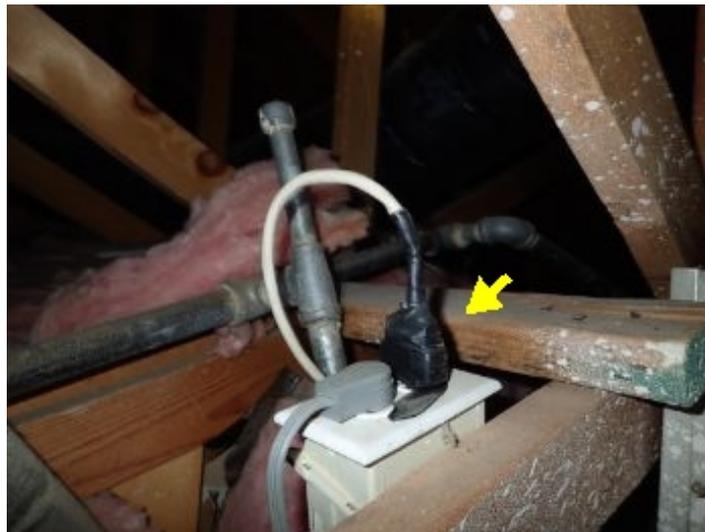
- Additional electrical is added to attic area, recommend review by licensed electrical contractor to ensure safe and adequate service.
- Extension cord wiring was noted at time of inspection.
- Unable to determine condition of all electrical due to being covered by insulation.

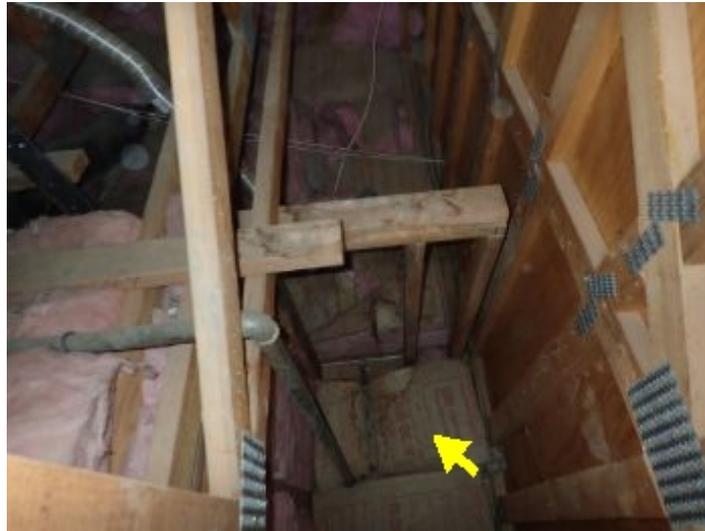
8. Insulation Condition

- Insulation is displaced in attic at a number of areas, recommend installing to avoid lose of energy.
- Stained insulation noted this is a indication of water or moisture entering attic area.
- Kraft paper on insulation is exposed to attic area, recommend repairing insulation.

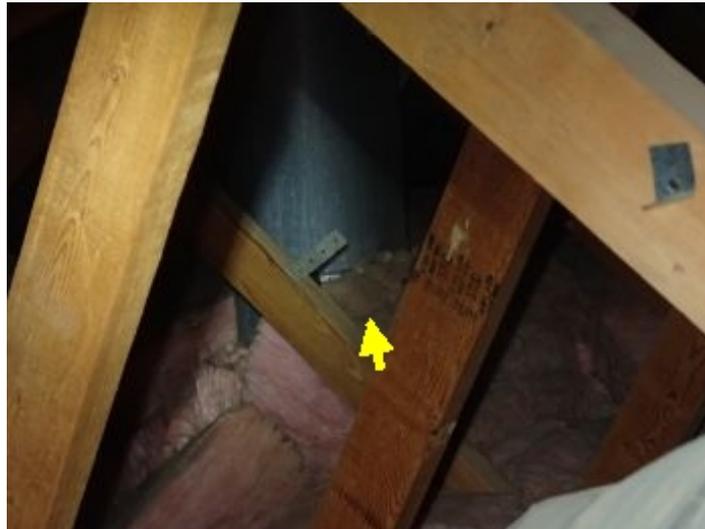
9. Chimney

- Evidence of past leaking noted, recommend review and repair by a licensed roofing contractor.
- ****Limited Review****

- **Chimney double wall vent pipe should maintain a minimum 1 inch clearance to combustible materials.**

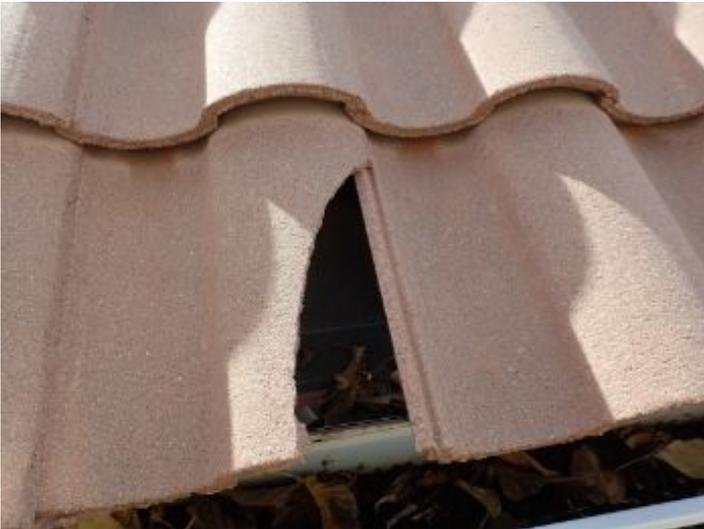
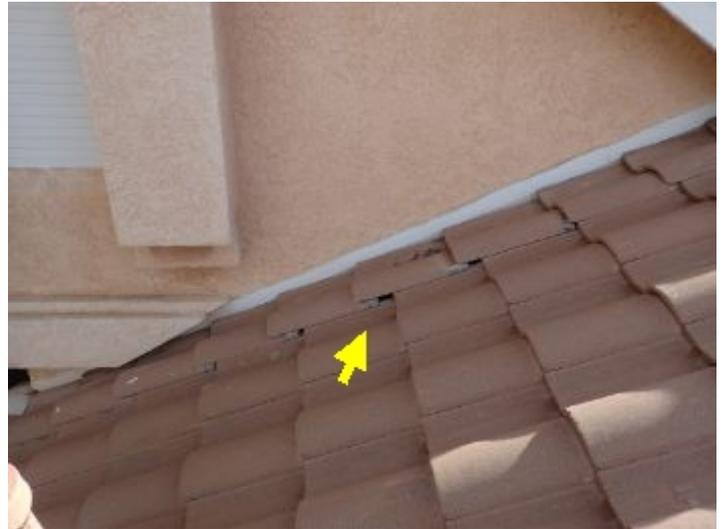
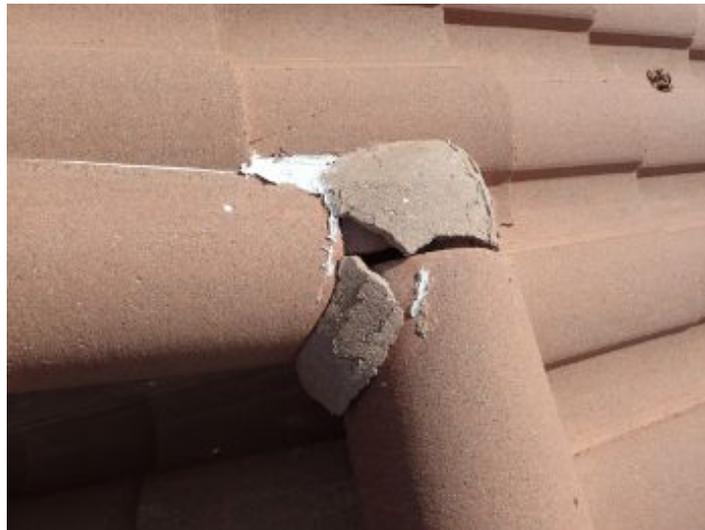
1. Roof Condition

- A number of broken roof tile noted at time of inspection.
- Roof tile have slipped out of place in a number of areas.
- Open areas noted on roof surface at time of inspection, possible water intrusion can occur.
- Exposed roofing felt noted at time of inspection.
- Concrete end caps are showing wear, recommend repairing or replacing.
- No leak or water test was performed at this inspection.

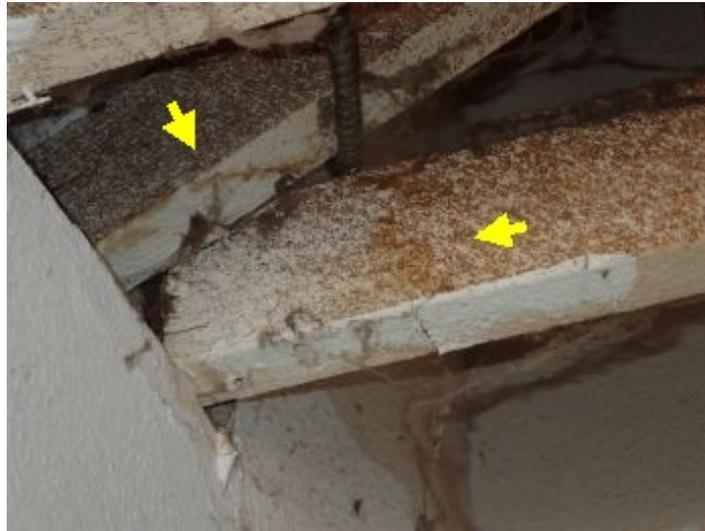
- Engineered wood truss framing noted.
- Evidence of past leaking noted, recommend review by a licensed roofing contractor.

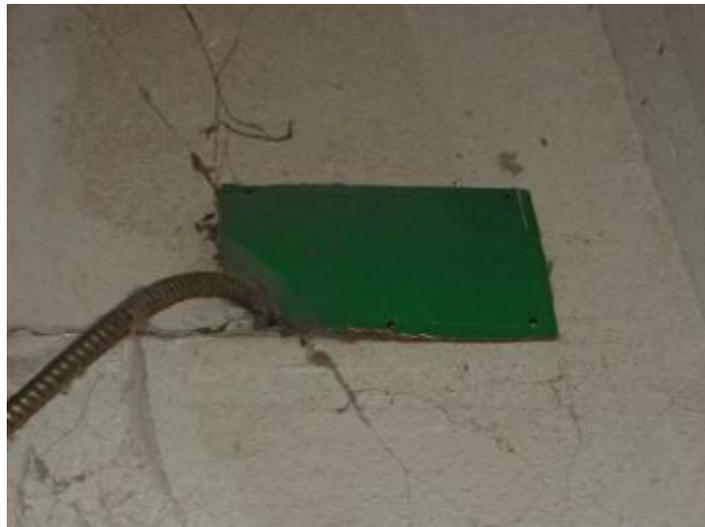
- Staining was noted from past water leaks, recommend consulting with seller.

- **The common wall between the garage and home has damage or improper covered areas. Fire potential to the home is at a greater risk. Recommend repairing or installing the proper fire rated materials.**

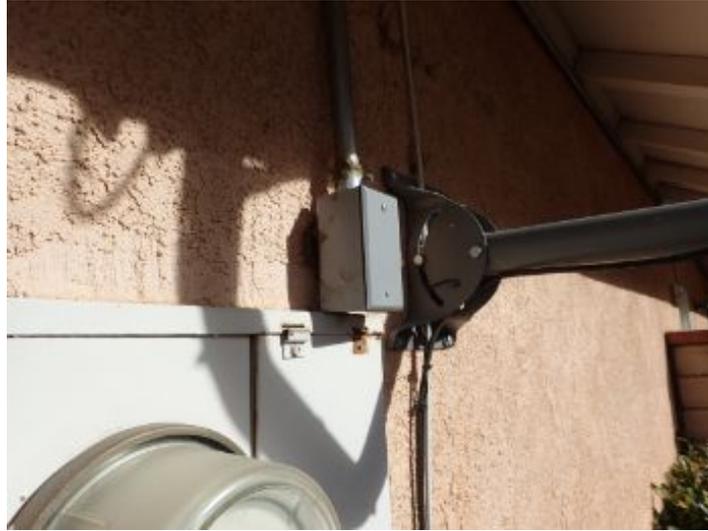
- ****Garage Trim****
- Damaged weatherstripping noted, recommend repairing.
- Exposed wood surfaces were observed at a number of areas.
- Peeling paint observed, suggest scraping and painting as necessary.

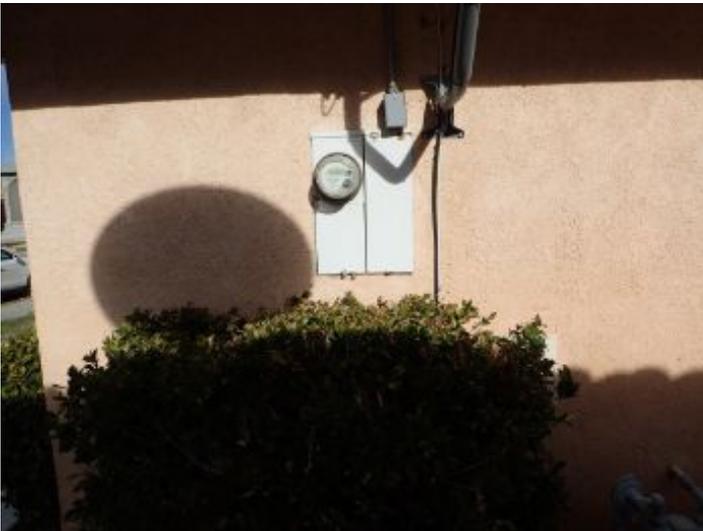
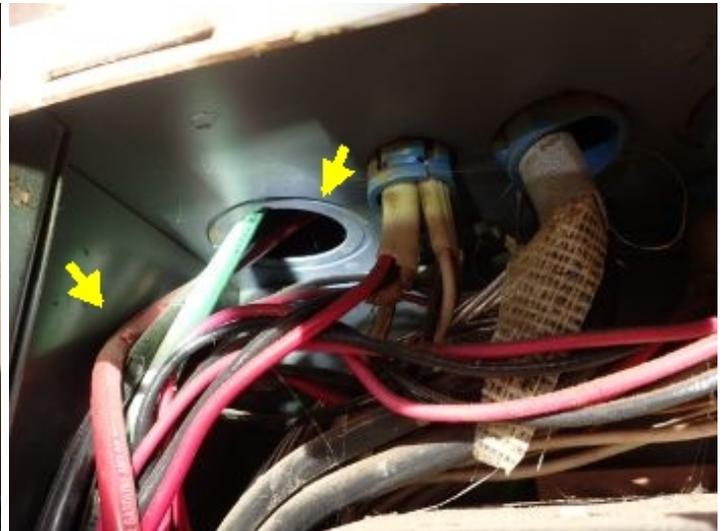
- Additional electrical added to panel, recommend review by a licensed electrical contractor to ensure safe and adequate service.
- Plastic sheathing is damaged at a number of wires, recommend review by a licensed electrical contractor.
- Wire clamp is missing at electrical panel, recommend installing to ensure safety.
- Missing hinge at panel cover, recommend repairing.
- The required electrical panel clearances for today's building standards is a minimum of 30" at sides and 36" in front of panel.
- ****Stucco****
- Previous owner penetrated the stucco water proofing due to adding an electrical box. This area may possibly leak during a rain event, recommend review by a licensed stucco contractor.

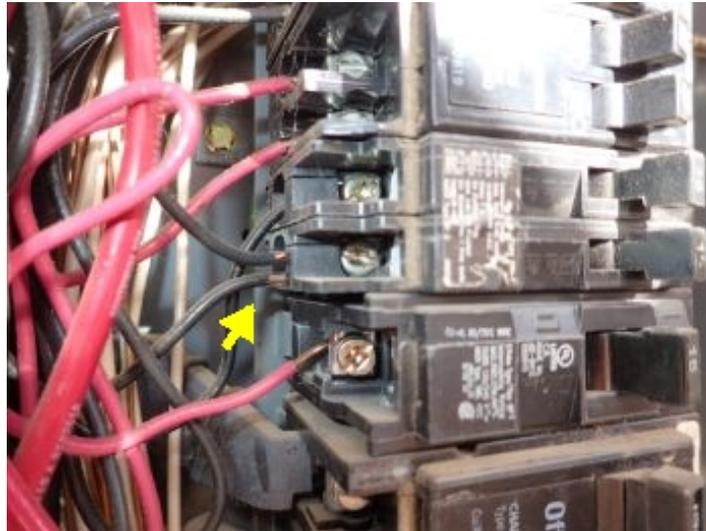
- Additional electrical added to panel, recommend review by a licensed electrical contractor to ensure safe and adequate service.
- Double tapping observed, (2 wires on a single pole breaker) this can add to the load of the circuit causing a possible overload and tripping of breakers.
- Breakers from different manufacturers are installed in panel, recommend review by a licensed electrical contractor.

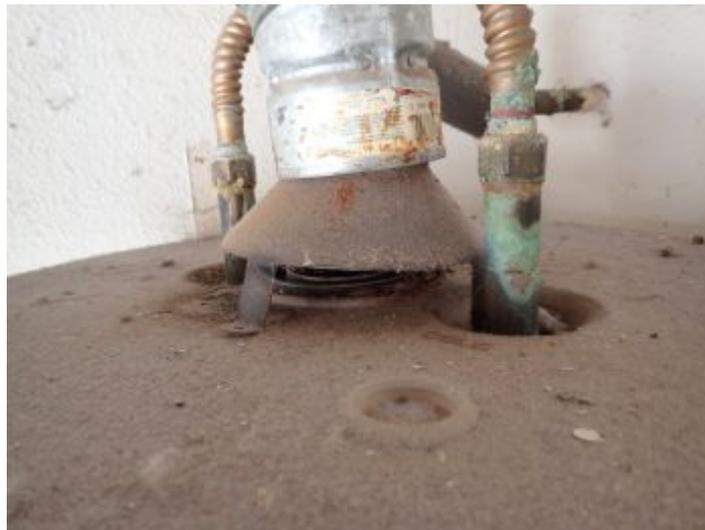
- ****Garage****
- Draft hood is loose and damaged, recommend repairing to ensure safety.
- Minimum 3 screws at each vent pipe connection, recommend review and repair by a licensed plumber.
- **The water heater vent pipe is not installed properly, recommend repair by a licensed plumbing contractor to ensure safety.**

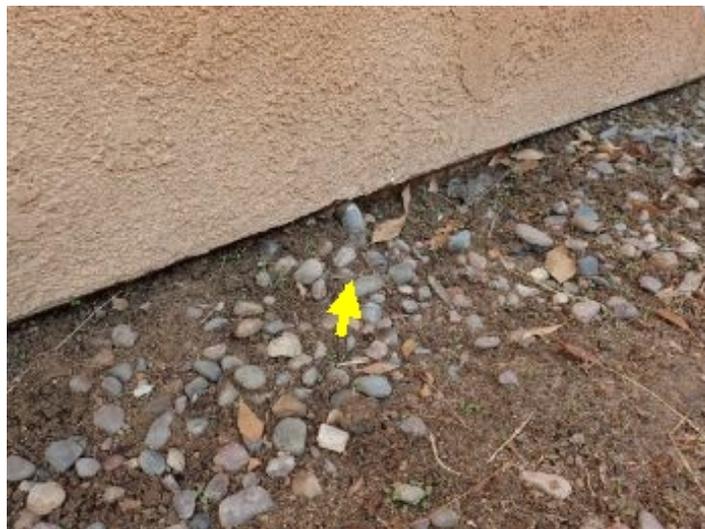
10. Overflow Condition

- Present at time of inspection, overflow lines are not tested.
- ****Exterior****
- Restricted overflow line noted, recommend clearing soil.

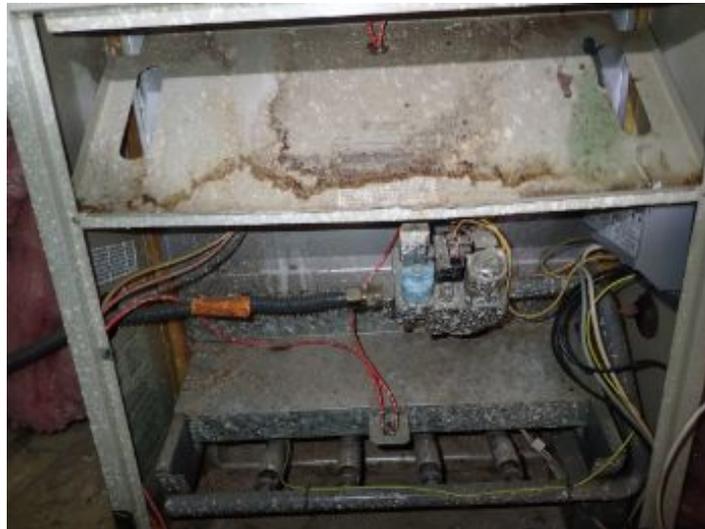
- Fan would not shut down at time of inspection, furnace was unplugged. Recommend review and repair by a licensed HVAC contractor.
- Staining and rust noted, recommend review by a licensed HVAC contractor.
- Fuel Furnace: Last service date is unable to be determined, there are areas which cannot be seen without specialized equipment and training. One such area is the combustion chamber / heat exchanger where cold air blows across the "firebox", becoming the hot air that circulates throughout your home. During the life span of any furnace, this metal wall may develop a crack or a broken weld, allowing carbon monoxide to circulate throughout the home. This is why a furnace specialist recommends a complete inspection annually; we recommend further evaluation of this unit by a licensed HVAC contractor prior to close of escrow.

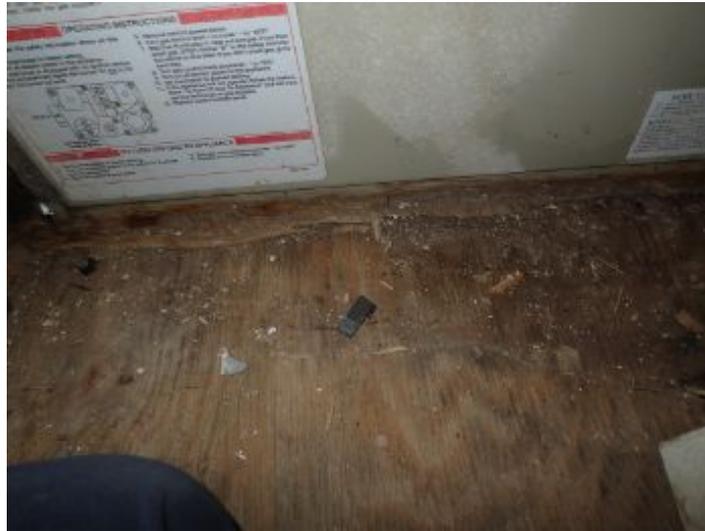
2. Heater Base

- Staining noted from past leaking, recommend review by a licensed HVAC contractor.
- Evidence of past or present animals noted, recommend further evaluation by a local licensed pest control company.

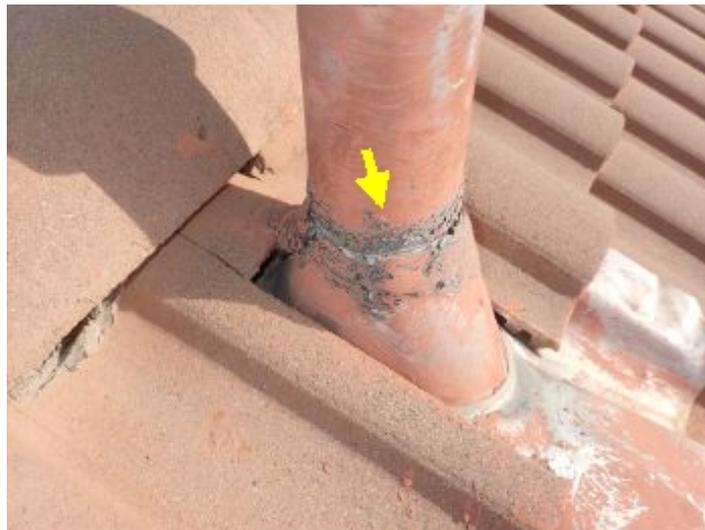
- ****Roof Flashing****
- Deteriorated sealant noted at vent pipe, sealant is recommended at flashing for a water tight seal. Recommend repair by a licensed roofing contractor.

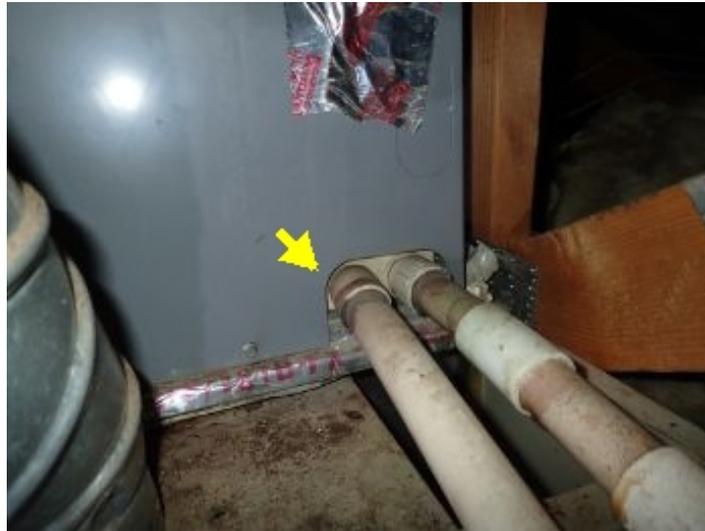
- ****Attic Area****
- Loose condensation drain line noted, recommend repair by a licensed HVAC contractor.
- Missing air gap and drain trap on condensate line, recommend review by a licensed HVAC contractor.
- ****Drain Pan****
- Drain pan is recommended under unit in attic area, recommend contacting a licensed HVAC contractor to evaluate.

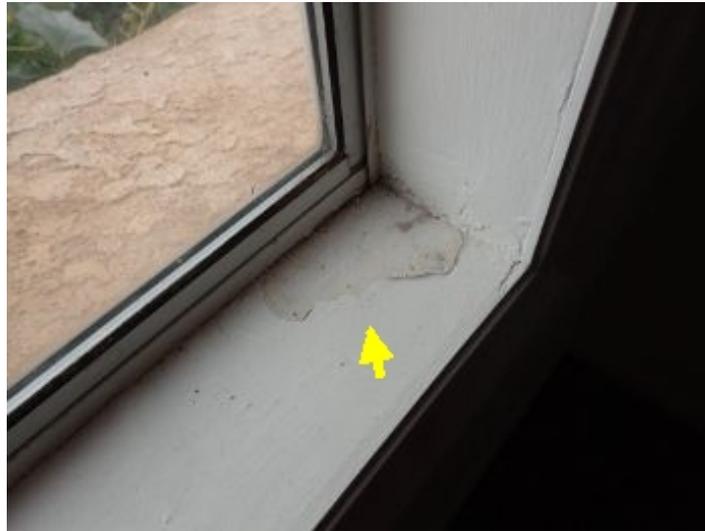
- Dual pane windows noted at time of inspection. Recommend cleaning tracks and weep holes at bottom of window frames. A number of damaged or missing window screens noted. Thermopane windows observed in the home. The inspector is unable to determine if all double glazed insulated windows in this property are completely intact and without compromised seals. Conditions indicating a broken seal are not always visible or present and may not be apparent or visible at the time of inspection. Changing conditions such as temperature, humidity, and lighting limit the ability of the inspector to visually review these windows for broken seals. For more complete information on the condition of all double glazed windows consult with a licensed window contractor.
- ****Living Room****
- Water intrusion noted at window, recommend review by a licensed window company for repair options.

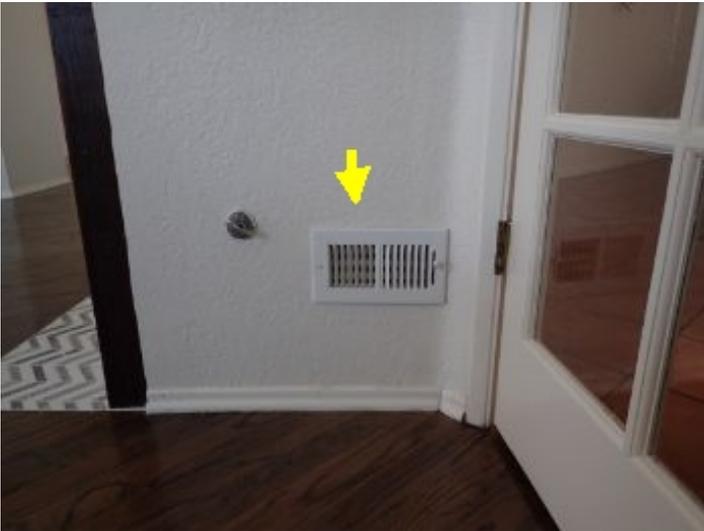
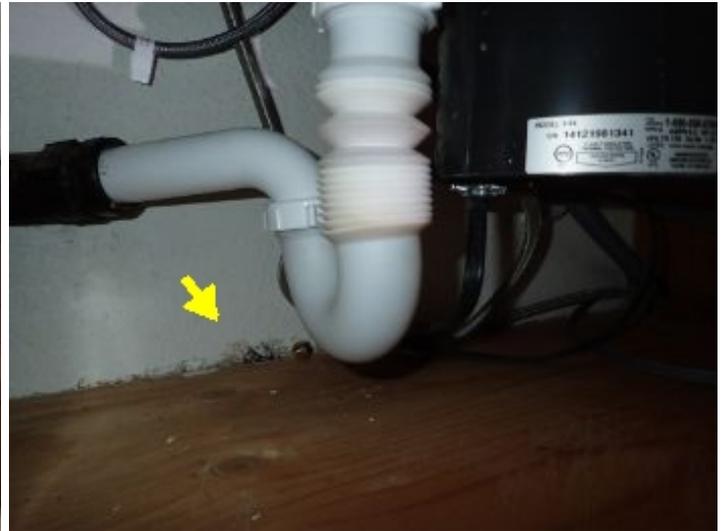
- Operational at time of inspection.
- False vent noted, recommend patching wall with approved materials.
- Some patching and minor damage noted.
- ****Under Sink Area****
- Some staining and minor damage noted from past leaking, recommend consulting with seller.
- Note; Possible organic substance could be present, if further testing is needed recommend contacting a licensed lab.

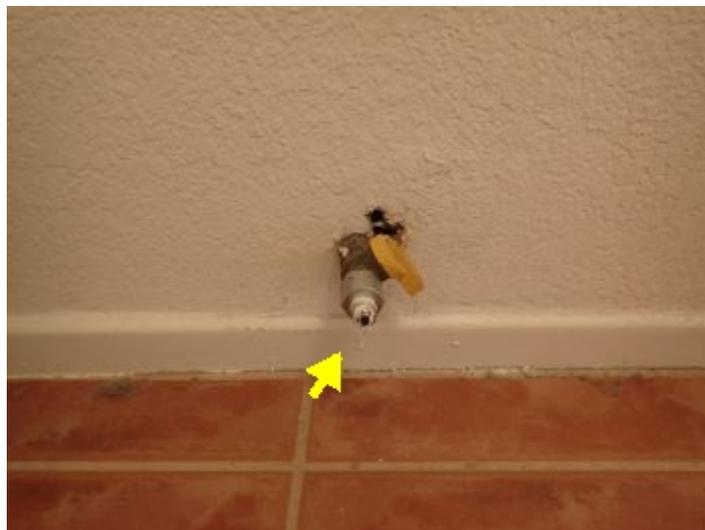
- Gas valve was not capped at time of inspection.
