CONSUMER REPORT

REFERENCE: Rhapsody Damage

LOCATION: Cable Beach 6726 WA

I am writing to report on the detailed inspection conducted at _____ Court, Cable Beach WA 6726, on 2 February 2024. At the time of inspection, the property was vacant. We were requested to quote on repairs and have also provided an assessment of the damage and its causes as part of our service for rental properties.

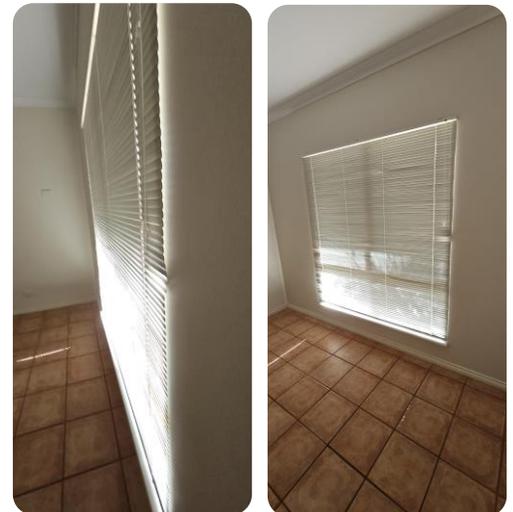
I. **Bedroom 1 – Minor Damage**

This bedroom features a single sliding window with Rhapsody venetian blinds installed on the face, with controls on the right-hand side. Based on photographs and detailed observations, the damage appears to be due to fair wear and tear, exacerbated by the product's age. These blinds are functional and provide adequate privacy.

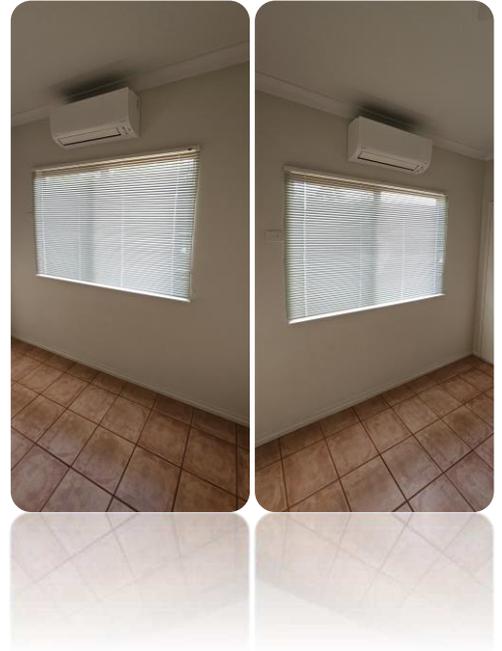
II. Bedroom 2 - No Damage

Similar to Bedroom 1, this room has a single sliding window with Rhapsody venetian blinds, showing no substantial damage. The blinds are in working condition and ensure privacy.

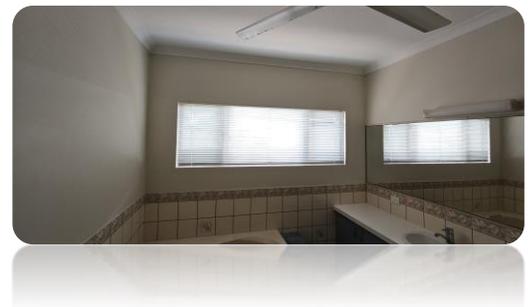
III. Bathroom (Common) - No Damage

The bathroom is equipped with a centre fixed and double sliding window and Rhapsody venetian blinds reveal fit, showing no damage. These blinds, too, are functional and ensure privacy.

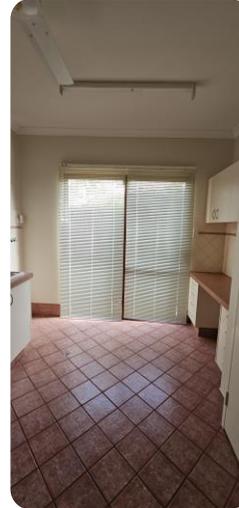
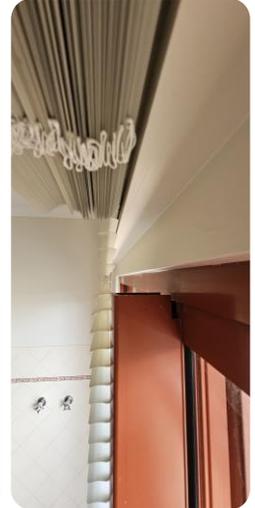
IV. Laundry – **Damaged Slats**

The laundry area features two Rhapsody venetian blinds with a common header. Installation issues have led to damage, as the blinds impede the sliding door's movement. Despite this, the blinds remain functional for privacy but require reinstallation to prevent further damage. My assessment, supported by photographs and detailed observations, concludes that the damage to the blinds is **as result of poor installation and use.** Evidence is documented in the attached photos (right), and further corroborated by manufactured date in June 2015 found on the product.

However, the blinds over the glass sliding doors in Bedroom 3 and the laundry have suffered due to poor and incorrect installation. When installing venetians in a cyclonic region it is common for windows and sliding doors to have an internal mullion to meet building standards for Category C, cyclonic regions. In this instance the installer failed to calculate the standoff required and despite obvious signs of the mullion striking the venetians didn't carry out any remedial work. These issues should be directed to the landlord for refitment.

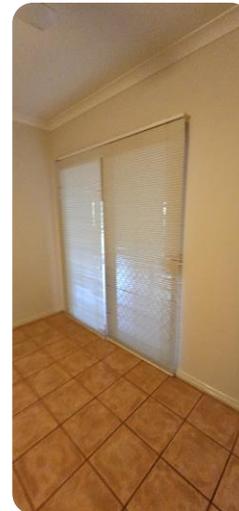
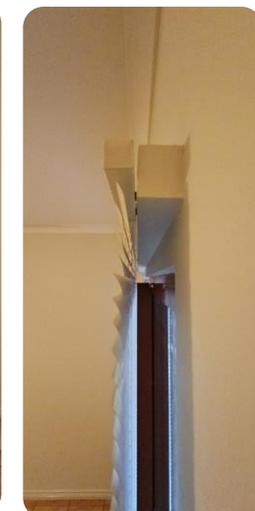
V. Bedroom 3 – **Damaged Slats & Missing Wand**

Similarly to the laundry area, Bedroom 3's blinds suffer from poor installation. They are not in working order and require a new control wand, although they still provide privacy. Corrective installation is recommended and a replacement control wand is required.

*Having tested these blinds they **are NOT in working order** and need a new control wand. We can supply to WACHS office FOC. However they are sufficient for privacy despite the damaged slats and missing wand, but should be mounted further off the wall to avoid further damage.*
