Case Study 1: Drone Roof Survey for Heritage Property in Wooler, Northumberland

4th August 2024

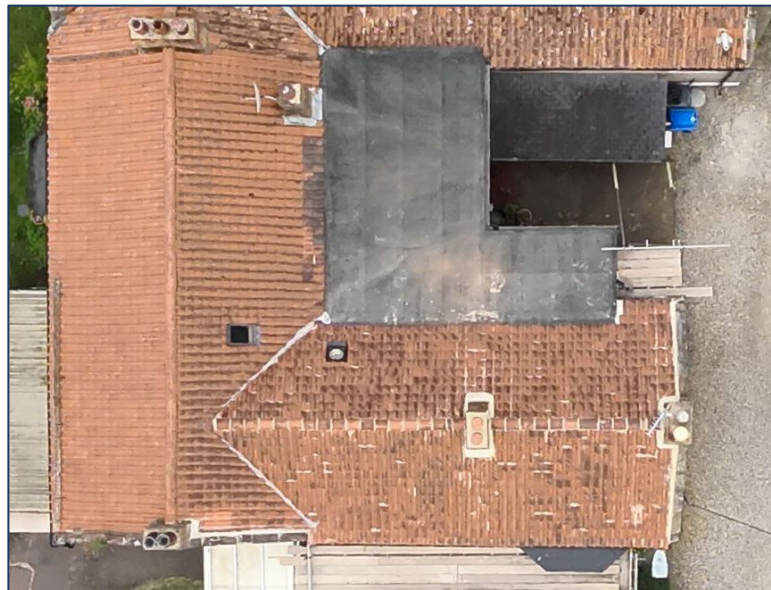
The property in question is a historic building featuring a red pantile roof, a type of roofing material known for its distinct curved shape and historical significance. Red pantiles are common in certain regions of the UK, particularly in older buildings. However, these tiles are fragile and prone to cracking or displacement over time, making regular inspections crucial to maintaining the roof's integrity.
