| | TITLE<br>IR-00MBDB / IR-W5MDB Solar Racking System | | | | |

Subject: Witness of Wind Tunnel Testing on IntegraRack Products at the George E Boeing Aeronautics Department (Kirsten Wind Tunnel) at the University of Washington

# PRELIMINARY LABORATORY TEST REPORT

| Diversi-Tech Corporation | | Multiballast DB Compression Test | | per S.A. |

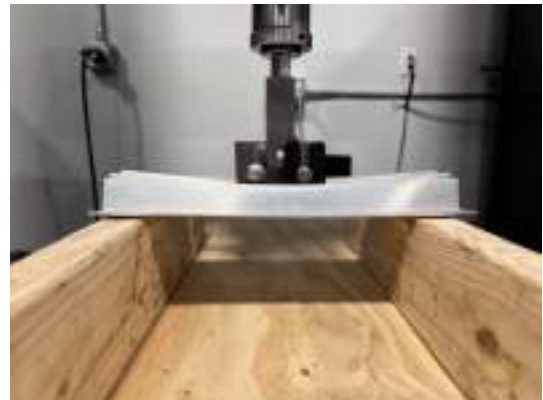
**Photo 4:** Deformation post testing

| 1 | Multiballast DB base with H-module bracket | 0.888 | 2,653 | Test stopped due to permanent deformation to the Multiballast DB base. |

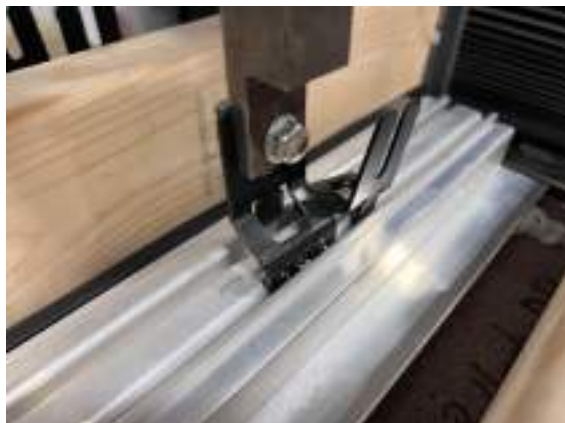
**Photo 5:** "H" bracket deformed and slipped out of Multiballast DB base test #1

| CLIENT | | PROJECT/TEST DESCRIPTION | | | | CLIENT ORDER NO. |
|---|---|---|---|---|---|---|
| 1 | Multiballast DB bonded to tile shingle #1 with H bracket (photo 3) | 0.602 | 594 | 9.1 | N/A | Test stopped when H-Module bracket slipped out of Multiballast DB base. Minor deformation was noted in the "H" bracket @ ~ 450 lbf |

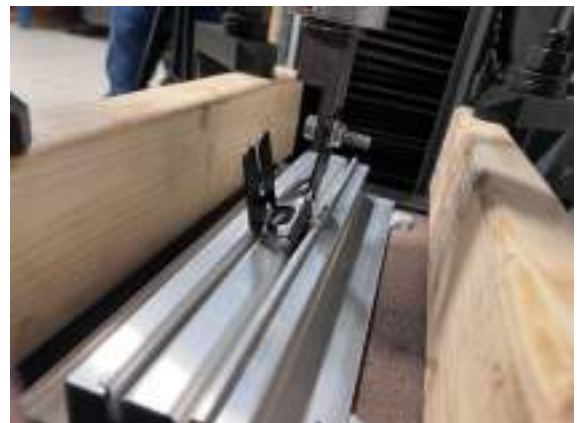
**Photo 6:** "H" bracket deformed and slipped out of Multiballast DB base test #2

| CLIENT | | PROJECT/TEST DESCRIPTION | | | | CLIENT ORDER NO. |
|---|---|---|---|---|---|---|
| 2 | Multiballast DB bonded to tile shingle #2 with H bracket (photo 4) | 0.592 | 557 | 9.6 | N/A | Test stopped when H-Module bracket slipped out of Multiballast DB base Minor deformation was noted in the "H" bracket @ ~ 430 lbf |

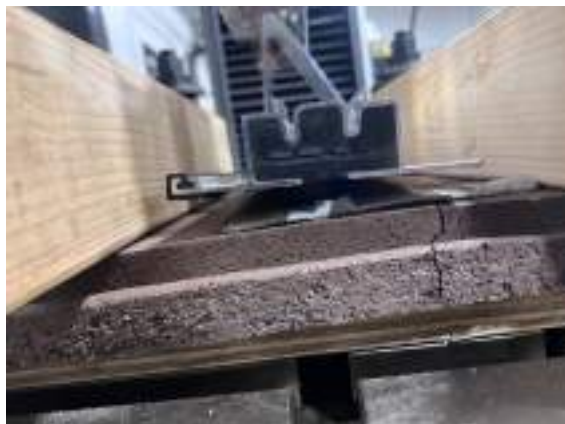
**Photo 11:** Tension test #2 adhesive failure, aluminum to adhesive

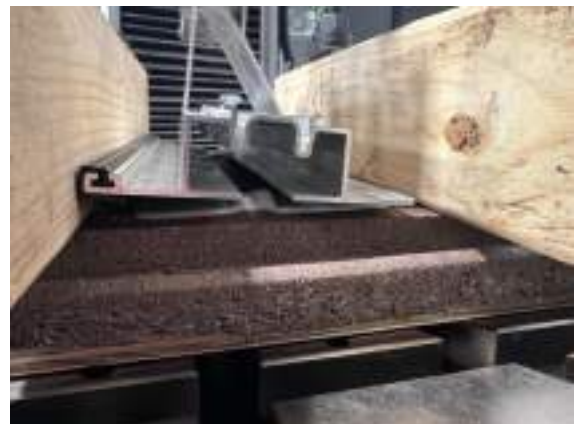
**Photo 12:** Tension test #4 adhesive failure, aluminum to adhesive

| CLIENT | | PROJECT/TEST DESCRIPTION | | | | CLIENT ORDER NO. |
|---|---|---|---|---|---|---|
| 4 | Multiballast DB bonded to tile shingle #1 with Riser bracket (photo 9) | 0.215 | 947 | 9.1 | 104 | 3 corners of the Multiballast DB de-bonded, aluminum to elastomeric sealant. The first corner popped @ ~ 919 lbf, the 2 <sup>nd</sup> corner @ ~ 740 lbf and the 3 <sup>rd</sup> corner @ ~ 336 lbf |

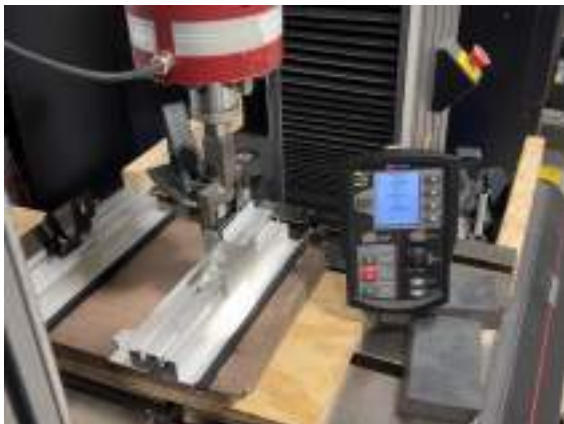
**Photo 15:** Compression test #1 near max load before tile broke

| CLIENT | | PROJECT/TEST DESCRIPTION | | | | CLIENT ORDER NO. |
|---|---|---|---|---|---|---|
| 1 | Multiballast DB bonded to tile shingle #2 with tower bracket (photo 15) | 0.272 | | 729 | Test automatically stopped due to load drop when the tile cracked @ 729 lbf | |

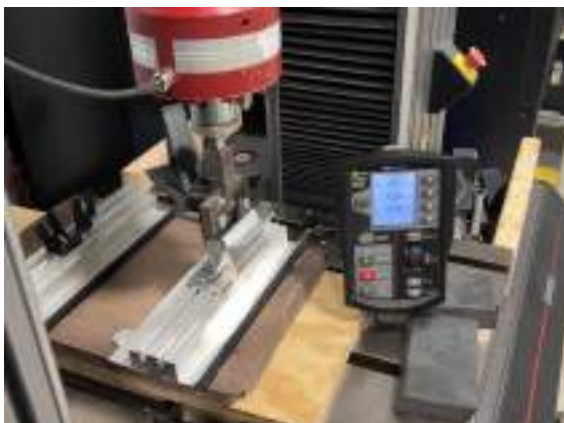
**Photo 17:** Compression test #2, permanent deformation visible

| CLIENT | | PROJECT/TEST DESCRIPTION | | | | CLIENT ORDER NO. |
|---|---|---|---|---|---|---|
| 2 | Multiballast DB bonded to tile shingle #2 with tower bracket (photo 16) | 0.530 | | 1,353 | Initial minor deformation was noted starting @ ~ 850 lbf, test continued until major deformation was witnessed load drop after hitting a max load of 1,353 lbf | |

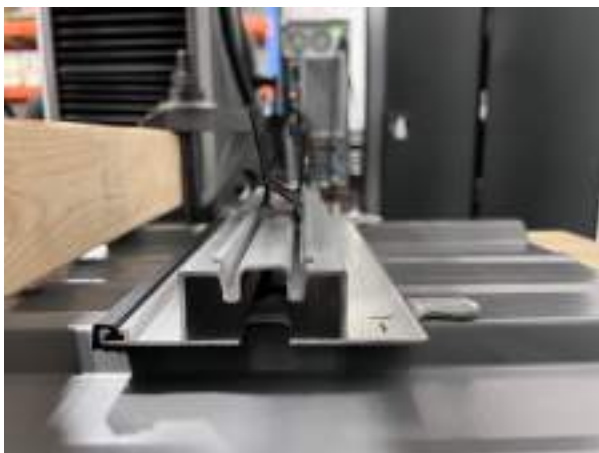
**Photo 5:** Tension test #1 "H" bracket slipped out

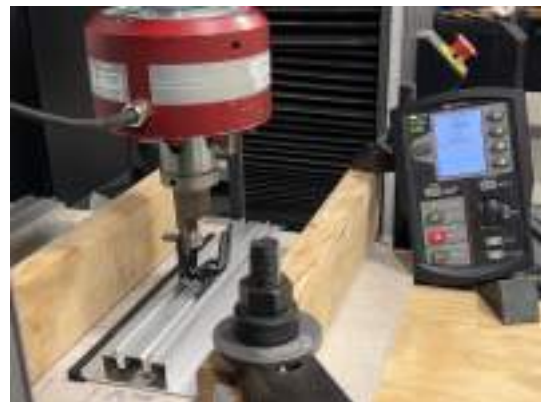
**Photo 4:** Approximate load before bolt slipped, 520 lbf
