Subject: Pullout Tests on AnchorSpike Epoxy Earth Anchors

INSPECTION AND TEST REPORT

Epoxy Earth Anchor Tensile Pullout (Uplift) Test

Small IR AnchorSpike Tensile Pullout (Uplift) Test

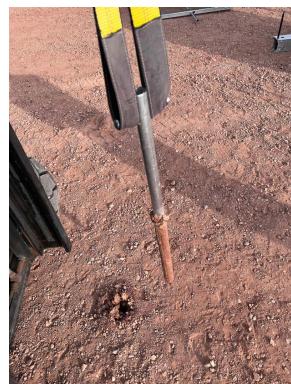
PHOTO 5: First anchor pullout

NO.	MAX FORCE REACHED (lbf)	OBSERVATIONS
1	1,950	Anchor pulled out of the ground (See Photos 2, 4-6)
2a	2,990	The bolt installed through the anchor for the purpose of the test bent and the load strap slipped off the anchor (See Photos 3, 7). The drilled thru hole had elongated.
2b	790	The load strap was reattached and test load was applied to the same anchor tested in test 2a. The drilled thru hole failed under load (Photo 8).

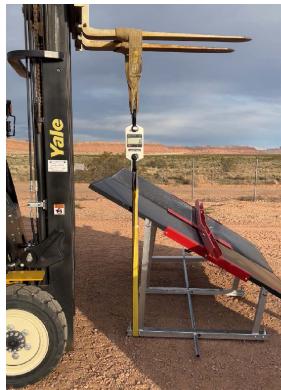
PHOTO 1: Test setup

CLIENT	CLIENT PROJECT REFERENCE	CLIENT ORDER NO.
IntegraRack	IR-30 Solar Racking System w/ Small IR AnchorSpike	per S.A.
SAMPLE DESCRIPTION		TECHNICIAN
Tensile Uplift Load Test on Small IR AnchorSpike		Weston A.
TEST DATA & EQUIPMENT INFORMATION		
TEMPERATURE:	65 °F ± 10 °F	HUMIDITY: 30% ± 10%
LOAD TYPE:	Simulated Wind - Tensile / Uplift	TEST LOAD: Record
EQUIPMENT TYPE:	Dyna-Link 2 Dynamometer	EQUIPMENT MODEL: MSI-7300RF (S/N 100326)
TEST SPECIMEN & COMPONENT INFORMATION		
TEST COMPONENT 1:	Small IR AnchorSpike System	SPECIMEN PART NO. 1: None
TEST COMPONENT 2:	IR-30 Frame Ground Rail Clamp	SPECIMEN PART NO. 2: IRP-30BT 1000-T
TENSILE UPLIFT FORCE TEST PROCEDURE/DESCRIPTION		
The IR-30 Solar Racking System Ground Frame was installed using the small IR AnchorSpikes (Photo 3) and a two part epoxy system. The AnchorSpike installation consists of pounding the anchors into the ground, filling with the two part epoxy system, and then clamping the anchors to the frame with the built in clamps. Anchors had been installed for 1 week per Client. Load was applied via a lifting strap run underneath the ground portion of the frame. The strap was positioned adjacent to the AnchorSpike to apply the pullout force in a vertical direction. The forklift was used to apply the load and load was monitored with the digital dynamometer.

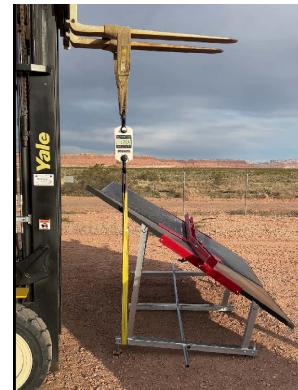
PHOTO 2: Test setup under max load

TENSILE UPLIFT FORCE INSPECTION DETAILS		
NO.	MAX FORCE REACHED (lbf)	OBSERVATIONS
1	915	
2	1,305	Initial minor pullout of anchor noted at 1135 lbf.
3	1,265	Initial minor pullout of anchor noted at 975 lbf.
4	780	
AVG.	1,066
