**IR-15 Solar Racking System**

PROJECT		
	IntegraRack		
TITLE			
IR-15 Solar Racking System			
Data Sheet		IR-15RF1000	
APPROVED	Paul Budge	7/22/2024	SIZE
CHECKED	Paul Budge	7/22/2024	CODE
DRAWN	Jeff Glauser	7/22/2024	DWG NO
			0722-010
		REV	
SCALE	1:20	WEIGHT	10lbs per frame
			SHEET 1/4

**Subject: Witness of Wind Tunnel Testing on IntegraRack Products at the George E Boeing Aeronautics Department (Kirsten Wind Tunnel) at the University of Washington**

Subject: Simulated Wind Load, Snow Load, and Horizontal Racking Load Testing on IR-30 Solar Racking System.

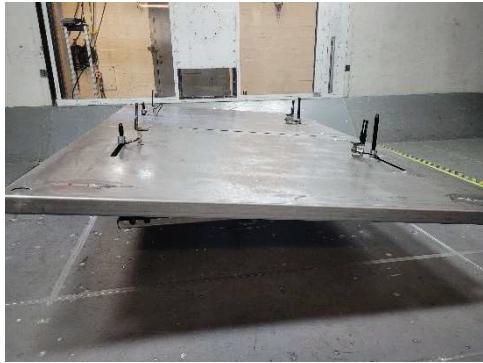
Figure 1: Run 1 through 3 simulated roof setup

A total of 8 runs were performed on IntegraRack products. Test Runs 1 through 3 were performed with the IR-D1 bracket (See Figures 1-4) with an installed 18 SF solar panel on a simulated roof incline. Run 1 was performed to tare KWT's system through the full 0 to 110 degree rotation of the test platform with the simulated roof and panel installed. The roof surface had been installed at an approximate 5 – 6 degree incline (See Figure 1). The solar panel was mounted at 0 degrees relative to the roof surface with a general height of 5 in from the roof surface. at all four corners of the panel. Test Runs 4 and 5 were performed on the same panel and bracket with the panel height adjusted and installed at an angle with the front corners set to 3-1/2 in. and the back corners set to a height of 6 in. from the roof surface.

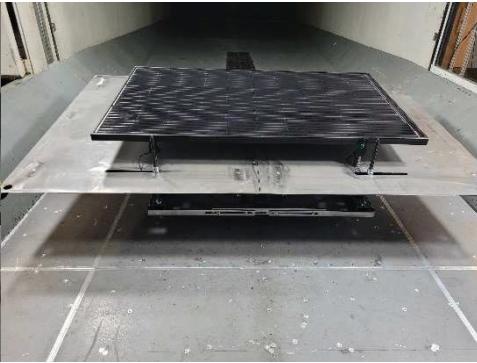
Figure 2: Run 1 through 3 setup with panel

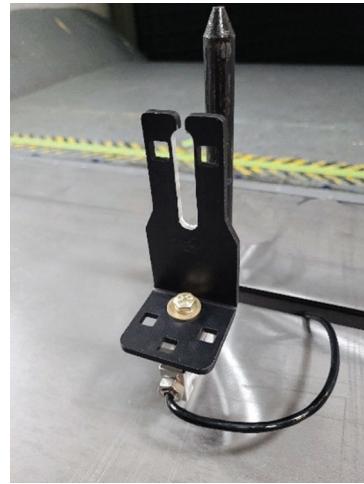
Figure 3: Bracket at leading edge LC0-1, LC0-2

Test Runs 2 through 5 included rotating the test setup from 0 to 110 degrees while KWT instrumentation recorded test data. Wind speed was increased until limitations of KWT instrumentation prevented it from being increased further. Four load cells, Omega model LC103B-250 lb Class N10, were installed between the IntegraRack bracket and the roof surface to monitor and record loads applied to the brackets throughout testing (See Figures 5-10). The load cells were labeled LC0-1, LC0-2, LC5-3, and LC5-4 with LC0 being installed at the leading edge and LC5 being installed at the back edge.

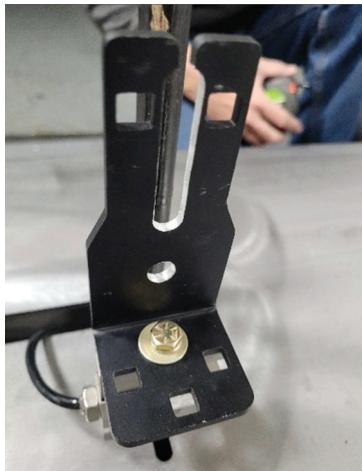
Figure 4: Bracket at back edge LC5-3, LC5-4

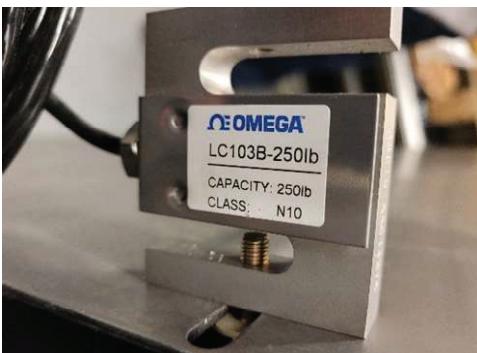
Figure 5: Load Cell Model used for tests

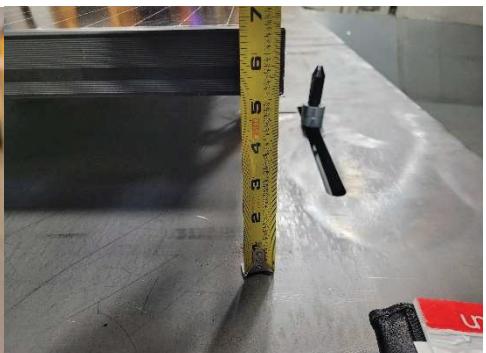
Figure 6: Height from roof to panel, Runs 2 & 3

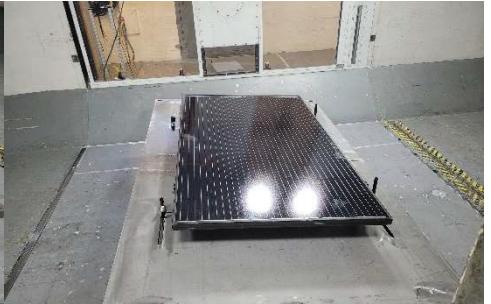
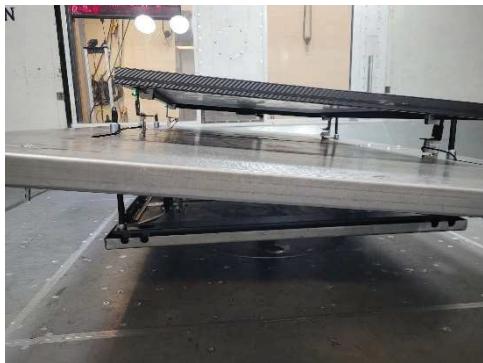
Figure 11: Setup after Run 2, 109 mph winds.  
No damages or loose hardware noted.

Figure 12: Setup after Run 2, 109 mph winds.  
No damages or loose hardware noted

Figure 13: Setup after Run 2, 109 mph winds.  
No damages or loose hardware noted

The maximum load at a bracket recorded during Test Runs 2 and 3 was 75.015 lbf at a wind speed of 157.67 MPH when the panel was at a rotation point of 60 degrees. No damage or deformation was noted

to any bracket during or after the test runs and all hardware was found to be secure upon completion of each test (See Figures 11-13).

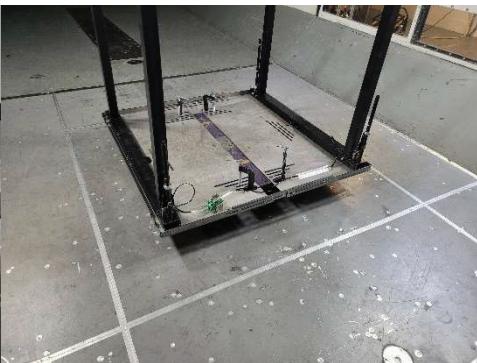
Figure 14: Setup for Run 6 with IR Ballast Frame

Test Runs 6 through 8 were performed on the IR Ballast Racks (See Figures 14-32). The simulated roof structure was removed and the frames and panel were mounted directly to the KWT test platform. These runs were performed at a set angle with no platform rotation during the test run. Two load cells were used for the test setups and were mounted at the brackets at the leading edge of the test platform at the wind intake side.

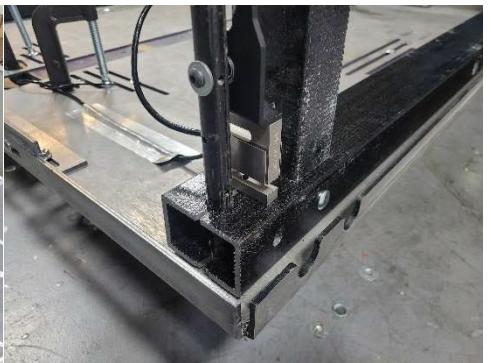
Figure 15: Load cell location at leading edge,  
LC0-1 & LC0-2

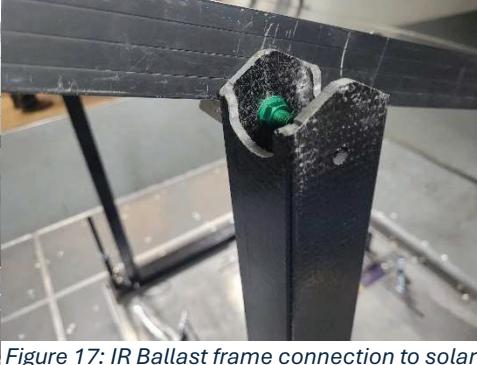
Figure 17: IR Ballast frame connection to solar panel

Figure 18: IR Ballast frame connection to solar panel

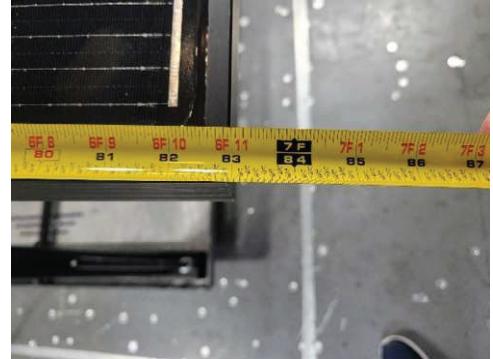
Figure 21: Solar panels total length 83 in.

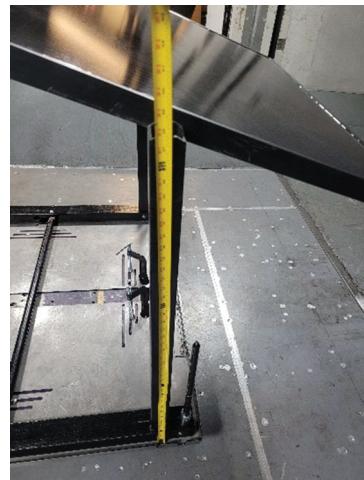
Figure 24: Run 6 trailing edge leg height

Run 6 was performed on the IR18C with the solar panel at an approximate 18 degree angle (Figures 24-25). The maximum load at a bracket recorded during Test Run 6 was 168.59 lbf at a wind speed of 101.59 MPH. Runs 7 and 8 were performed on the IR30C with the solar panel at a 30 degree angle (Figures 30-32) with Run 7 having the solar panel mounted and aligned with the wind direction to produce maximum forces on the frame and Run 8 being run in an orientation 90 degrees offset from Run 7. The maximum load at a bracket was during Test Run 7 and was 183.38 lbf at a wind speed of 81.138 MPH. Run 7 was stopped when the drag limit of the KWT test apparatus was reached. The solar frame experienced shaking under wind load but no damage was found to any part and all bolts were found to still be tight and in place after the test run. Run 8 was pitch limited by the KWT test apparatus. Similar to Run 7 the frame and solar panel had experienced shaking under load but no damage to the frame or panel was noted and all bolts and connections remained tight.

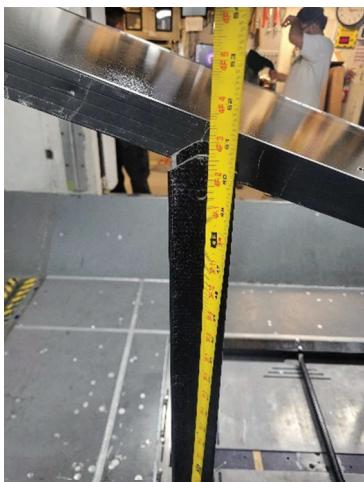
Figure 25: Run 6 leading edge leg height

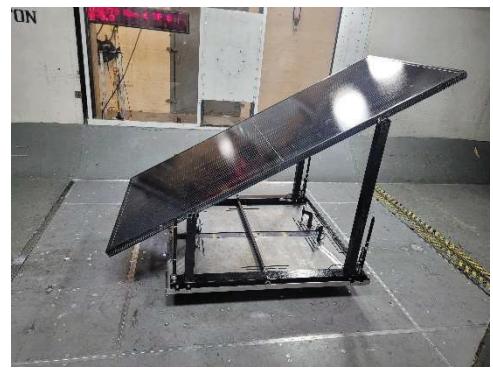
Figure 30: Runs 7 - 8 Test setup

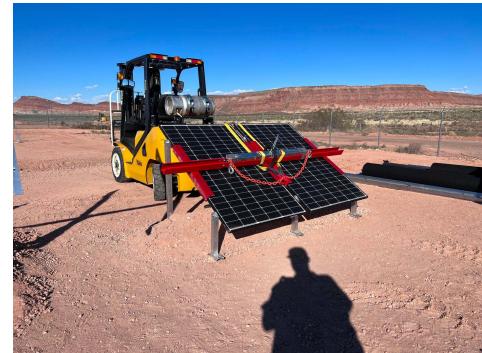
PHOTO 3: Test setup - IR-30 Solar Racking System with red test cross frame

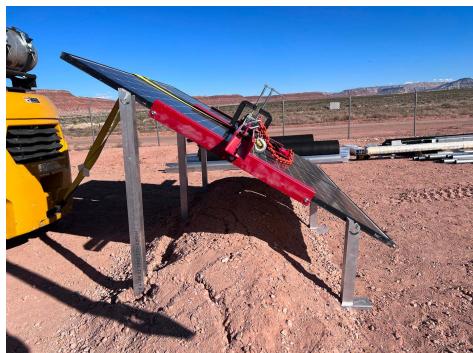
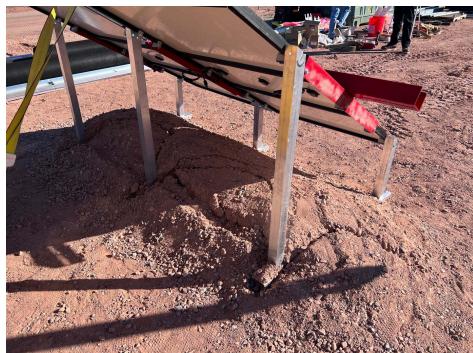
**PHOTO 13:** Ballast after completion of testing

**PHOTO 14:** Ballast and frame after completion of testing

The solar panels were set at an approximate 30° angle. The tensile force was applied upwards and away, at a perpendicular angle from the solar panels using the skid steer (Photo 4). Load was monitored with the digital dynamometer. Load was recorded when an initial shift of the solar panel frame was noted and when the shift was large enough to cause visual changes to the frame and in the ballast surface (Photos 5-13).

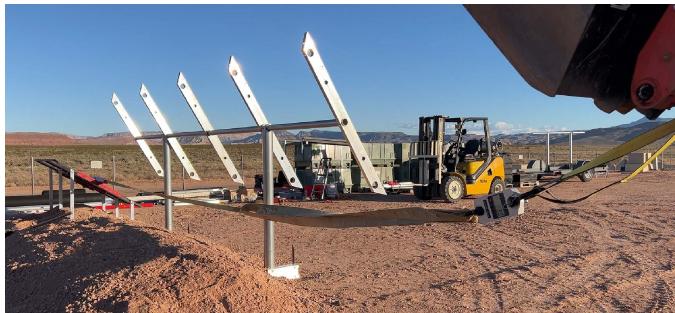
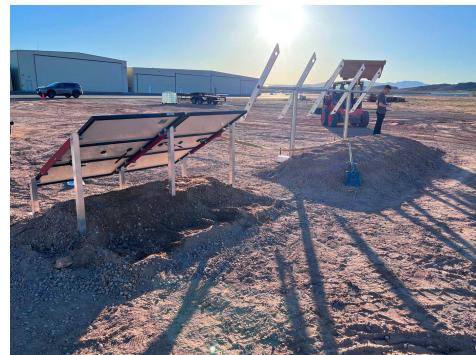
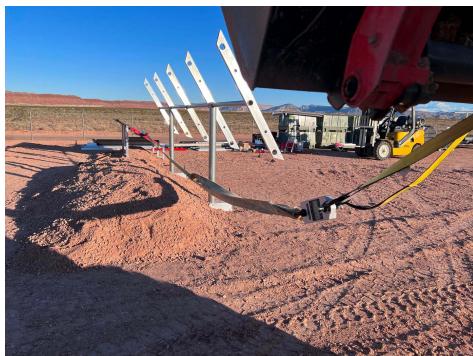
**PHOTO 1:** Horizontal force test setup

**PHOTO 2:** Horizontal force test setup

**PHOTO 3:** Horizontal force test setup

The IR-30 Solar Racking System Ground Frame was installed with the IR EarthBallast System and two solar panels. The EarthBallast system utilizes a mesh that is epoxied to the frame which is then loaded with loose dirt fill (ballast) that supports and holds down the frame. The horizontal load test was performed after the vertical uplift tensile load test. The system was tested with 3 loads of dirt from a Kubota SSV75 skid steer. The skid steer dirt loads were estimated at ~ 500 lbf each using an estimate of 100 lbf/ft<sup>3</sup> for the density of soil. A lifting strap was wrapped around the panel lengthwise and run parallel to the frame in order to apply a horizontal force to the system (Photos). Force was applied using the skid steer and load was monitored with the digital dynamometer. The test was stopped at a load of 645 lbf. No movement or damage was visually noted during or after the test.

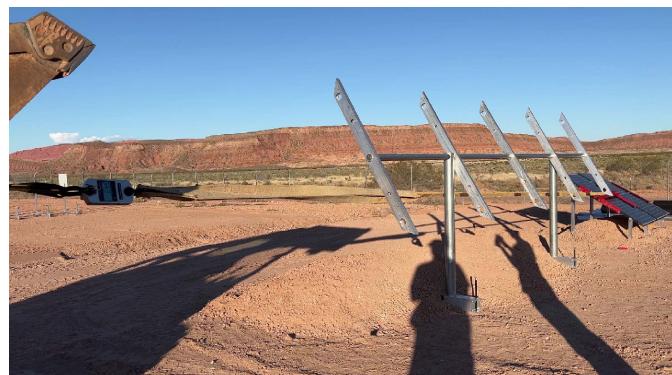
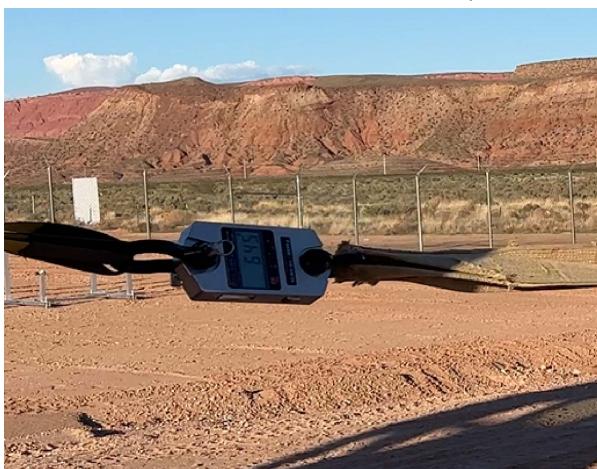
**Photo 4:** Horizontal force test at max load

**Photo 4:** Horizontal force test max load

TEST NO.	BALLAST DETAILS		MAX. HORIZONTAL FORCE (lbf)	OBSERVATIONS
	SIZE (LxWxH) (in.)	WEIGHT (lbf)		
1	90 in. x 42 in. x 14 in. (14 CF)	~ 1400 lbf (3 skid steer buckets)	645	Test was stopped at 645 lbf. No damage or movement was visually noted.

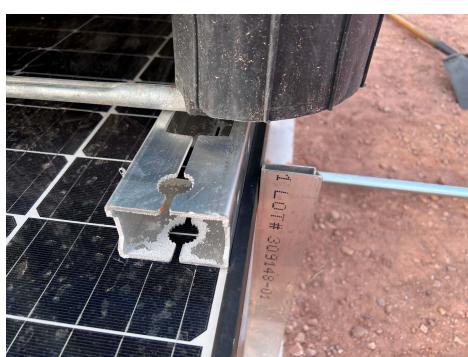
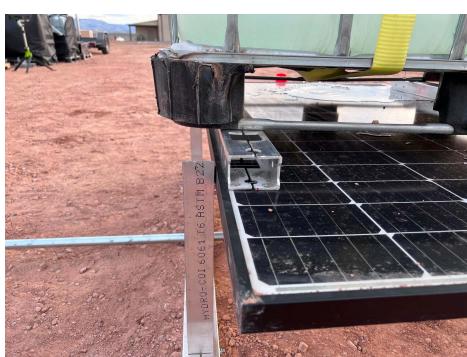
PHOTO 7: Slight deflections noted under load

PHOTO 8: Slight deflection noted under load

COMPRESSIVE FORCE		OBSERVATIONS
	DESCRIPTION	WEIGHT (lbf)	
1	Large water tank	2410	Solar panel held load overnight (> 10 h).
2	Large water tank + (12) five gallon jugs	2950	Solar panel held load, ~ 10 -15 minutes under observation. Slight deflections noted under load (See Photos). Minor permanent deformation noted after load removal (See Photos). The alignment tabs in the vertical uprights were no longer flat with the uprights.

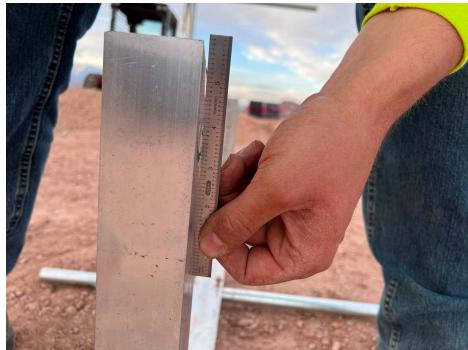
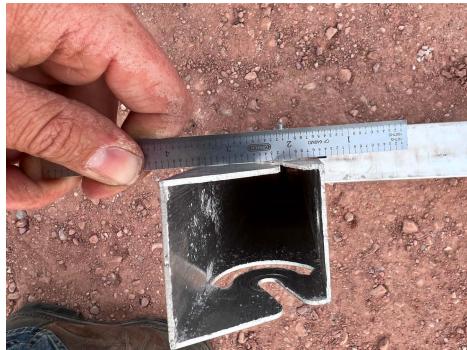
**PHOTO 10:** Slight deformation after load removed

**PHOTO 11:** Slight deformation after load removed

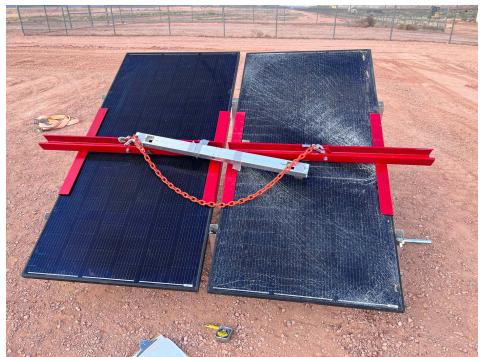
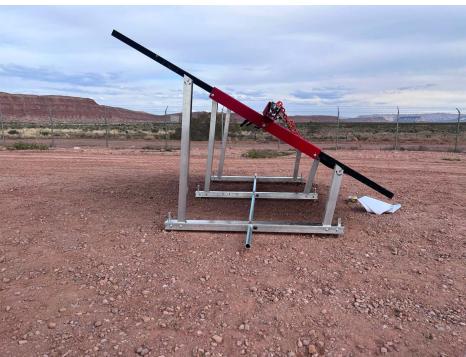
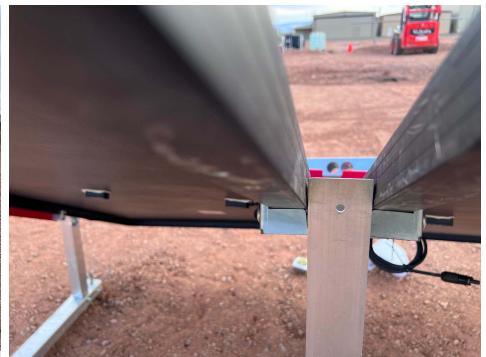
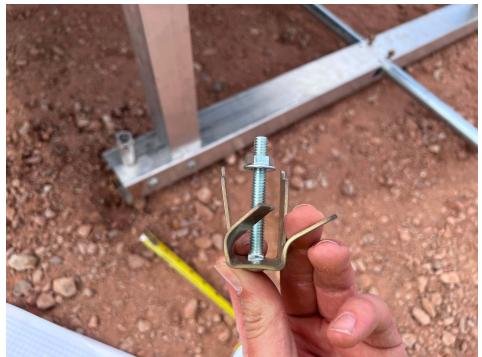
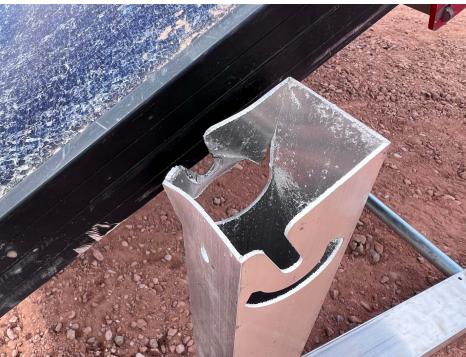
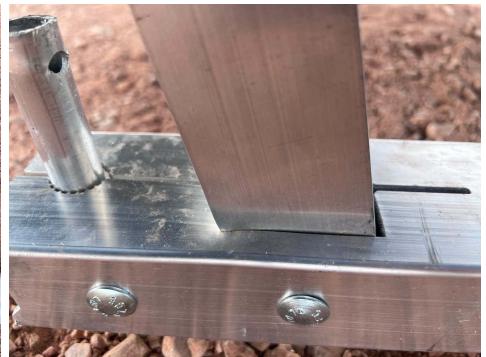
PHOTO 10: Solar panels after testing

PHOTO 11: Frame after testing

PHOTO 12: Middle brackets after testing

PHOTO 13: Bracket deformation after testing

PHOTO 14: Upright mount deformation after testing

PHOTO 15: Upright deformation after testing

<b>SIMULATED WIND LOAD (TENSILE UPLIFT) FORCE INSPECTION DETAILS</b>												
TEST NO.	MAX. FORCE (lbf)	OBSERVATIONS										
1	2385	<p>At 1500 lbf the frame visibly shifted and started to roll forward.</p> <p>At 2385 lbf one of the solar panels failed and shattered (Photos 7-9). The frame and brackets holding the solar panel kept it in place and were permanently deformed. The aluminum tube upright had bent forward and outward causing the seam of the tube to tear and it allowed the through bolt to come free. Two mounting brackets permanently deformed and there was additional permanent deformation in the base frame (Photos 10-15)</p>

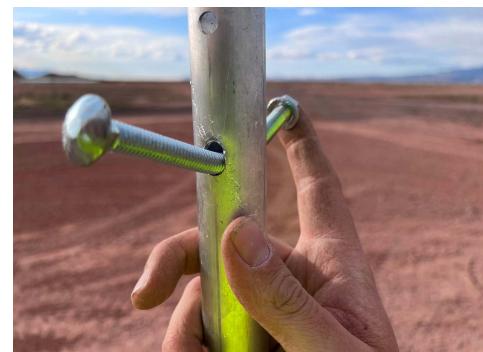
PHOTO 6: First anchor pullout with drilled thru hole deformed

NO.	MAX FORCE REACHED (lbf)	OBSERVATIONS
1	1,950	Anchor pulled out of the ground (See Photos 2, 4-6)
2a	2,990	The bolt installed through the anchor for the purpose of the test bent and the load strap slipped off the anchor (See Photos 3, 7). The drilled thru hole had elongated.
2b	790	The load strap was reattached and test load was applied to the same anchor tested in test 2a. The drilled thru hole failed under load (Photo 8).

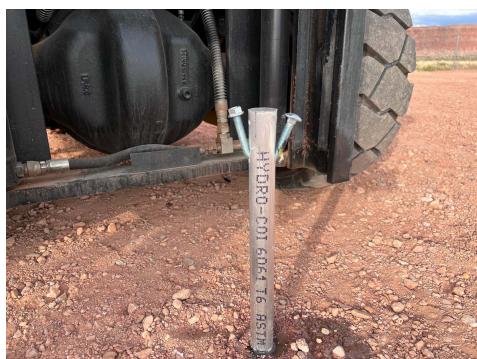
PHOTO 7: Second anchor - first pull where the thru bolt bent and load strap slipped off

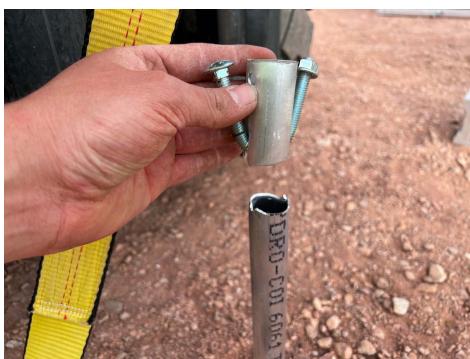
PHOTO 8: Second anchor - second test where anchor failed at drilled thru hole
