| | | IR-30 Solar Racking System | | | |
| | | Data Sheet | | | |
| | | IR-30RF1000 | | | |

Subject: Simulated Wind Load, Snow Load, and Horizontal Racking Load Testing on IR-30 Solar Racking System.

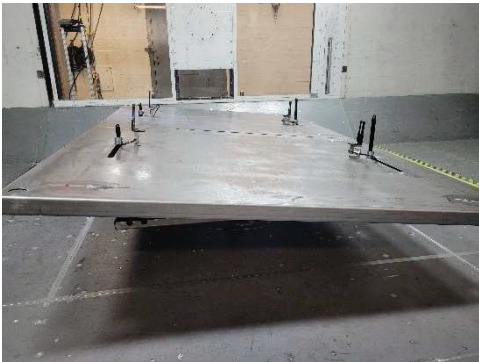
Figure 1: Run 1 through 3 simulated roof setup

A total of 8 runs were performed on IntegraRack products. Test Runs 1 through 3 were performed with the IR-D1 bracket (See Figures 1-4) with an installed 18 SF solar panel on a simulated roof incline. Run 1 was performed to tare KWT's system through the full 0 to 110 degree rotation of the test platform with the simulated roof and panel installed. The roof surface had been installed at an approximate 5 – 6 degree incline (See Figure 1). The solar panel was mounted at 0 degrees relative to the roof surface with a general height of 5 in from the roof surface. at all four corners of the panel. Test Runs 4 and 5 were performed on the same panel and bracket with the panel height adjusted and installed at an angle with the front corners set to 3-1/2 in. and the back corners set to a height of 6 in. from the roof surface.

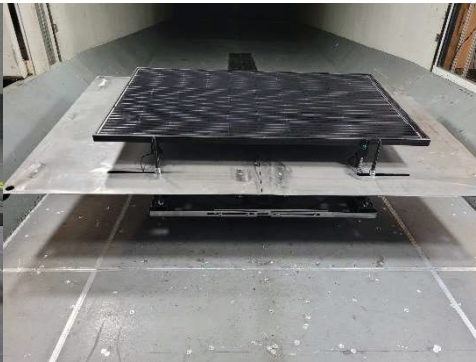
Figure 2: Run 1 through 3 setup with panel

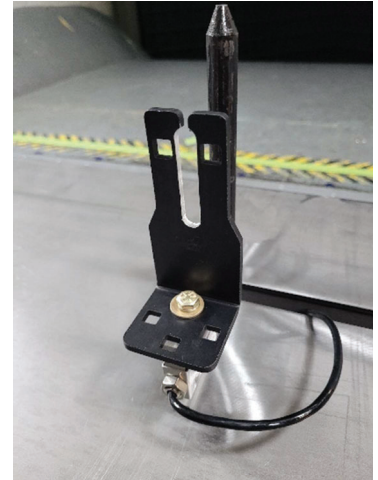
Figure 3: Bracket at leading edge LC0-1, LC0-2

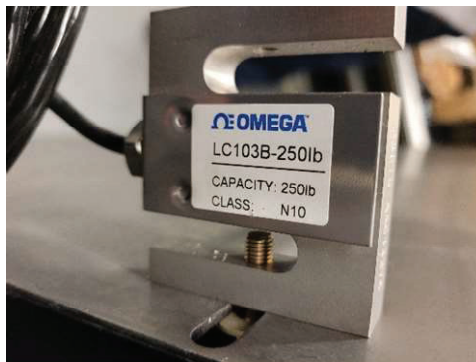
Figure 5: Load Cell Model used for tests

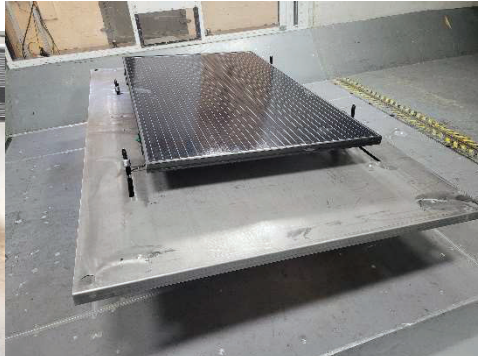
Figure 11: Setup after Run 2, 109 mph winds.  
No damages or loose hardware noted.

to any bracket during or after the test runs and all hardware was found to be secure upon completion of each test (See Figures 11-13).

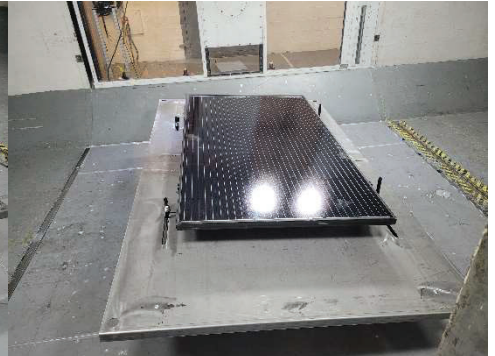
Figure 12: Setup after Run 2, 109 mph winds.  
No damages or loose hardware noted

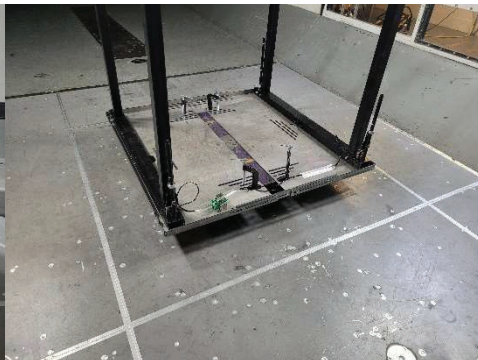
Figure 14: Setup for Run 6 with IR Ballast  
Frame

Test Runs 6 through 8 were performed on the IR Ballast Racks (See Figures 14-32). The simulated roof structure was removed and the frames and panel were mounted directly to the KWT test platform. These runs were performed at a set angle with no platform rotation during the test run. Two load cells were used for the test setups and were mounted at the brackets at the leading edge of the test platform at the wind intake side.

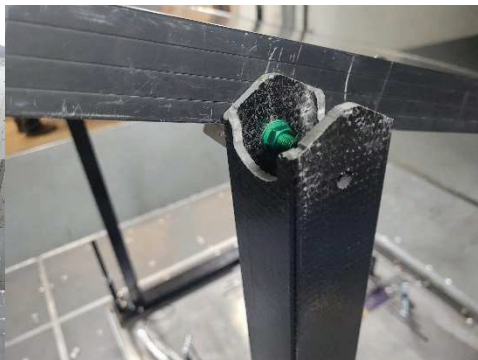
Figure 17: IR Ballast frame connection to solar  
panel

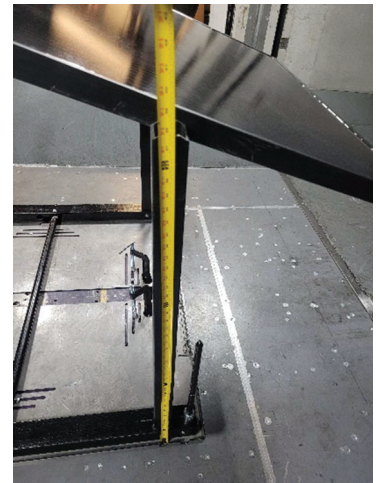
Figure 24: Run 6 trailing edge leg height

Run 6 was performed on the IR18C with the solar panel at an approximate 18 degree angle (Figures 24-25). The maximum load at a bracket recorded during Test Run 6 was 168.59 lbf at a wind speed of 101.59 MPH. Runs 7 and 8 were performed on the IR30C with the solar panel at a 30 degree angle (Figures 30-32) with Run 7 having the solar panel mounted and aligned with the wind direction to produce maximum forces on the frame and Run 8 being run in an orientation 90 degrees offset from Run 7. The maximum load at a bracket was during Test Run 7 and was 183.38 lbf at a wind speed of 81.138 MPH. Run 7 was stopped when the drag limit of the KWT test apparatus was reached. The solar frame experienced shaking under wind load but no damage was found to any part and all bolts were found to still be tight and in place after the test run. Run 8 was pitch limited by the KWT test apparatus. Similar to Run 7 the frame and solar panel had experienced shaking under load but no damage to the frame or panel was noted and all bolts and connections remained tight.

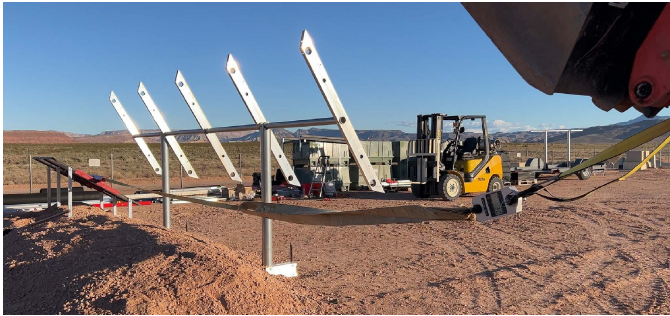
**PHOTO 1:** Horizontal force test setup

The horizontal racking load test was performed on the same IR-30 Solar Racking System Ground Frame that had two solar panels installed at a 30 ° angle and utilized the EarthBallast System and three loads of loose fill dirt ballast. A lifting strap was used to wrap around the panel and run parallel to the frame in order to apply the horizontal racking force. The system was monitored for movement as the simulated load was applied and the maximum load was recorded. The system held the load and no damage or permanent deformation was noted as detailed in the test observations table below.

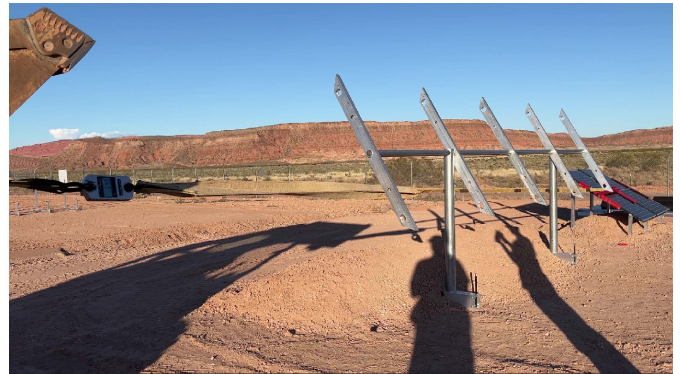
**Photo 4:** Horizontal force test at max load

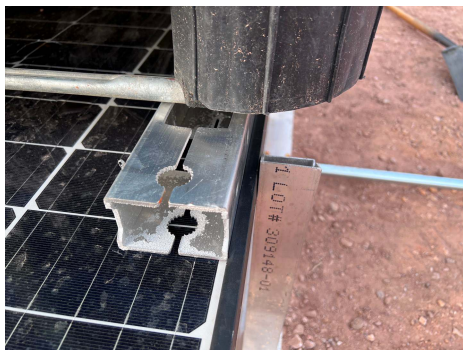
**PHOTO 7:** Slight deflections noted under load

| SIMULATED SNOW LOAD (COMPRESSIVE LOAD) INSPECTION DETAILS | | | |
|---|---|---|---|
| 2 | Large water tank + (12) five gallon jugs | 2950 | Solar panel held load, ~ 10 -15 minutes under observation. Slight deflections noted under load (See Photos). Minor permanent deformation noted after load removal (See Photos). The alignment tabs in the vertical uprights were no longer flat with the uprights. |

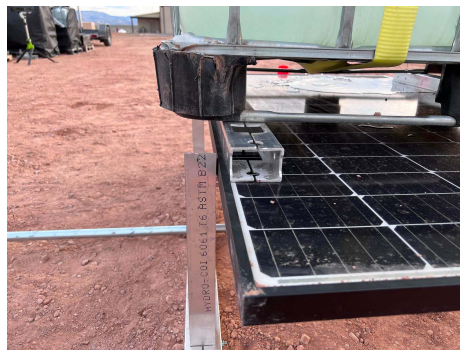
**PHOTO 8:** Slight deflection noted under load

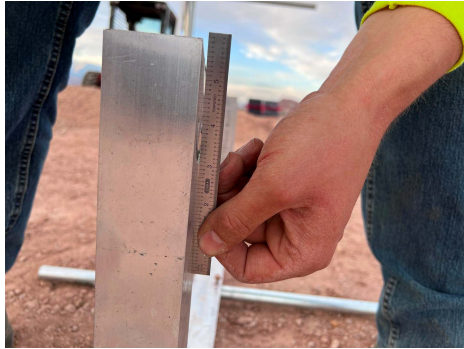
PHOTO 10: Slight deformation after load removed

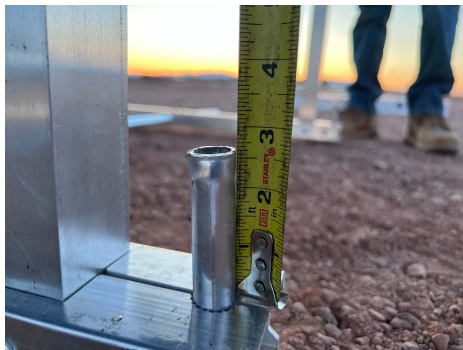
PHOTO 4: 'Stickout' measurement example at Spike #3

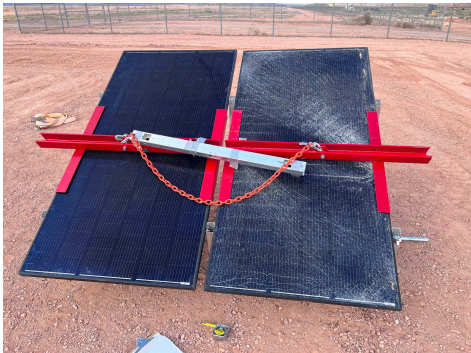
**PHOTO 10:** Solar panels after testing

| SIMULATED WIND LOAD (TENSILE UPLIFT) FORCE INSPECTION DETAILS | | |
|---|---|---|
| 1 | 2385 | At 1500 lbf the frame visibly shifted and started to roll forward.<br><br>At 2385 lbf one of the solar panels failed and shattered (Photos 7-9). The frame and brackets holding the solar panel kept it in place and were permanently deformed. The aluminum tube upright had bent forward and outward causing the seam of the tube to tear and it allowed the through bolt to come free. Two mounting brackets permanently deformed and there was additional permanent deformation in the base frame (Photos 10-15) |

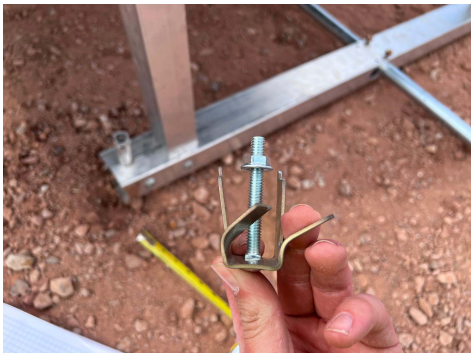
**PHOTO 13:** Bracket deformation after testing

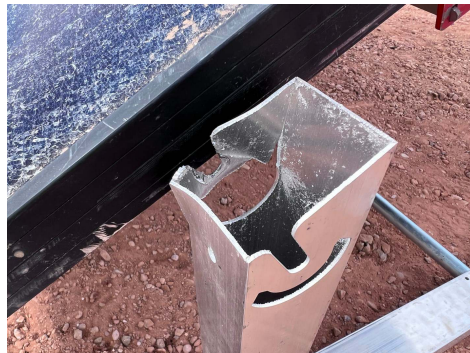
**PHOTO 14:** Upright mount deformation after testing

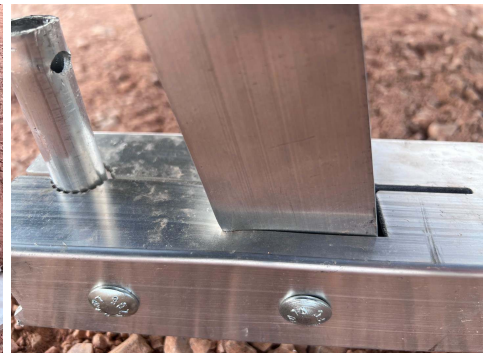
**PHOTO 15:** Upright deformation after testing

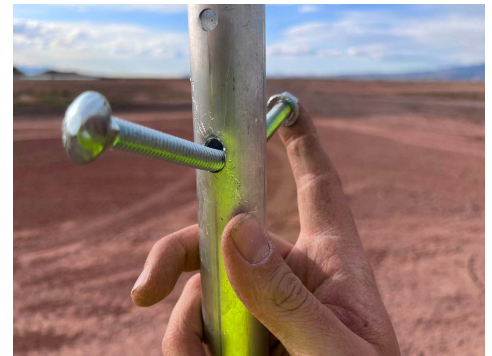
PHOTO 6: First anchor pullout with drilled thru hole deformed

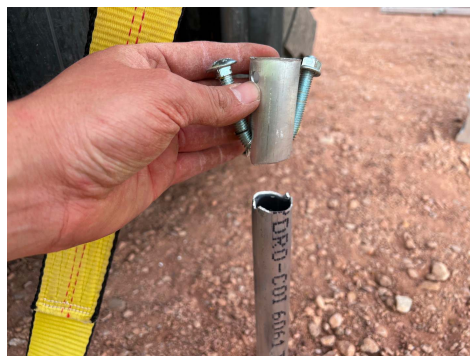
PHOTO 8: Second anchor - second test where anchor failed at drilled thru hole

| LARGE EPOXY EARTH ANCHOR TENSILE UPLIFT FORCE INSPECTION DETAILS | | |
|---|---|---|
| 2b | 790 | The load strap was reattached and test load was applied to the same anchor tested in test 2a. The drilled thru hole failed under load (Photo 8). |
