PROJECT IntegraRack			
	TITLE IR-T1 No Penetration TileBallast™ Solar Module Mounting System IR-T1TB1031			
	APPROVED Paul Budge 08/02/2024	SIZE	CODE	DWG NO
CHECKED Paul Budge 08/02/2024	B			REV
DRAWN Jeff Glauser 08/01/2024	SCALE 1:2.5	WEIGHT 1lb 3oz	SHEET 1/1

Subject: Compression, Horizontal, and Uplift Load Testing on the Universal L Foot Bracket (PN IR-DMLF2000) & IR-T1 No Penetration Tile Roof Bracket (IR-FCTR1500)

LABORATORY TEST REPORT

Compression Load Test
Ceramic Tile Roof

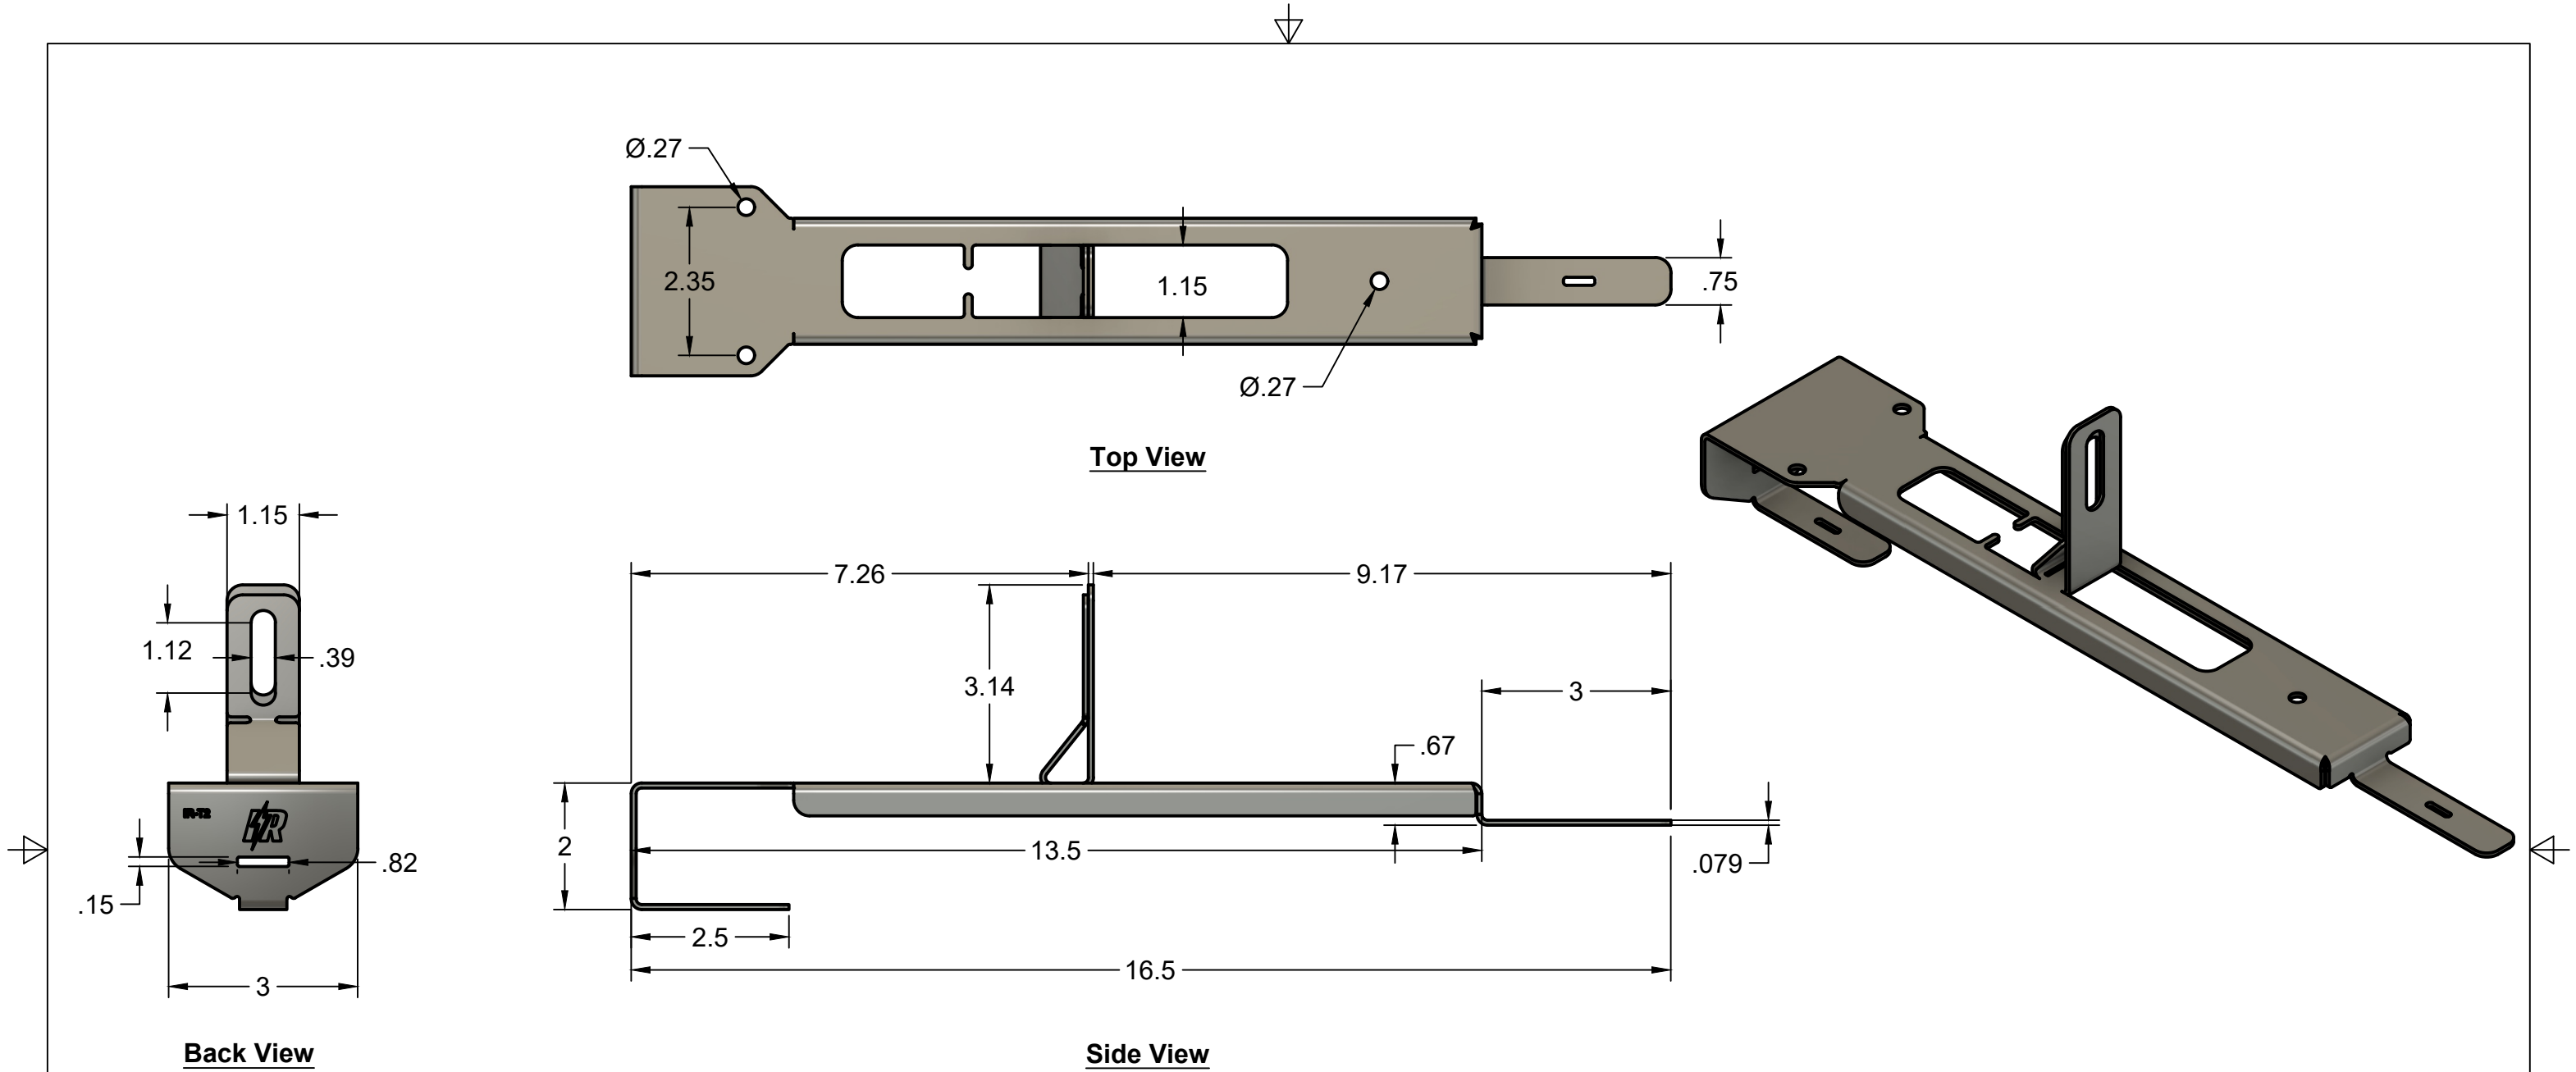
IR-T1 TileBallast Roof Mount				
PART NAME	PART NUMBER	DESCRIPTION	MATERIAL	COATING
IR-T1	IR-T1TB0031	No penetration TileBallast™ Roof Mount	.079" [2mm] A1008 Carbon Steel	Black Zinc Electroplated

Maximum Solar Module Size		
24 SQFT		
IR-T1 Spacing For Rails	Maximum Wind Speed	Maximum Snow Load
One Mount Every 6 ft	120 MPH	10 LBS/SQFT
One Mount Every 4 ft	160 MPH	15 LBS/SQFT

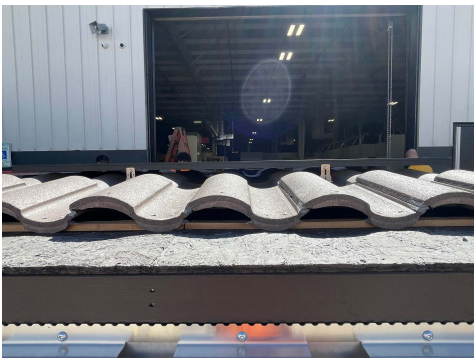
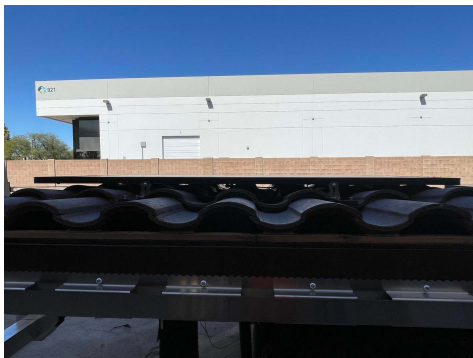
PHOTO 7: Unloaded - after tests

PHOTO 8: Unloaded - after tests

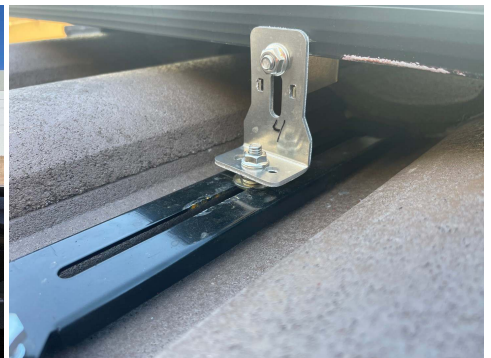
PHOTO 9: Unloaded Bracket - after tests

Note: Bracket photos are typical of all locations

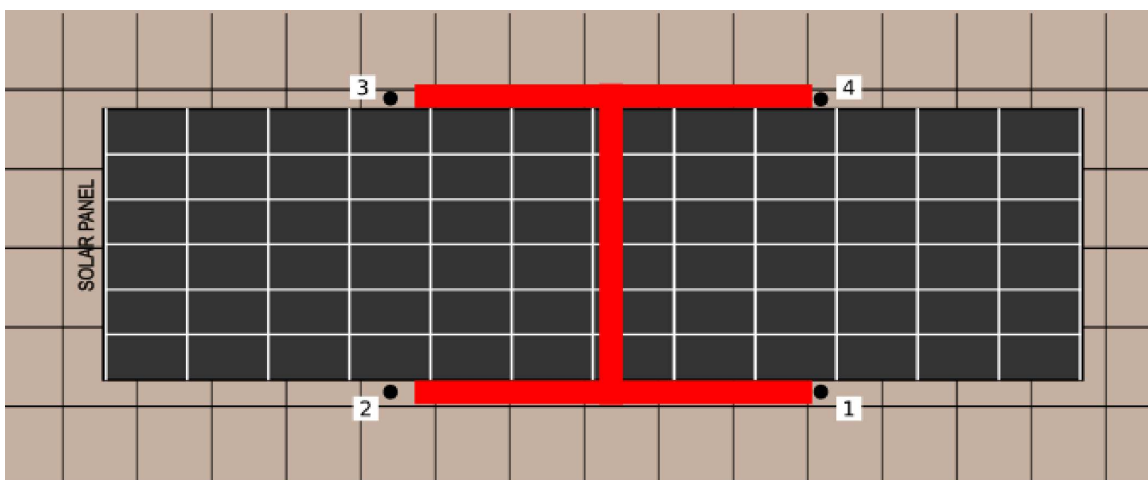
SKETCH

● Bracket/Panel Gap Spacing Check
