PROJECT			
	IntegraRack			
TITLE				
IR-40FSAA / FSAB / FSAC Solar Racking System				
Data Sheet				
IR-40FSAA0041, IR-40FSAB0040, IR-40FSAC0042				
APPROVED Paul Budge 2/21/2025	SIZE	CODE	DWG NO	REV
CHECKED Paul Budge 2/21/2025	B			
DRAWN Jeff Glauser 2/21/2025	SCALE 1:20	WEIGHT 15lbs / 22lbs / 16lbs	SHEET 1/4

Subject: Witness of Wind Tunnel Testing on IntegraRack Products at the George E Boeing Aeronautics Department (Kirsten Wind Tunnel) at the University of Washington

Subject: Simulated Wind Load, Snow Load, and Horizontal Racking Load Testing on IR-30 Solar Racking System.

INSPECTION AND TEST REPORT

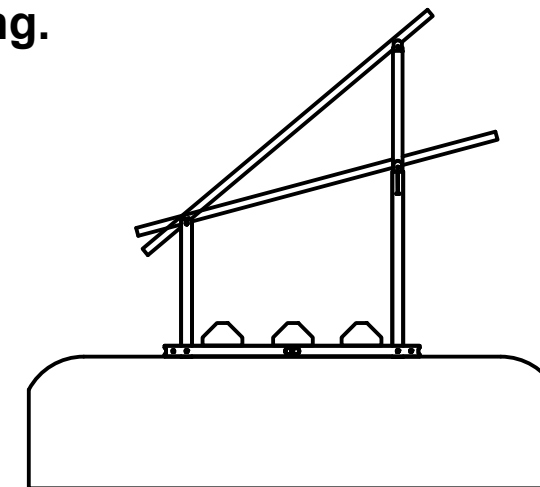
Base Frame Ballasted:
 Three 175lb curb stop ballasts per solar module.
 525lbs minimum per solar module for
 60-70 mph windspeed at 40 degree angle.
 (No stakes required)

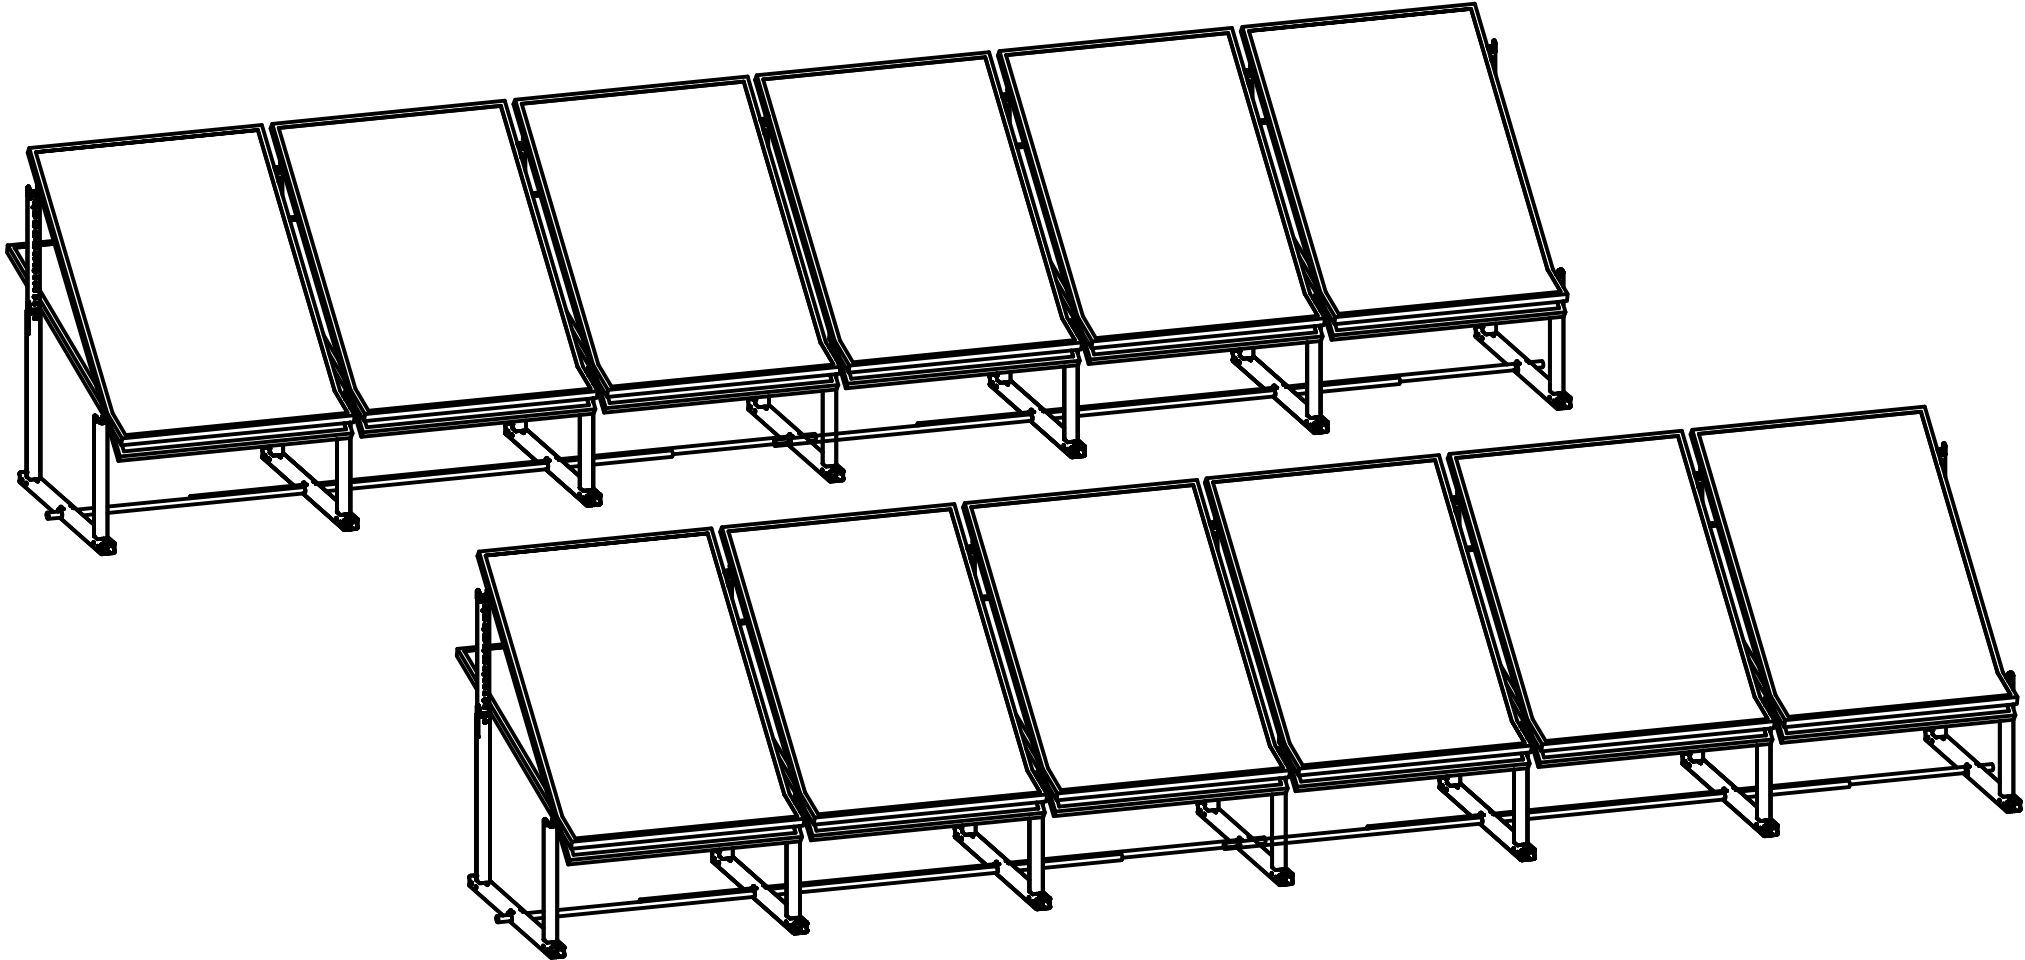
REQUIRED SPACING BETWEEN ROWS

15 degrees	11 feet 6 inches / 3.5 meters ON CENTER
20 degrees	12 feet 2 inches / 3.7 meters ON CENTER
25 degrees	12 feet 10 inches / 3.9 meters ON CENTER
30 degrees	13 feet 6 inches / 4.1 meters ON CENTER
35 degrees	13 feet 10 inches / 4.2 meters ON CENTER
40 degrees	14 feet 2 inches / 4.3 meters ON CENTER

*The measurements listed above are from the center point of each base tube.

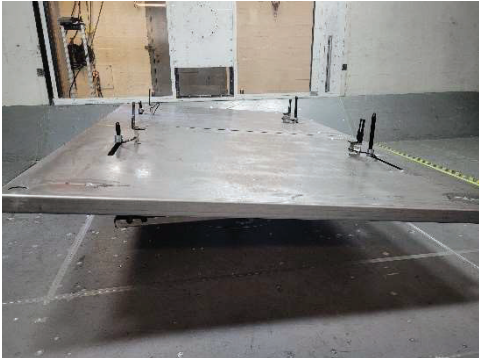
Figure 1: Run 1 through 3 simulated roof setup

A total of 8 runs were performed on IntegraRack products. Test Runs 1 through 3 were performed with the IR-D1 bracket (See Figures 1-4) with an installed 18 SF solar panel on a simulated roof incline. Run 1 was performed to tare KWT's system through the full 0 to 110 degree rotation of the test platform with the simulated roof and panel installed. The roof surface had been installed at an approximate 5 – 6 degree incline (See Figure 1). The solar panel was mounted at 0 degrees relative to the roof surface with a general height of 5 in from the roof surface. at all four corners of the panel. Test Runs 4 and 5 were performed on the same panel and bracket with the panel height adjusted and installed at an angle with the front corners set to 3-1/2 in. and the back corners set to a height of 6 in. from the roof surface.

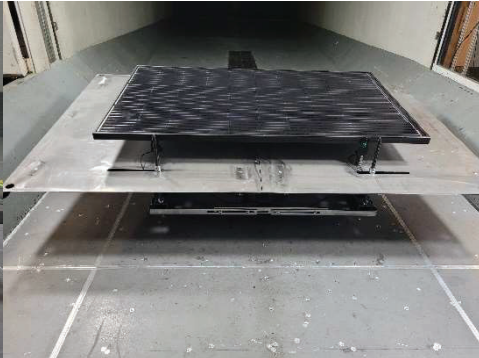
Figure 2: Run 1 through 3 setup with panel

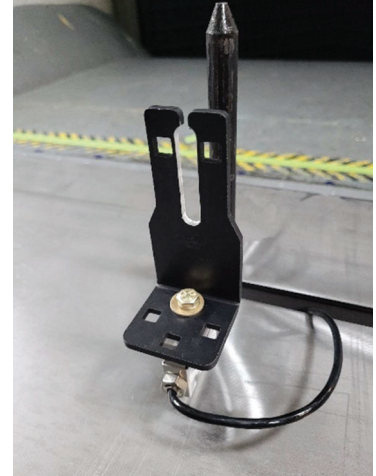
Figure 3: Bracket at leading edge LC0-1, LC0-2

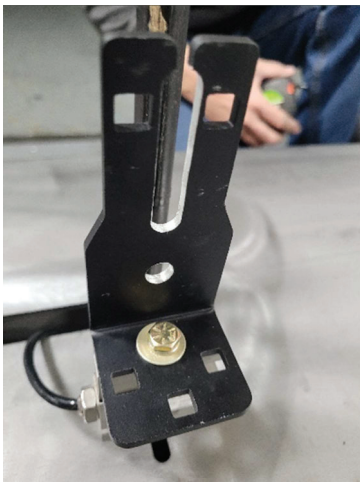
Figure 4: Bracket at back edge LC5-3, LC5-4

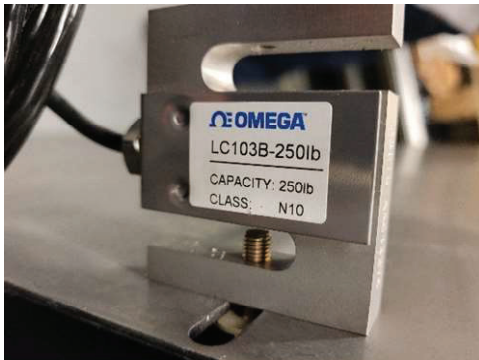
Figure 5: Load Cell Model used for tests

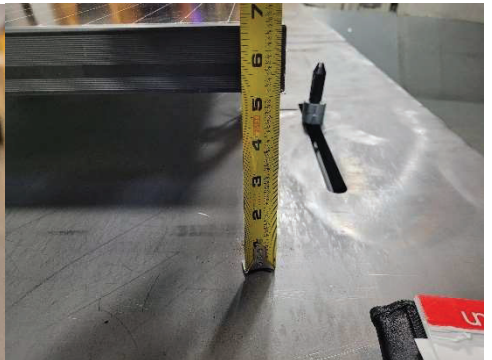
Figure 6: Height from roof to panel, Runs 2 & 3

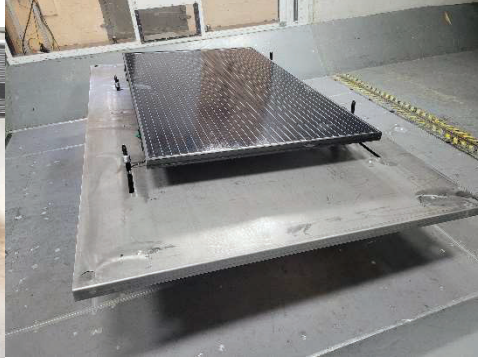
Figure 11: Setup after Run 2, 109 mph winds.
 No damages or loose hardware noted.

to any bracket during or after the test runs and all hardware was found to be secure upon completion of each test (See Figures 11-13).

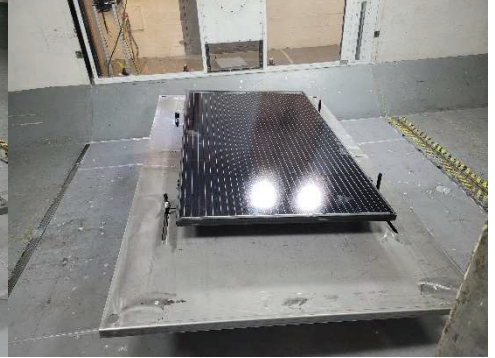
Figure 12: Setup after Run 2, 109 mph winds.
 No damages or loose hardware noted

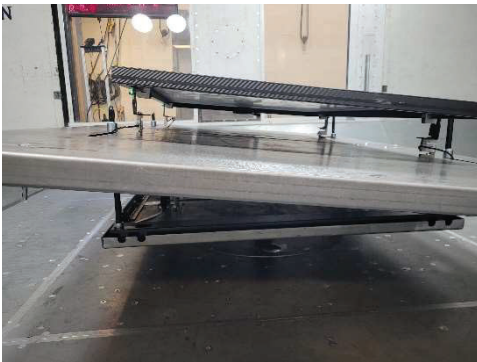
Figure 13: Setup after Run 2, 109 mph winds.
 No damages or loose hardware noted

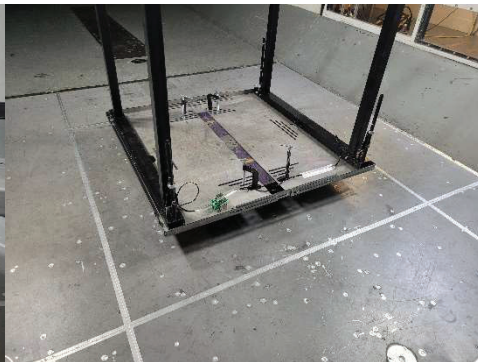
Figure 14: Setup for Run 6 with IR Ballast
 Frame

Test Runs 6 through 8 were performed on the IR Ballast Racks (See Figures 14-32). The simulated roof structure was removed and the frames and panel were mounted directly to the KWT test platform. These runs were performed at a set angle with no platform rotation during the test run. Two load cells were used for the test setups and were mounted at the brackets at the leading edge of the test platform at the wind intake side.

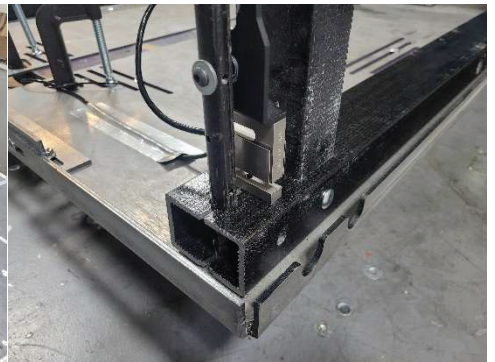
Figure 15: Load cell location at leading edge,
 LC0-1 & LC0-2

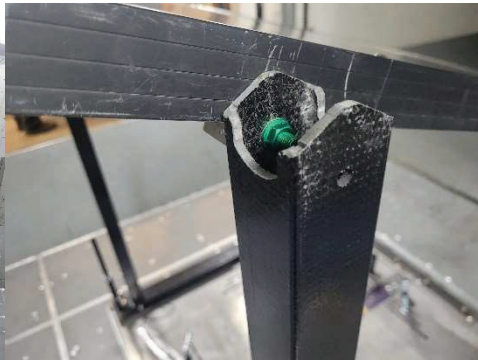
Figure 17: IR Ballast frame connection to solar
 panel

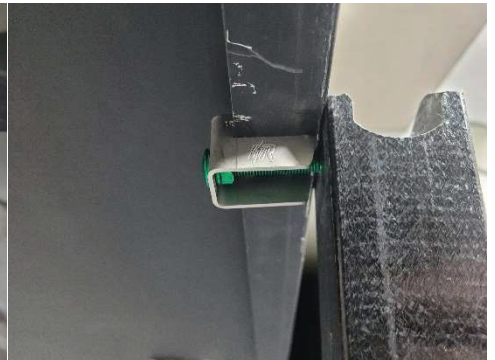
Figure 18: IR Ballast frame connection to solar
 panel

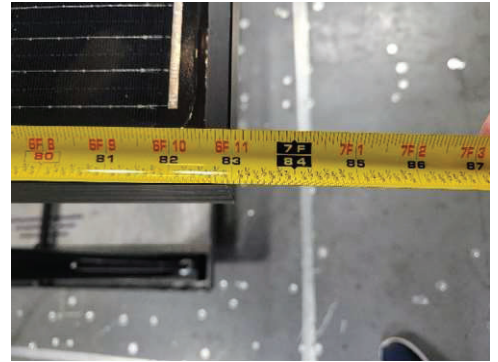
Figure 21: Solar panels total length 83 in.

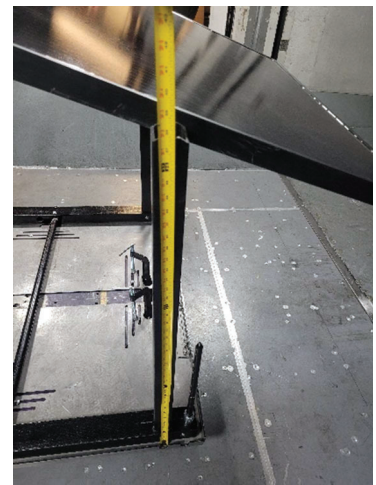
Figure 24: Run 6 trailing edge leg height

Run 6 was performed on the IR18C with the solar panel at an approximate 18 degree angle (Figures 24-25). The maximum load at a bracket recorded during Test Run 6 was 168.59 lbf at a wind speed of 101.59 MPH. Runs 7 and 8 were performed on the IR30C with the solar panel at a 30 degree angle (Figures 30-32) with Run 7 having the solar panel mounted and aligned with the wind direction to produce maximum forces on the frame and Run 8 being run in an orientation 90 degrees offset from Run 7. The maximum load at a bracket was during Test Run 7 and was 183.38 lbf at a wind speed of 81.138 MPH. Run 7 was stopped when the drag limit of the KWT test apparatus was reached. The solar frame experienced shaking under wind load but no damage was found to any part and all bolts were found to still be tight and in place after the test run. Run 8 was pitch limited by the KWT test apparatus. Similar to Run 7 the frame and solar panel had experienced shaking under load but no damage to the frame or panel was noted and all bolts and connections remained tight.

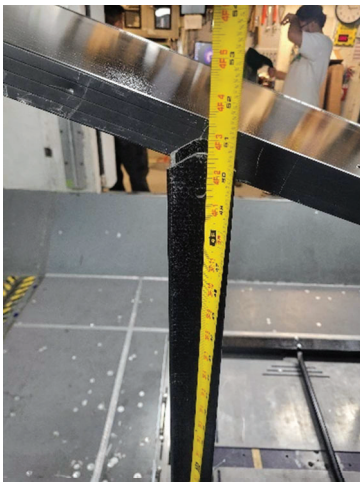
Figure 25: Run 6 leading edge leg height

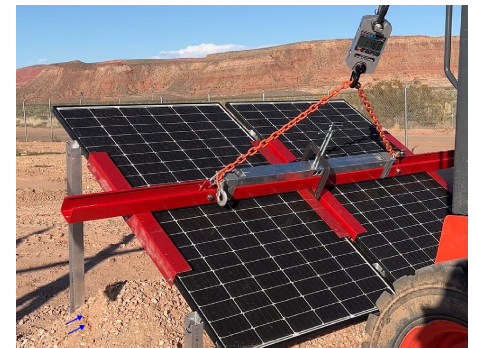
PHOTO 9: Test 2 - Evidence of ballast shift

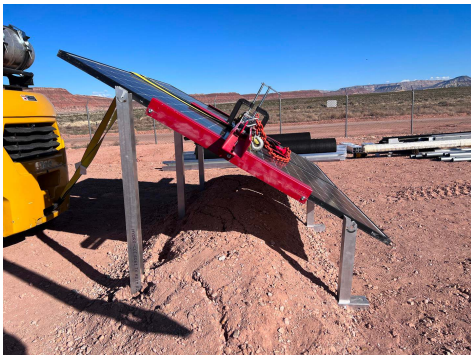
PHOTO 13: Ballast after completion of testing

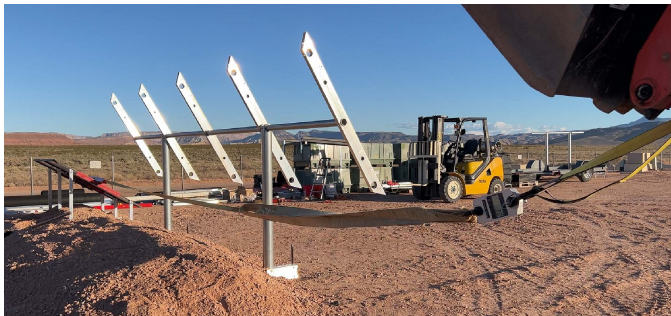
PHOTO 1: Horizontal force test setup

The IR-30 Solar Racking System Ground Frame was installed with the IR EarthBallast System and two solar panels. The EarthBallast system utilizes a mesh that is epoxied to the frame which is then loaded with loose dirt fill (ballast) that supports and holds down the frame. The horizontal load test was performed after the vertical uplift tensile load test. The system was tested with 3 loads of dirt from a Kubota SSV75 skid steer. The skid steer dirt loads were estimated at ~ 500 lbf each using an estimate of 100 lb/ft³ for the density of soil. A lifting strap was wrapped around the panel lengthwise and run parallel to the frame in order to apply a horizontal force to the system (Photos). Force was applied using the skid steer and load was monitored with the digital dynamometer. The test was stopped at a load of 645 lbf. No movement or damage was visually noted during or after the test.

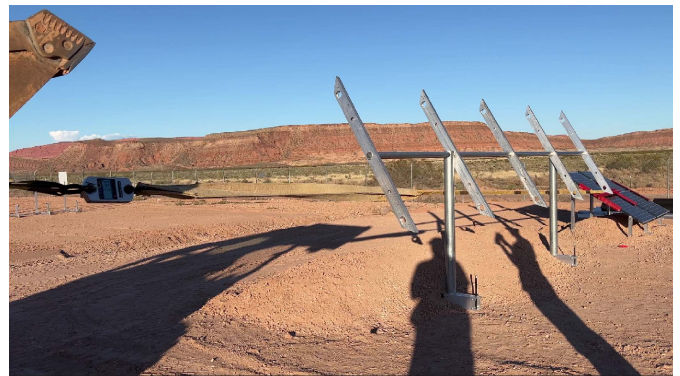
Photo 4: Horizontal force test at max load

TEST NO.	BALLAST DETAILS		MAX. HORIZONTAL FORCE (lbf)	OBSERVATIONS
	SIZE (LxWxH) (in.)	WEIGHT (lbf)		
1	90 in. x 42 in. x 14 in. (14 CF)	~ 1400 lbf (3 skid steer buckets)	645	Test was stopped at 645 lbf. No damage or movement was visually noted.

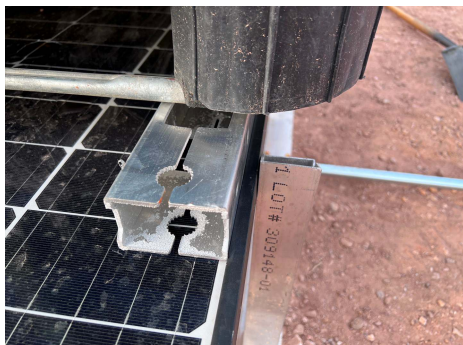
PHOTO 7: Slight deflections noted under load

SIMULATED SNOW LOAD (COMPRESSIVE LOAD) INSPECTION DETAILS				
COMPRESSIVE FORCE			OBSERVATIONS	
	DESCRIPTION	WEIGHT (lbf)		
1	Large water tank	2410	Solar panel held load overnight (> 10 h).	
2	Large water tank + (12) five gallon jugs	2950	Solar panel held load, ~ 10 -15 minutes under observation. Slight deflections noted under load (See Photos). Minor permanent deformation noted after load removal (See Photos). The alignment tabs in the vertical uprights were no longer flat with the uprights.

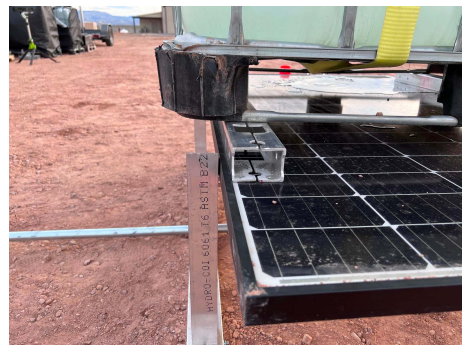
PHOTO 8: Slight deflection noted under load

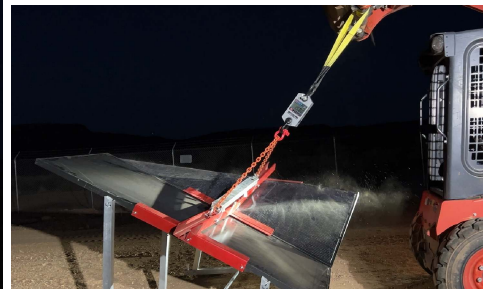
PHOTO 9: IR-30 Solar Racking System right after max load when panel failed

SIMULATED WIND LOAD (TENSILE UPLIFT) FORCE INSPECTION DETAILS		
TEST NO.	MAX. FORCE (lbf)	OBSERVATIONS
1	2385	At 1500 lbf the frame visibly shifted and started to roll forward. At 2385 lbf one of the solar panels failed and shattered (Photos 7-9). The frame and brackets holding the solar panel kept it in place and were permanently deformed. The aluminum tube upright had bent forward and outward causing the seam of the tube to tear and it allowed the through bolt to come free. Two mounting brackets permanently deformed and there was additional permanent deformation in the base frame (Photos 10-15)

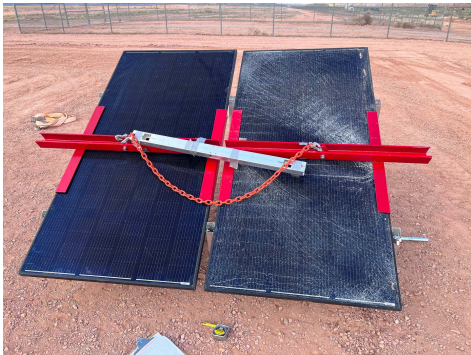
PHOTO 10: Solar panels after testing

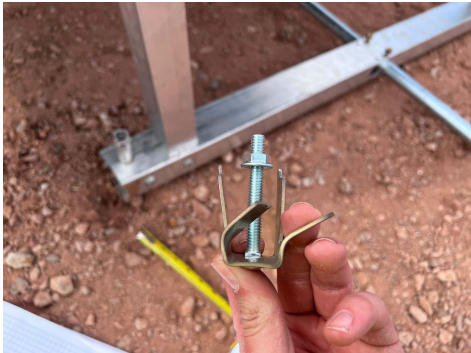
PHOTO 13: Bracket deformation after testing

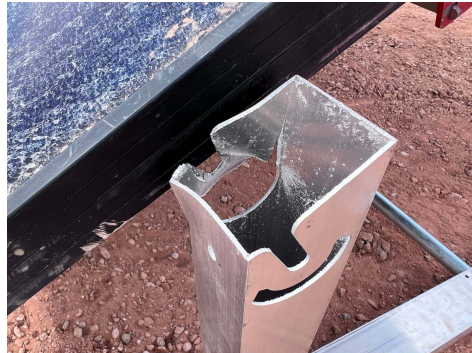
PHOTO 14: Upright mount deformation after testing

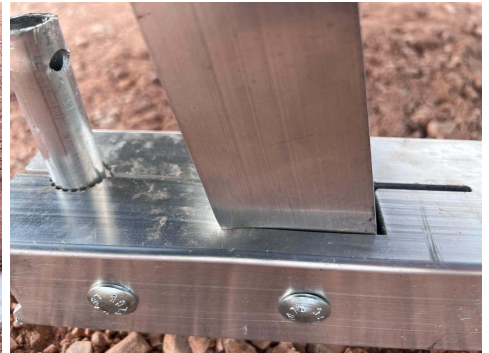
PHOTO 15: Upright deformation after testing

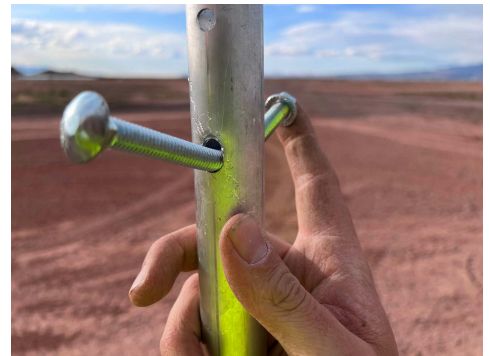
PHOTO 6: First anchor pullout with drilled thru hole deformed

TENSILE UPLIFT FORCE INSPECTION DETAILS					
NO.	MAX FORCE REACHED (lbf)	OBSERVATIONS			
1	1,950	Anchor pulled out of the ground (See Photos 2, 4-6)			
2a	2,990	The bolt installed through the anchor for the purpose of the test bent and the load strap slipped off the anchor (See Photos 3, 7). The drilled thru hole had elongated.			
2b	790	The load strap was reattached and test load was applied to the same anchor tested in test 2a. The drilled thru hole failed under load (Photo 8).

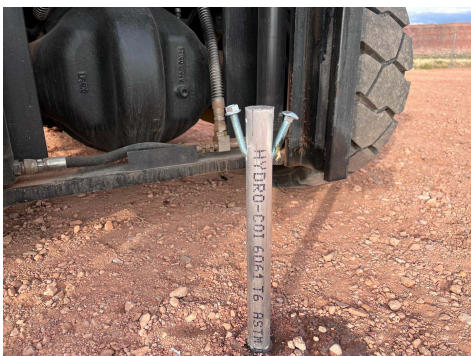
PHOTO 7: Second anchor - first pull where the thru bolt bent and load strap slipped off

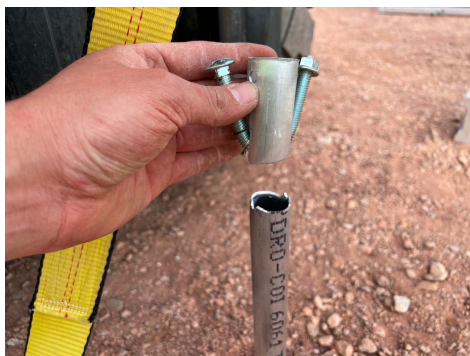
PHOTO 8: Second anchor - second test where anchor failed at drilled thru hole
