PROJECT			
IntegraRack			
TITLE			
IR-05 Flat Roof Ballast System			
IR-05RF1005			
APPROVED Paul Budge 08/16/2024	SIZE	CODE	DWG NO
CHECKED Paul Budge 08/16/2024	B		
DRAWN Jeff Glouser 08/15/2024	SCALE 1:3	WEIGHT 1lbs 4oz	SHEET 1/1
			REV

Subject: Simulated Snow Load and Horizontal Racking Load on IR-05 and IR-F1

INSPECTION AND TEST REPORT

PNL REF. # 26-240383 S.O. # 001 INDEX 04
 INSPECTION DATE 03/20/2024
 IR-05 & IR-F1 w/ Simulated Plywood Roof: Horizontal Racking Load

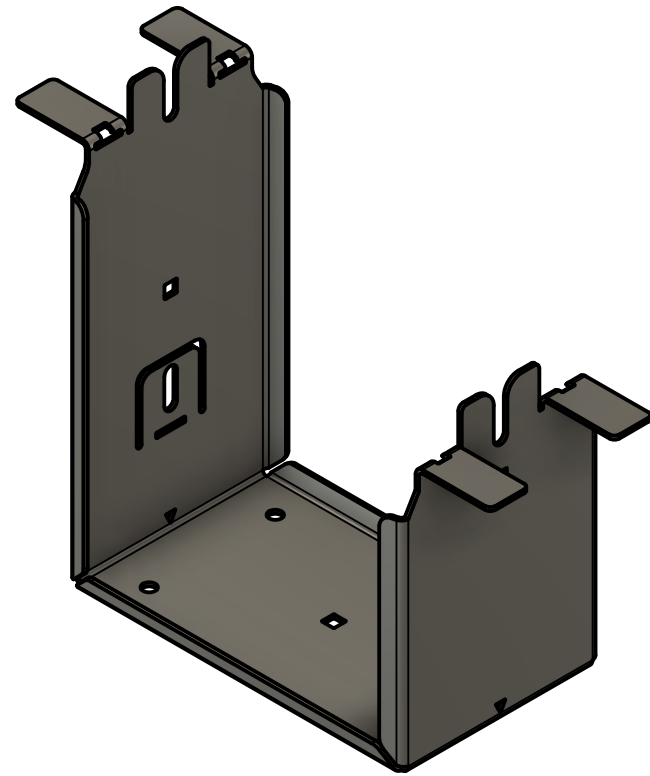
Isometric View

IR-05 BALLAST SYSTEM			
PART NAME	PART NUMBER	DESCRIPTION	MATERIAL
IR-05	IR-05RF1000	Solar module ballasted racking system for flat roof applications.	.090" 5052 Aluminum Mill finish, no coating

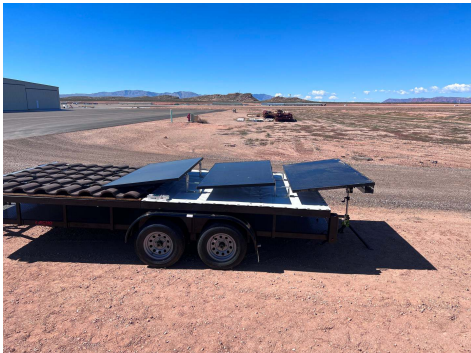
PHOTO 1: Overview of solar panel test setup

BRACKET COMPONENT 2:	Mounting Bracket		BRACKET PART NO. 2:	IR-FCMH5000 (IR-F1)			
SIMULATED SNOW LOAD (COMPRESSIVE LOAD) TEST PROCEDURE/DESCRIPTION							
Solar panels were installed to a simulated roof made from 7/16 in. plywood using the IR-05 and IR-F1 brackets and bracket clips (Photo 1). A total of 4 brackets and clips were used for the installation. 2x4 joists were every two feet on center. The installed solar panels measured 49.5 in. x 83 in. The test consisted of placing the large water tank directly onto aluminum tubes that were placed along the longitudinal edges of the solar panel to distribute the load across the solar panel (Photo 2). The water tank weight was measured with the dynamometer and recorded as 2410 lbf.							
SIMULATED SNOW LOAD (COMPRESSIVE LOAD) INSPECTION DETAILS							
NO.	INITIAL			Applied Load (lbf)	AFTER LOAD REMOVAL		
	Panel to Surface Distance (in.)	Initial Bracket Angle	Initial Panel Edge Angle		Panel to Surface Distance (in.)	Final Bracket Angle	Final Panel Edge Angle

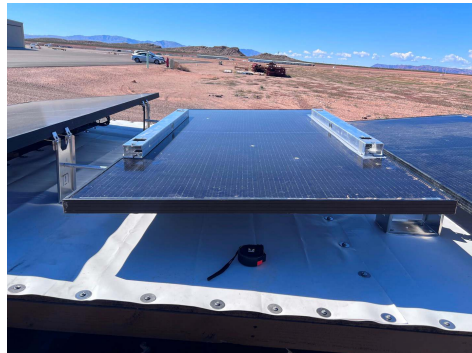
PHOTO 2: Setup with no load and aluminum distribution bars in place

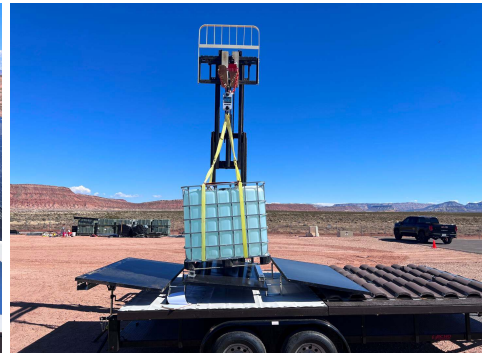
PHOTO 3: Test load being lowered

A filled water tank weighing 2410 lbf was used to apply the compressive load to the middle solar panel. As the load was being lowered into position the brackets were visually noted to be flexing. The flexing of the brackets caused one rivnut in the cross-member for the IR-F1 bracket to slip out. The total load applied at the moment flexing was noted was 1605 lbf.

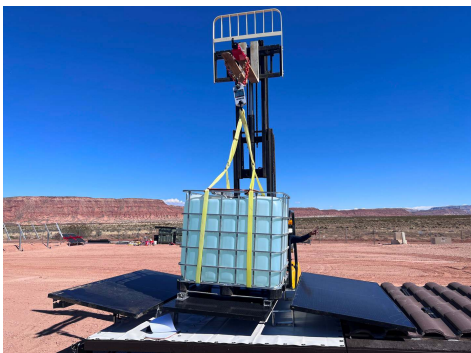
PHOTO 4: Applied load

1	6.063	0.3°	2.8°	1,605	6.000	2.8°	0.1°
2	10.063	1.8°	5.8°		9.938	0.7°	2.9°
3	9.938	2.0°	4.6°		9.813	2.4°	5.1°
4	6.063	0.6°	1.7°		6.000	0.4°	3.2°
OBSERVATIONS							
1605 lbf was briefly applied to the center solar panel on the simulated roof before the weight was unloaded (Photo 4). It was visually noted that the brackets attached to the roof were flexing due to the applied weight being distributed solely to the middle panel, rather than evenly to all the panels, and since the outer panels were not attached to the roof on their outer edge. The flexing of the brackets caused one rivnut in the cross-member for the IR-F1 bracket to slip out (Photo 9).

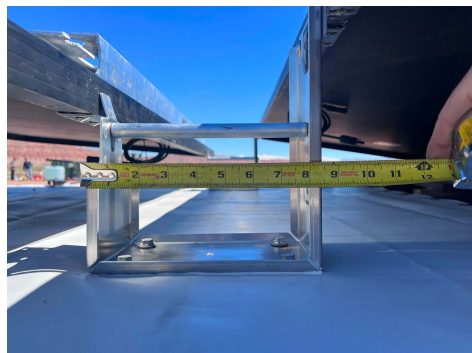
PHOTO 5: Bracket before load

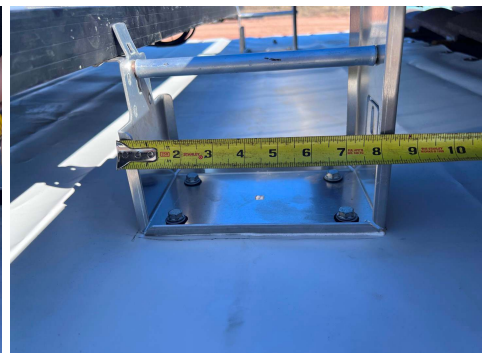
PHOTO 6: Bracket after load

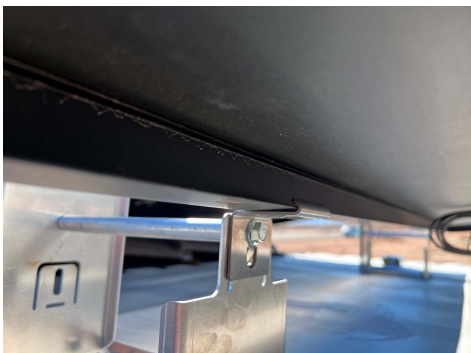
PHOTO 7: Clip before load

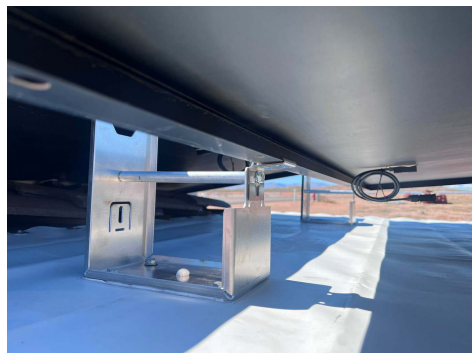
PHOTO 8: Clip after load

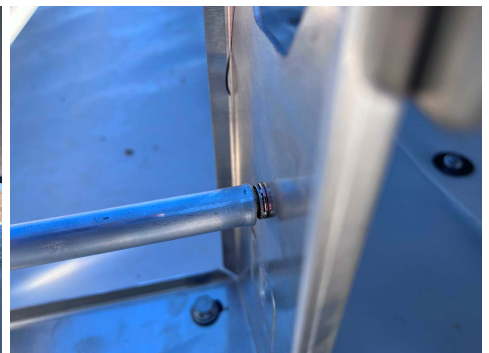
PHOTO 9: Rivnut slip / failure

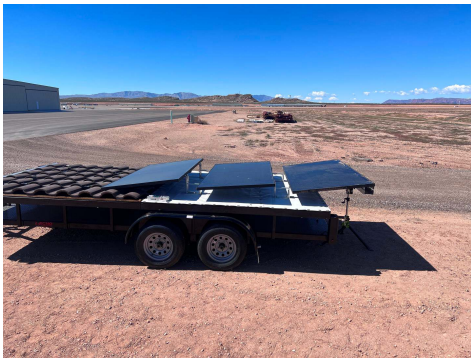
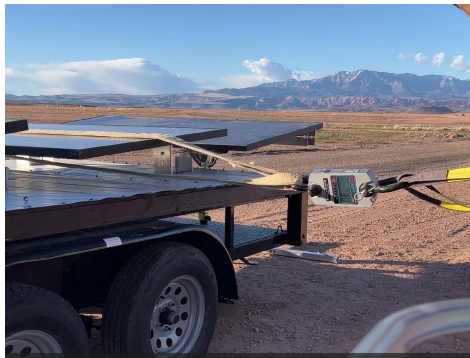
PHOTO 1: Test setup

PHOTO 2: Test setup

CLIENT		CLIENT PROJECT REFERENCE		CLIENT ORDER NO.
IntegraRack		IR-05 & IR-F1 Simulated Plywood Roof - Side Load		per S.A.
SAMPLE DESCRIPTION				TECHNICIANS
Horizontal Load Slide on Simulated Plywood Roof with IR-05 and IR-F1				Weston A.
TEST CONDITIONS & EQUIPMENT INFORMATION				
TEMPERATURE:	65 °F ± 10 °F	HUMIDITY:	30% ± 10%	
LOAD TYPE:	Horizontal Racking Load	TEST LOAD:	Record	
EQUIPMENT TYPE:	Dyna-Link 2 Dynamometer	EQUIPMENT MODEL:	MSI-7300RF (S/N 100326)	
SKID STEER MODEL:	Kubota SSV65			
TEST SPECIMEN & COMPONENT INFORMATION				
TEMPERATURE:	65 °F ± 10 °F	HUMIDITY:	30% ± 10%	
SOLAR PANELS SIZE:	49.5 in. x 83 in.	TEST SPECIMEN AREA:	28.531 ft ²	
BRACKET COMPONENT 1:	Solar Panel Clip	BRACKET PART NO. 1:	IR-FCBB7500 (IR-05)	
BRACKET COMPONENT 2:	Mounting Bracket	BRACKET PART NO. 2:	IR-FCMH5000 (IR-F1)	
HORIZONTAL RACKING FORCE TEST PROCEDURE/DESCRIPTION				
<p>Solar panels were installed to a simulated roof made from 7/16 in. plywood using the IR-05 and IR-F1 brackets and bracket clips (Photo 1). A total of 4 brackets and clips were used for the installation. 2x4 joists were every two feet on center. The installed solar panels measured 49.5 in. x 83 in. The horizontal load test was performed after completion of the simulated snow load / compressive load test (PNL Report 26-240383.001.01). A lifting strap was wrapped around the panel lengthwise and run parallel to the solar panel to apply a horizontal force to the system (Photo 1). Force was applied using the skid steer and load was monitored with the digital dynamometer. Slide movement was noted at 135 lbf and 220 lbf.</p>

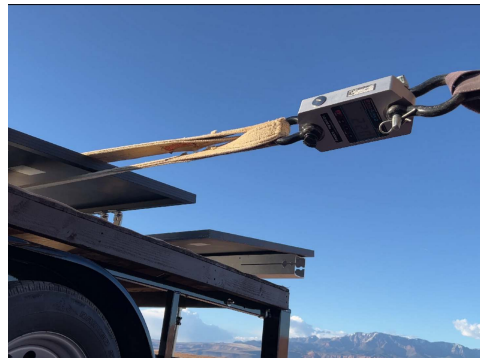
PHOTO 3: Panel under load

HORIZONTAL RACKING FORCE INSPECTION DETAILS				
No.	Initial Measurement from Clip to Edge of Panel (in.)	After 1 st Slide Movement @ ~ 135 lbf: Measurement from Clip to Edge of Panel	After 2 nd Slide Movement @ ~ 220 lbf: Measurement from Clip to Edge of Panel	Observations
1	17.500	19.938	20.438	The previously shifted cross-member from the compressive force test had not been fixed prior to start of the horizontal load test and it came fully apart during the test. This led to shifting of the entire bracket and pullout of one of the screws holding the bracket down (Photos 3-5) at ~ 220 lbf.
2	15.188	16.438	17.625	
3	14.875	14.375	14.625	
4	17.563	15.063	13.500

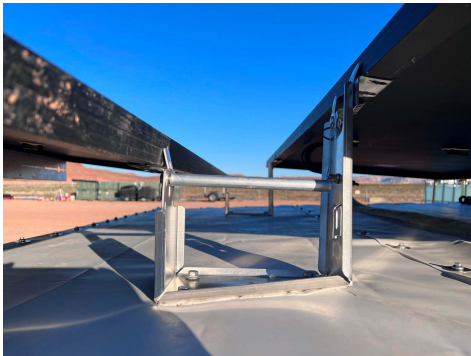
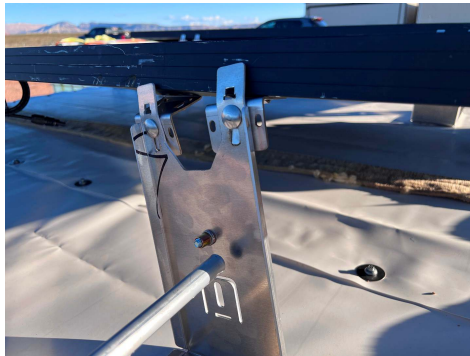
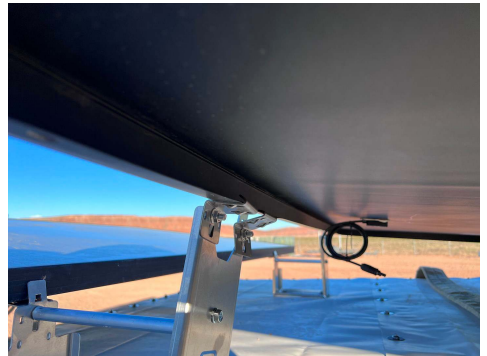
PHOTO 4: After cross-member disengagement

PHOTO 5: After cross-member disengagement

PHOTO 6: After cross-member disengagement
