PROJECT  
**IntegraRack**  
 TITLE  
**IR-T1 No Penetration TileBallast™ Solar Module  
 Mounting System**  
 IR-T1TB1031

Subject: Compression, Horizontal, and Uplift Load Testing on the Universal L Foot Bracket (PN IR-DMLF2000) & IR-T1 No Penetration Tile Roof Bracket (IR-FCTR1500)

# LABORATORY TEST REPORT

Compression Load Test  
Ceramic Tile Roof

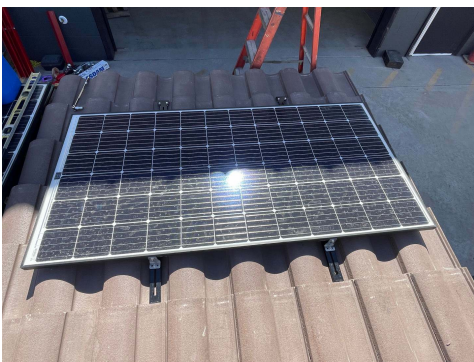
**PHOTO 1:** Overview of solar panel and tile roof deck - before tests

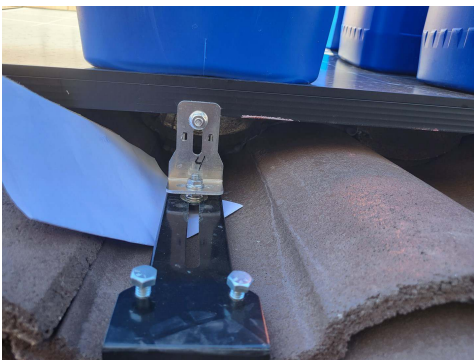
**PHOTO 4:** Load 1 - Bracket under load

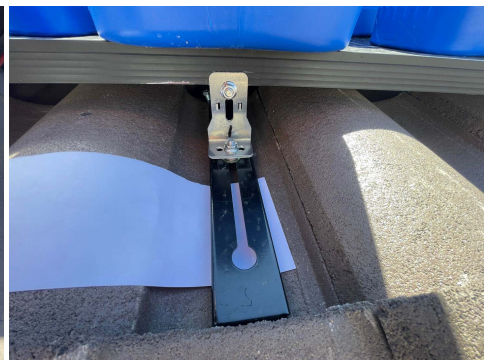
**PHOTO 6:** Load 2 - Bracket under load

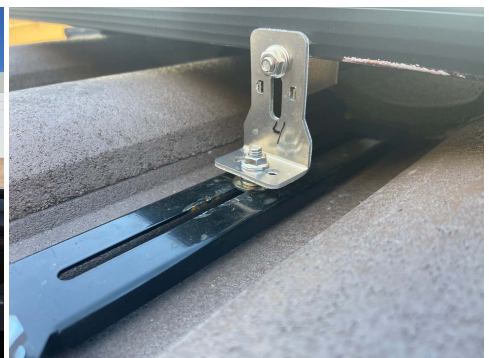
**PHOTO 9:** Unloaded Bracket - after tests

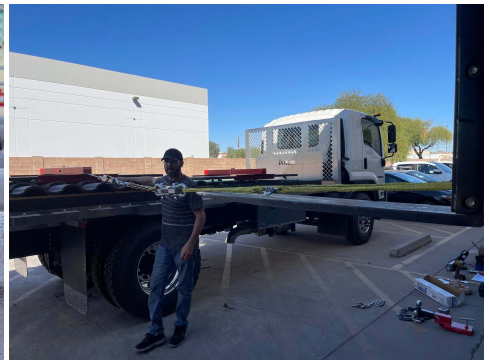
**PHOTO 3:** Test setup for horizontal pull load

The horizontal load test was conducted using a Weightronic Digital Dynamometer (Model OCS-Y) and chain hoist. A horizontal load of at least 500 lbf was applied at the center of the crossbeam that was attached to the panel brackets. The test specimen held the load and no damage or permanent deformation was noted as shown in the test observations table shown below.

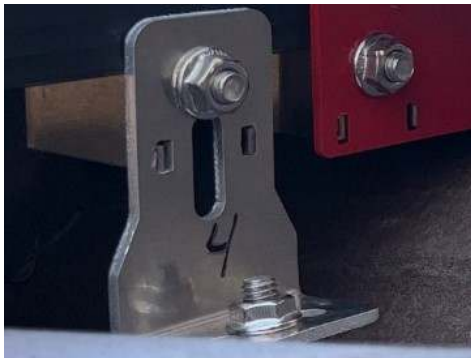
**PHOTO 5:** Bracket under load

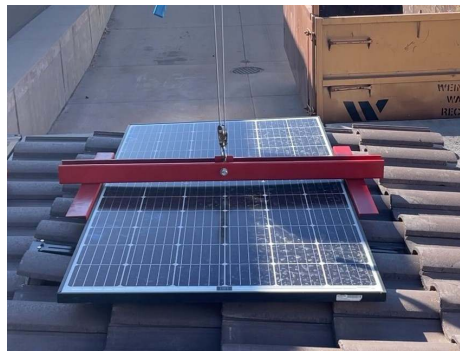
**PHOTO 5:** Test specimen while under tensile load

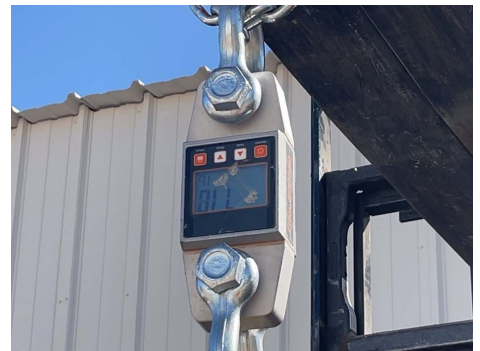
**PHOTO 6:** Dynamometer scale under load

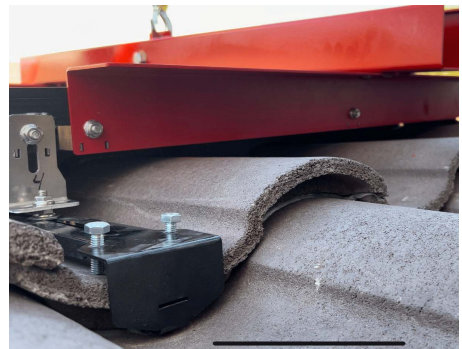
**PHOTO 7:** Bracket under test load

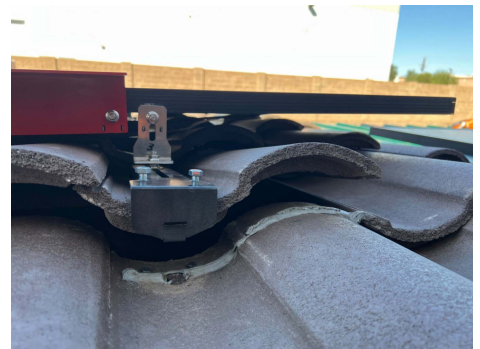
**PHOTO 9:** Bracket unloaded after test - roof tile bond pulled apart.

<p>After removal of the uplift test load all brackets returned to original position with no permanent deformation noted.</p> <p>The solar panel did not show any signs of permanent damage or deformation.</p> <p>At Bracket No. 3, the tile roof shingle separated at the glue bond from the shingle underneath.</p>
