| | PROJECT<br>IntegraRack | | | | |
| | TITLE<br>IR-05MBDB Solar Racking System<br>Data Sheet<br>5 Degree North/South With Wind Spoiler | | | | |

Subject: Witness of Wind Tunnel Testing on IntegraRack Products at the George E Boeing Aeronautics Department (Kirsten Wind Tunnel) at the University of Washington

# PRELIMINARY LABORATORY TEST REPORT

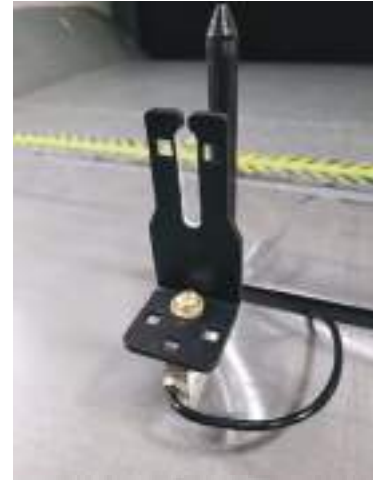
Figure 2: Run 1 through 3 setup with panel

A total of 8 runs were performed on IntegraRack products. Test Runs 1 through 3 were performed with the IR-D1 bracket (See Figures 1-4) with an installed 18 SF solar panel on a simulated roof incline. Run 1 was performed to tare KWT's system through the full 0 to 110 degree rotation of the test platform with the simulated roof and panel installed. The roof surface had been installed at an approximate 5 – 6 degree incline (See Figure 1). The solar panel was mounted at 0 degrees relative to the roof surface with a general height of 5 in from the roof surface. at all four corners of the panel. Test Runs 4 and 5 were performed on the same panel and bracket with the panel height adjusted and installed at an angle with the front corners set to 3-1/2 in. and the back corners set to a height of 6 in. from the roof surface.

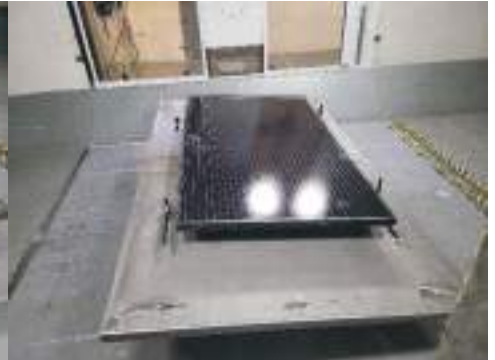
Figure 12: Setup after Run 2, 109 mph winds.  
No damages or loose hardware noted

The maximum load at a bracket recorded during Test Runs 2 and 3 was 75.015 lbf at a wind speed of 157.67 MPH when the panel was at a rotation point of 60 degrees. No damage or deformation was noted

to any bracket during or after the test runs and all hardware was found to be secure upon completion of each test (See Figures 11-13).

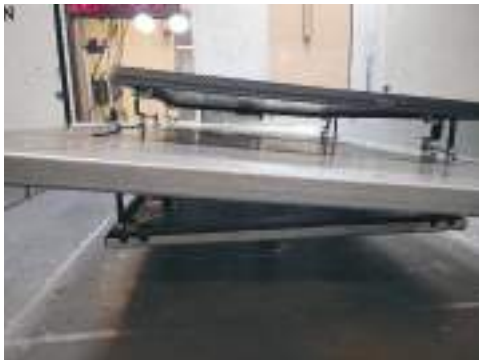
Figure 13: Setup after Run 2, 109 mph winds.  
No damages or loose hardware noted

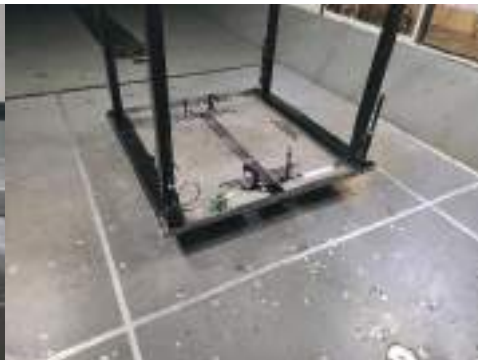
Figure 14: Setup for Run 6 with IR Ballast  
Frame

Test Runs 6 through 8 were performed on the IR Ballast Racks (See Figures 14-32). The simulated roof structure was removed and the frames and panel were mounted directly to the KWT test platform. These runs were performed at a set angle with no platform rotation during the test run. Two load cells were used for the test setups and were mounted at the brackets at the leading edge of the test platform at the wind intake side.

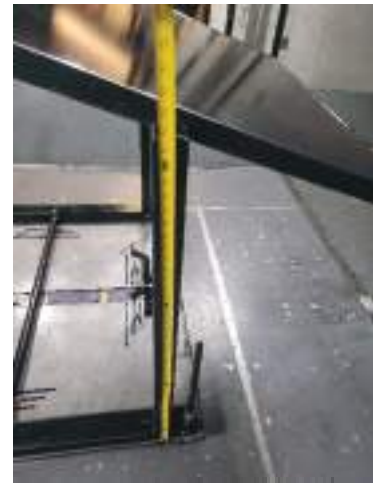
Figure 23: Total width 41-1/4 in.

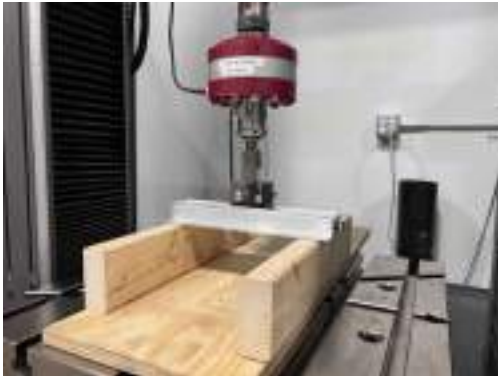
**Photo 1:** Test setup

| CLIENT | | PROJECT/TEST DESCRIPTION | | CLIENT ORDER NO. |
|---|---|---|---|---|
| <p>The Multiballast DB base with a H-module bracket was set on top of two 2x4's that had a spacing of 8" between the 2x4's (photos 1 and 2). The H-module bracket was installed on the Multiballast DB base mount using the designed slide rails for installation. Using both of the mounting holes on the H-module the universal test machine (UTM) was bolted to the H-module bracket applied a compression force pushing straight down on the bracket H-module bracket and the Multiballast DB base at a test speed of 2 in./min.</p> | | | | |

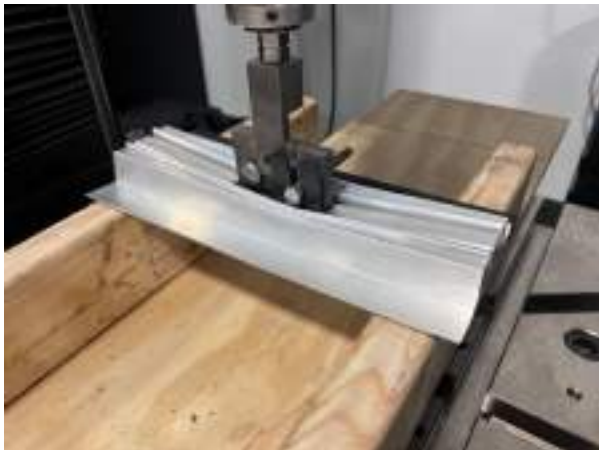
**Photo 5:** Deformation post testing

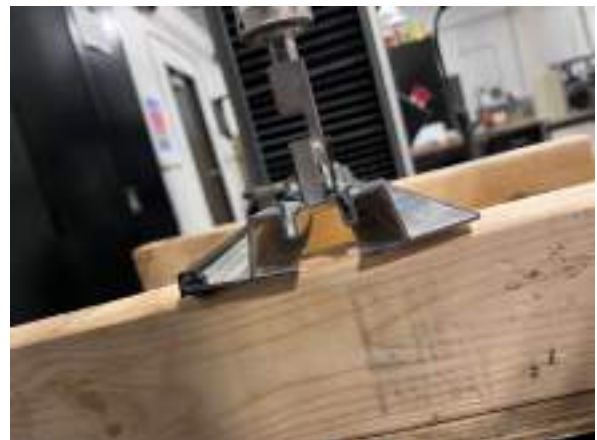
**Photo 6:** Deformation post testing

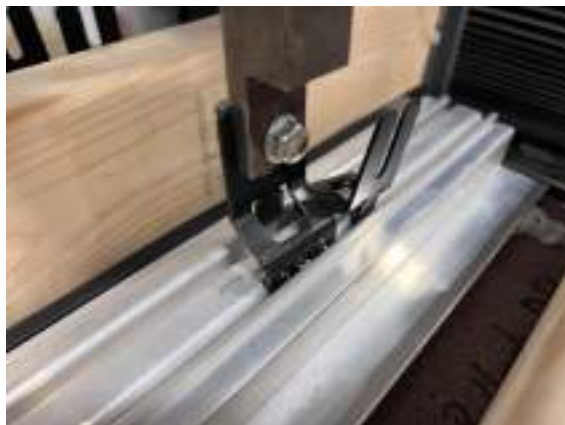
**Photo 5:** "H" bracket deformed and slipped out of Multiballast DB base test #1

| CLIENT | | PROJECT/TEST DESCRIPTION | | | | CLIENT ORDER NO. |
|---|---|---|---|---|---|---|
| 1 | Multiballast DB bonded to tile shingle #1 with H bracket (photo 3) | 0.602 | 594 | 9.1 | N/A | Test stopped when H-Module bracket slipped out of Multiballast DB base. Minor deformation was noted in the "H" bracket @ ~ 450 lbf |

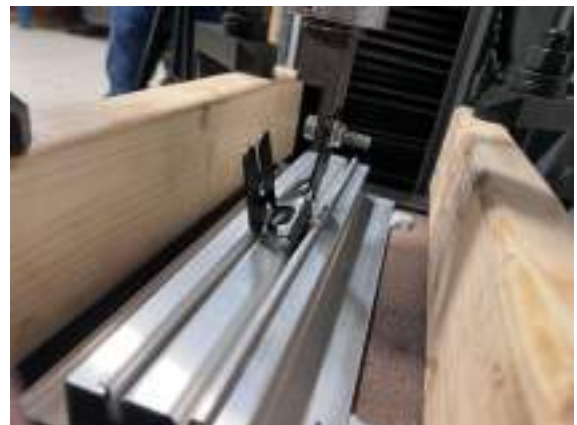
**Photo 6:** "H" bracket deformed and slipped out of Multiballast DB base test #2

| CLIENT | | PROJECT/TEST DESCRIPTION | | | | CLIENT ORDER NO. |
|---|---|---|---|---|---|---|
| 2 | Multiballast DB bonded to tile shingle #2 with H bracket (photo 4) | 0.592 | 557 | 9.6 | N/A | Test stopped when H-Module bracket slipped out of Multiballast DB base Minor deformation was noted in the "H" bracket @ ~ 430 lbf |

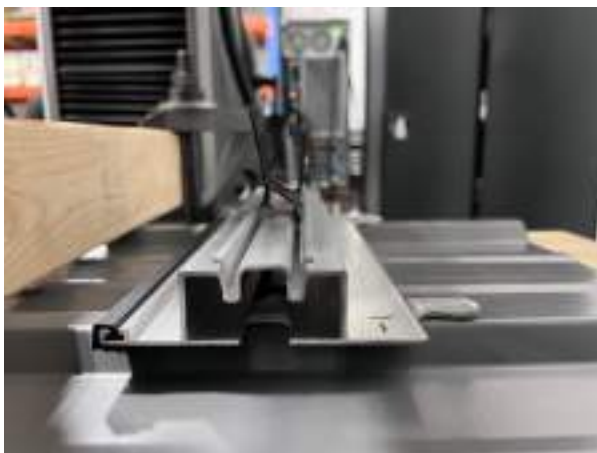
**Photo 5:** Tension test #1 "H" bracket slipped out

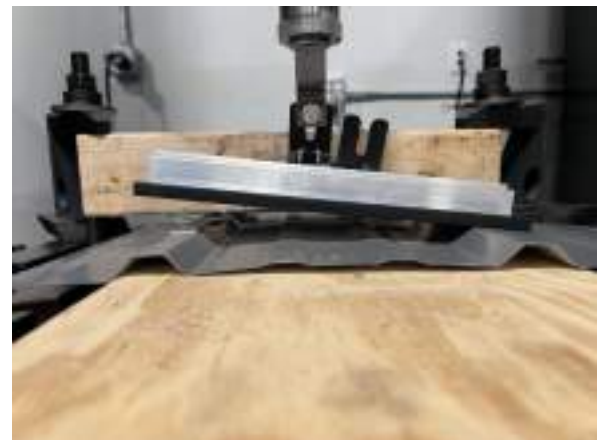
**Photo 6:** Tension test #2 adhesive failure, aluminum to adhesive interface

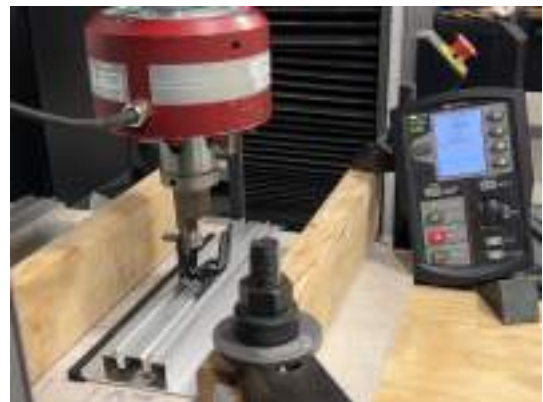
**Photo 4:** Approximate load before bolt slipped, 520 lbf

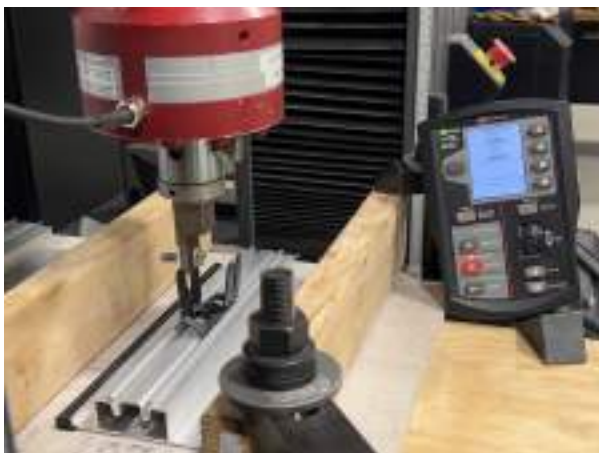
**Photo 5:** Bolt slipping out of "H" bracket

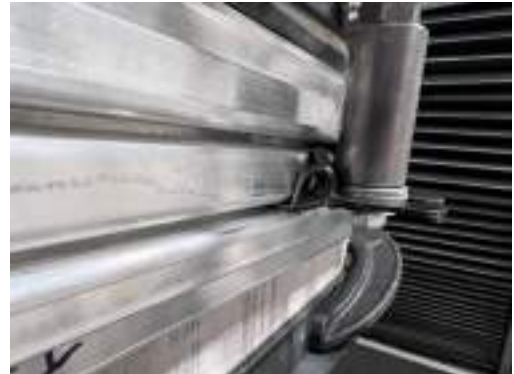
**Photo 10:** "H" bracket deformation post test

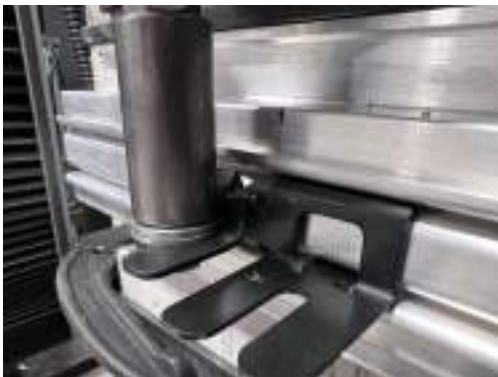
**Photo 11:** "H" bracket deformation post test
