To: Rex Vaughn, Chairperson
Cedar Lake Improvement Board

Date: November 18, 2025

From: Mark Kieser, Senior Scientist
Kieser & Associates, LLC

RE: Cedar Lake Nearshore and Tributary Monitoring to Assess Possible
Phosphorus Sources Stimulating Nuisance Algal Growths Near Jones Ditch

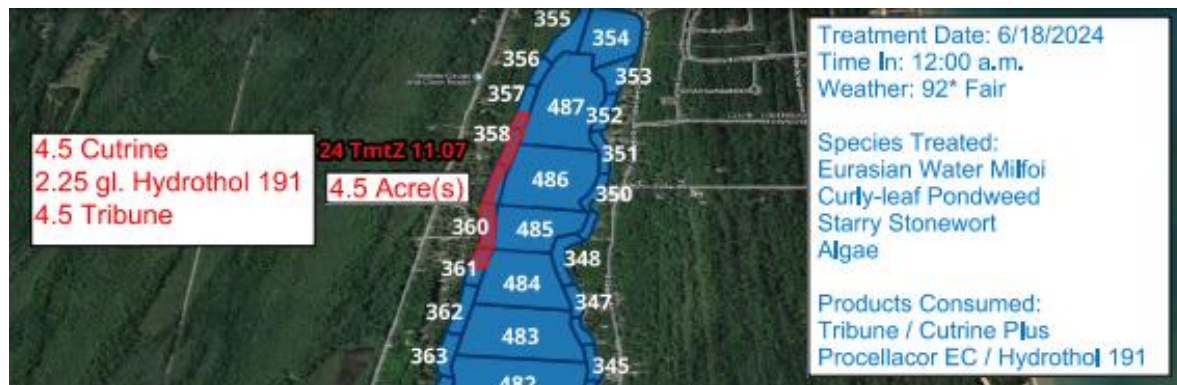
Figure 2 – Excerpted Figure B3 – Solitude Lake Management treatment map for Cedar Lake, Alcona and Iosco counties, on June 18, 2024 (appearing in K&A’s February 24, 2024 Final LakeScan™ Report for Cedar Lake North) highlighting (in red) treatment in the areas of AROS 357 and 358.¹

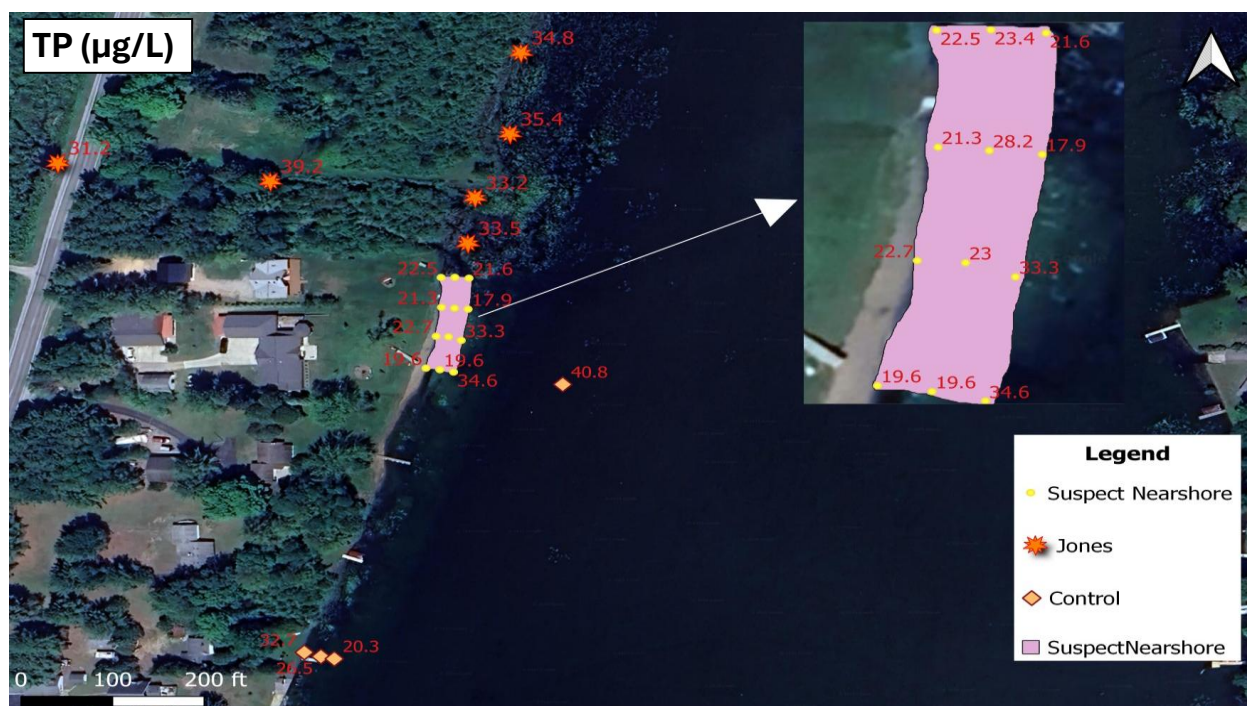
Figure 4 portrays all TP data from the August sampling where they were collected. The inset is an enlargement of results specific to the suspect shoreline area. The highest TP concentration noted was the open lake control at 40.8 $\mu\text{g/L}$. This was not expected, and contrasts with typically low TP levels cited earlier from Cedar Lake CLMP sampling at 14 $\mu\text{g/L}$. A cluster of higher TP concentrations appears at Jones Ditch, around the mouth of the ditch and to the north. Nearshore suspect areas to the immediate south of the ditch were generally lower than levels around the ditch. The southern nearshore control area had TP concentrations similar to the range noted in the nearshore suspect area.

Notable along residential shoreline areas was the localized variability in TP concentrations compared to those around the ditch that were quite consistent. This initially suggests that Jones ditch flows could be creating ubiquitous conditions where it enters the lake amidst rooted macrophytes dominating the shoreline, at least during the time of August sampling.

This ubiquitous distribution of TP is not noted along residential shorelines. In the suspect area with dense algal growth, sampling within the matrix of *Chara* and filamentous green algae may be a reason for varying concentrations ranging from 17.9-34.6 $\mu\text{g/L}$ over this small area. Shorelines with limited algal or plant growth will tend to have similar levels where there is no localized source of phosphorus and circulation evenly mixes ambient lake water. Those with dense growths observed along the suspect shoreline area, may impede nearshore circulation. Add possible localized phosphorus sources (Jones Ditch and/or septic systems), such variation in TP concentrations over a limited area might not be unexpected. There is no decisive explanation of higher TP concentrations near the shoreline of the southern control location, diminishing as these move lakeward, other than a possible onshore localized source.

Figure 4. Total Phosphorus results by sampling station for the August 27, 2025 monitoring.

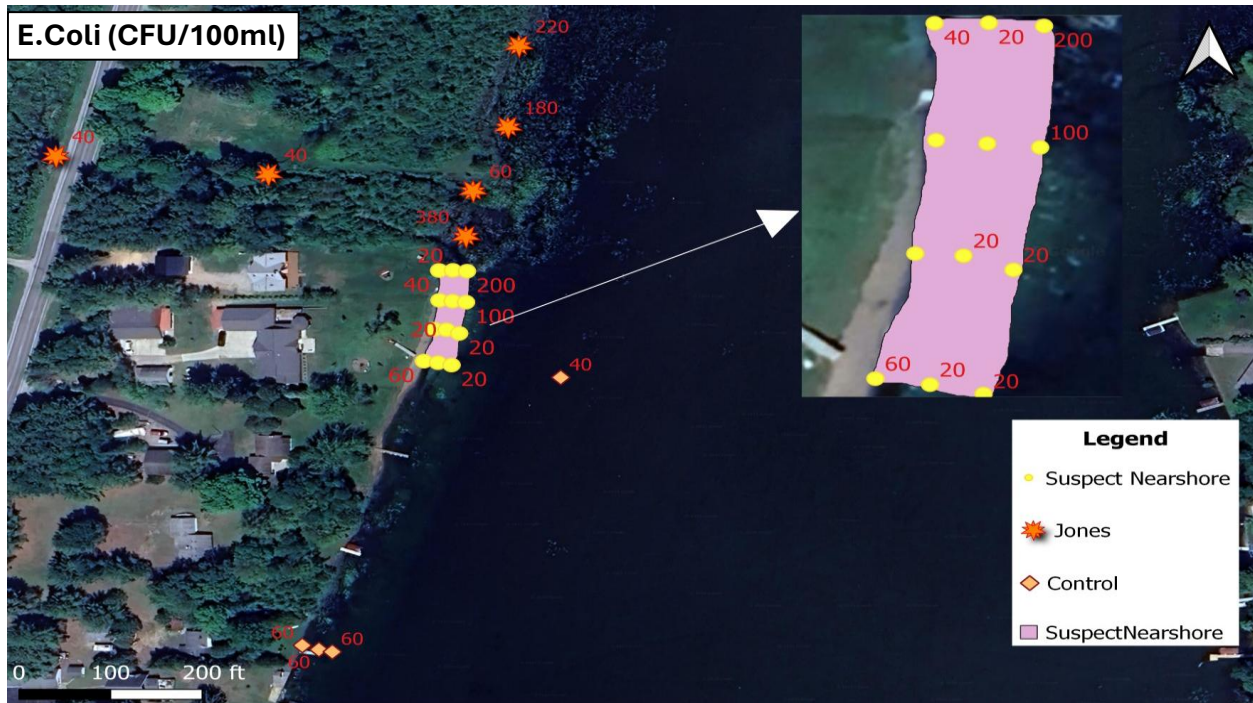
Sampling results show that *E. coli* and Total Coliform bacteria are broadly distributed throughout the areas sampled (Figures 6 and 7, respectively). This includes at control locations. *E. coli* was detected at levels ranging from non-detect to 380 CFU/100ml across all samples collected on August 27th. All *E. coli* detections were generally higher than what has typically been observed at the Greenbush Township public beach. One sample at the ‘southern wetland’ location just off the mouth of Jones Ditch exceeded the state standard for full body contact of 300 CFU/100ml. The highest *E. coli* detections appeared to be clustered near the mouth of Jones Ditch and to the north (Figure 6). Notable were the ubiquitous measures of *E. coli* at 60 CFU/100ml in the nearshore control area. Their presence here might suggest a localized source such as a septic system discharge, though SRP data at this control location do not necessarily affirm such an inference.

Figure 6. *E. coli* results by sampling station for the August 27, 2025 monitoring (monitoring locations with no mapped data indicate there were no detections of *E. coli* bacteria).

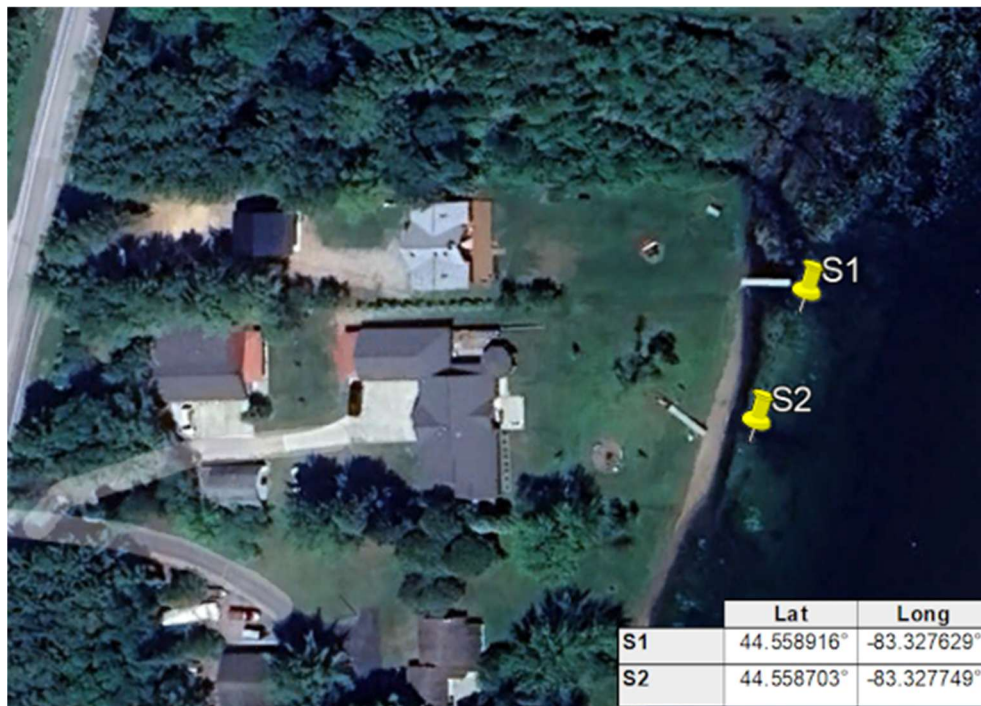
K&A sample collection occurred under partly cloudy conditions with temperatures reaching 84°F. Winds ranging from 6 to 15 mph from the northwest resulted in calm conditions in this sampled section of the Cedar Lake shoreline. (Refer to Attachment A of this memo for site photos taken at the time of sample collection.) Two water quality samples were collected at locations shown in Figure 1 by submersing and then inverting 250ml wide-mouth plastic sample containers to capture water from below the lake surface. Water samples were collected amongst dense growths of *Chara* sp. and filamentous green algae. Site 1 (S1) was located approximately 35 ft from the shoreline while Site 2 (S2) was located approximately 16.5 ft from the shoreline. The depth near each site was approximately 2-3 feet.

Figure 1. Water quality sampling locations on July 2, 2025.

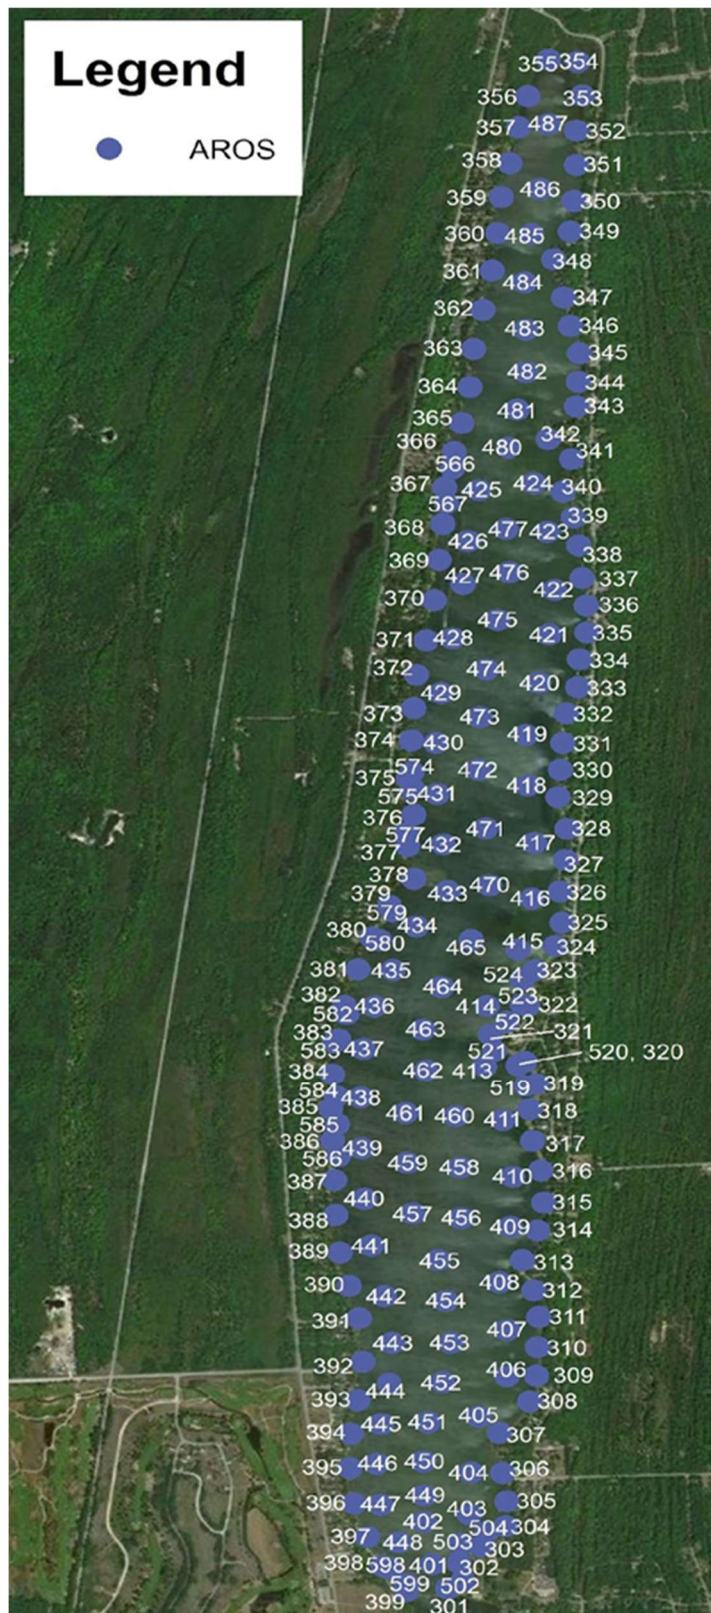
This sampling occurred within Aquatic Resource Observation Site (AROS) 358 (refer to Figure 2). AROS locations have been monitored for aquatic vegetation by the K&A team for almost two decades on Cedar Lake using the LakeScan™ survey methodology. Native vegetation located within this AROS during the July 2 survey included the calcareous macroalgae, *Chara*, and vascular macrophytes including Sago Pondweed (*Stuckenia pectinata*), Variable Pondweed (*Potamogeton graminus*), Broadleaf Pondweed (*Potamogeton amplifolius*), Variable Watermilfoil (*Myriophyllum heterophyllum*), Waterlily (*Nymphaea* sp.), Spatterdock (*Nuphar* sp.), Rush (*Juncus pelocarpus*) and Cattail (*Typha* sp.). Mixed in amongst the *Chara* and vascular plants were notable growths of filamentous green algae. Though not observed in July 2025, the invasive hybrid Eurasian watermilfoil was previously observed at this location prompting past chemical treatments in this area. Observed plants at this location this year appeared at high densities; a consistent observation over the years despite periodic chemical

treatments intended to suppress such luxuriant growth. Such aquatic vegetation at other locations along the northwest was not observed at the densities seen at AROS 358.

Figure 2. Aquatic Resource Observation Sites (AROS) map of the northern section of Cedar Lake.

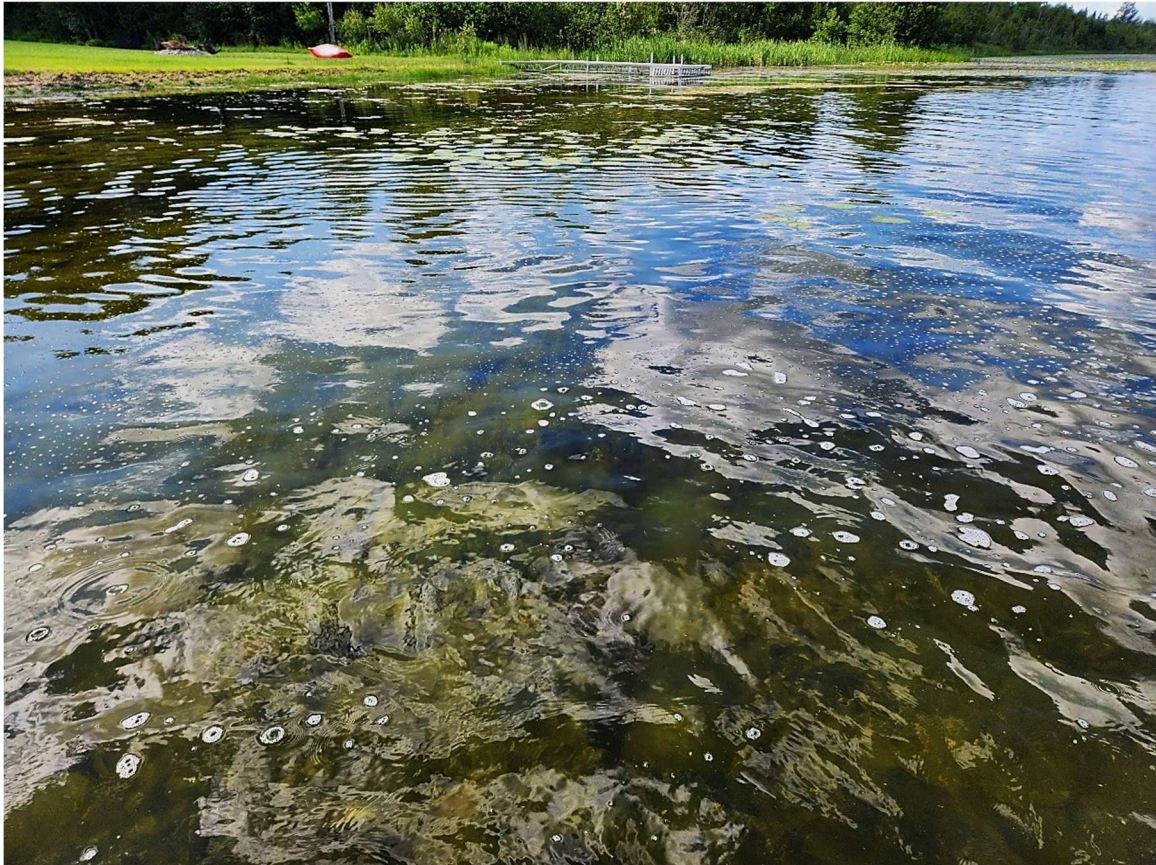
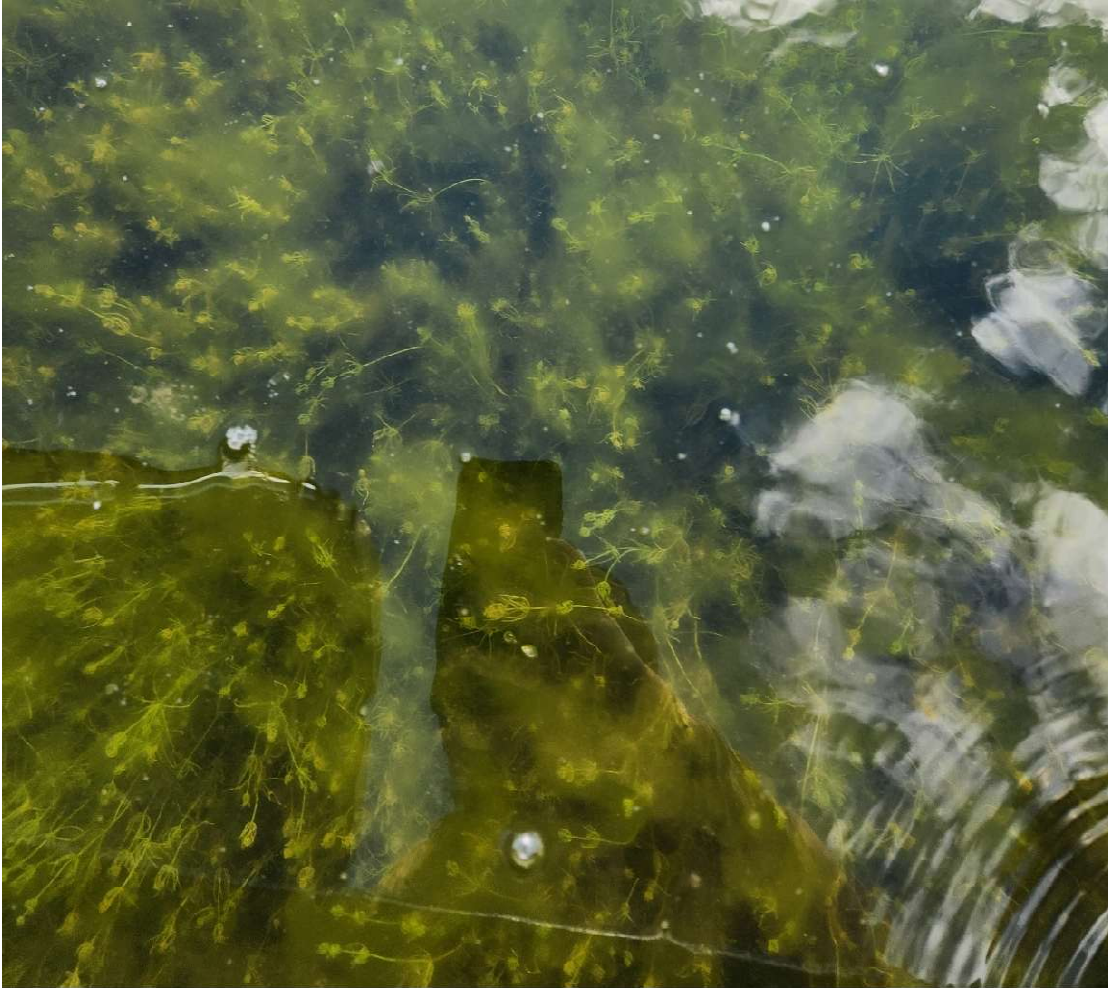
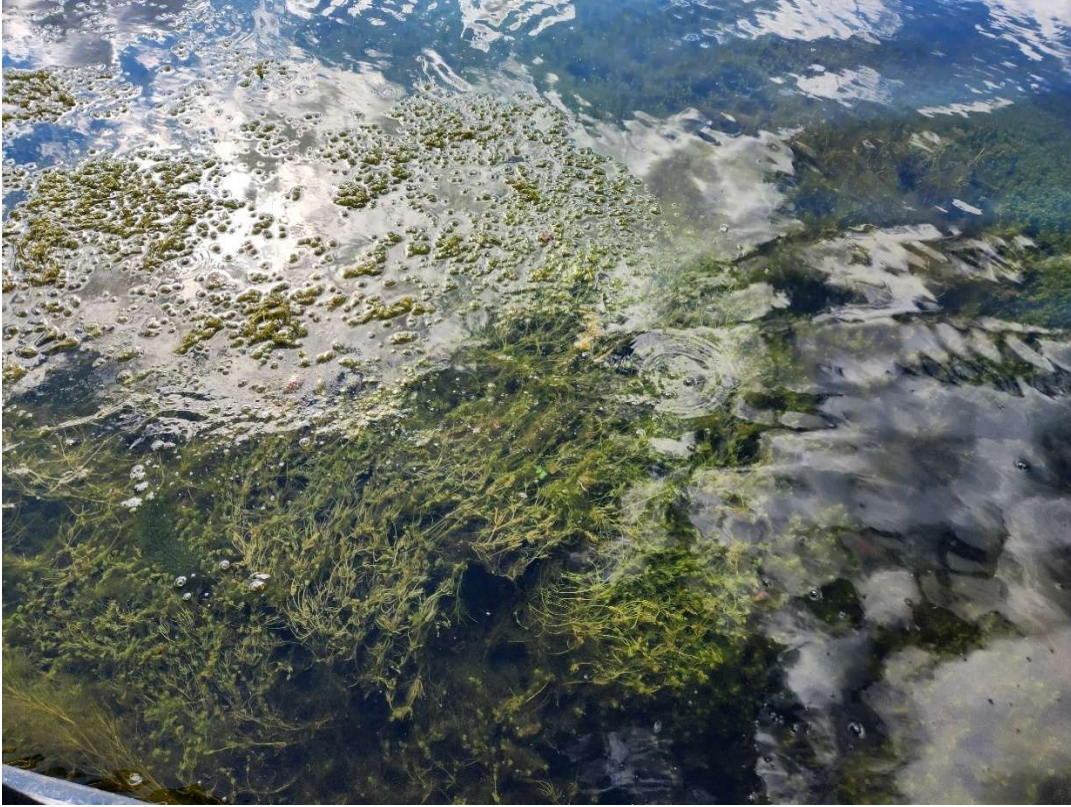
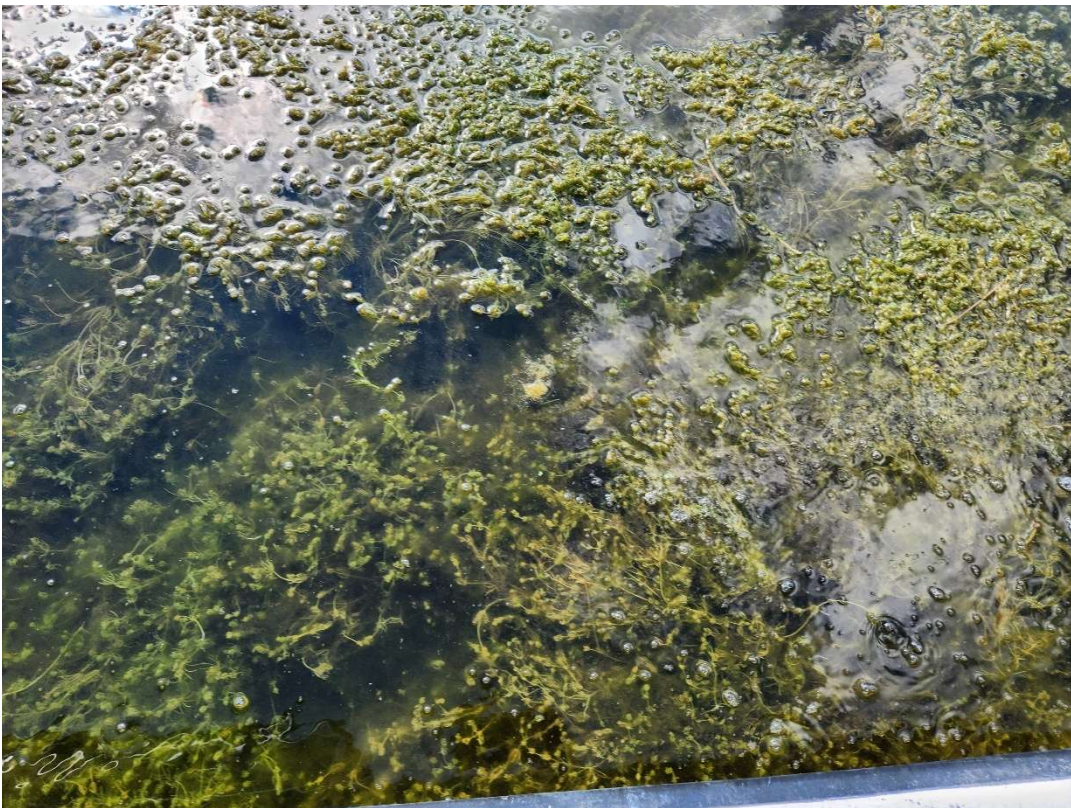
Field Photos of Site Conditions

Photos of the excessive growth of *Chara sp.* and filamentous algae near the sampling locations, taken on July 2, 2025.

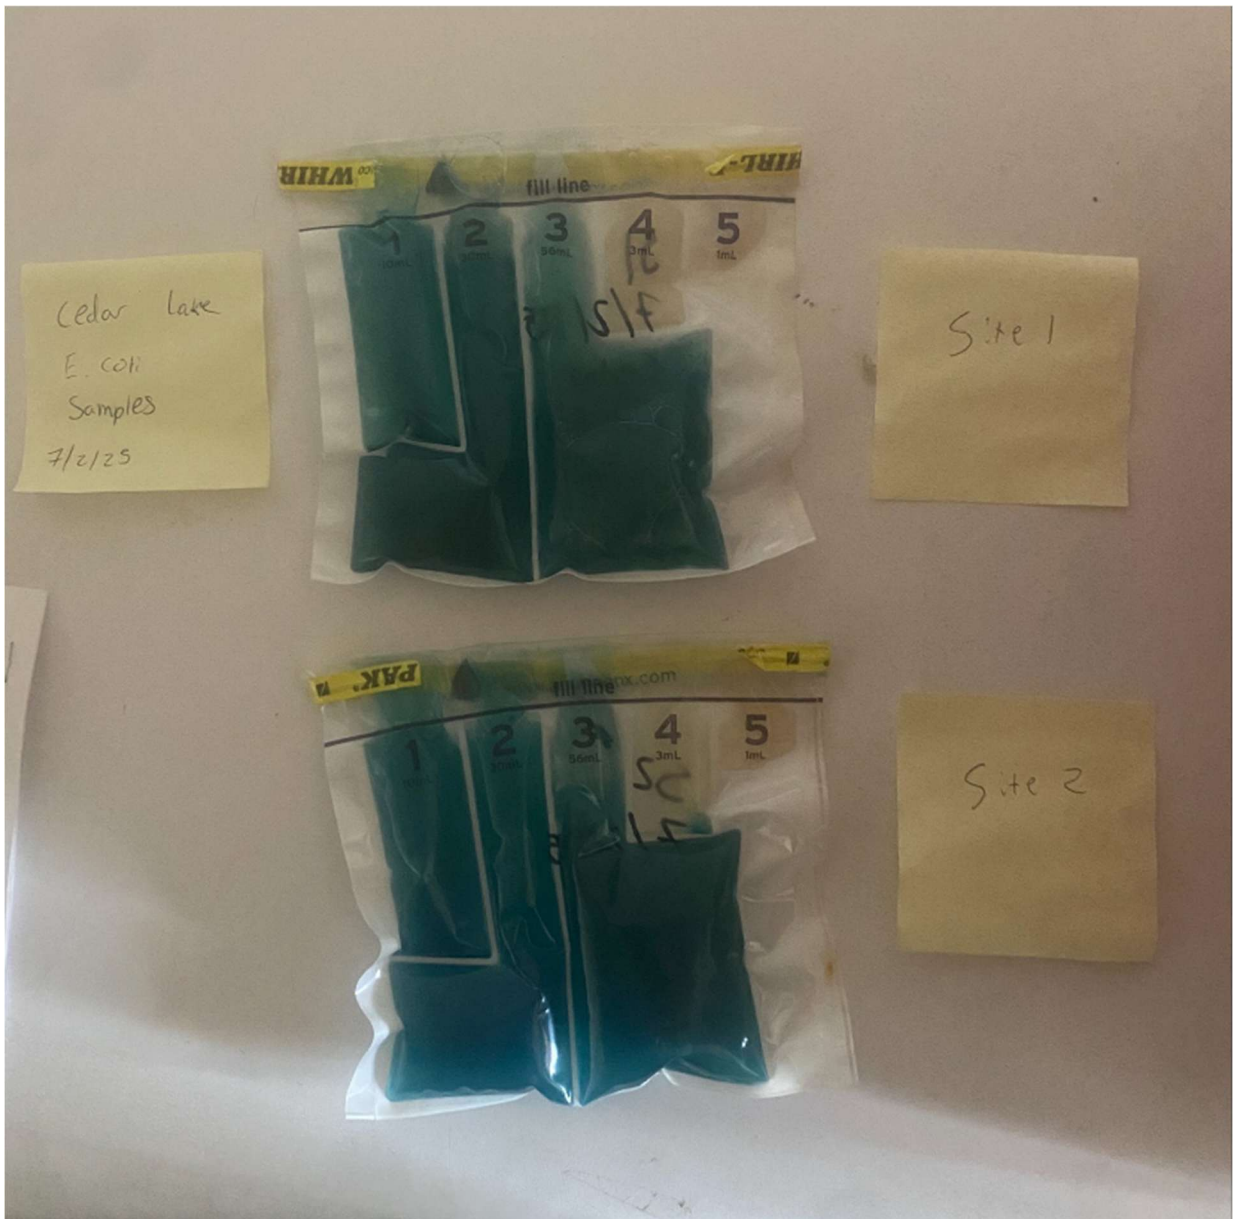
Photo of S1 and S2 Aquagenex Field Test Kit results in ambient lighting after a 5-day incubation period at room temperature. Blue coloration indicates the presence of *E. coli* (Channels 1-3 for Site 1; Channels 1-4 for Site 2).

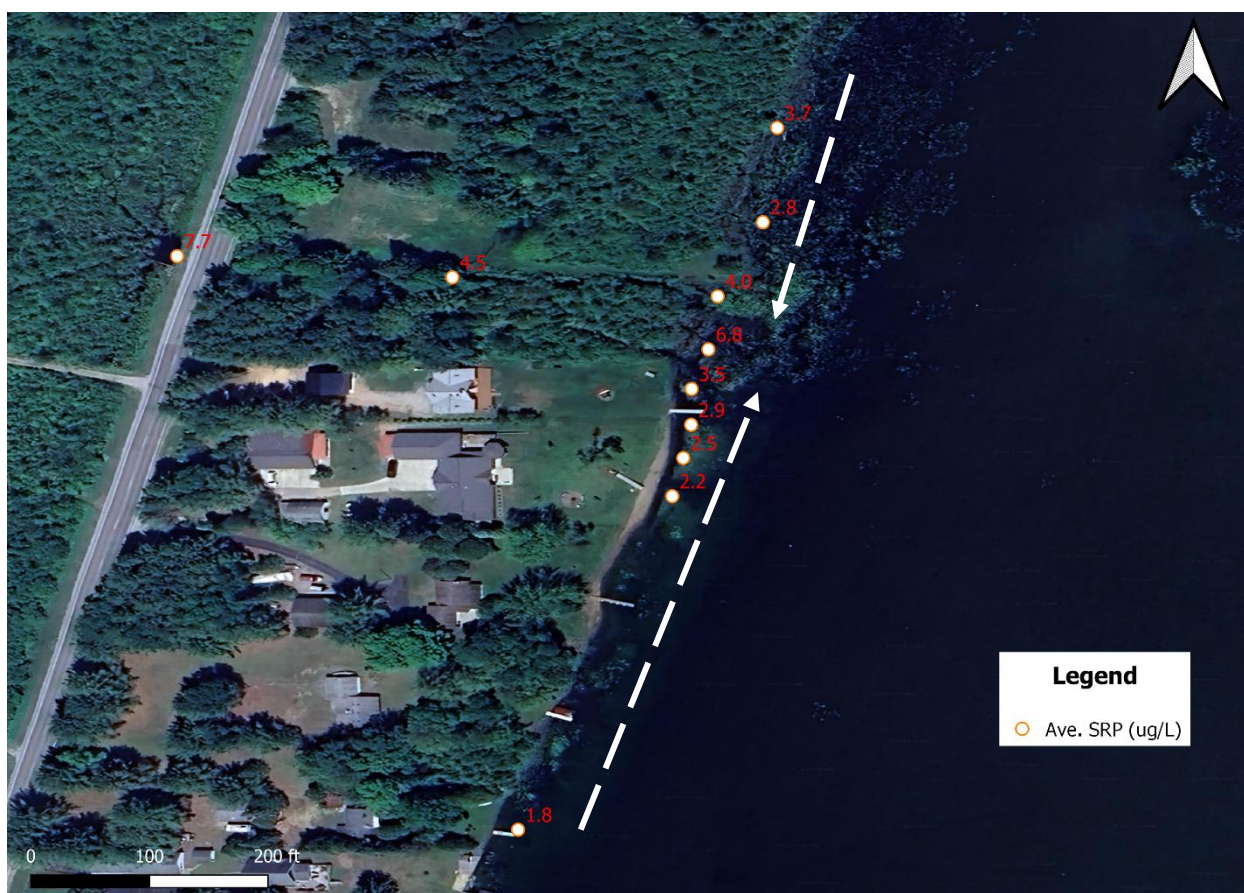
Figure E-2 shows the average SRP levels at each nearshore sampling site south of Jones Ditch, along with individual data points at and north of the ditch confluence with the shoreline. For the suspect nearshore zone south of Jones Ditch and the control area, averages represent the three sampling points of each transect. Interestingly, mapped results indicate that the average SRP concentration increases as it gets closer to Jones Ditch (white arrows) from the south and somewhat so for sampling results at, and north of the confluence. This suggests a hot spot or source of SRP originating from the confluence area.

Figure E-2. Average SRP ($\mu\text{g/L}$) at each sampling site.
