### **MEMORANDUM**

RE: Summary of July 2, 2025 Water Quality Sampling of Select Nearshore Areas of

Cedar Lake with Preliminary Discussion of Field Screening for E. coli Bacteria

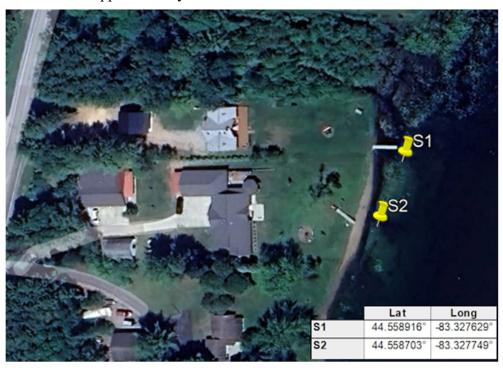
K&A sample collection occurred under partly cloudy conditions with temperatures reaching 84°F. Winds ranging from 6 to 15 mph from the northwest resulted in calm conditions in this sampled section of the Cedar Lake shoreline. (Refer to Attachment A of this memo for site photos taken at the time of sample collection.) Two water quality samples were collected at locations shown in Figure 1 by submersing and then inverting 250ml wide-mouth plastic sample containers to capture water from below the lake surface. Water samples were collected amongst dense growths of *Chara* sp. and filamentous green algae. Site 1 (S1) was located approximately 35 ft from the shoreline while Site 2 (S2) was located approximately 16.5 ft from the shoreline. The depth near each site was approximately 2-3 feet.

Figure 1. Water quality sampling locations on July 2, 2025.

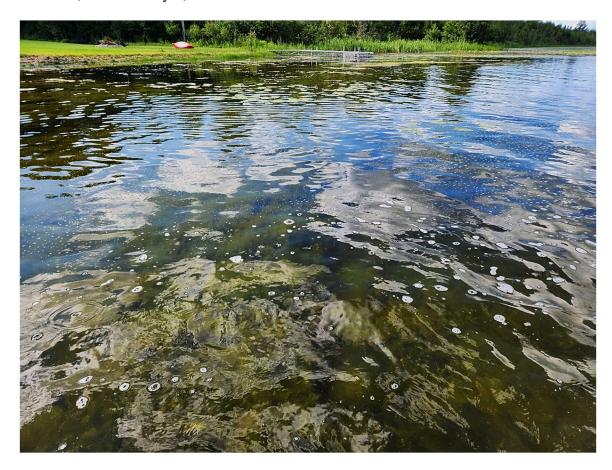
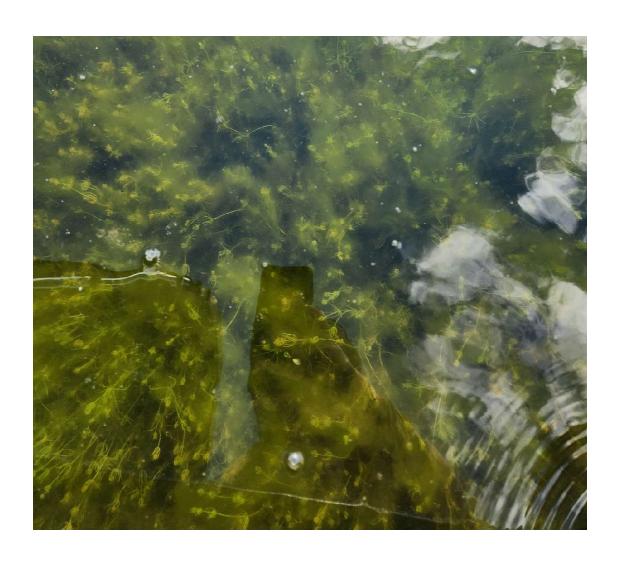
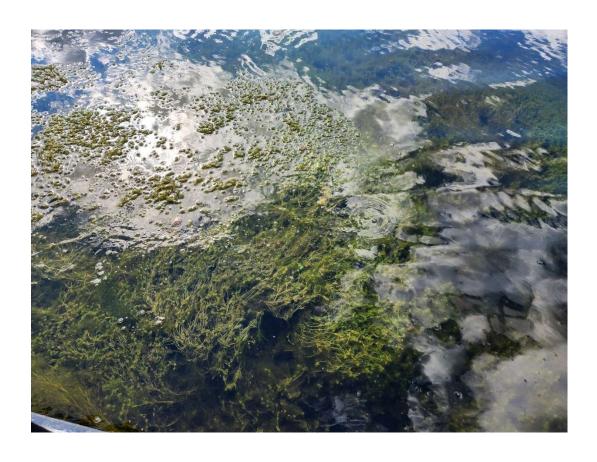
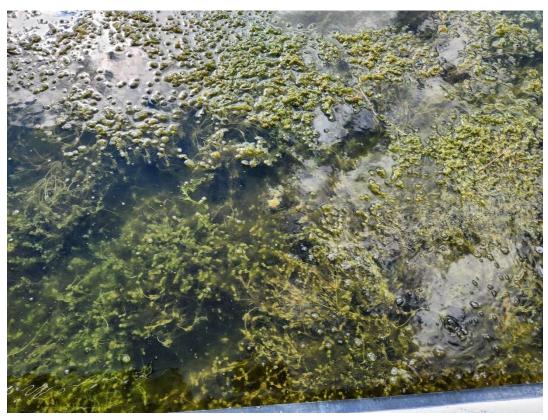
## **Field Photos of Site Conditions**

SRP samples have been submitted to the Great Lakes Environmental Center (GLEC) laboratory in Traverse City, MI. Analytical results should be reported by GLEC before the end of July. The luxuriant growth observed in the sampling area (particularly the level of filamentous green algae) suggests a higher level of soluble phosphorus here than is likely present in other observed shoreline areas with little to no algae and lower plant densities. In anticipation of July 2 testing results, K&A will compare reported lab data against nearby Jones Ditch phosphorus sampling in 2024.

Many filamentous green algae exhibit similar growth habits and are morphologically similar to *Cladophora* (John and Rindi 2015). Because of these similarities, it is possible that the prolific filamentous green algae growths observed as Site 1 and 2 may also act as a secondary habitat for *E. coli*, prolonging its presence in this area. As a substantial source of soluble phosphorus is required for the observed algal growth, these conditions lead K&A to believe that septic system leachate could be the primary reason for observed conditions.

Photos of the excessive growth of *Chara sp.* and filamentous algae near the sampling locations, taken on July 2, 2025.

With the levels of bacteria observed through field-testing, septic leachate would also be the suspected source based on K&A research of other northern Michigan lakes over the past decades. Thus, additional testing should be performed at this nearshore location. K&A recommends this testing be conducted by the county health department which could also assist residents with recommendations for additional inspections of existing septic system performance.

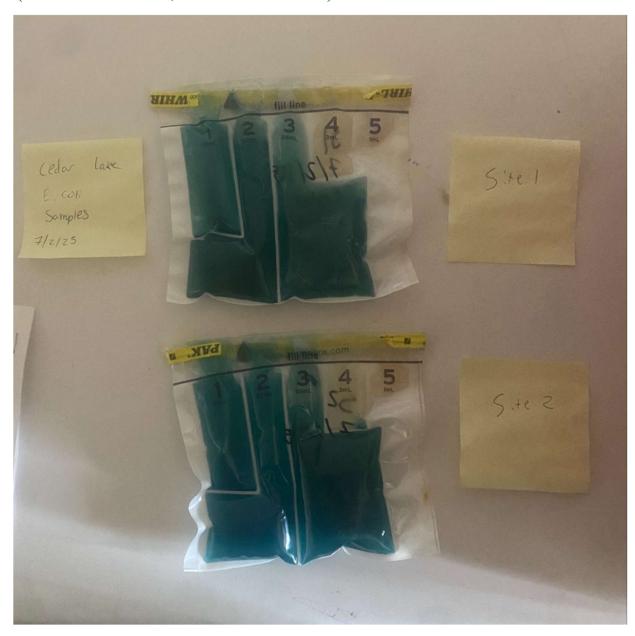
### **Field Test Kit Results**

Photo of S1 and S2 Aquagenex Field Test Kit results in ambient lighting after a 5-day incubation period at room temperature. Blue coloration indicates the presence of *E. coli* (Channels 1-3 for Site 1; Channels 1-4 for Site 2).

Using the Aquagenx® MPN table: Total coliform analysis is based on the yellow cells that fluoresce under UV light (representing positive for coliforms). Cells that are blue in ambient light are positive for E. coli, which also means they are positive for coliforms (Attachment B). This means that both Sites 1 and 2 would fall under the last row of the MPN estimation table provided by Aquagenx®. Therefore, the MPN/100mL of both samples is greater than 1,000 MPN/100mL, with an upper 95% confidence level of 94,351.

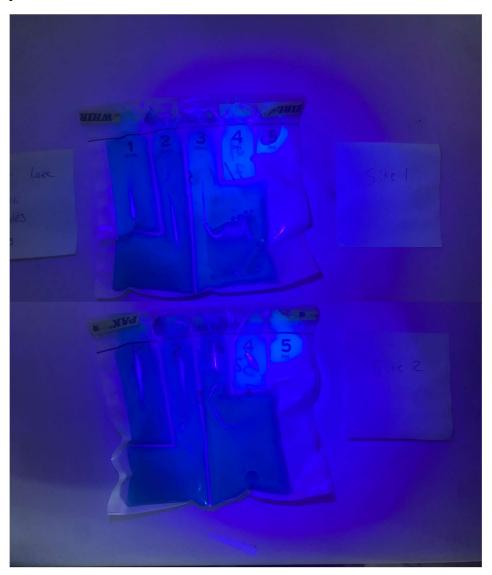
Photo of Aquagenex samples under UV lighting after a 5-day incubation period at room temperatures. The blue fluorescence (Channels 4 and 5 in each sample pack) indicates the presence of other coliform bacteria.
