A Summary of Findings from LakeScan™
Guided Surveys and Analysis of:

Cedar Lake North

Alcona and Iosco Counties

2024 DATA AND ANALYSIS SUMMARY REPORT WITH MANAGEMENT RECOMMENDATIONS

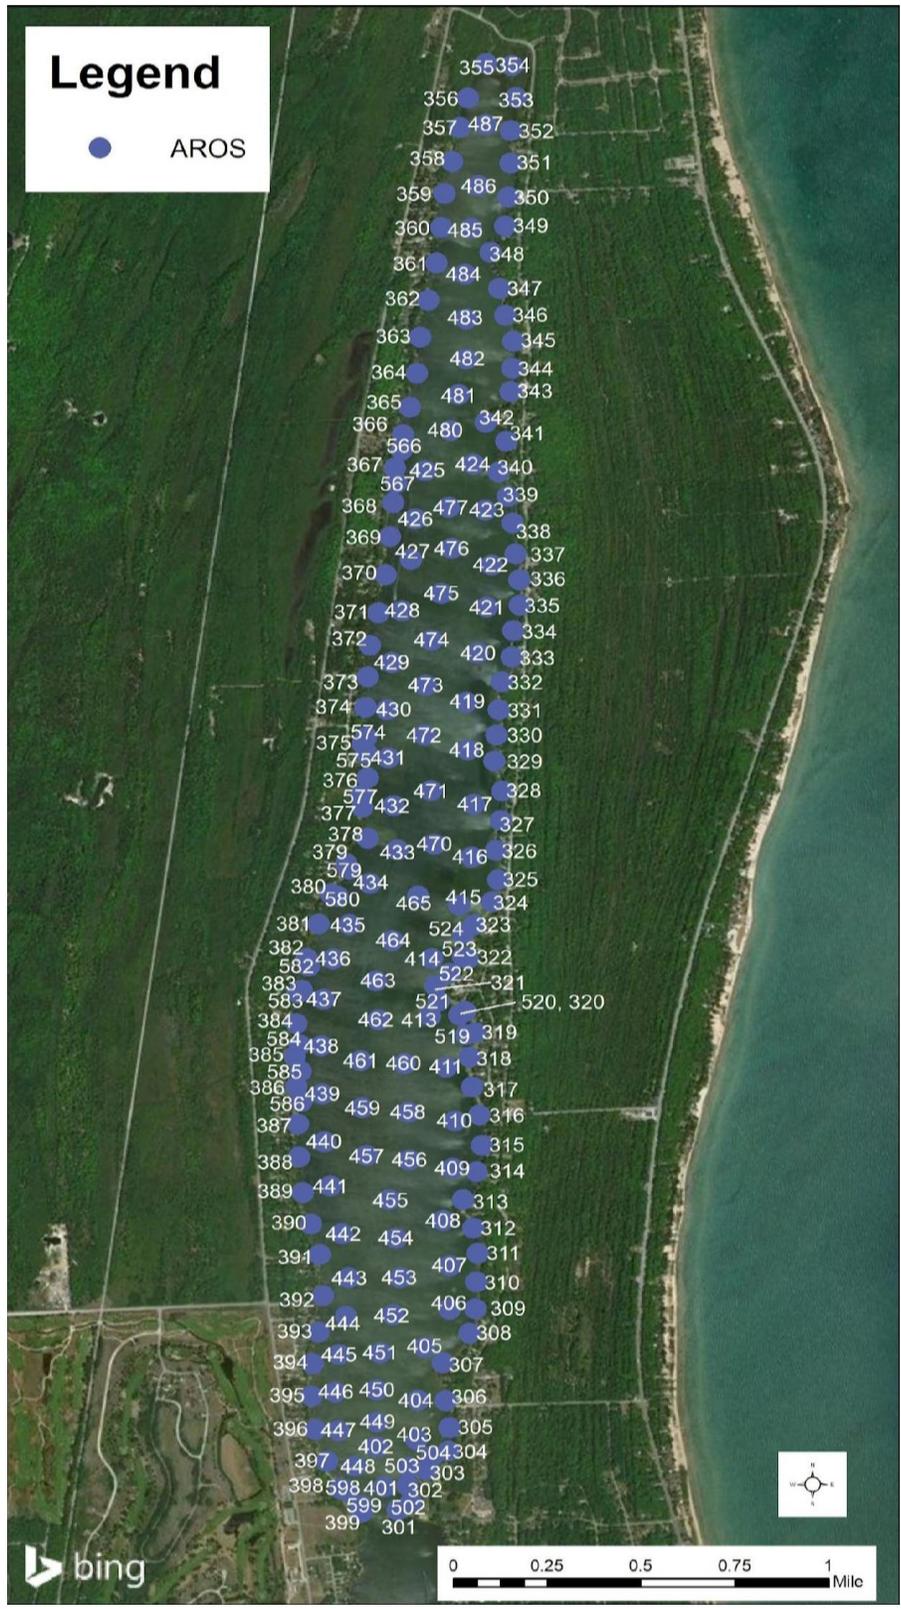
Figure 1 - Map of Aquatic Resource Observation Sites (AROS).

The LakeScan™ analysis involves collecting data over two vegetation surveys during the critical summer recreational season. These surveys are based on a system where the lake is first divided into biological tiers (Table 1) and then further subdivided into Aquatic Resource Observation Sites (AROS; Figure 1). For each survey, field personnel record the density, distribution, and position in the water column of each aquatic plant species in each AROS, as well as noting any nuisance conditions. Dissolved oxygen profiles, temperature profiles, and Secchi depth are additionally recorded. Other water quality sampling can be included with surveys when requested.

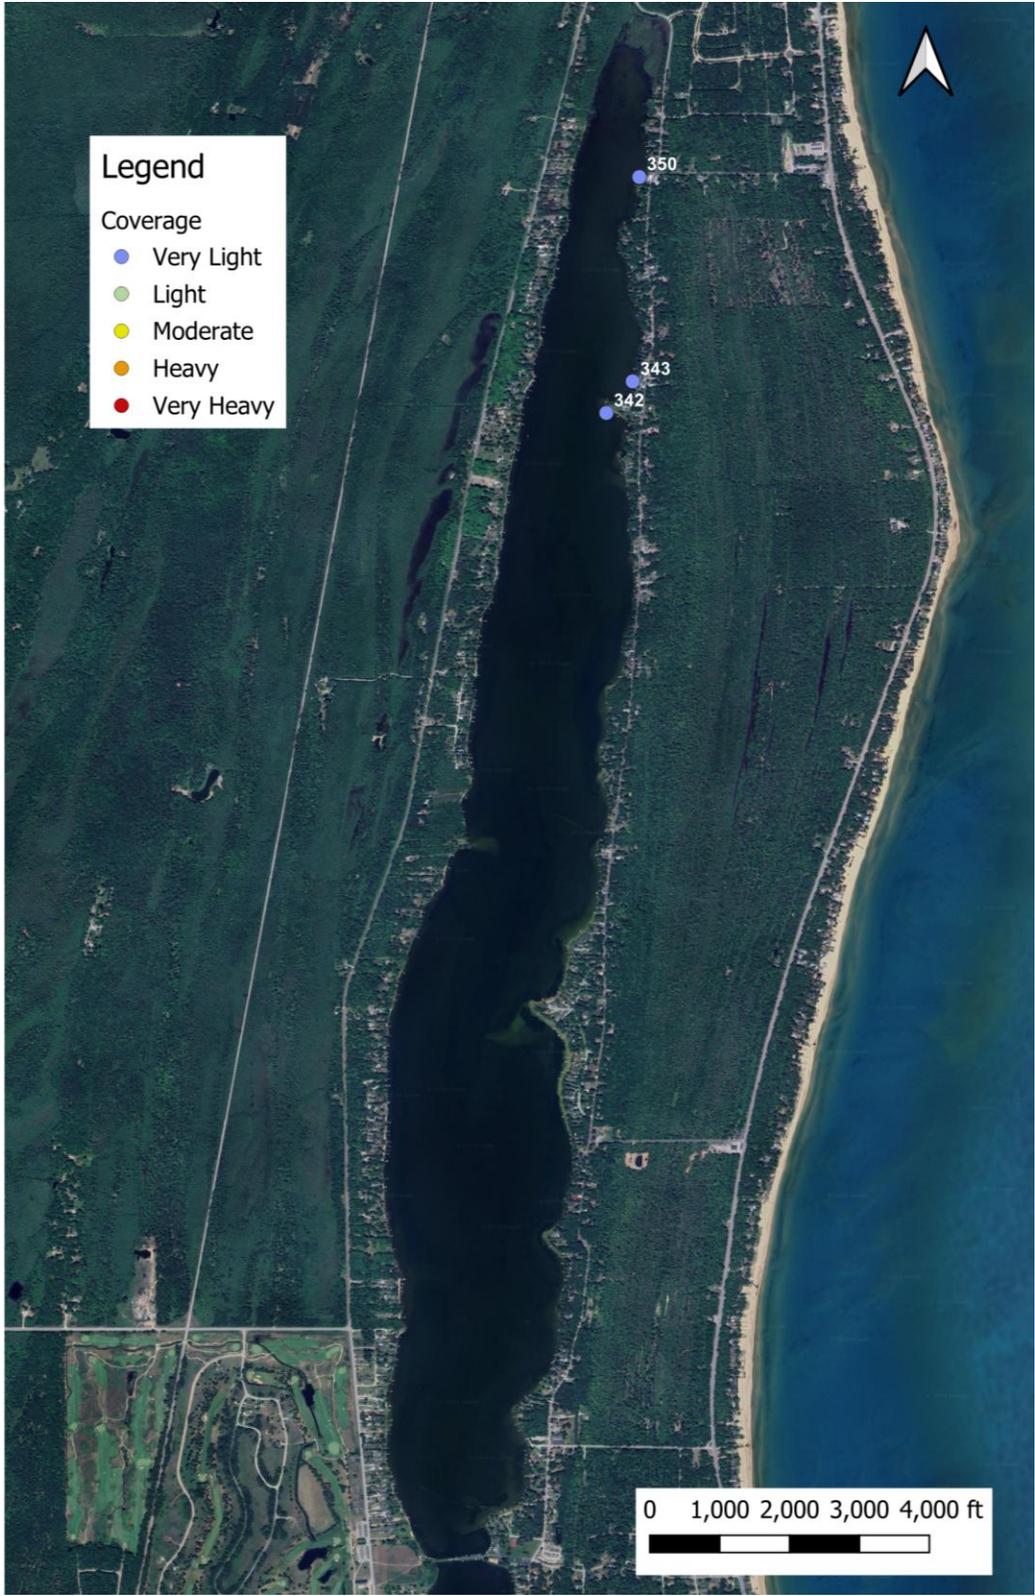
Figure 6 – Early-season (7/1/2024) Eurasian watermilfoil coverage.

The only submerged aquatic invasive species observed in Cedar Lake North during the 2024 early-season survey was hybrid Eurasian watermilfoil. Eurasian watermilfoil was found in single stand-alone clusters in AROS 342, 343, and 350 and did not appear to be very hardy and was expected to drop from the water column on its own (Figure 6). Additionally, the emergent invasive species *Phragmites* and purple loosestrife were found along the shoreline, with *Phragmites* only at AROS 361, and purple loosestrife at AROS 340, 351, and 352, neither causing management concerns at the time of the survey (Figures 7 and 8).

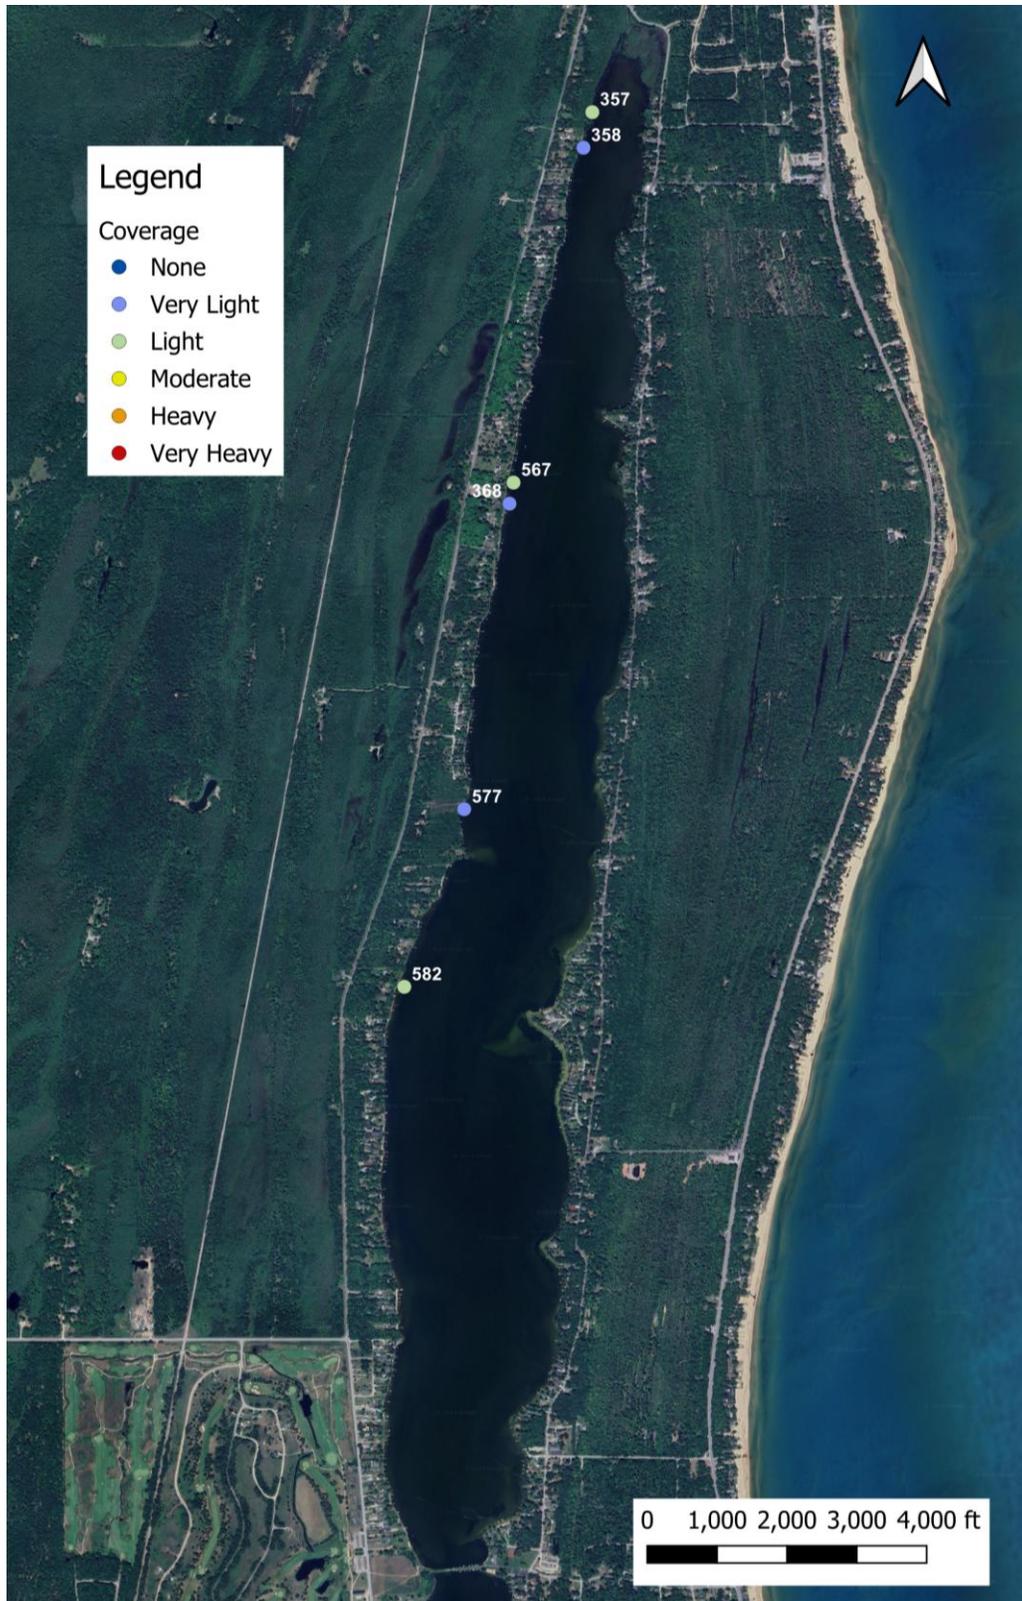
Figure 11 – Late-season (8/7/2024) Eurasian watermilfoil coverage.

The only submerged aquatic invasive species observed in Cedar Lake North during the 2024 late-season survey was hybrid Eurasian watermilfoil. Eurasian watermilfoil was found in clusters in AROS 357, 358, 368, 567, 577, and 582 (Figure 11). The milfoil that was spotted in AROS 342, 343, and 350 in the early-season survey was not observed at the time of the late-season survey. The emergent invasive species *Phragmites* and purple loosestrife were found along the shoreline, with *Phragmites* at AROS 360, 361, and 364. Purple loosestrife was flowering during the time of the survey making it more conspicuous. It was spotted in stand-alone pockets across much of the shoreline (Figure 12). Purple loosestrife was the densest and widely distributed in AROS 340, 352, 358, 360, 368, 376, 380, and 392 (Figure 13).

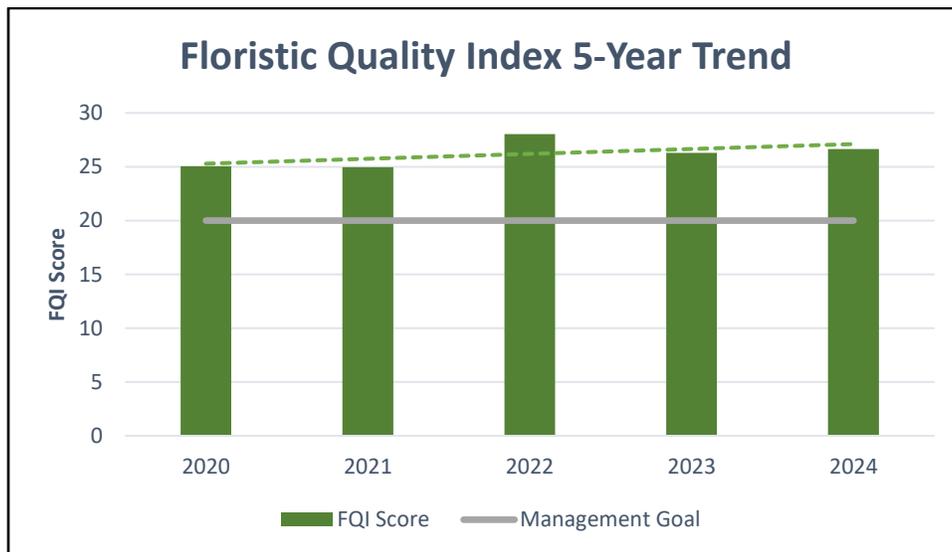
Figure 14 – Floristic Quality Index 5-Year Trend.

Over the past five years, the Floristic Quality Index on Cedar Lake North has exhibited a positive trend, indicating an increase in desirable, native plants and a decrease in undesirable, invasive aquatic species (Figure 14). Cedar Lake North Lake has met the FQI management score of 20 for the past the last five years, displaying a high level of floristic quality that is maintained from year-to-year by the current management regimen.

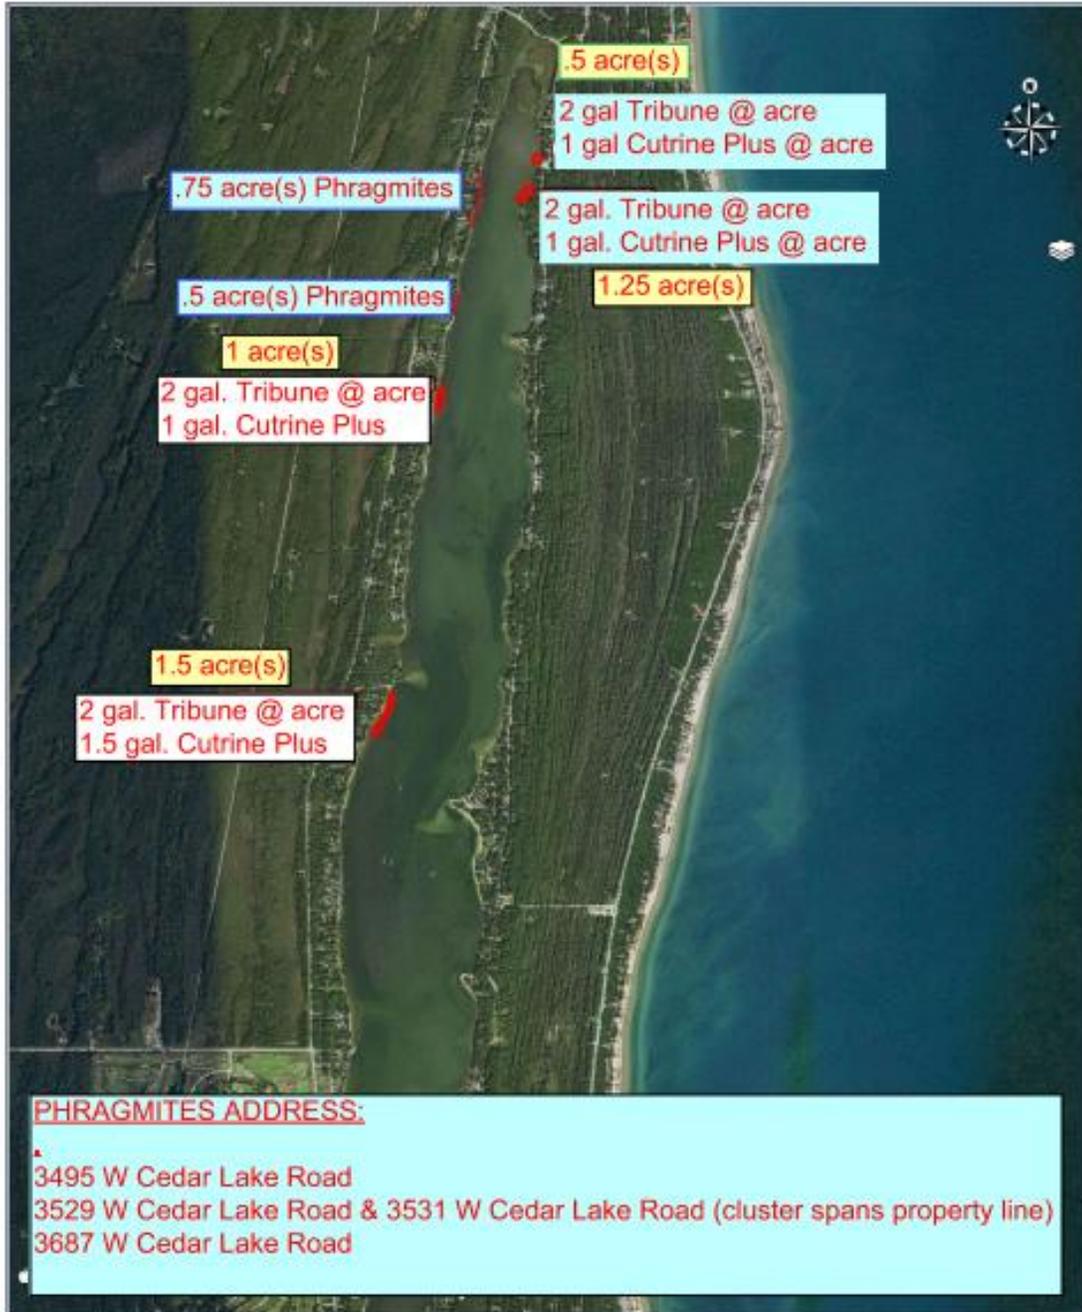
Figure B4 – Solitude Lake Management treatment map for Cedar Lake, Alcona and Iosco counties, on September 18, 2024.

Treatment Date: 9/18/2024
Time In: 12:00 P.M.
Weather: 78° Fair

Species Treated:
Eurasian Water Milfoil
Phragmites

Products Consumed:
Tribune
Cutrine Plus
Habitat
Aqua-neat
Cygnet Plus
