A Summary of Findings from LakeScan™
Guided Surveys and Analysis of:

Cedar Lake North

2022 DATA AND ANALYSIS SUMMARY REPORT WITH MANAGEMENT RECOMMENDATIONS

February 28, 2023

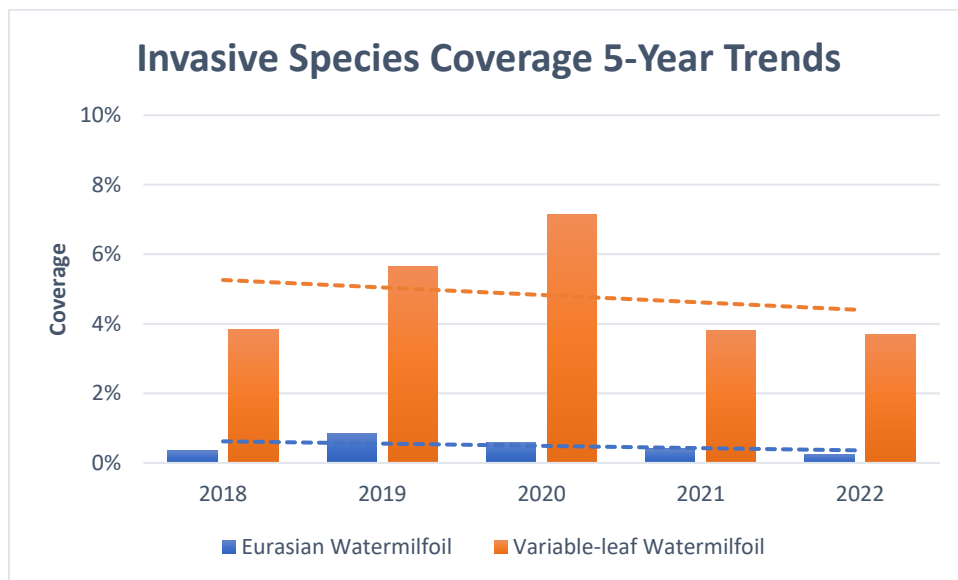
For this report, K&A also analyzed the past five years of LakeScan™ data for invasive species coverage (Figure ES -1). Cedar Lake North’s Eurasian watermilfoil coverage maintains a minimal presence and has begun to exhibit a slight downward trend over the past five years. It is likely management activities are successfully controlling the Eurasian watermilfoil population and suppressing any additional population growth. While variable-leaf watermilfoil is not considered an invasive species, it does contribute to nuisance conditions on Cedar Lake. Over the last five years, variable-leaf watermilfoil has exhibited a slight decrease in coverage, after two relatively high coverage years in 2019 and 2020. This suggests that recent management activities have been an effective means to suppress the growth of this species. During both 2021 and 2022, variable-leaf watermilfoil coverage decreased from previous highs to 3.8% and 3.7%, respectively.

Figure ES-1 – Invasive and Nuisance Species Coverage 5-year Trends.

- **Continued management intervention is recommended for Eurasian watermilfoil.** Eurasian watermilfoil coverages have trended downward over the last five years and coverage in 2022 was the lowest observed since 2018. Thus, current management interventions appear to be effective at suppressing growth and reducing the cumulative coverage of EWM. Cedar Lake Improvement Board should explore the use of new chemical technologies as they become available to treat Eurasian watermilfoil residing in the northern trenches.

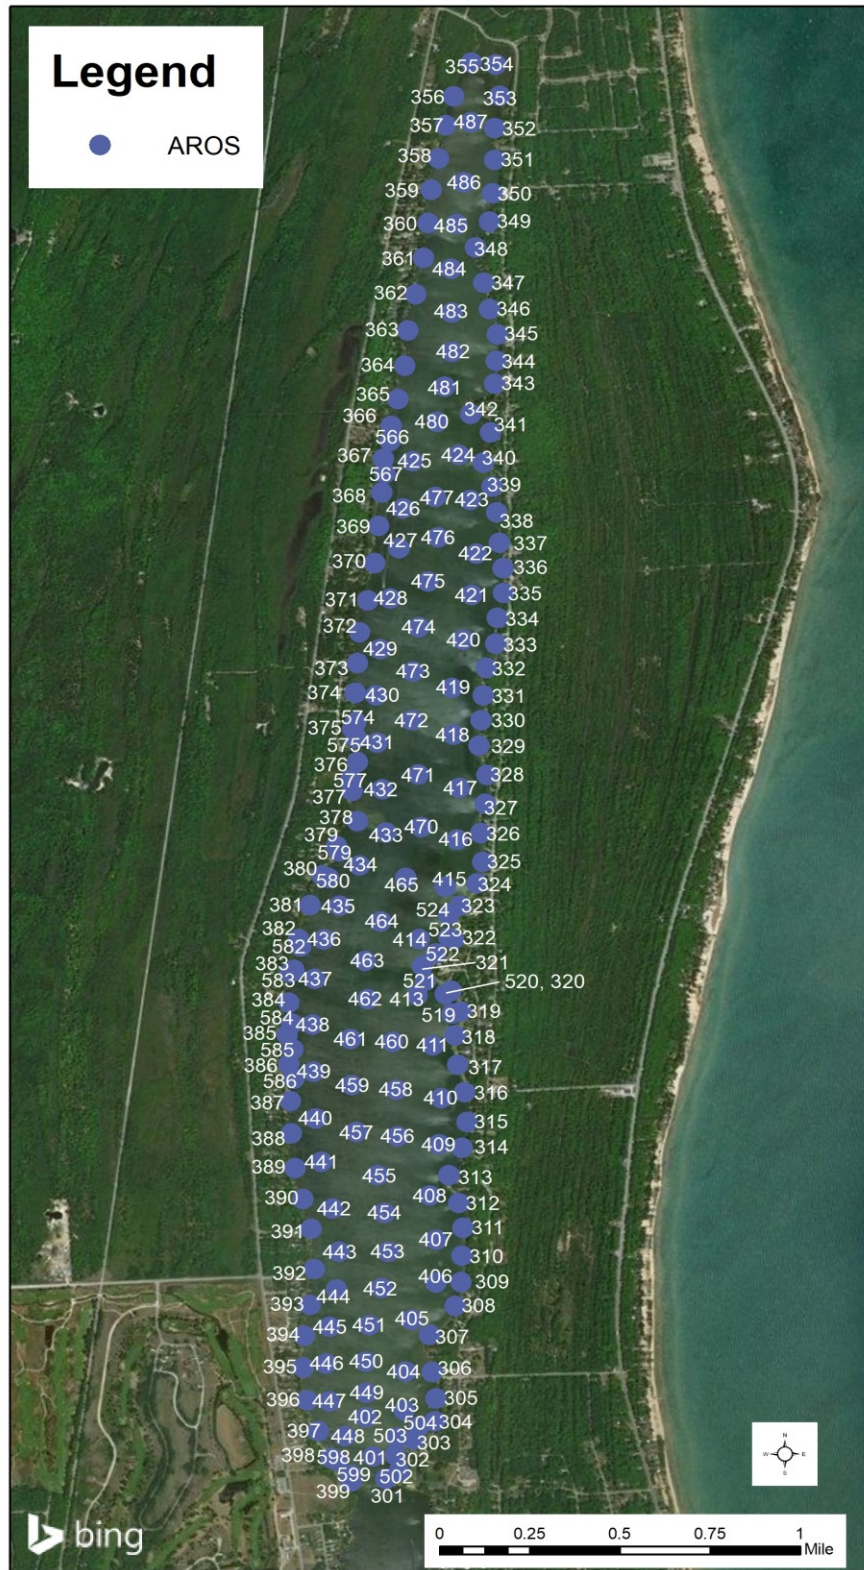
The LakeScan™ analysis involves collecting data over two vegetation surveys during the critical summer recreational season. These surveys are based on a system where the lake is first divided into biological tiers (see Table 1) and then further subdivided into Aquatic Resource Observation Sites (AROS; see Figure 1). For each survey, field personnel record the density, distribution, and position in the water column of each aquatic plant species in each AROS, as well as noting any nuisance conditions. Dissolved oxygen profiles and temperature profiles as well as Secchi depth are additionally recorded. Other water quality sampling can be included with surveys when requested.

Figure 1 - Map of Aquatic Resource Observation Sites (AROS).

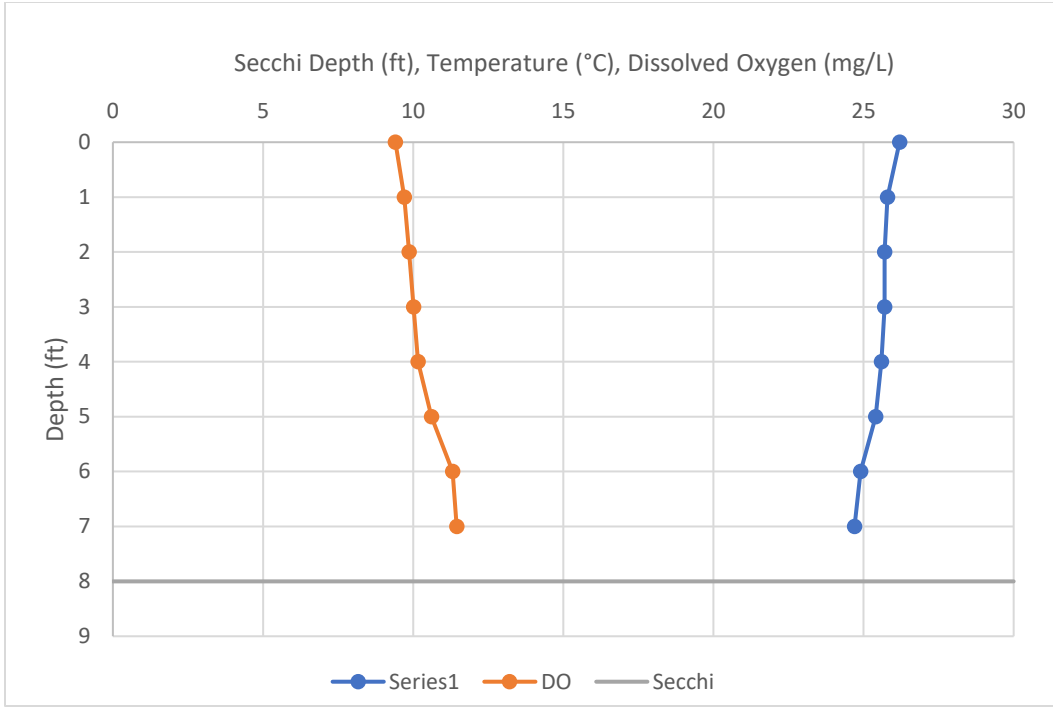
Secchi depth, dissolved oxygen and temperature data were collected during each vegetation survey. Data are shown in Figures 2 and 3 for early and late season surveys, respectively. Secchi disk transparency is the depth at which a Secchi disk (a flat white or black and white platter, approximately 20 centimeters in diameter) suspended into a lake disappears from the investigator's sight. In general, the greater depth at which the Secchi disk can be viewed, the lower the productivity of the water body. Secchi depth readings of greater than 15 feet can be indicative of low productivity or oligotrophic conditions.²

Dissolved oxygen levels and temperature were measured by K&A using a YSI ProODO dissolved oxygen meter, calibrated prior to use. Michigan water quality standards for surface waters designated for warm water fish and aquatic life call for a DO of at least 5 mg/L.³ Temperature and DO concentrations during both the early and late-season surveys were relatively uniform from the surface to the lake bottom. Both parameters fell within the range of desirable conditions for fish and aquatic life.

Figure 2 - Early season survey (July 13, 2022) dissolved oxygen and temperature profiles with Secchi depth, taken at the deepest point in the lake.

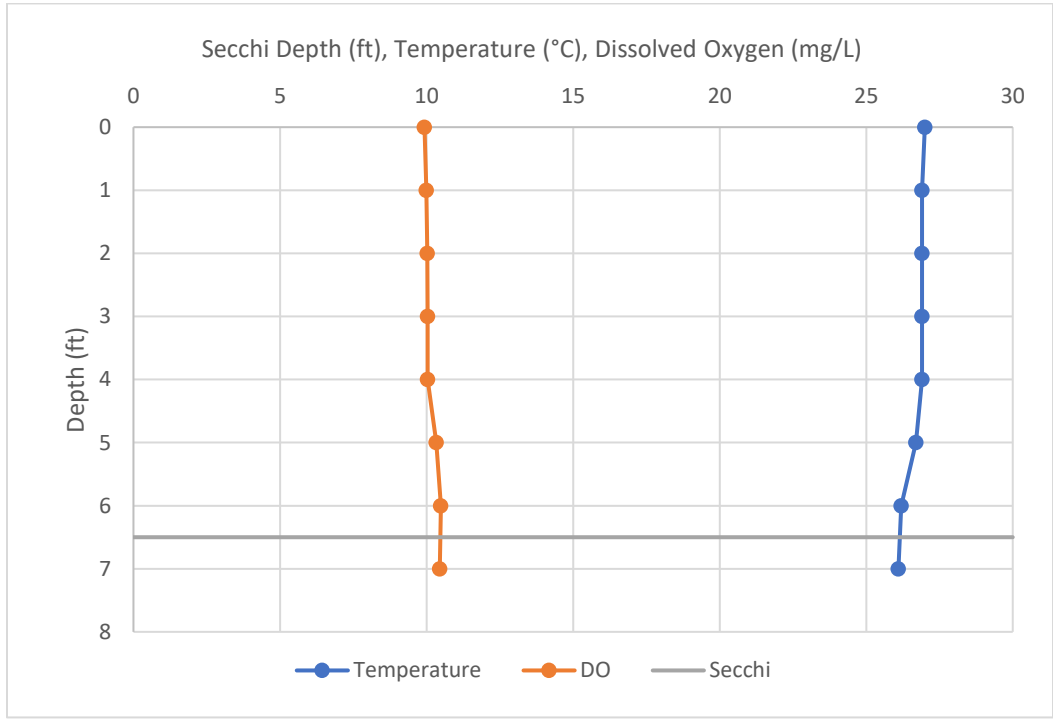
Figure 3 - Late season survey (September 20, 2022) dissolved oxygen and temperature profiles with Secchi depth, taken at the deepest point in the lake.

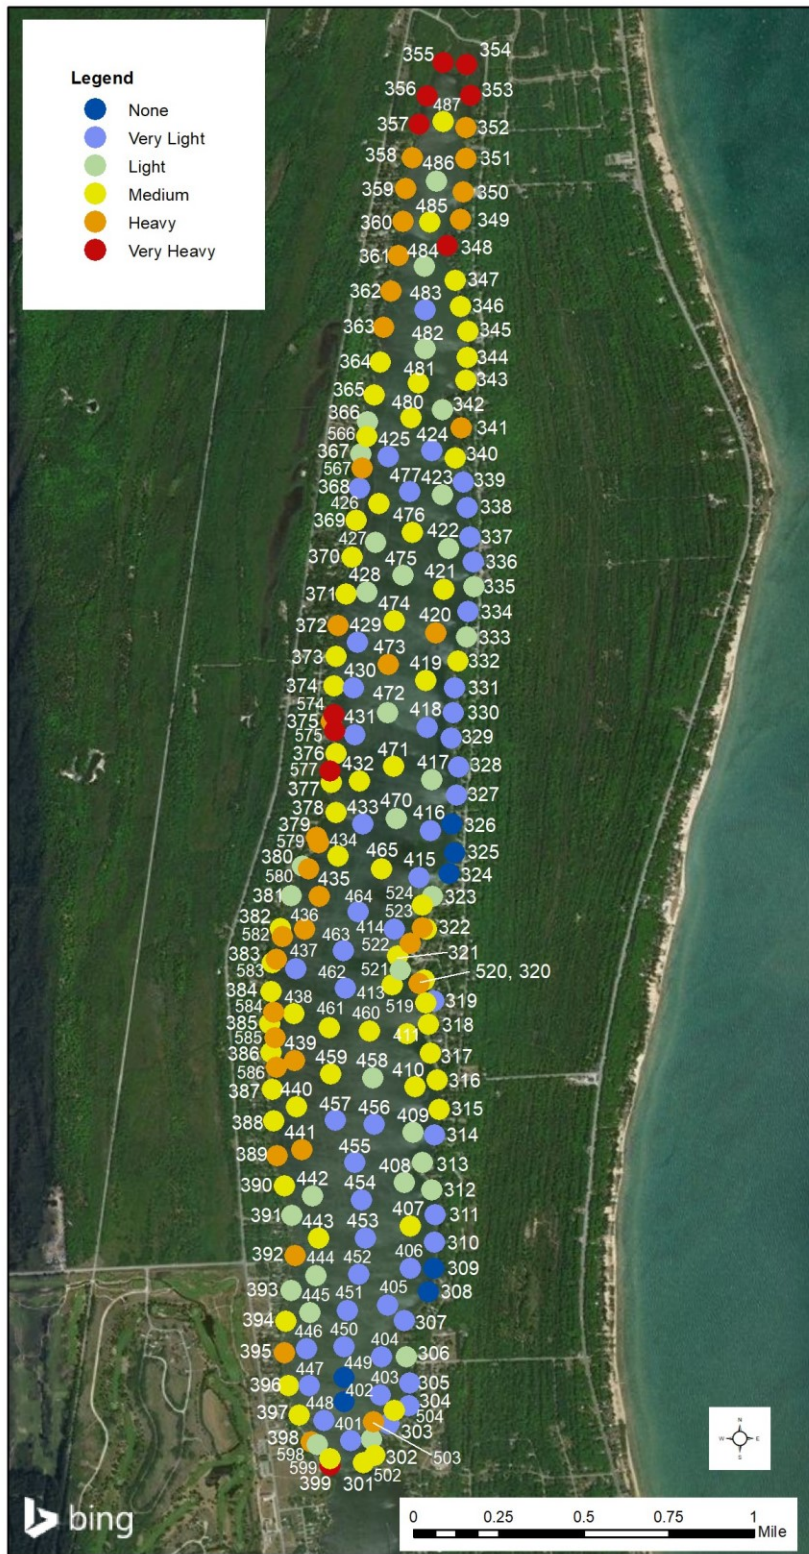
The Cedar Lake North early-season LakeScan™ vegetation survey was conducted on Wednesday, July 13, 2022. The morning of the survey began with overcast skies, temperatures of 60°F, and 5 mph west winds. Weather in the afternoon shifted to sunny and partly cloudy skies with temperatures reaching up to 75°F and northeast winds of 5-10mph. Visibility through the water column was good with a Secchi disk depth reading of 7.2ft. However, the overcast skies and high winds made visibility challenging at times throughout the day. Figure 4 depicts data on all combined species using three-dimensional density, which reflects a combination of vegetation density, distribution and height observations of all species observed on Cedar Lake North during the early-season survey. Color-coding is provided for each AROS that helps to spatially depict observed vegetation data. The colors range from dark blue which depicts no vegetation observed, to yellow depicting medium density and distribution of plant species, to red which depicts high density and distribution of vegetation within the AROS.

Figure 4 - Early season survey (July 13, 2022) vegetation 3D Density (a function of observed vegetation coverage, and height of all vegetation species).

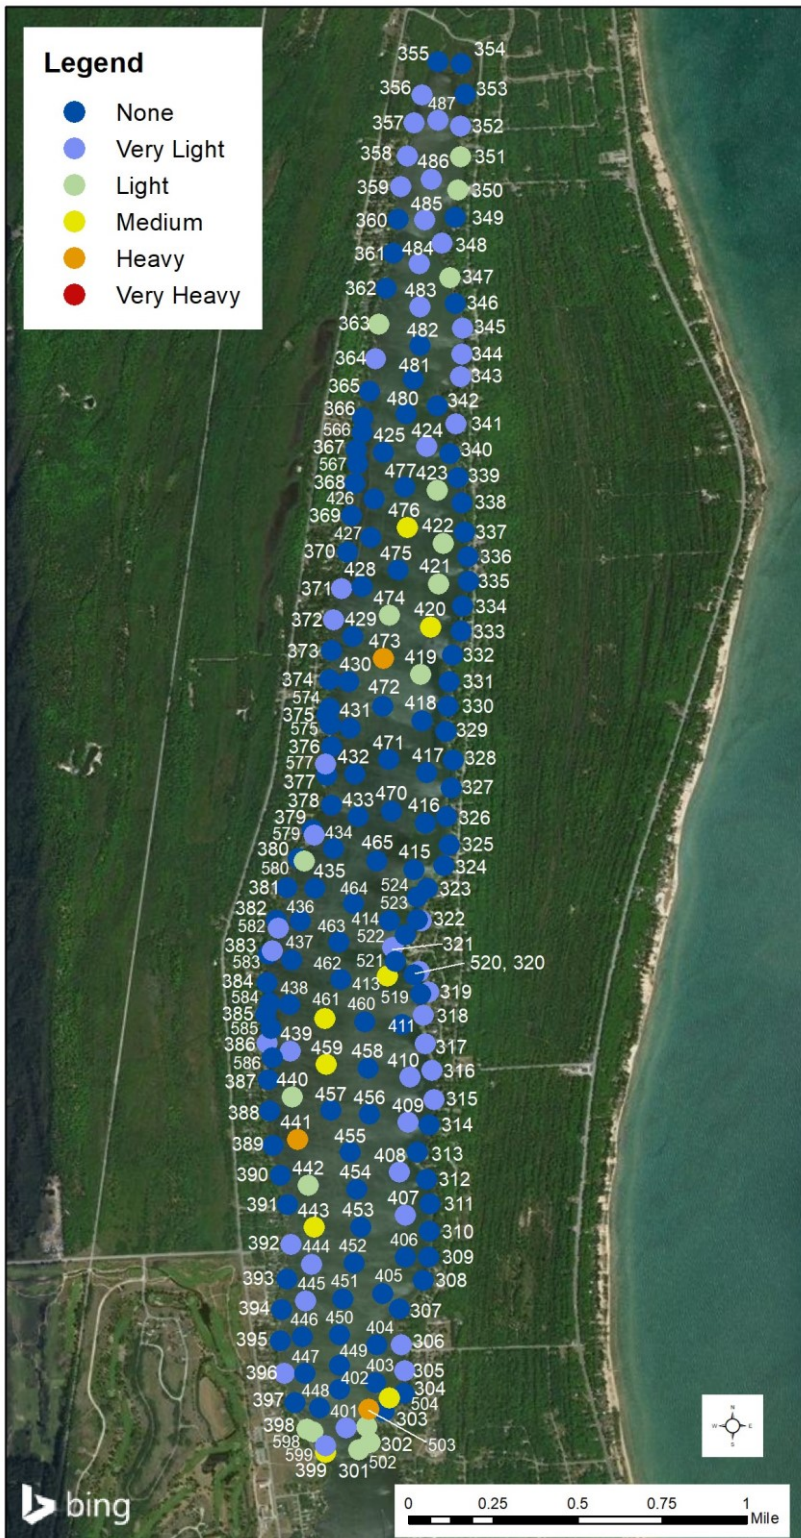
Variable-leaf watermilfoil has historically created recreational nuisance conditions within Cedar Lake. While this species does still exhibit some nuisance conditions, its density coverage has decreased since it was targeted for management in 2020. Figure 5 shows variable-leaf watermilfoil coverage during the early-season survey. Other native species causing nuisance conditions during the early-season survey include variable pondweed, American pondweed, and Richardson's pondweed. Variable-leaf watermilfoil and Richardson's pondweed were typically found intermixed and offshore in the Tier 4 AROS. Generally, these species exhibited recreational nuisance conditions along the western shoreline and in the northern portion of the lake (AROS 413, 420, 432, 435-444, 473, & 476). High densities of native species were also commonly observed causing nuisance conditions within the trenches (Tier 5 AROS).

Figure 5 - Early season (July 13, 2022) Variable-leaf Watermilfoil coverage.

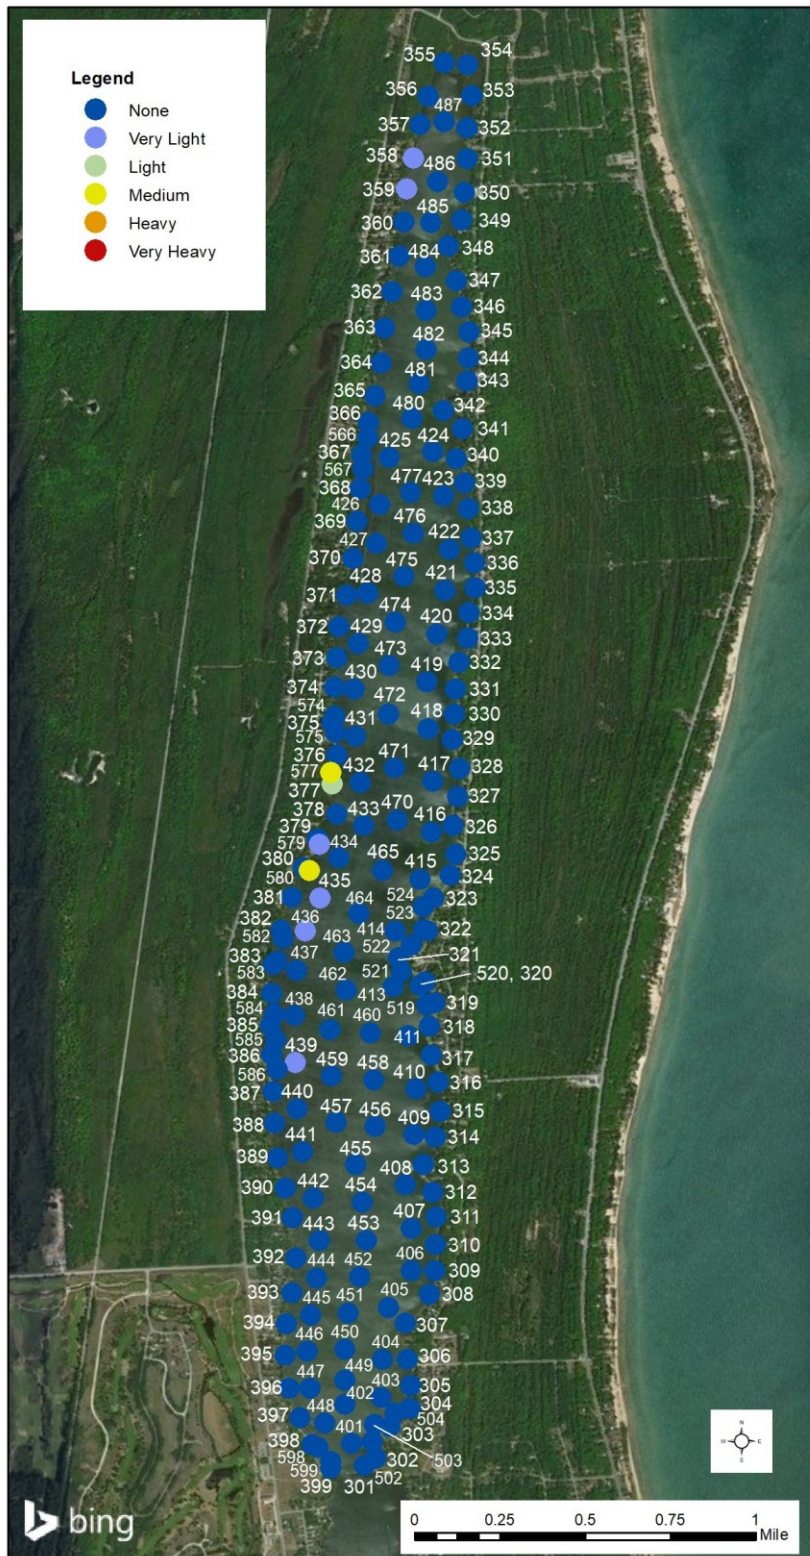
Eurasian watermilfoil (*Myriophyllum spicatum x sibiricum*; EWM) was the only aquatic invasive species observed at the time of the survey. EWM was observed at a total of only 9 locations (Figure 6). Primarily, EWM was observed within or around the trenches along the eastern shoreline (AROS 358, 359, 377, 435, 436, 439, 577, 579, 580). Early-season herbicide treatments to treat EWM took place on Wednesday, June 22, 2022. This was 21 days prior to the early-season vegetation survey. Generally, chemical treatments take about 10 days before full effects are observed, therefore, full treatment efficacy would have been observed during the early-season vegetation survey. Observations made during the survey deemed that the herbicide treatments appeared to be only moderately effective at controlling Eurasian watermilfoil. Each location identified as an EWM treatment area still had EWM present following the herbicide applications. Lower densities of Eurasian watermilfoil were observed at each of the treatment locations compared to the pre-season survey. (Treatment maps are provided in Appendix C).

Figure 6 - Early season (July 13, 2022) Eurasian Watermilfoil and Hybrids coverage.

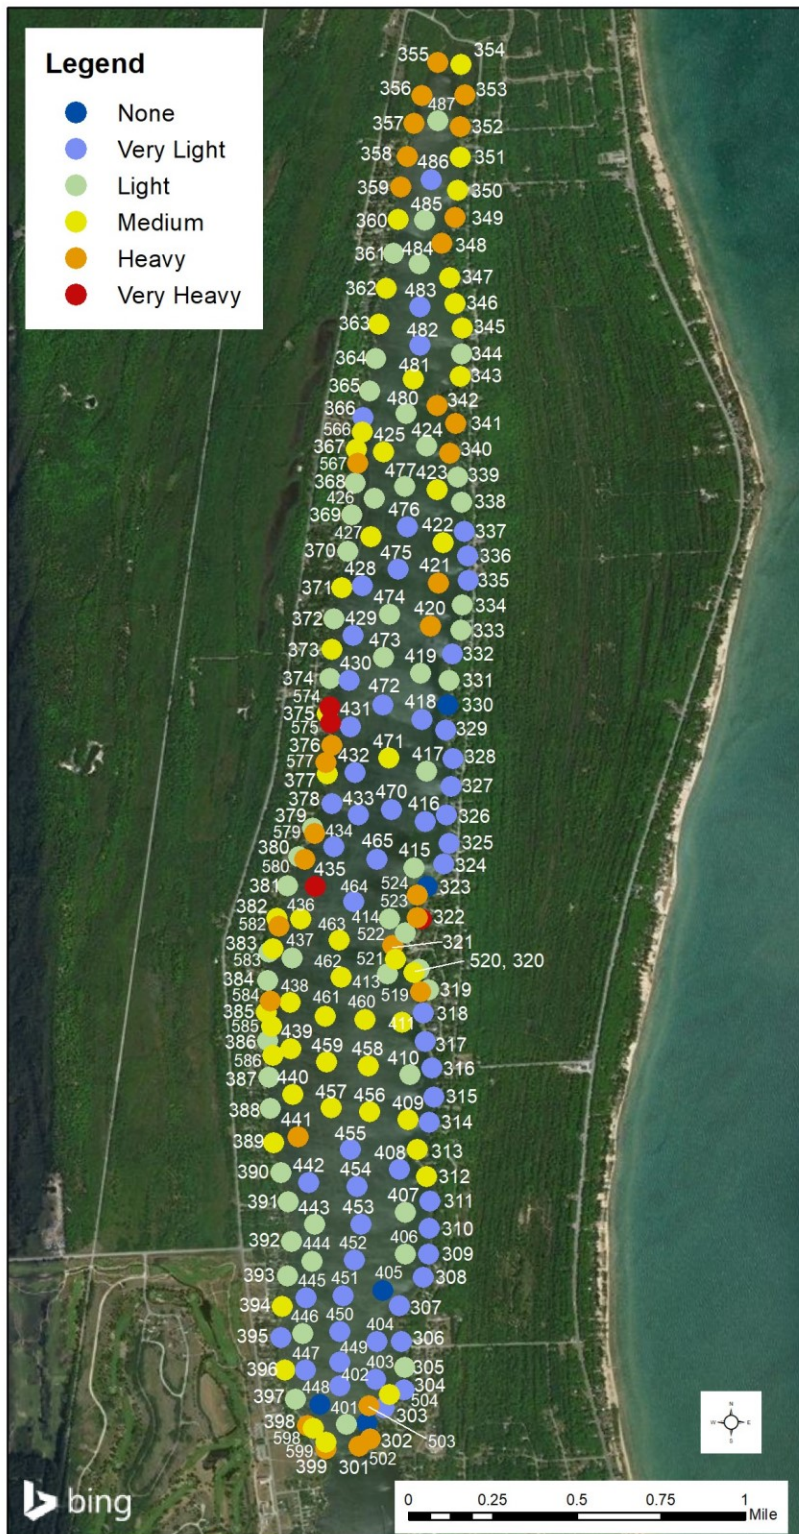
The late-season LakeScan™ vegetation survey for North Cedar Lake took place on Tuesday, September 20, 2022. Weather was sunny and partly cloudy with temperatures reaching 80°F and southwest winds of 5-10 mph. Visibility through the water column was good with a Secchi disk depth reading of 8.2 feet. Figure 7 depicts data on all combined species using three-dimensional density, which reflects a combination of vegetation density, distribution and height observations of all species observed on Cedar Lake North during the late-season survey.

Figure 7 - Late season survey (September 20, 2022) vegetation 3D Density (a function of observed vegetation coverage, and height of all vegetation species).

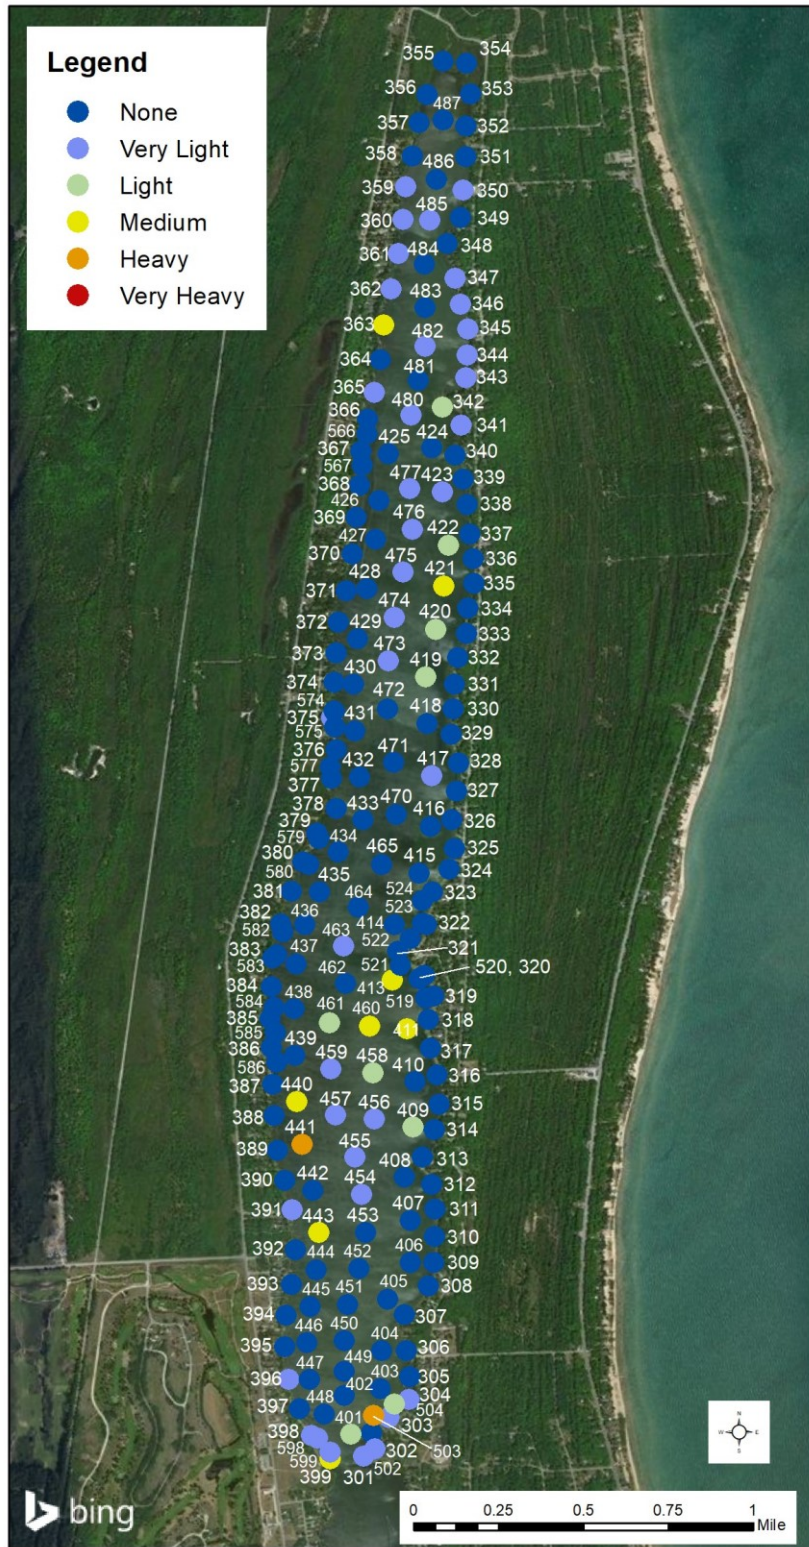
Variable-leaf watermilfoil, variable pondweed, Illinois pondweed, Richardson's pondweed, wild celery, naiad, and *Chara* were the most abundant native species observed during the survey. Native emergent species commonly observed nearshore include white water-lily, spatterdock and bullrush. *Chara sp.* and naiad were the most widely distributed species within Cedar Lake. Both of these species were found intermixed within nearly every AROS at low densities. Wild celery, variable-leaf watermilfoil and the various pondweed species were most often observed exhibiting greater densities in nearshore areas (AROS Tier 3) and in the trenches (AROS Tier 5). Low to moderate densities were observed scattered throughout the center of the lake as well (AROS Tier 4). The native pondweed species and wild celery reached the surface of the water in some areas causing some minor recreational or navigational nuisance conditions. Specifically, potential nuisance conditions were most often observed within the trenches (AROS Tier 5) and nearshore at AROS 301, 312, 320-322, and 341-348. Variable-leaf watermilfoil only exhibited potential nuisance conditions within AROS 458-461. Variable-leaf watermilfoil was widely distributed but often observed at low densities (Figure 8). This suggests that the 2020 variable-leaf watermilfoil treatments have successfully controlled growth over multiple years.

Figure 8 - Late season (September 20, 2022) Variable-leaf Watermilfoil coverage.

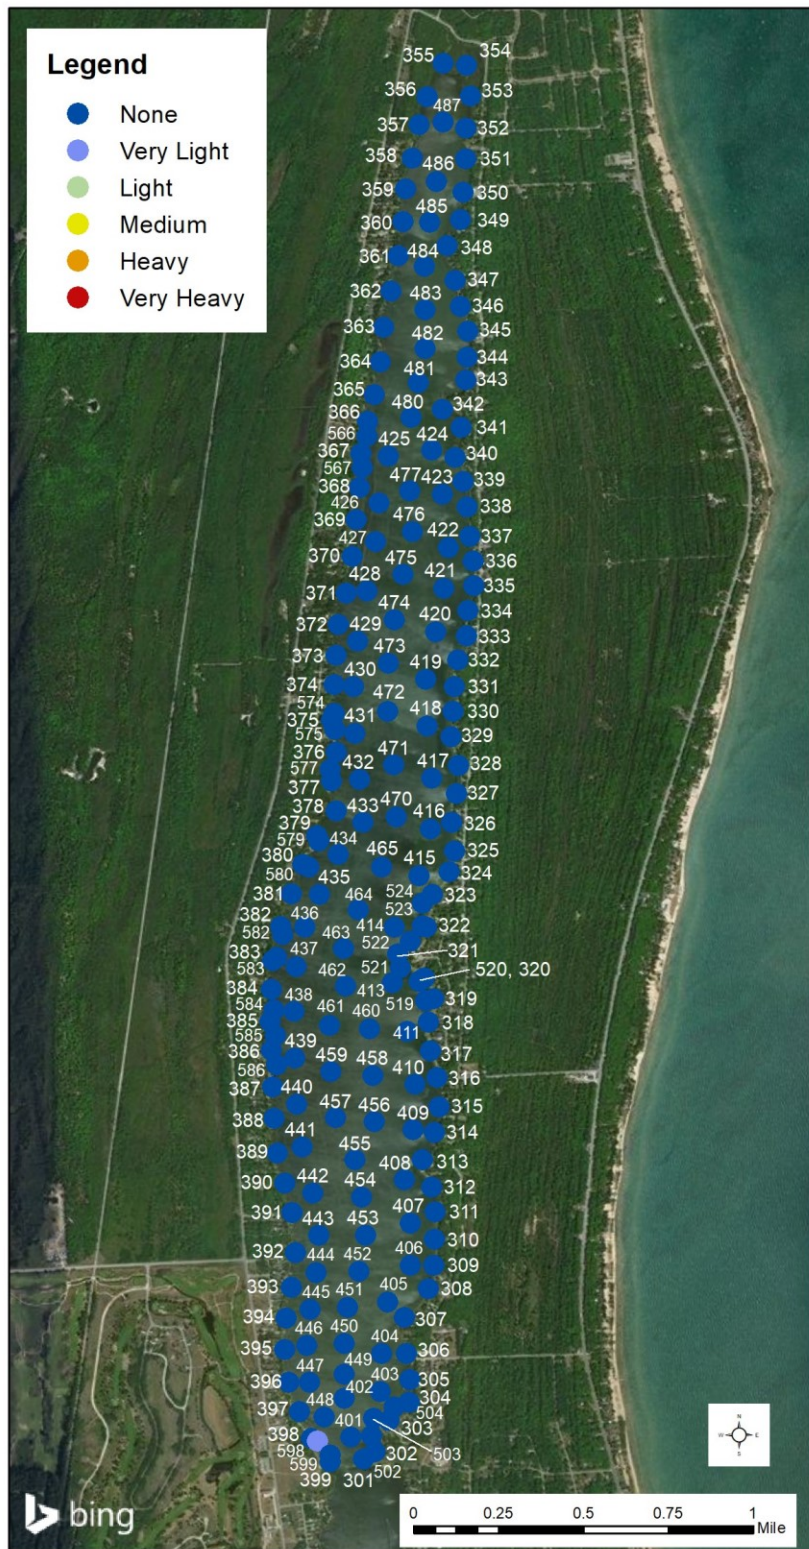
The late-season herbicide treatment took place 14 days prior to the late-season survey on September 6, 2022, allowing for enough time to observe the effectiveness of the herbicide applications (Appendix C). Eurasian watermilfoil was targeted for treatment, the only aquatic invasive species observed in Cedar Lake during the late-season survey. Eurasian watermilfoil was observed during the late-season survey in a single location, AROS 598, and at very low densities (Figure 9). The density and distribution of Eurasian watermilfoil observed during the late-season survey was much lower compared to observations made during the early-season survey. This would suggest that the herbicide applications on September 6th did effectively control the Eurasian watermilfoil population and treatments were much more successful compared to the June herbicide applications.

Figure 9 -Late season (September 20, 2022) Eurasian Watermilfoil and hybrids coverage.

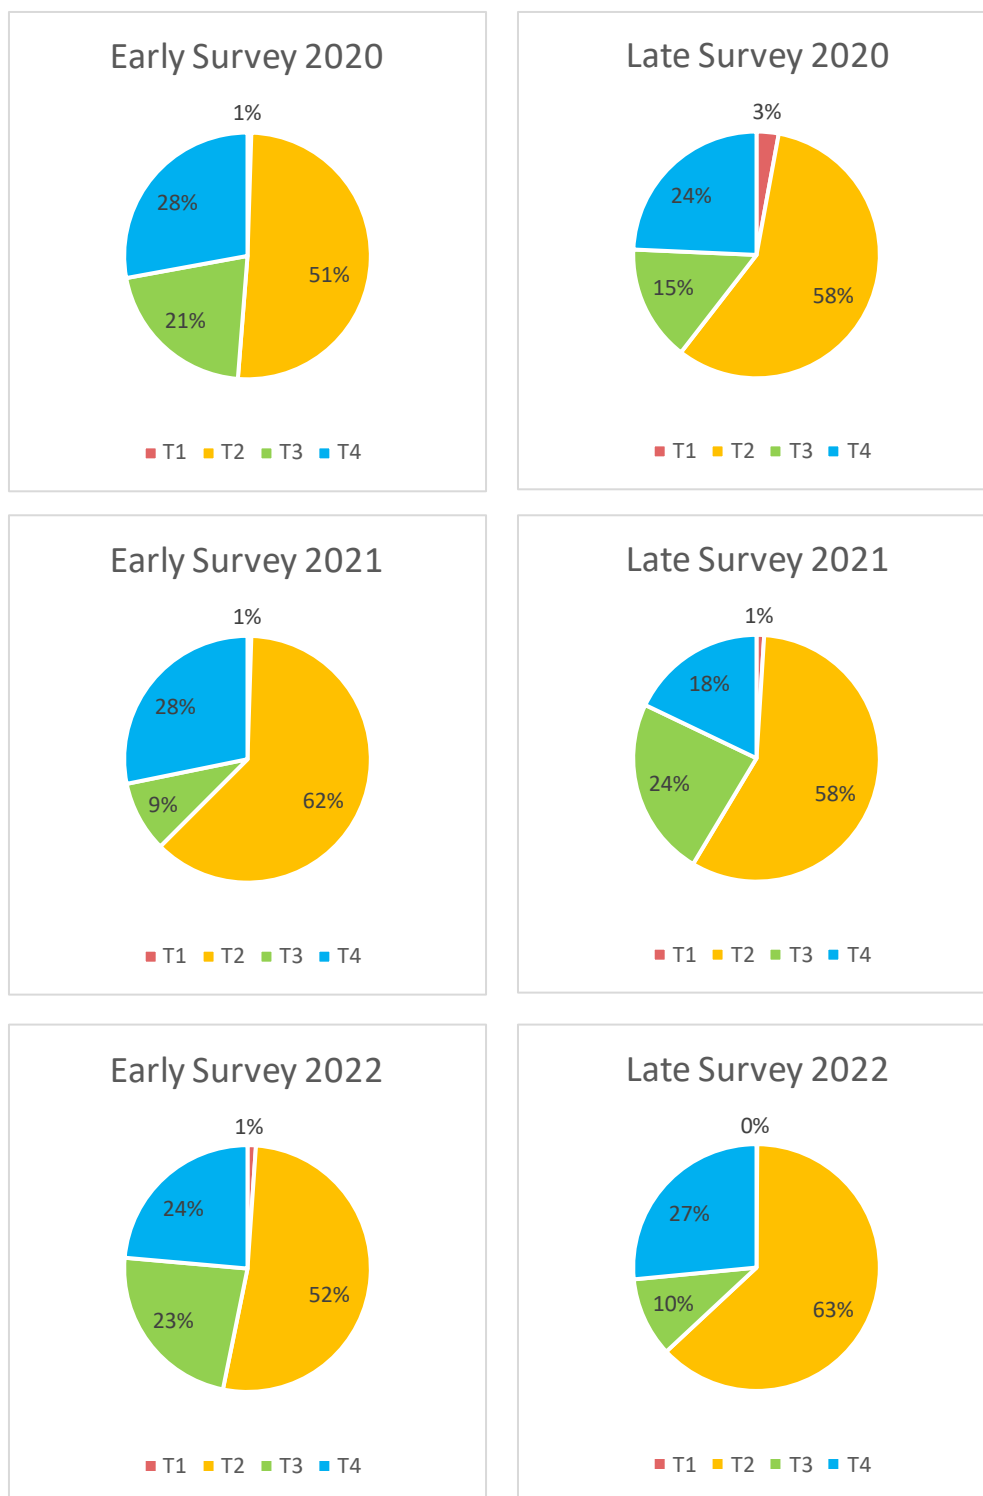
Aquatic plant species observed during the 2022 vegetation surveys are identified in Table 2. The 'T Value' in this table is a qualitative value ranging from 1 to 4 that is assigned to each species, where 1 represents an undesirable species highly likely to require treatment and 4 represents a desirable species highly unlikely to require treatment (thus, 1 is 'bad'; 4 is 'good'). 'Frequency' represents the percentage of survey sites (AROS) where a given species was found. 'Coverage' represents the lake bottom spatial cover observed for each species, represented as a percentage of available area. 'Dominance' represents the degree to which a species is more numerous than its competitors. Figure 10 illustrates dominance by T Value categories for early and late season surveys over the last few years.

Figure 10 - Distribution of aquatic plant coverage by T Value comparing early-season and late-season surveys from 2020 – 2022.

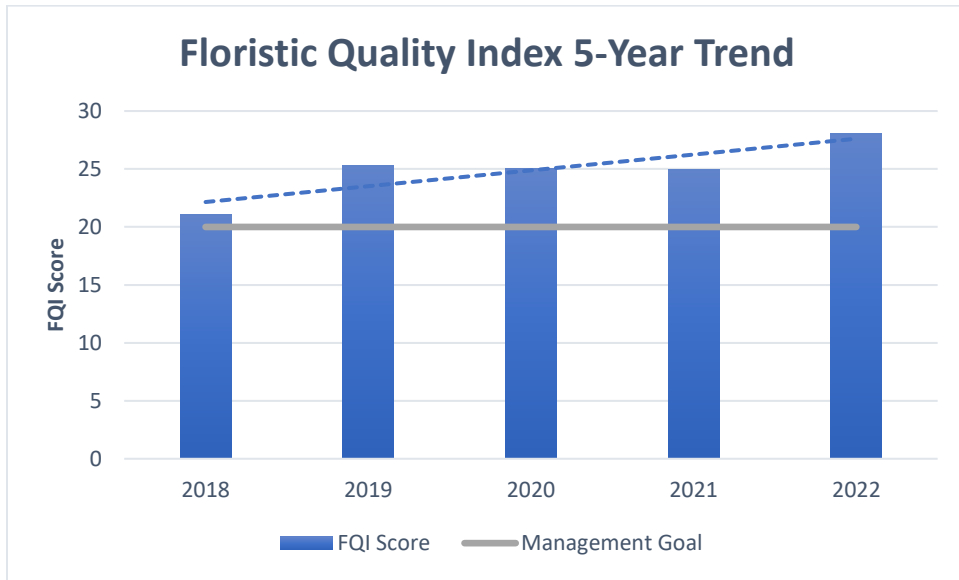
Over the last five years, the FQI score for Cedar Lake North has exhibited a positive trend, which indicates an increase in desirable, native plant species and a decrease in undesirable, non-native plant species (Figure 11). For the last five years, Cedar Lake North’s FQI score has exceeded the management

Figure 11 – Floristic Quality Index 5-Year Trend.

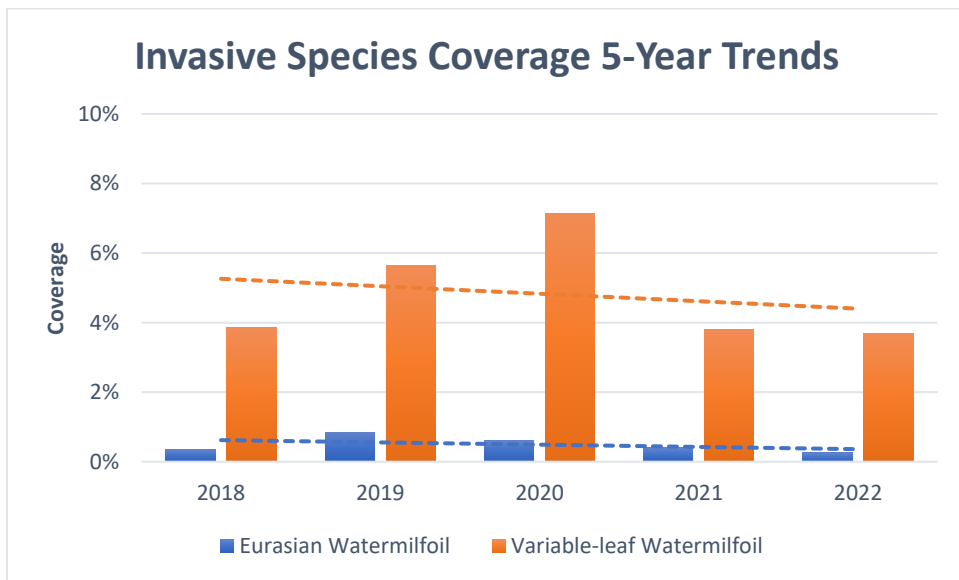
goal of 20. Furthermore, Cedar Lake North’s Eurasian watermilfoil coverage has exhibited a slight declining trend over the last five years (Figure 12), suggesting that management activities appear to be controlling the invasive and suppressing any additional Eurasian watermilfoil population expansion. Variable-leaf watermilfoil, has also experienced a decreasing trend over the last five years (Figure 12). During the past two seasons, this species has exhibited lower average coverage compared to what was observed in the three years prior. This suggests that the management actions which had targeted variable-leaf watermilfoil in 2020 have successfully acted as a multi-year control for this species.

Figure 12 – Invasive and Nuisance Native Species Coverage 5-Year Trends.

Continued management intervention is recommended for Eurasian watermilfoil. Although Eurasian watermilfoil early-season treatments were not very effective, EWM coverage substantially decreased between the early and late-season surveys (the latter conducted after a second EWM treatment). Furthermore, Eurasian watermilfoil coverages have trended downward over the last five years and coverage in 2022 was the lowest observed since 2018. Thus, current management interventions appear to be effective at suppressing the possible spread and reducing the cumulative coverage of Eurasian watermilfoil. Cedar Lake Improvement Board should explore the use of new chemical technologies as they become available to treat Eurasian watermilfoil residing in the northern trenches.

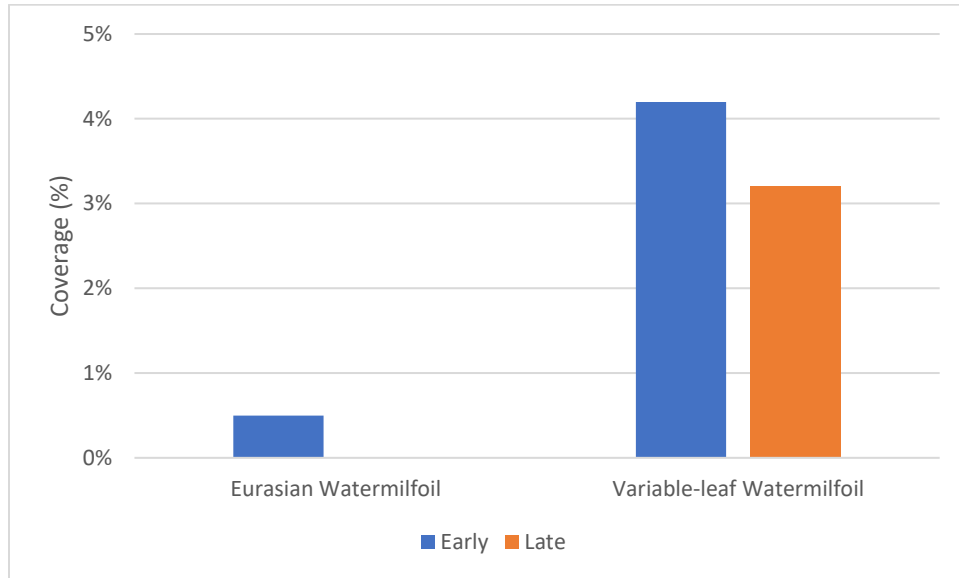
Figure 13 – Changes in coverage across both surveys for targeted species.

Eurasian watermilfoil coverage in 2022 was the lowest observed in Cedar Lake since 2018. Low coverage in 2022 and a slight decrease in coverage trend over the last five years suggest that lake management activities have successfully been suppressing Eurasian watermilfoil growth and expansion. It is also possible that conditions are not conducive for substantial Eurasian watermilfoil growth outside of the deep trenches on Cedar Lake North.

Until it no longer appears effective, continued ProcelleCOR applications to treat Eurasian watermilfoil in the northern trenches of Cedar Lake North is recommended. Recent ProcelleCOR applications in Cedar Lake appear to have been an effective strategy for controlling the Eurasian watermilfoil population. Applications and testing should continue through 2023 to determine if ProcelleCOR continues to be an effective means to treat Eurasian watermilfoil.

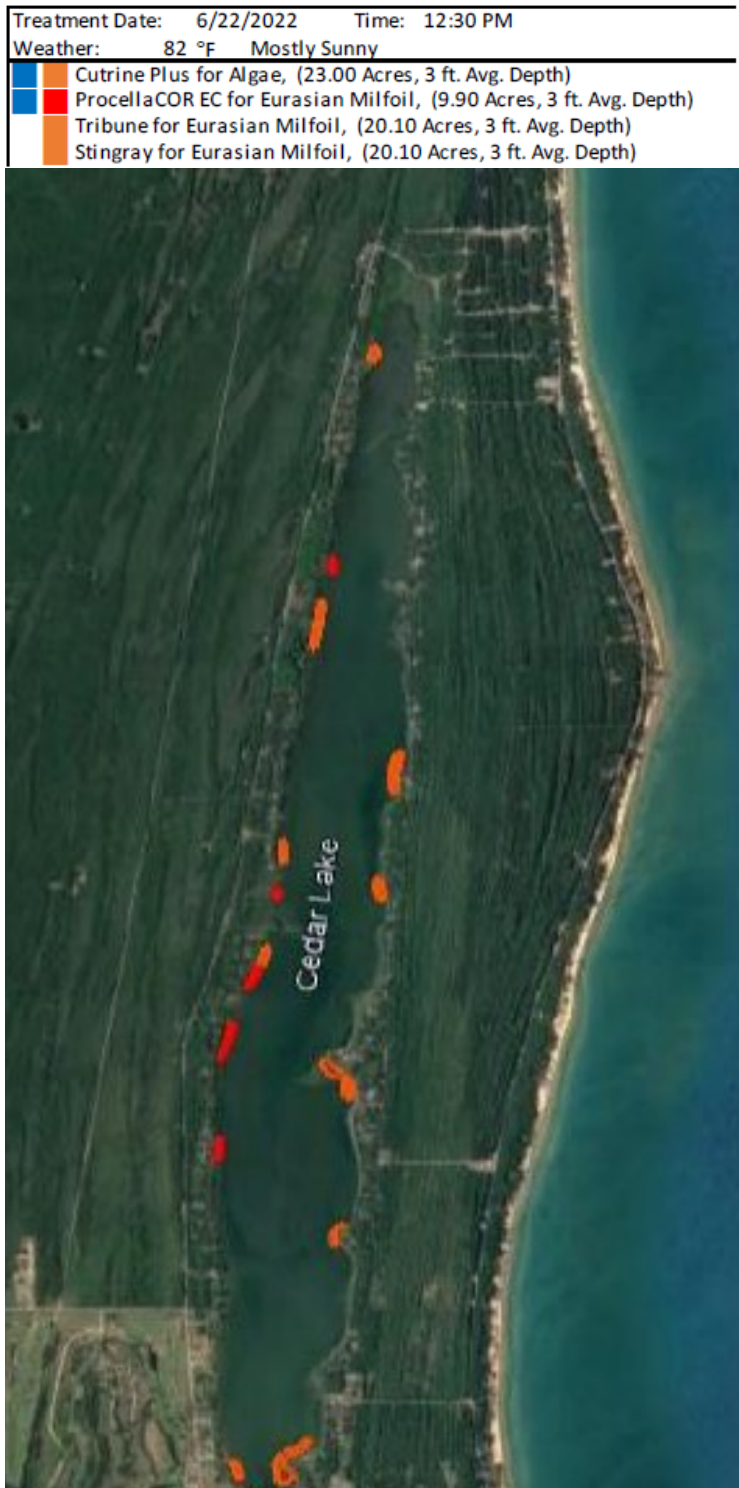
Figure C1 – Herbicide applicator treatment maps from June 22, 2022 chemical treatments targeting Eurasian watermilfoil

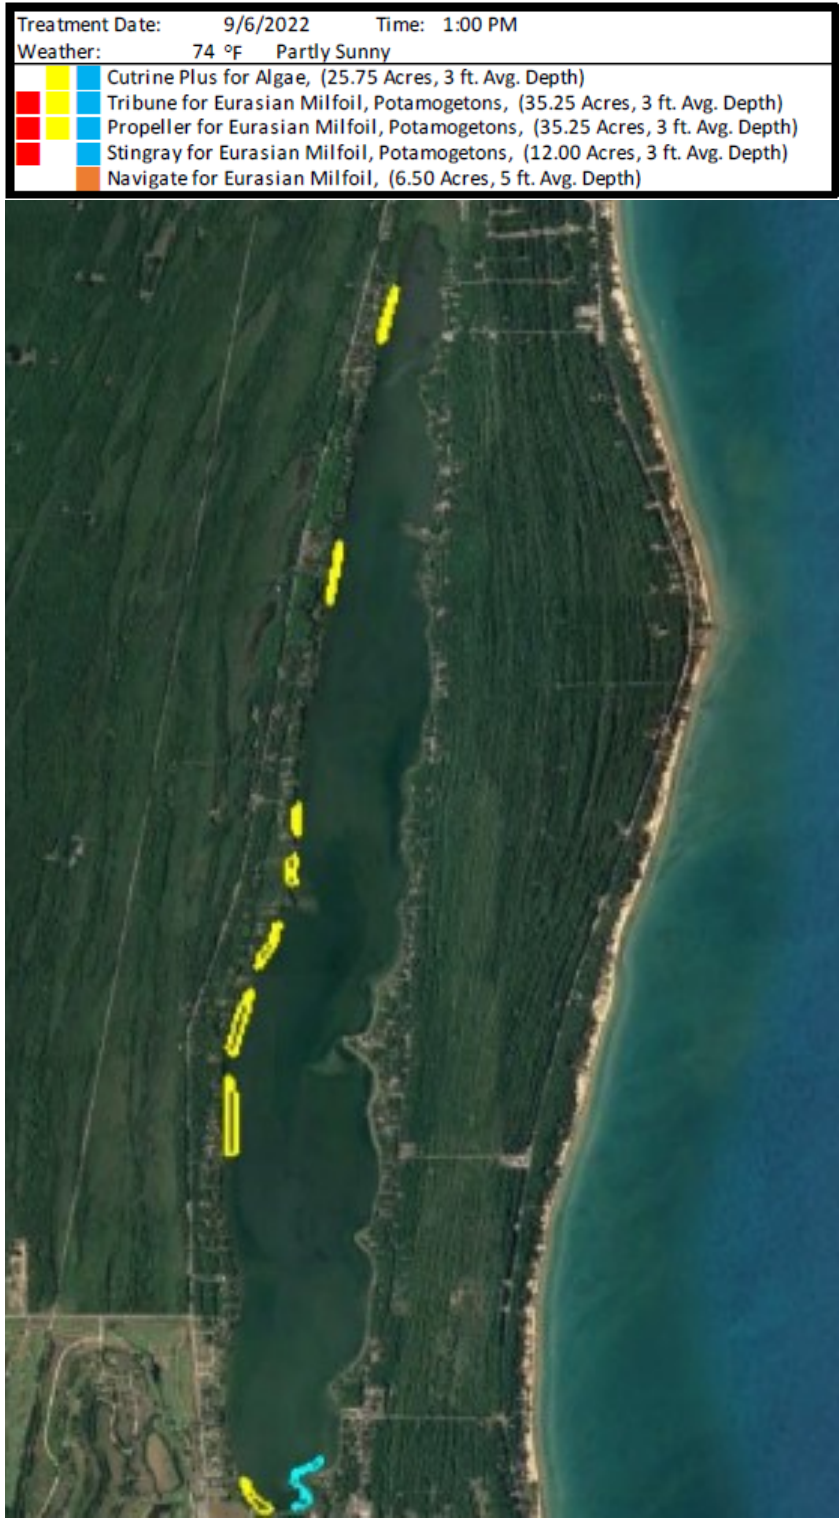
Figure C2 – Herbicide applicator treatment maps from September 6, 2022 chemical treatments to target Eurasian watermilfoil and native pondweeds.
