A Summary of Findings from LakeScan™
Guided Surveys and Analysis of:

Cedar Lake North

2021 DATA AND ANALYSIS SUMMARY REPORT WITH MANAGEMENT RECOMMENDATIONS

January 14, 2022

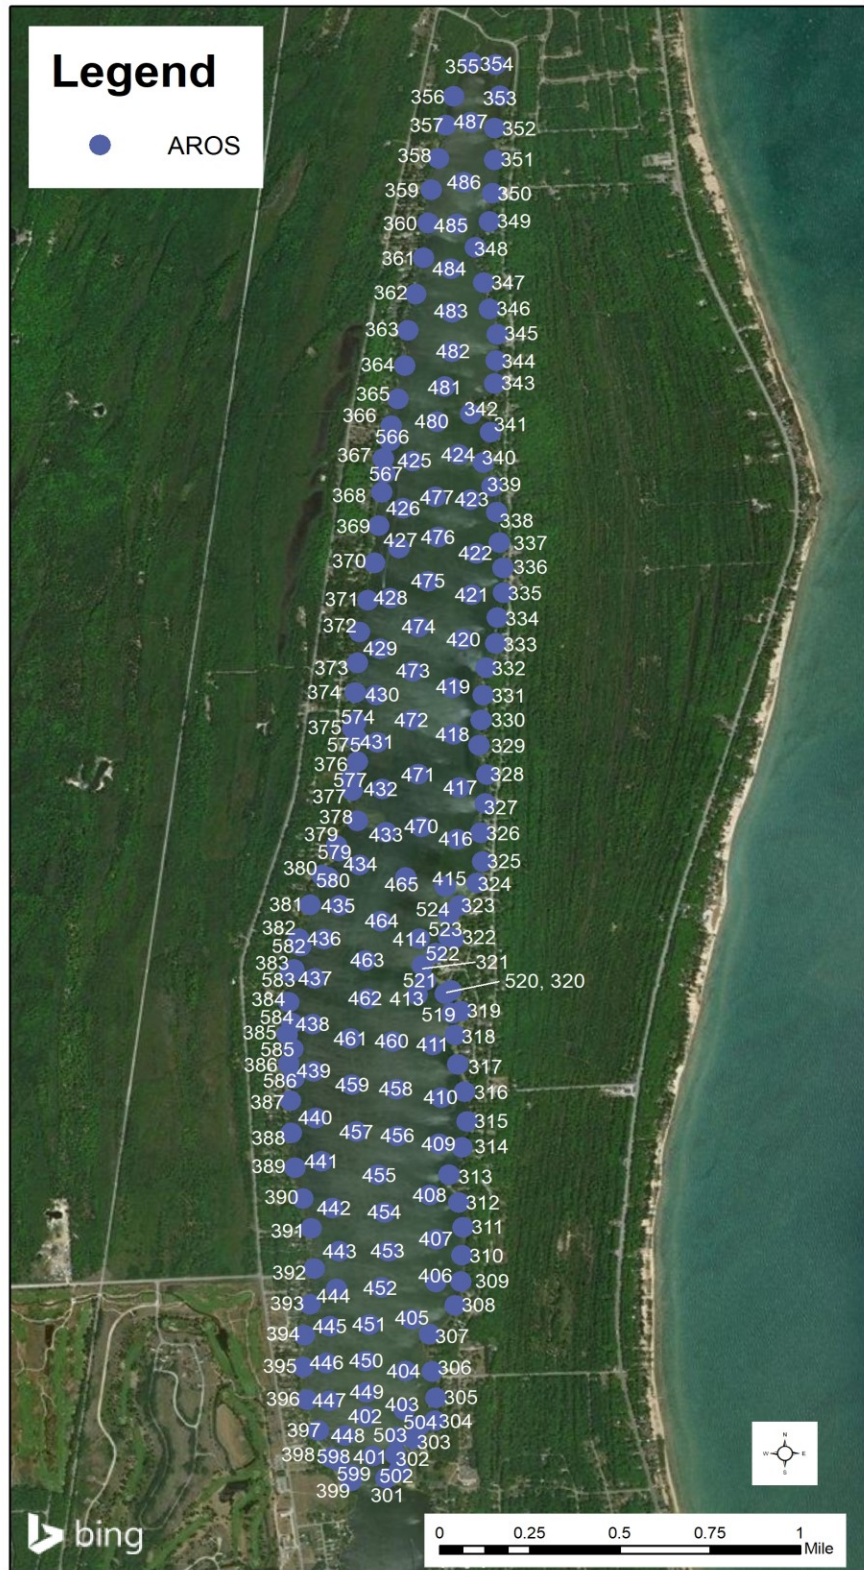
Figure 1 - Map of Aquatic Resource Observation Sites (AROS)

The LakeScan™ analysis involves collecting data over two vegetation surveys during the critical summer recreational season. These surveys are based on a system where the lake is first divided into biological tiers (see Table 1) and then further subdivided into Aquatic Resource Observation Sites (AROS; see Figure 1). For each survey, field personnel record the density, distribution, and position in the water column of each aquatic plant species in each AROS, as well as noting any nuisance conditions. Dissolved oxygen profiles and temperature profiles as well as Secchi depth are additionally recorded. Other water quality sampling can be included with surveys when requested.

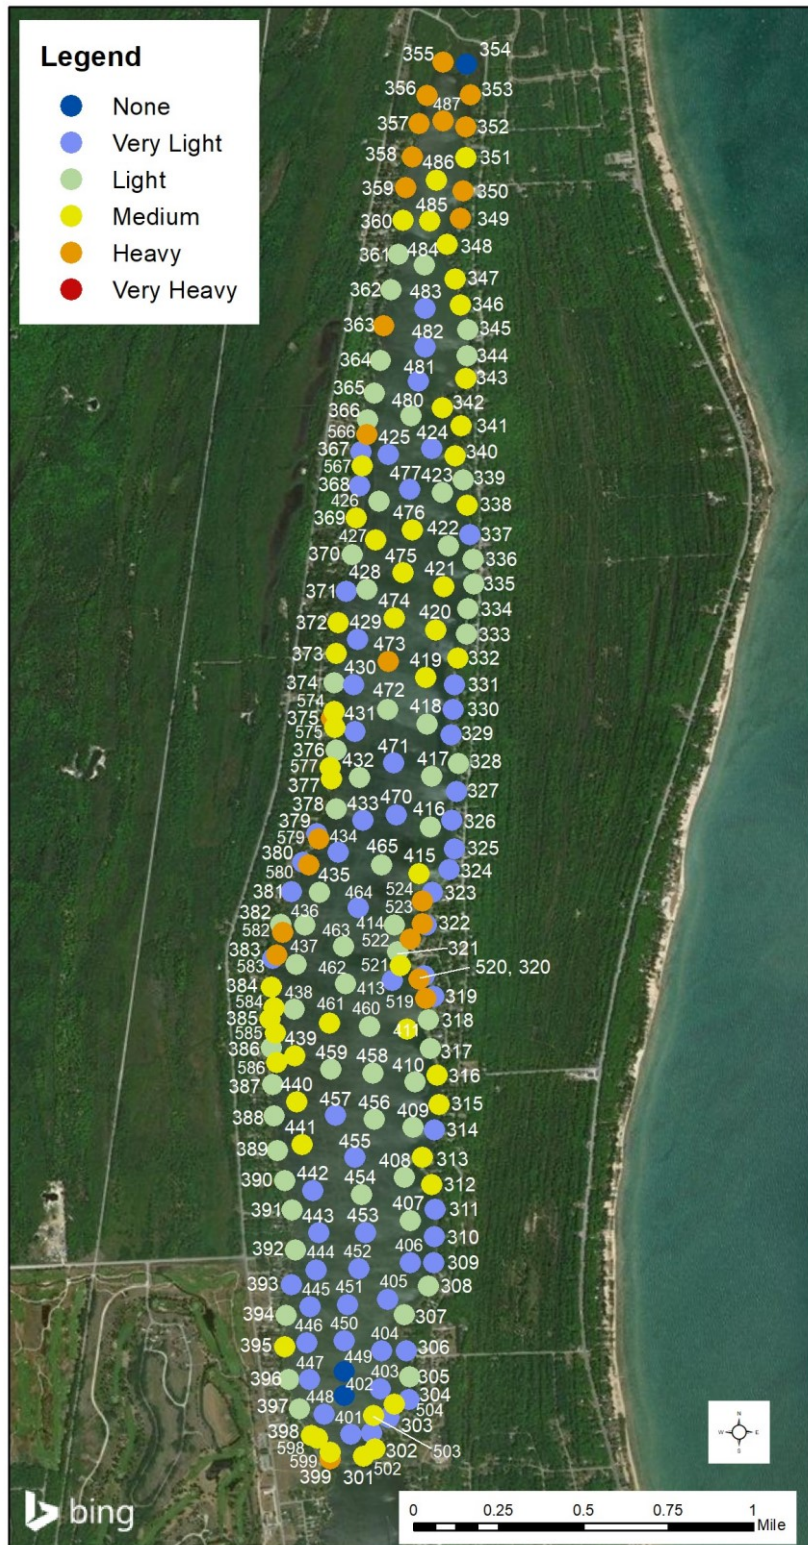
Figure 4 – Early-season survey (June 30, 2021) vegetation 3D Density (a function of observed vegetation coverage, and height of all vegetation species).

this time of year. Figure 4 depicts data on all combined species using three-dimensional density, which reflects a combination of vegetation density, distribution and height observations of all species observed on Cedar Lake North during the early-season survey. Color-coding is provided for each AROS that helps to spatially depict observed vegetation data. The colors range from dark blue which depicts no vegetation observed, to yellow depicting medium density and distribution of plant species, to red which depicts high density and distribution of vegetation within the AROS.

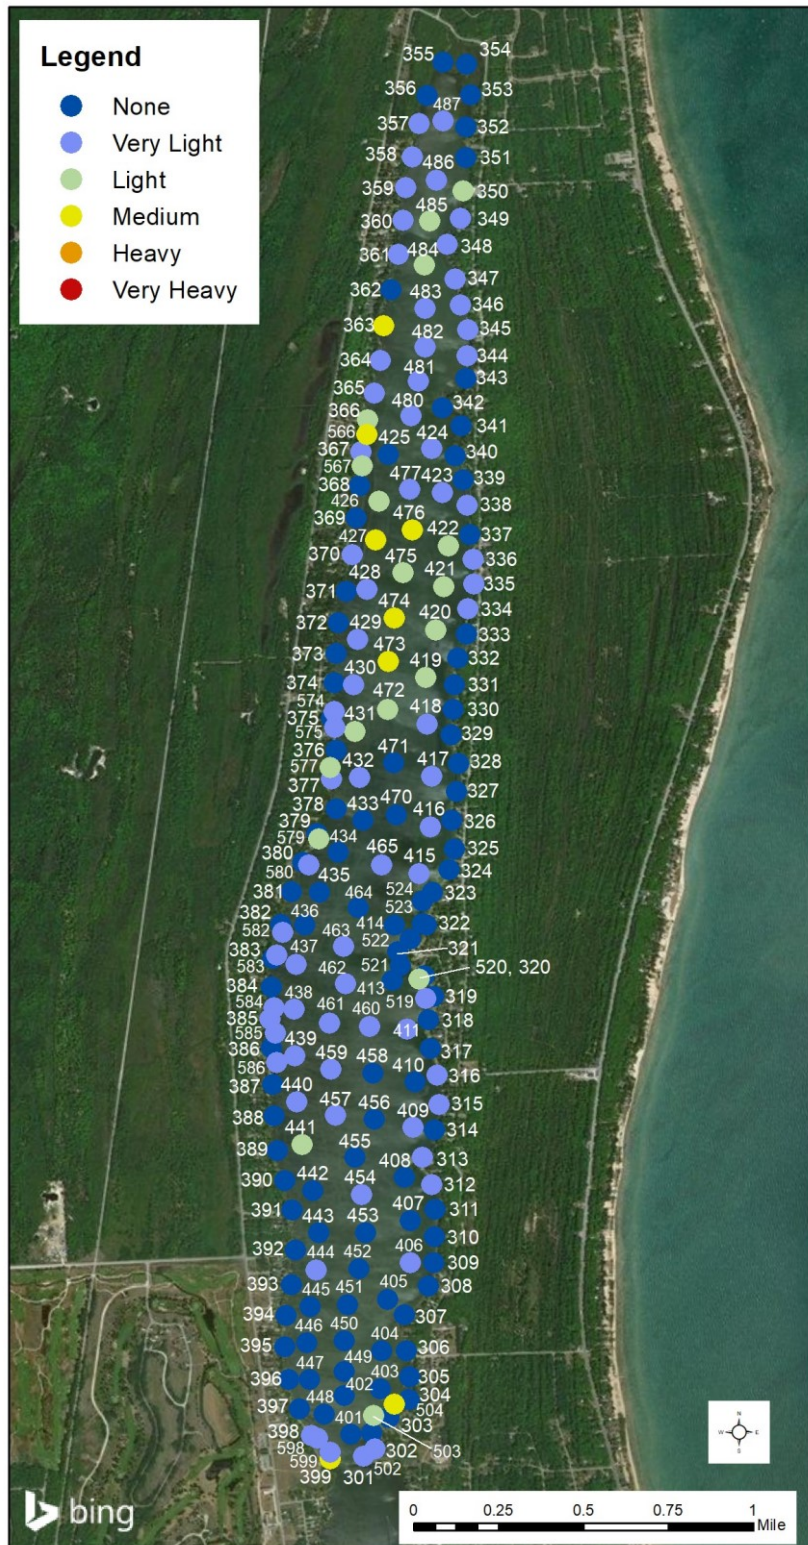
Figure 5 – Early-season (June 30, 2021) Variable Watermilfoil coverage (a combination of the LakeScan™ density and distribution observations).

Figure 5 shows variable-leaf watermilfoil coverage during the 2021 early-season survey. In the late-season survey of 2020, variable-leaf watermilfoil was observed to be causing major recreational hazards, leading to a treatment conducted on September 15, 2020, to help alleviate these conditions. According to herbicide applicator information, this treatment was projected to have lasting effects noticeable for up to three years. Results of the early season vegetation survey conducted on June 30th, 2021, indicate that variable-leaf watermilfoil was exhibiting light density and distribution in many of the areas that were treated in September 2020 suggesting that this prior treatment may have been suppressing early season conditions in 2021.

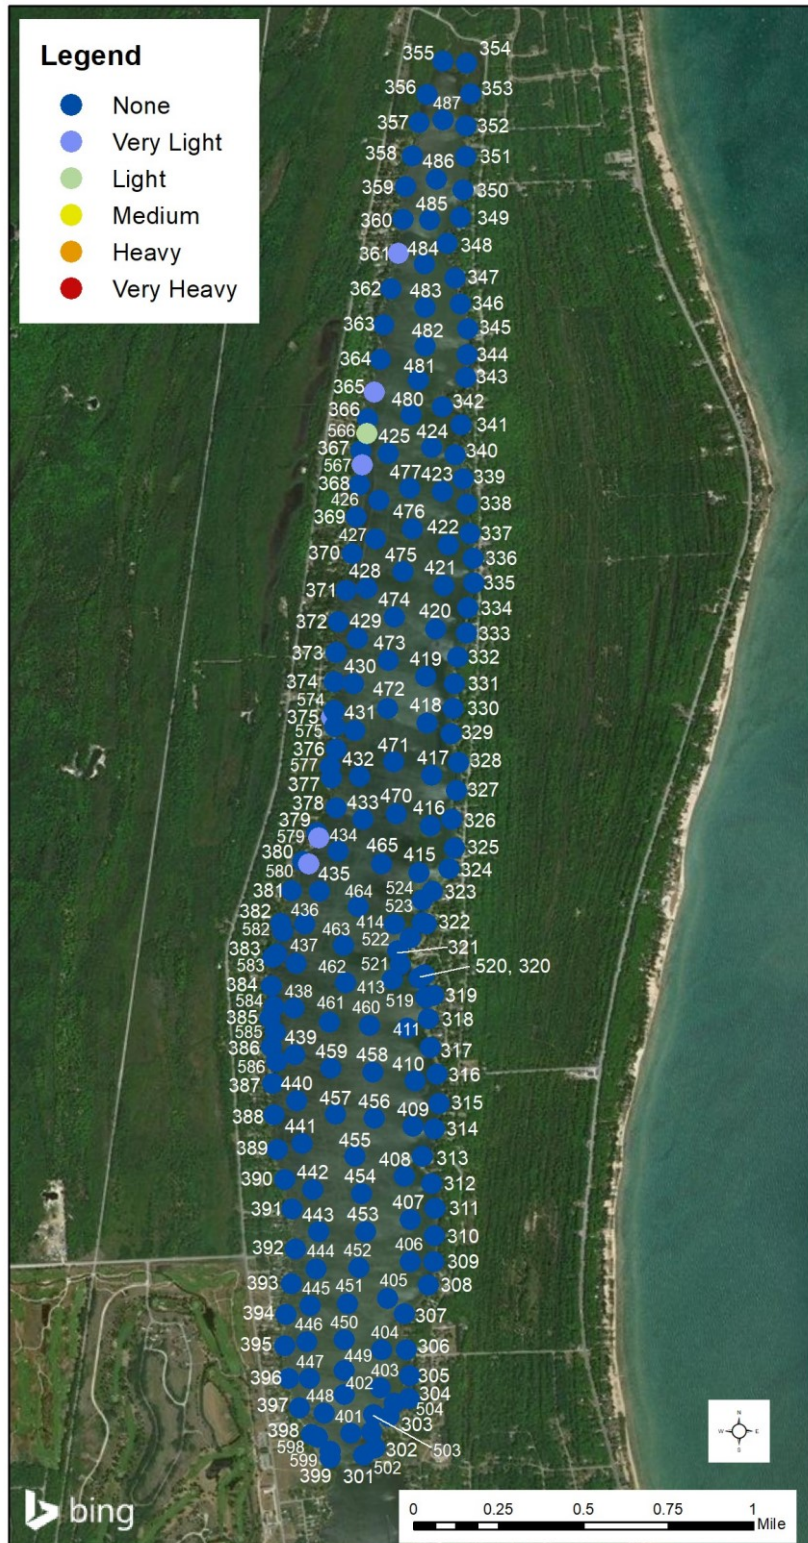
Figure 6 – Early-season (June 30, 2021) Eurasian Watermilfoil and Hybrids coverage.

In Cedar Lake North, the only aquatic invasive species observed was Eurasian watermilfoil hybrid (*Myriophyllum spicatum x sibiricum*). Eurasian watermilfoil hybrid was observed at low densities and abundances in only seven of Cedar Lake North's AROSs including: 580, 579, 567, 566, 375, 365, and 361 (Figure 6). Treatment of Eurasian watermilfoil and other nuisance aquatic plant species was conducted on June 16th, 2021, fourteen days prior to the early season vegetation survey. Treatment was focused on the trenches and areas close to shore, located on the northern half of Cedar Lake North. When comparing Eurasian watermilfoil data from the early season survey to the pre-season survey (collected before treatment occurred), Eurasian watermilfoil density and distribution, specifically in AROS 566 and 567, appears to have been reduced after treatment. On the other hand, Eurasian watermilfoil was observed in more AROSs (580, 579, 375, 365, and 361) than what was observed in the pre-season survey. Nevertheless, in each AROS where Eurasian watermilfoil was observed, its density and distribution were very light and not widely distributed following treatment.

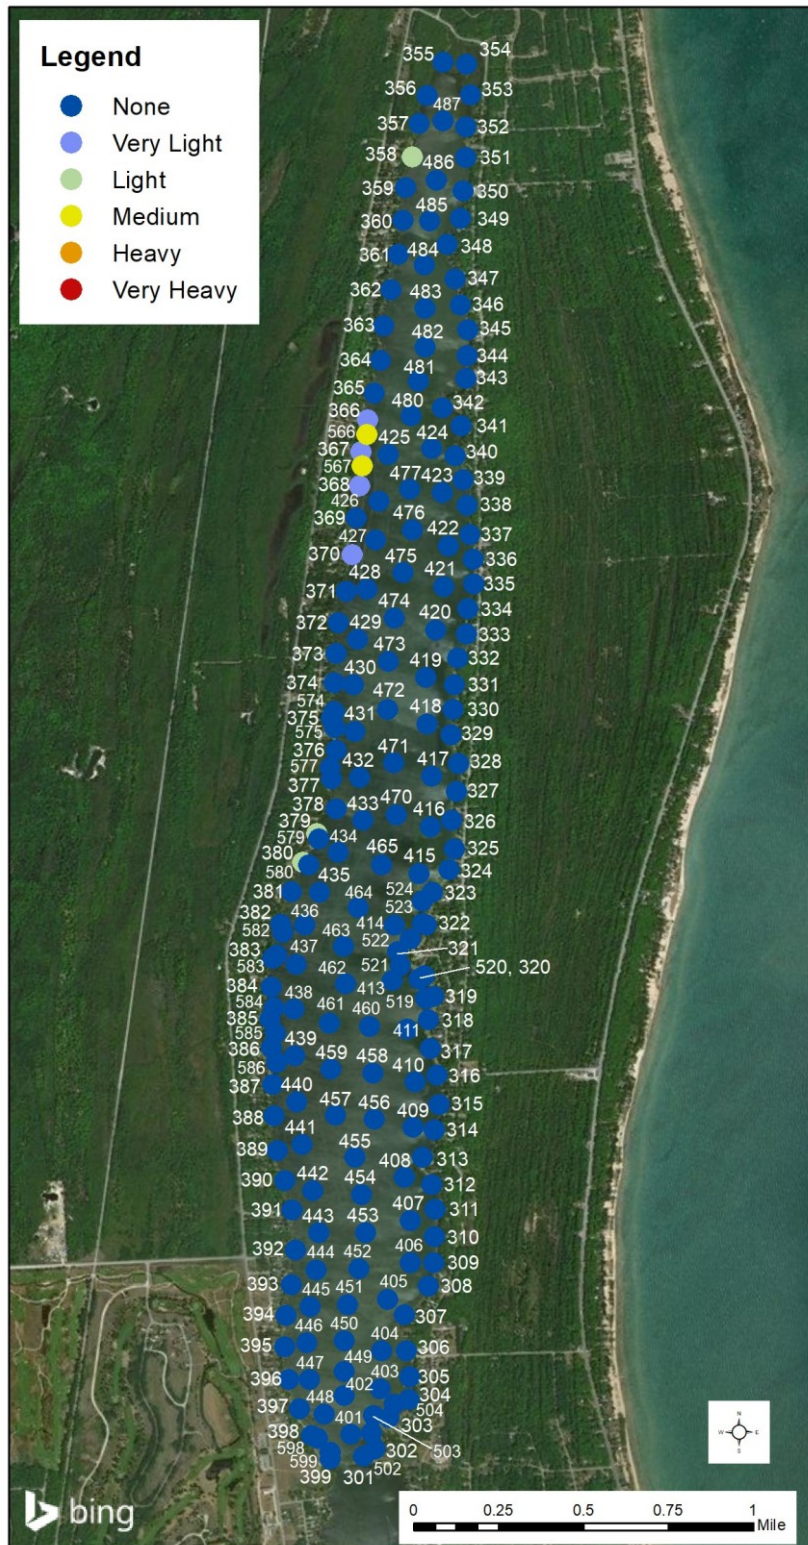
Figure 9 – Late-season (August 24, 2021) Eurasian Watermilfoil and Hybrids coverage.

The only aquatic invasive macrophyte species observed in Cedar Lake was hybrid Eurasian watermilfoil (*Myriophyllum spicatum x sibiricum*). Figure 9 shows the coverage of Eurasian watermilfoil and hybrids observed during the late-season survey. Hybrid Eurasian watermilfoil was present in nine (9) of the 300 and 400 AROS tiers along the western and northwestern shoreline of Cedar Lake, and in two (2) of the 500 tier AROS (567 and 566). Eurasian watermilfoil was most dense in the 500 tier AROS, but poses a relatively minor recreational hazard condition considering its low distribution.

Continued management intervention is recommended for Eurasian watermilfoil. While a slight increase in Eurasian watermilfoil coverage was observed from the early-season to late-season survey in 2021, the trend for the last five years show essentially no change in coverage. Thus, while management interventions do not appear to be significantly decreasing Eurasian watermilfoil coverage, these activities may be suppressing possible spread and coverage increases of Eurasian watermilfoil. Cedar Lake Improvement Board should continue to explore the use of new chemical technologies as they become available to treat Eurasian watermilfoil residing in the northern trenches. This would include testing the use of ProcelleCOR applications in the northern trenches of Cedar Lake North. Recent ProcelleCOR applications in Cedar Lake appear to have been an effective strategy for treating Eurasian watermilfoil in 2021. Applications and testing should continue through 2022 to determine if ProcelleCOR continues to be an effective means to treat Eurasian watermilfoil, with closer consultant oversight.
