# Cedar Lake South

Iosco County

2021 DATA AND ANALYSIS SUMMARY REPORT WITH MANAGEMENT RECOMMENDATIONS

January 18, 2022

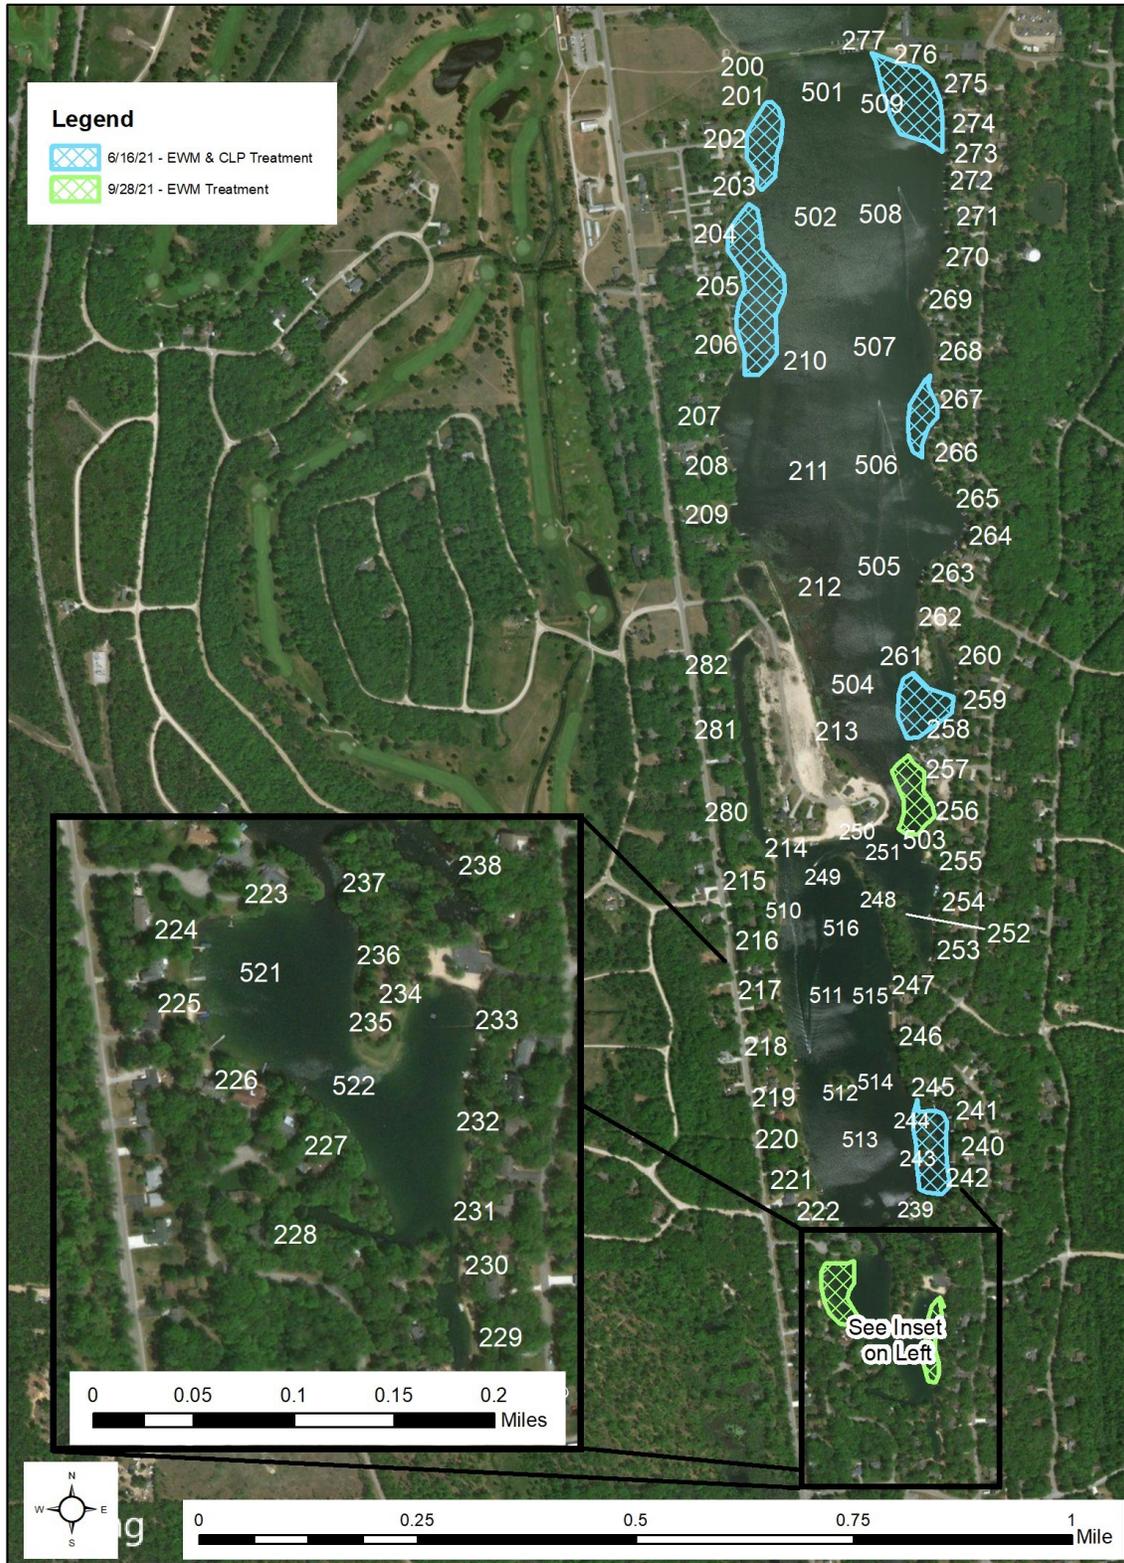
summer 2021 EWM treatment in select areas (Figure 14) should be considered in pre-season and early season observations in 2022.

Figure 14 – 2021 Herbicide Application Map.

Continued Eurasian watermilfoil management is recommended. Eurasian watermilfoil's 5-year trend shows coverage has slightly increased in Cedar Lake South. Monitoring of early season 2022 conditions will be important given late summer 2021 treatments.
