Summary of Findings from LakeScan™
Surveys and Analysis of:

Cedar Lake North

2023 DATA AND ANALYSIS SUMMARY REPORT WITH MANAGEMENT RECOMMENDATIONS

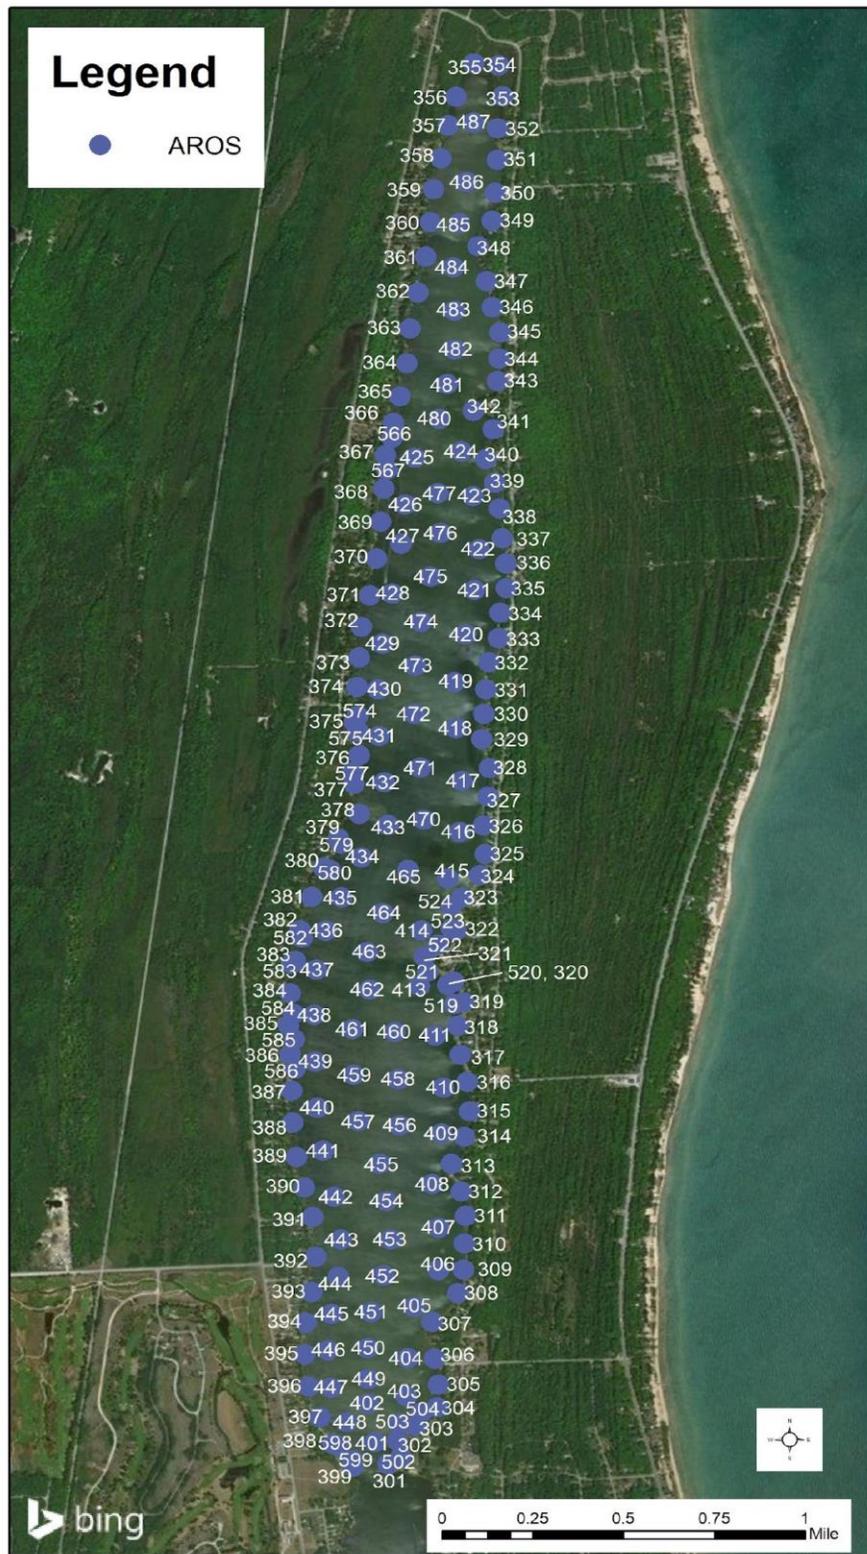
Figure 1 - Map of Aquatic Resource Observation Sites (AROS).

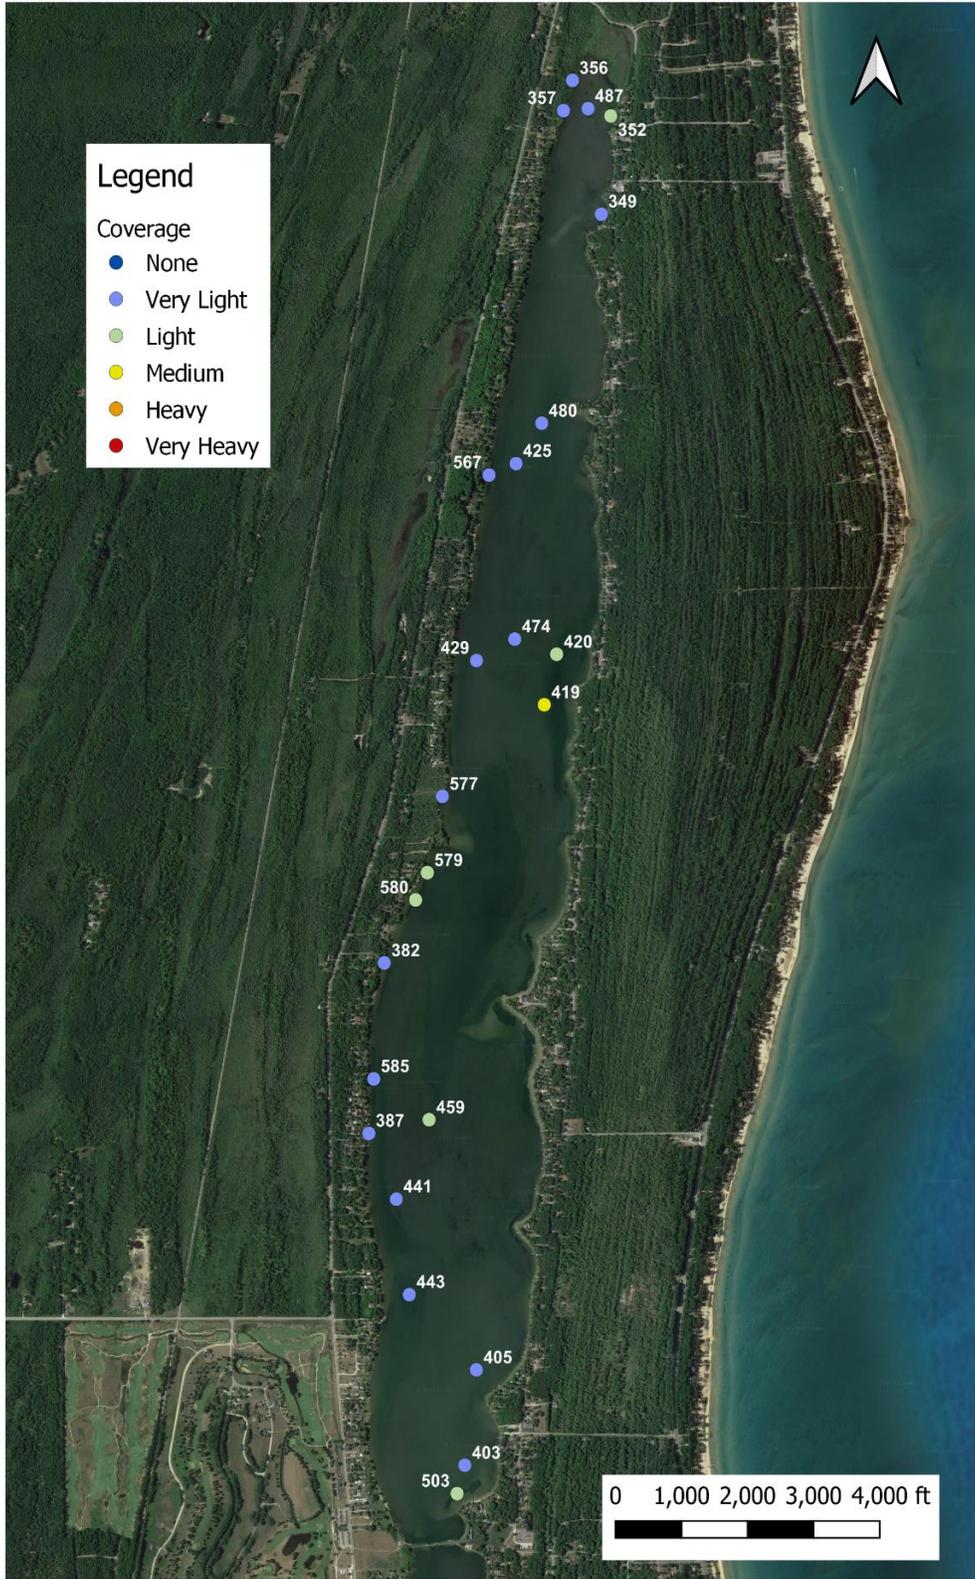
Variable-leaf watermilfoil has historically created recreational nuisance conditions within Cedar Lake North and has been a target of previous control efforts. While this species does still create some nuisance conditions, density and coverage has decreased since it was last widely managed in 2020 (Figure 5). Overall, this observed native species did not appear to be causing nuisance conditions during the time of the survey, although some pondweeds were at the surface and flowering in a few AROS. The trenches and excavation zones (Tier 5 AROS) displayed the highest densities of native pondweeds and *Chara*. Trench 1 (AROS zones 567 & 566) was of particular concern with dense sago pondweed near the surface and *Chara* bubbling up from the bottom post-herbicide treatment.

Figure 5 – Early-season (July 10-11, 2023) Variable-leaf Watermilfoil and Hybrids coverage.

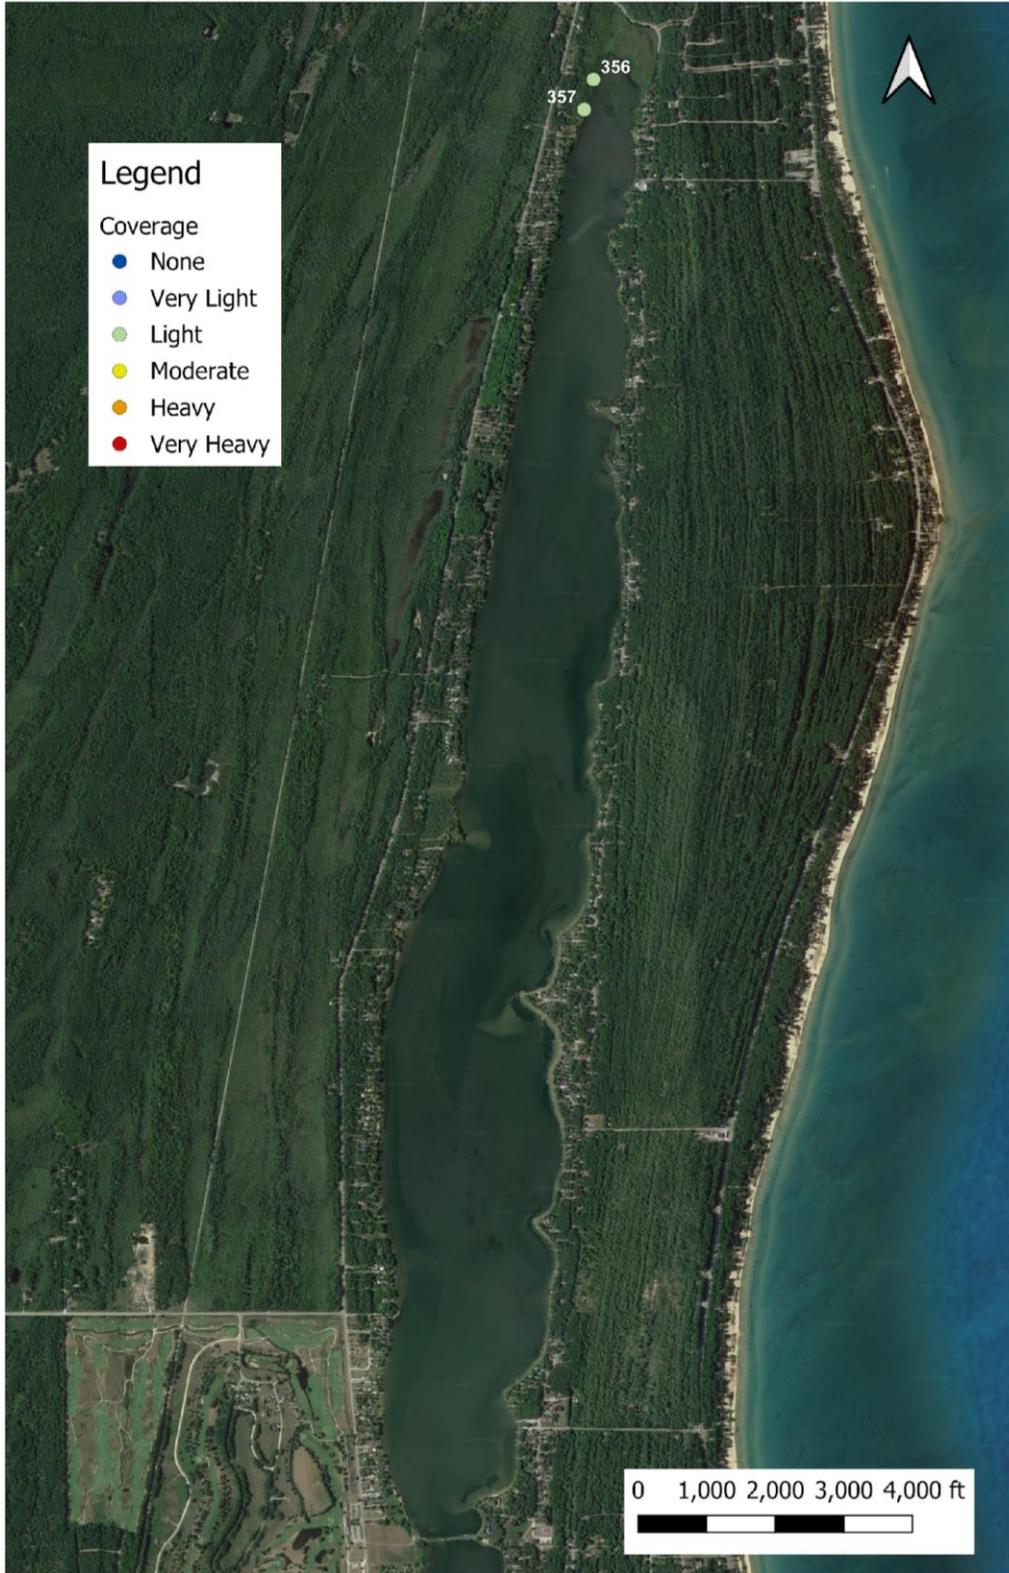
The most common native species observed throughout the survey included *Chara*, Richardson's pondweed, broadleaf pondweed, naiad, and sago pondweed. In addition, emergent plant species, such as white water-lily and spatterdock were regularly observed nearshore in high densities which could cause some navigation concerns, especially in the northern bay of the lake, although the lilies appeared less dense than they were in the early-season survey. *Chara*, broadleaf pondweed, and Richardson's pondweed were regularly found throughout most of the lake with *Chara* being present in almost all AROS zones. The observed native species did not cause many nuisance conditions, however, the pondweeds, mainly broadleaf but occasionally sago and Richardson's, were at the surface and flowering in some locations, creating recreational nuisance concerns around swimming areas and docks. The trenches and excavation zones (Tier 5 AROS) displayed the highest densities of native pondweeds and *Chara*, creating some recreational nuisance concerns. Trench 1 and Trench 2 (AROS 567-566 & 574-575) were of particular concern with dense sago pondweed near the surface. Variable-leaf watermilfoil was sparsely distributed and only observed at low densities in AROS zones 356 and 357 (Figure 7). These observations suggest that variable-leaf watermilfoil treatments have successfully controlled nuisance growth over multiple years.

Figure 7 – Late-season (August 30, 2023) Variable-leaf Watermilfoil coverage.

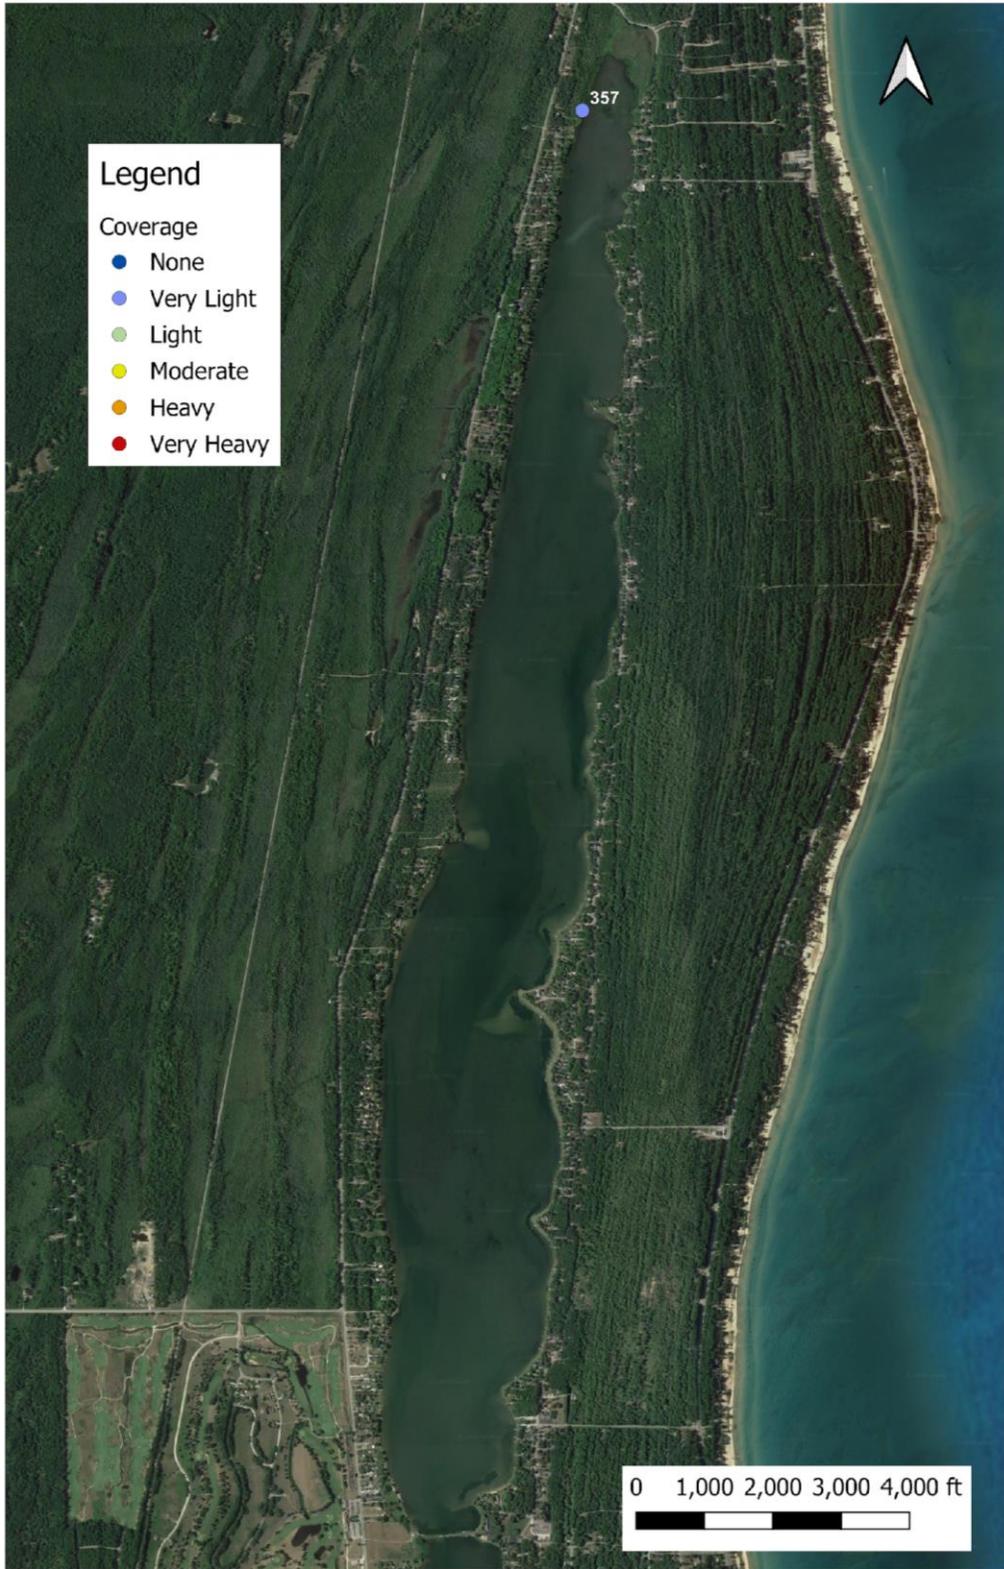
The only observed submerged aquatic invasive species during the time of the survey was Eurasian watermilfoil hybrid (*Myriophyllum spicatum x sibiricum*; EWM) which was only found in AROS 357 and was not part of the early-season treatment in June. The small patch of EWM did not appear dense or continuous enough to warrant treatment at the time of the survey (Figure 8). The terrestrial invasive species purple loosestrife (*Lythrum salicaria L.*) and phragmites (*phragmites sp.*) were observed during the late-season survey at very light coverages. Exotic phragmites was found in the same single AROS in both 2022 and 2023 indicating that the species has persisted, but not expanded its population over the past year. Purple loosestrife was more common, and was observed in isolated patches in 17% of shoreline AROS. The trends in purple loosestrife coverage closely mirror those observed in 2020 suggesting that the year-to-year spread of the species is minimal.

Figure 8 – Late-season (August 30, 2023) Eurasian Watermilfoil and hybrids coverage.

Continued ProcelleCOR applications to treat nuisance Eurasian watermilfoil in the northern trenches of Cedar Lake North is recommended. Recent ProcelleCOR applications in Cedar Lake where an effort was made to inject the herbicide below the water surface appear to have been an effective strategy for controlling nuisance Eurasian watermilfoil populations. Applications and testing should continue through 2024 to determine if ProcelleCOR continues to be an effective means to treat Eurasian watermilfoil.

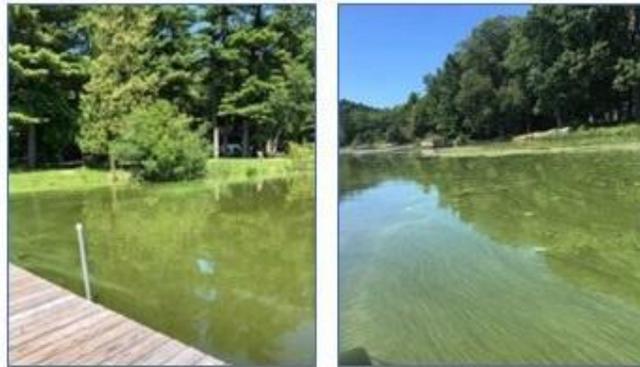
Figure A1: Example blue-green algae images from the 2019 LakeScan™ field crew.

Blue-green algal blooms are becoming increasingly common in Michigan. Blooms can appear as though green latex paint has been spilled on the water, or resemble an oil slick in enclosed bays or along leeward shores. Blue-green algal blooms are usually temporal events and may disappear as rapidly as they appear. Such blooms have become more common for a variety of potential reasons; however, the spread and impact of zebra mussels has been closely associated with blooms of blue-green algae.

Management: Treatment methods for blue-green algae are generally preventative rather than reactionary. One of the most common forms of algae treatment is limiting nutrients, namely phosphorus, from entering the lake ecosystem through several sources. Phosphorus mainly enters lake systems through surface water inputs such as rivers, creeks, or overland runoff. In some inland lakes that experience late-summer stratification, sediment-bound phosphorus at the lake bottom becomes mobilized due to low-oxygen conditions which, under high sustained wind conditions, can mix surface and bottom waters. This is particularly problematic in the late summer. Phosphorus-reducing practices include: implementing Best Management Practices (BMPs) in upstream agricultural and urban areas, limiting nutrient (fertilizer) applications on lawns, planting vegetative buffer strips between nutrient-producing areas and surface water, reducing septic system leaching (if riparian homes are not sewered), binding lake-bottom phosphorus using alum or other adsorbent materials (e.g., Phoslock®), and treating/infiltrating stormwater prior discharge into upstream surface waters of the lake. Some blue green algae blooms are caused by species/communities that depend on luxuriant sediment nutrient pools. The restriction of nutrient inputs to these lakes cannot be realistically expected to resolve nuisance bloom conditions in any reasonable amount of time, if at all. K&A is investigating the use of products that can serve as barriers to the mobilization of sediment nutrients for use by bottom associated noxious algae blooms.

When nuisance conditions occur, contact algaecides or hydrogen peroxide may be used as a reactionary treatment to destroy algae present in the water column. However, chemicals should be applied with caution due to concerns of bioaccumulation and toxicity to other forms of aquatic life. Sometimes, algaecide applications are made to surface blooms. However, the effectiveness of such treatments is compromised because the surface blooms can be pushed to different areas of the lake with prevailing winds.

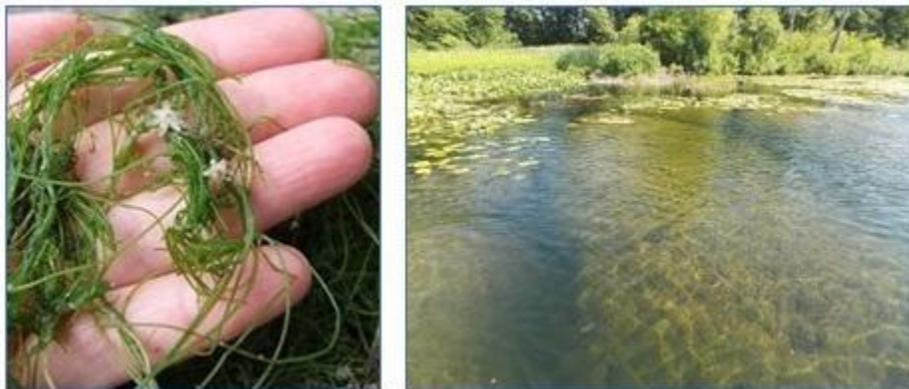
Figure B2: Example starry stonewort images from the 2019 LakeScan™ field crew.

Background: Starry stonewort, a macroalgae native to northern Eurasia, invaded North American inland lakes after becoming established in the St. Lawrence Seaway/Great Lakes system. Though not positively identified in a Michigan inland lake until 2006, by Aquest Corporation in Lobdell Lake, Genesee County, starry stonewort has likely been present in Michigan’s inland lakes since the late 1990’s. Since then, this invasive species has spread throughout Michigan. Able to spread by both fragmentation and asexual reproduction, starry stonewort has thrived in Michigan’s high-quality oligotrophic and mesotrophic lakes, particularly those with marl sediments. Once established, this opportunistic species can bloom and crash and impose a very significant and deleterious impact on many ecosystem functions. Bloom and crash events are unpredictable and can happen at any time of the year. In some years starry stonewort can become a horrendous nuisance while it can be inconspicuous in others. It can comele with other similar species and be very difficult to find when it is not blooming.

Management: Starry stonewort is capable of growing to extreme nuisance levels and can significantly impact important ecosystem functions. This species is difficult to control due to its asexual reproductive

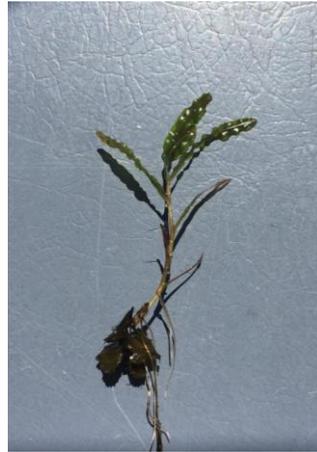
Figure B3: Example curly-leaf pondweed image from the 2021 LakeScan™ field crew.

Curly-leaf pondweed can create problems such as recreational nuisances, ecological nuisances (by outcompeting native species and reducing light availability to other plants), and degraded fish spawning habitat. Curly-leaf pondweed is easily detectable in early spring as it will be one of the few plants readily growing and the first submersed plant to reach the surface. This gives it a competitive advantage and can grow 4 to 5 feet tall before other plants begin germinating from the bottom sediments. As water

Management: Like other invasive species, CLP is easy to control, but once established it is for all practical purposes seemingly impossible to eradicate. It is considered widespread in Michigan. Therefore, prevention of new populations in uninfected waters is the most economical management approach. Several herbicides have been shown to be effective at achieving season-long, species selective control of CLP. Bottom barriers have shown effectiveness at combating CLP in small areas, and mechanical harvesting of CLP can be effective if timed and managed correctly.¹⁵

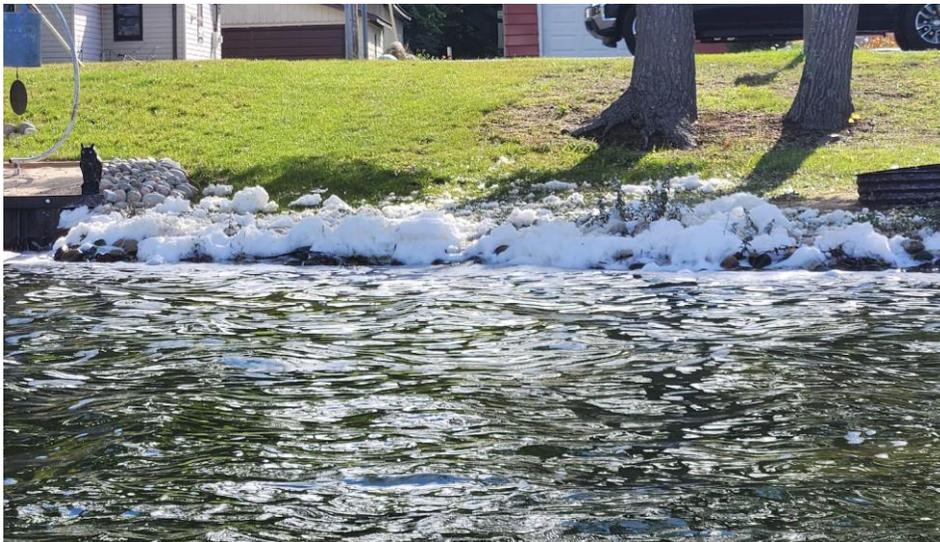
Background: During the late-season LakeScan™ vegetation survey on August 30, 2023, large amounts of foam was observed along the shoreline (Figures C1 & C2). Lake foam is often naturally occurring due to chemical changes in the lake and from decomposing plant material or, in rarer instances, lake foam can be caused by pollutants such as per- and polyfluoroalkyl substances (PFAS & PFOS).¹⁷

The abundance of the foam observed during the survey, and the presence of the foam in years past suggests that the foam found on Cedar Lake North during the August survey could be caused by PFAS pollutants.¹⁸ Between 2018 and early 2020, EGLE sampled foam at Cedar Lake as part of a broader study. Results from samples found PFOS in foam from Cedar Lake at 7,260 ppt while a previous test, done in December 2018, found PFOS at 158 ppt¹⁹.

Figure C1. Foam found along Cedar Lake North shoreline, August 30, 2023.

Management: There are no EGLE standards for PFAS in foam, so no regulatory actions can be taken based on the results collected at Cedar Lake. All results from EGLE are shared with the Michigan Department of Health and Human Services (MDHHS) to determine if a foam advisory is needed. The variability in reported PFOS levels in Cedar Lake North has influenced the Iosco County district health department to recommend that residents avoid contact with foam around on the lake. EGLE has also posted informational signs at the Cedar Lake boat launch warning against coming into contact with the foam (Figure C3).

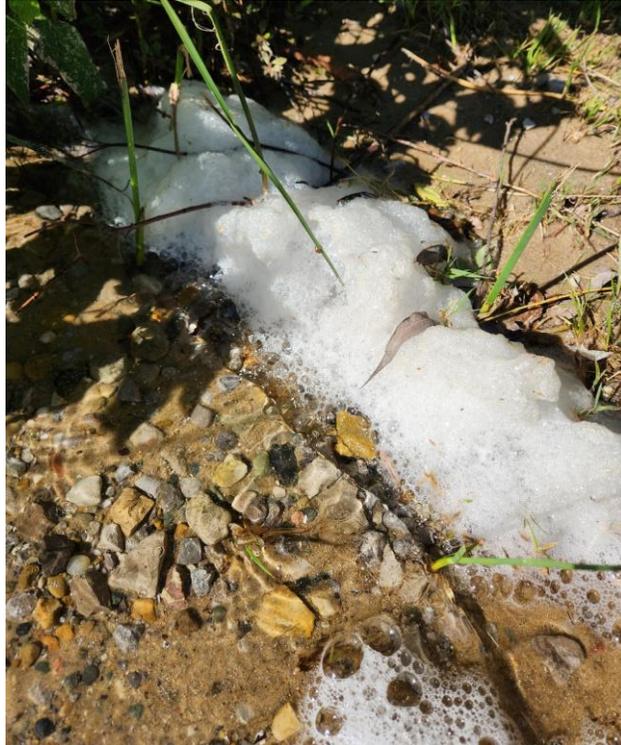
Figure C2. Close up example of foam found at the boat launch on Cedar Lake North, August 30, 2023.
