# Cedar Lake South

Iosco County

2023 DATA AND ANALYSIS SUMMARY REPORT WITH MANAGEMENT RECOMMENDATIONS

January 29, 2024

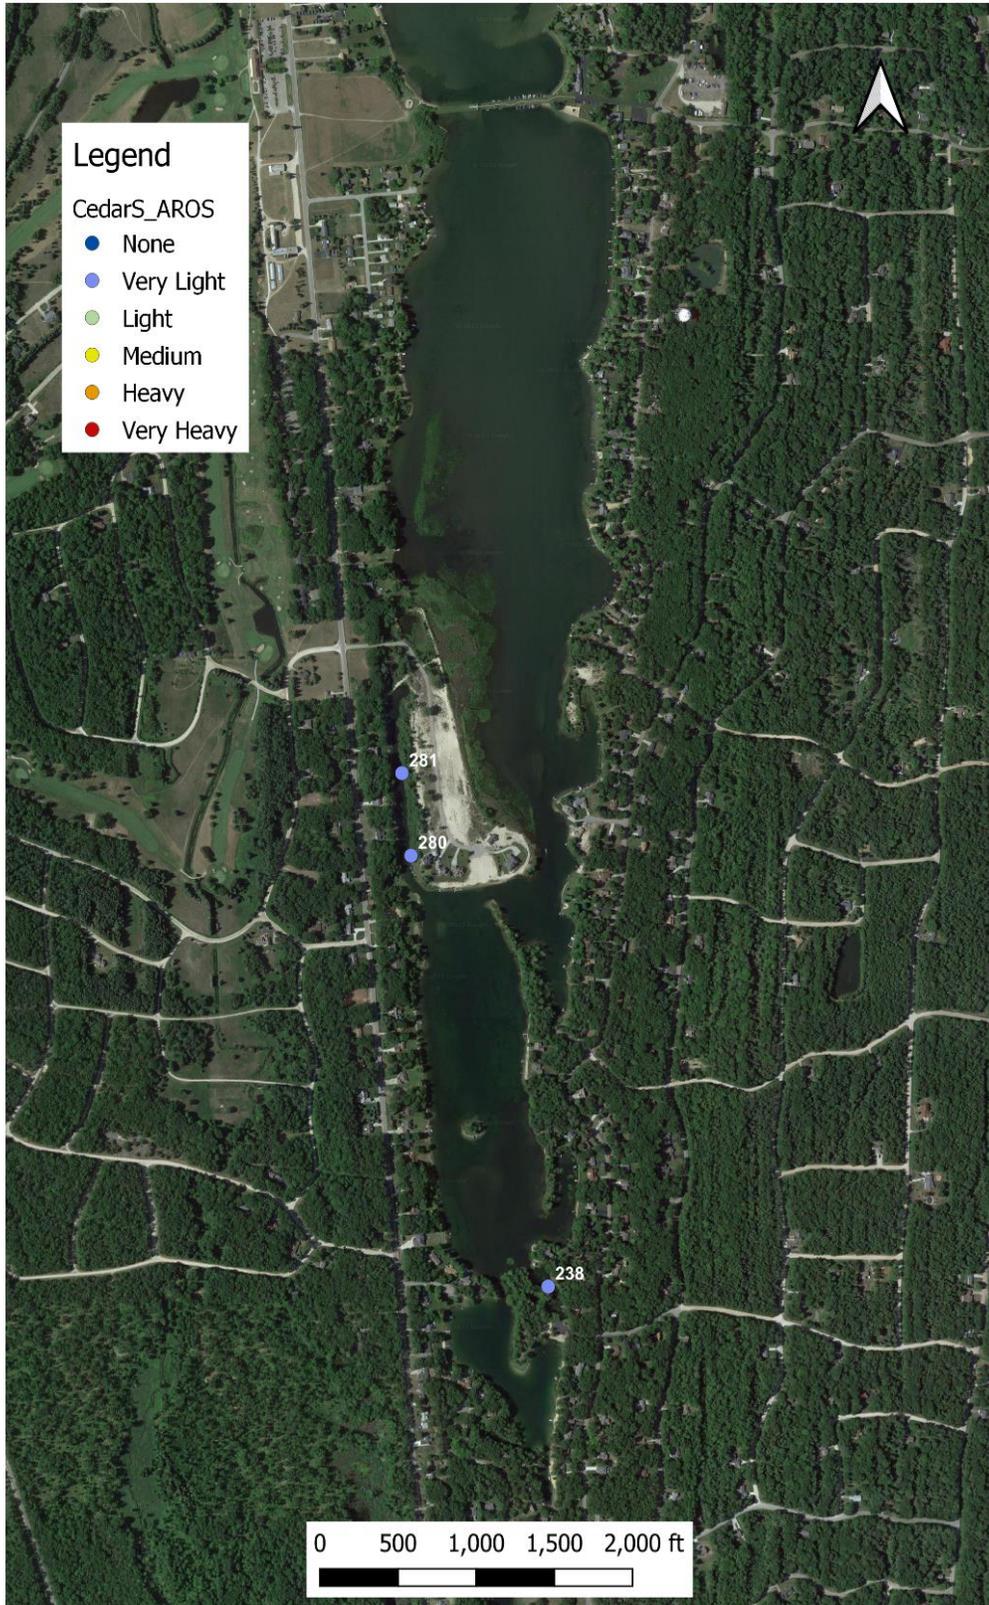
The only submerged aquatic invasive species observed during the time of the survey was hybrid Eurasian watermilfoil (*Myriophyllum spicatum x sibiricum*; EWM) which was found in scattered patches in AROS 281, 280, and 238 (Figure 5). During the time of the survey, these small patches did not appear dense or continuous enough to warrant treatment.

Figure 5 – Early-season (July 11, 2023) Eurasian Watermilfoil and Hybrids coverage.

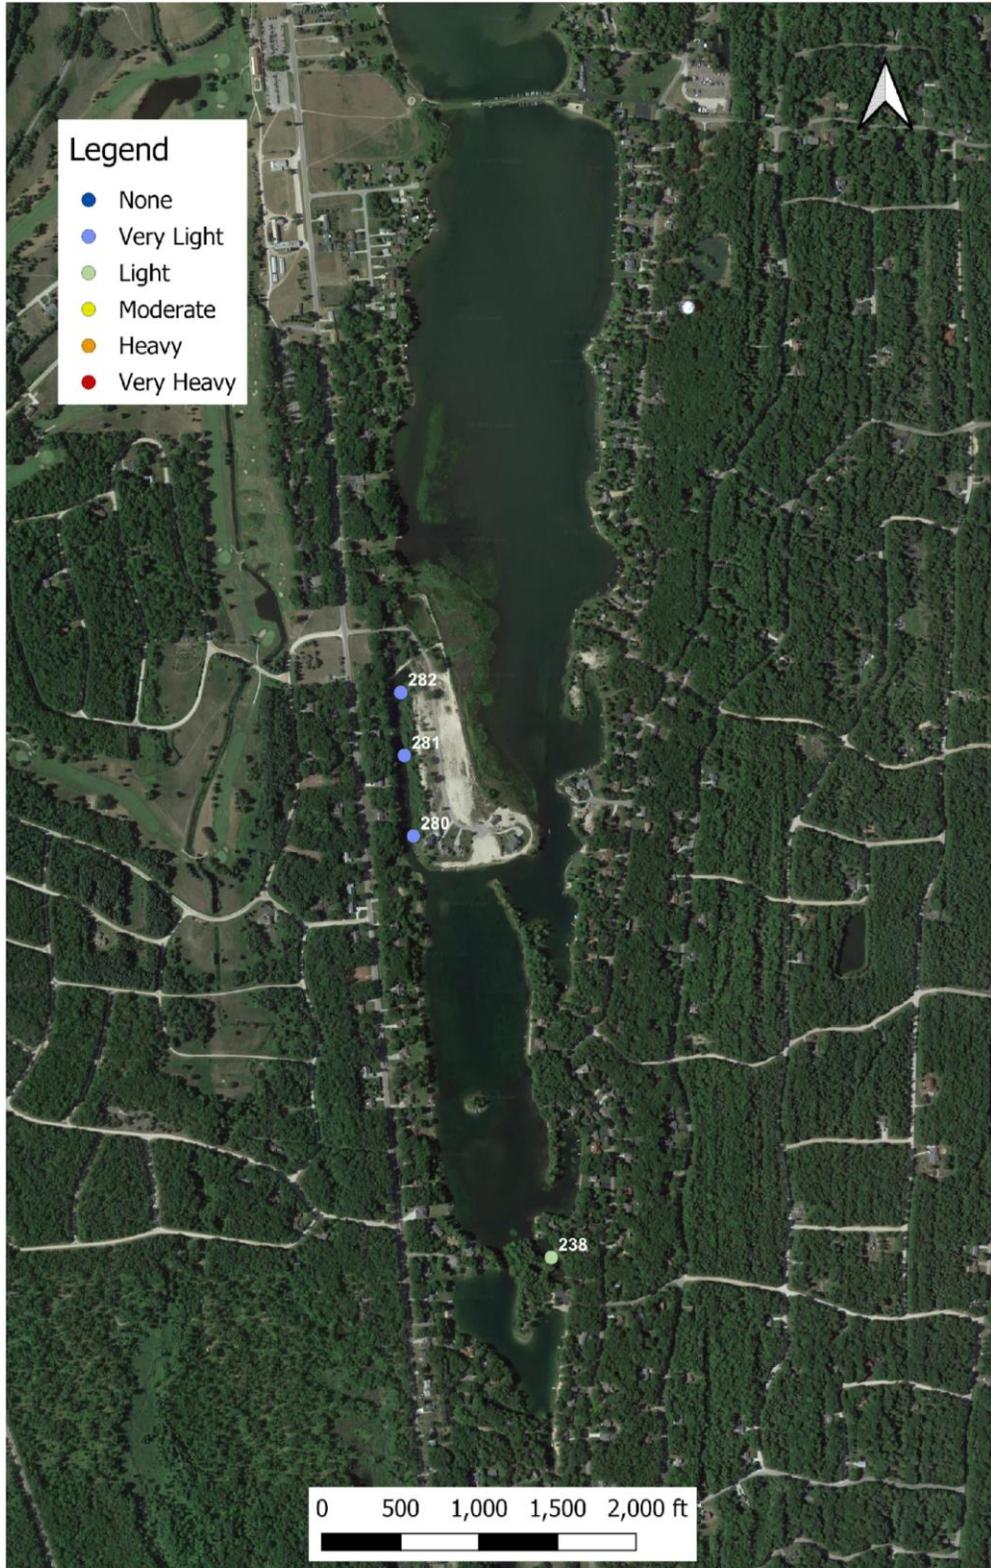
The only observed submerged aquatic invasive species during the time of the survey was hybrid Eurasian watermilfoil which was found in scattered patches in AROS 280 - 282 and 238 (Figure 8). The distribution of EWM was similar to what was observed during the early-season survey, although it had spread further up the western channel and was in higher coverage in AROS 238. Despite the slightly higher density and distribution of the species in the late-season survey, the relatively consistent distribution of the species throughout both surveys suggests that EWM is not aggressively spreading throughout this southern section of the lake, or growing in dense patches. While EWM coverage was light, the canal where the EWM was located was also noted for potential recreational nuisance concerns caused by the floating leaf pondweed (*Potamogeton natans*) and the other flowering pondweed species. This area was therefore included in a late-season herbicide treatment (Appendix C). The terrestrial invasive species purple loosestrife (*Lythrum salicaria* L.) was found in isolated clusters across 16 AROS in the Late-season survey. The coverage of purple loosestrife mirrors the conditions observed previously in 2020, suggesting that the species is not rapidly spreading across the shoreline from year-to-year.

Figure 8 - Late season (August 29, 2023) Eurasian Watermilfoil coverage.

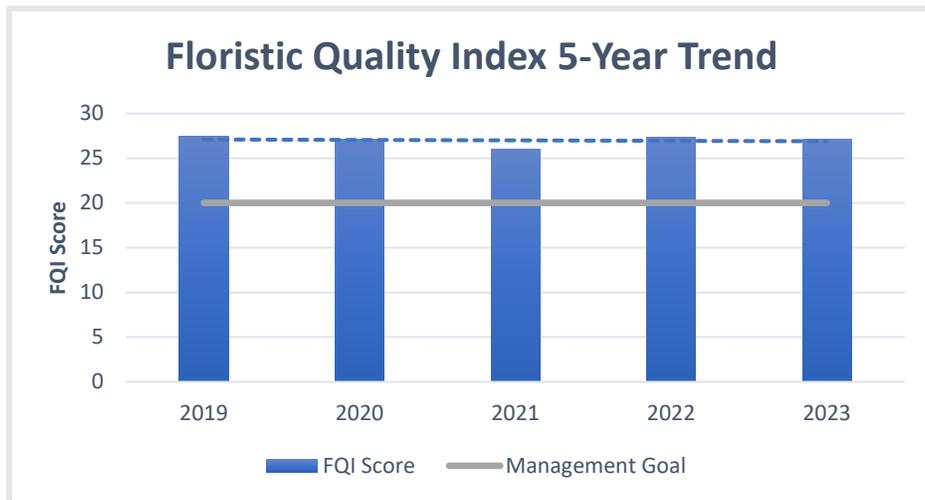
The 5-year historical trends for Floristic Quality Index (FQI) scores and the average nuisance species coverage values are presented in (Figures 10 and 11), respectively. Trendlines shown are calculated using Microsoft Excel’s linear trendline function. Positive trends for the FQI scores indicate increases in desirable plant species and/or decreases in undesirable plant species. Negative trends for the nuisance species coverage values suggest herbicide treatment and other lake management activities are showing success.

Over the last five years, the FQI score for Cedar Lake South has exhibited a linear trend, which indicates an equilibrium between desirable, native plant species and undesirable, non-native plant species (Figure 10). For the last five years, Cedar Lake South’s FQI score has exceeded the management goal of 20. Furthermore, Cedar Lake South’s average invasive species coverage of Eurasian watermilfoil and starry stonewort have exhibited a decreasing 5-year trend, with no starry stonewort observed during the 2023 surveys. These observations suggest management activities are likely contributing to reducing invasive species populations and suppressing population expansion. Additionally, the average coverage of the native species, variable-leaf watermilfoil, has decreased over the last five years (Figure 11), suggesting that management activities have contributed to the suppressed growth of the species. Prior to 2020, variable-leaf watermilfoil coverage was increasing year-over-year, prompting treatment during September of 2020 to relieve nuisance conditions. Since treatment, variable-leaf watermilfoil coverage has consistently been the lowest observed over the last five years. These observations suggest that management actions targeting variable-leaf watermilfoil have successfully contributed to the reduced growth of the species over multiple years.

Figure 10 – Floristic Quality Index 5-Year Trend.

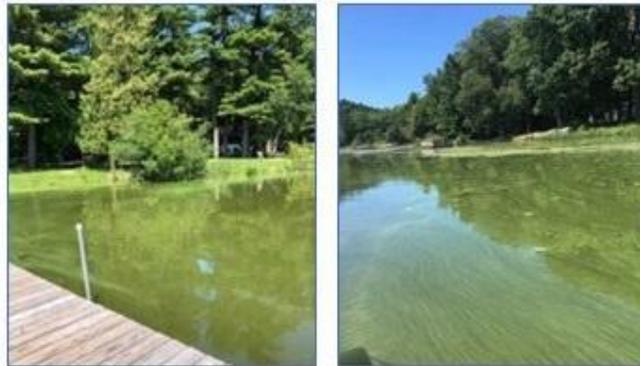
Figure A1: Example blue-green algae images from the 2019 LakeScan™ field crew.

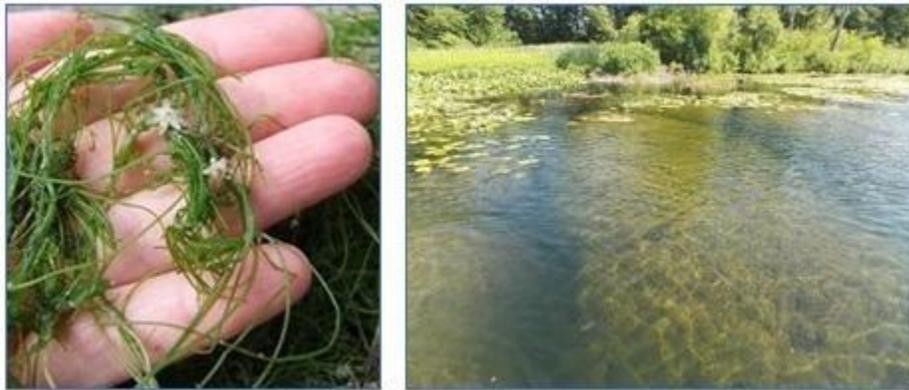
Figure B2: Example starry stonewort images from the 2019 LakeScan™ field crew.

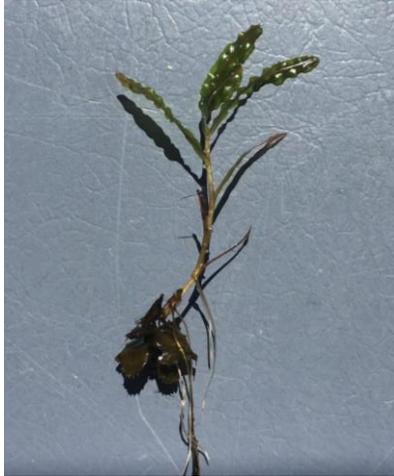
Figure B3: Example curly-leaf pondweed image from the 2021 LakeScan™ field crew.

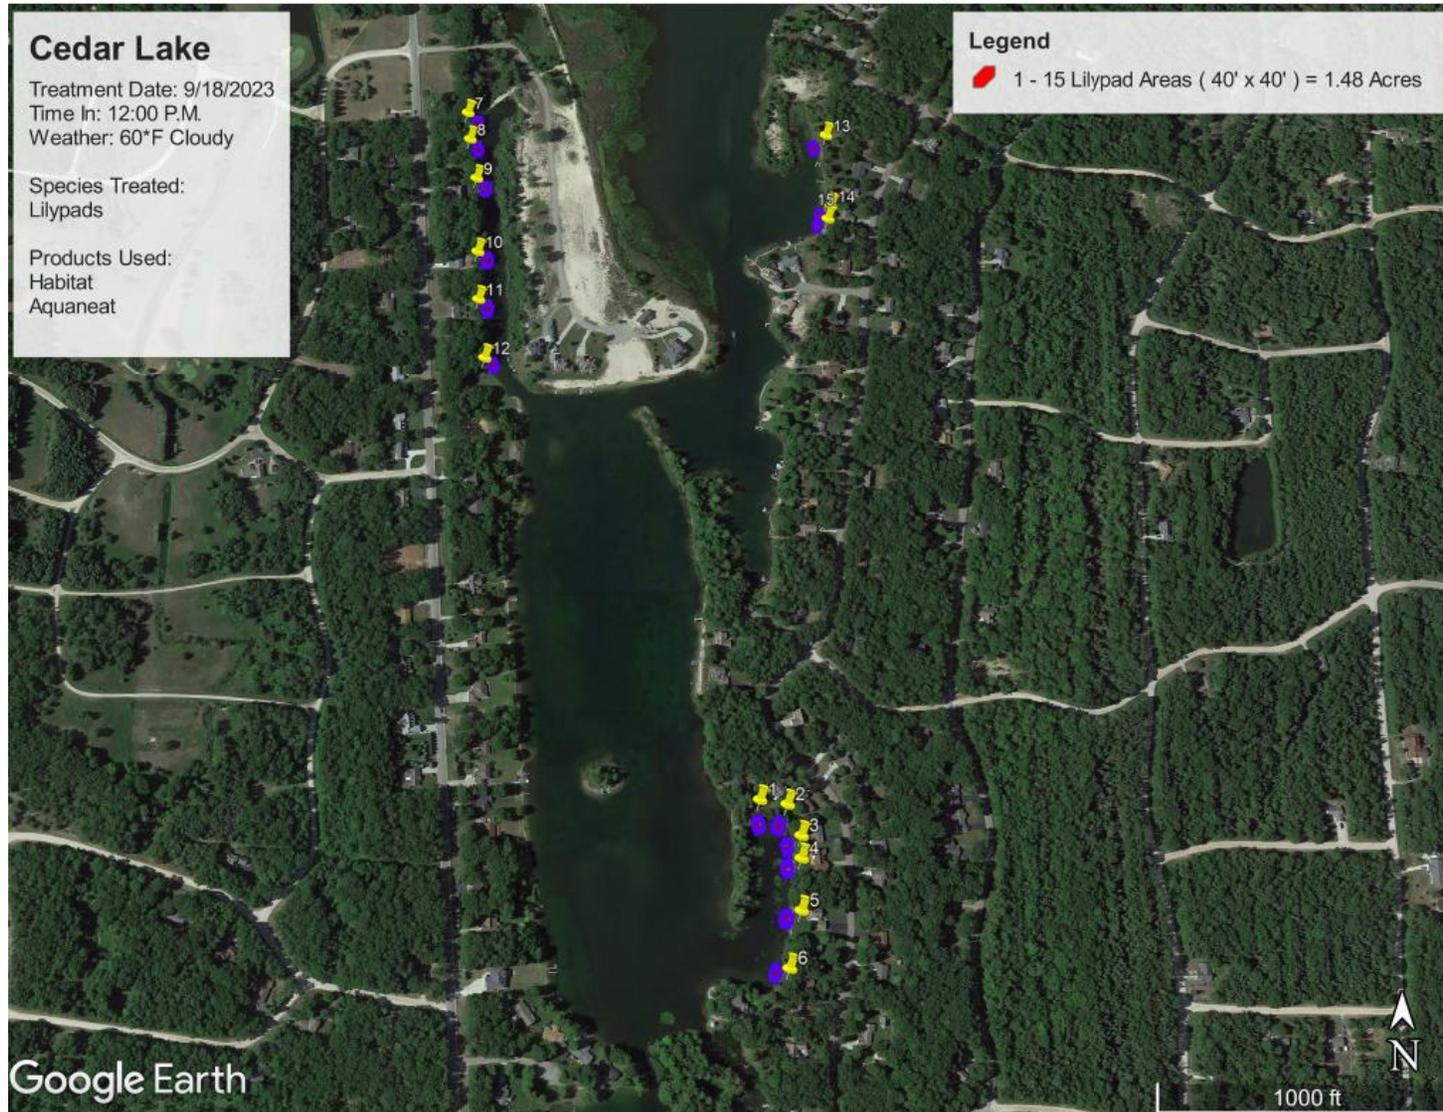
Appendix C: Herbicide Applicator Map

On September 18, 2023, 1.48 acres of Cedar Lake South was treated by SOLitude Lake Management, targeting lily pads, and other plants causing nuisance conditions. The goal of the treatment was to alleviate the shallow bays of the lake from the nuisance conditions observed in the late-season survey.
