A Summary of Findings from LakeScan™
Guided Surveys and Analysis of:

Cedar Lake South

Iosco County

2020 DATA AND ANALYSIS SUMMARY REPORT WITH MANAGEMENT RECOMMENDATIONS

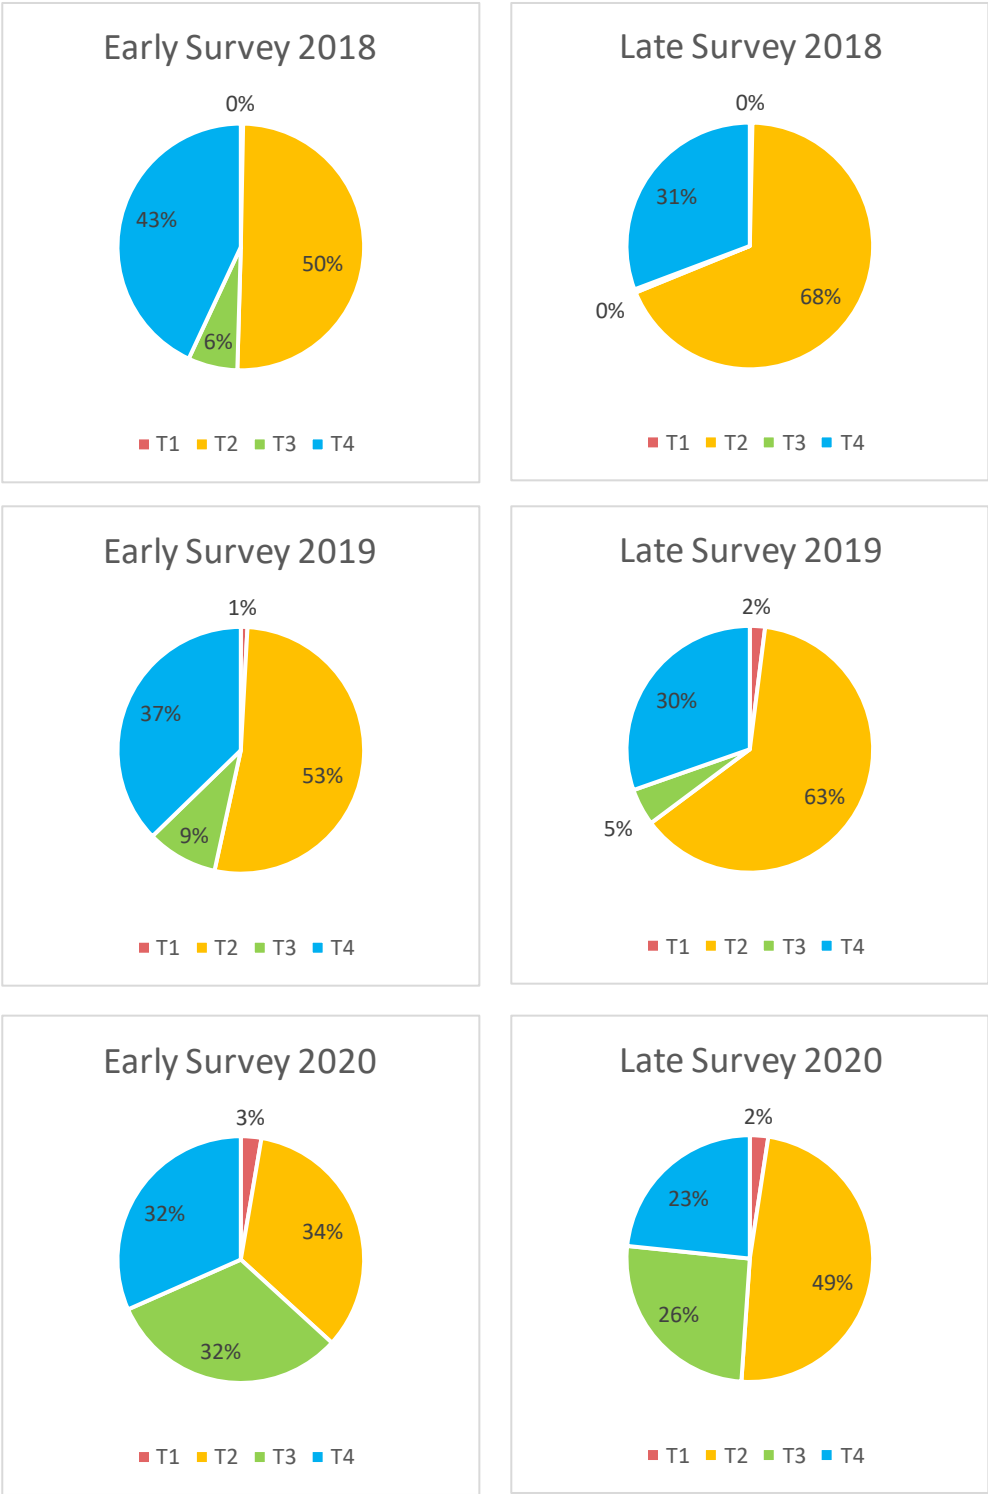
Figure 12– Distribution of aquatic plant coverage by T Value comparing early-season and late-season surveys from 2018 – 2020.

Aquatic plant species observed during the 2020 vegetation surveys are identified in Table 2. The 'T Value' in this table is a qualitative value ranging from 1 to 4 that is assigned to each species, where 1 represents an undesirable species highly likely to require treatment and 4 represents a desirable species highly unlikely to require treatment (thus, 1 is 'bad'; 4 is 'good'). 'Frequency' represents the percentage of survey sites (AROS) where a given species was found. 'Coverage' represents the lake bottom spatial cover observed for each species, represented as a percentage of available area. 'Dominance' represents the degree to which a species is more numerous than its competitors. Figure 12 illustrates dominance by T Value categories for early and late season surveys over the last few years.

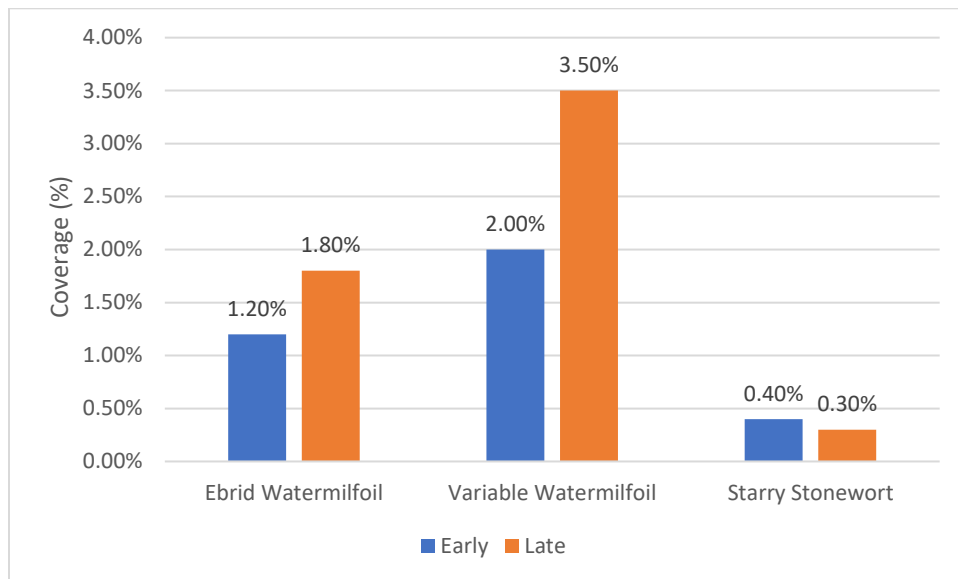
Figure 15 – Changes in coverage across both 2020 surveys for targeted species

Ebrid watermilfoil coverage slightly increased from early to late-season surveys, while starry stonewort coverage did not change substantially.
