A Summary of Findings from LakeScan™
Guided Surveys and Analysis of:

Cedar Lake North

2020 DATA AND ANALYSIS SUMMARY REPORT WITH MANAGEMENT RECOMMENDATIONS

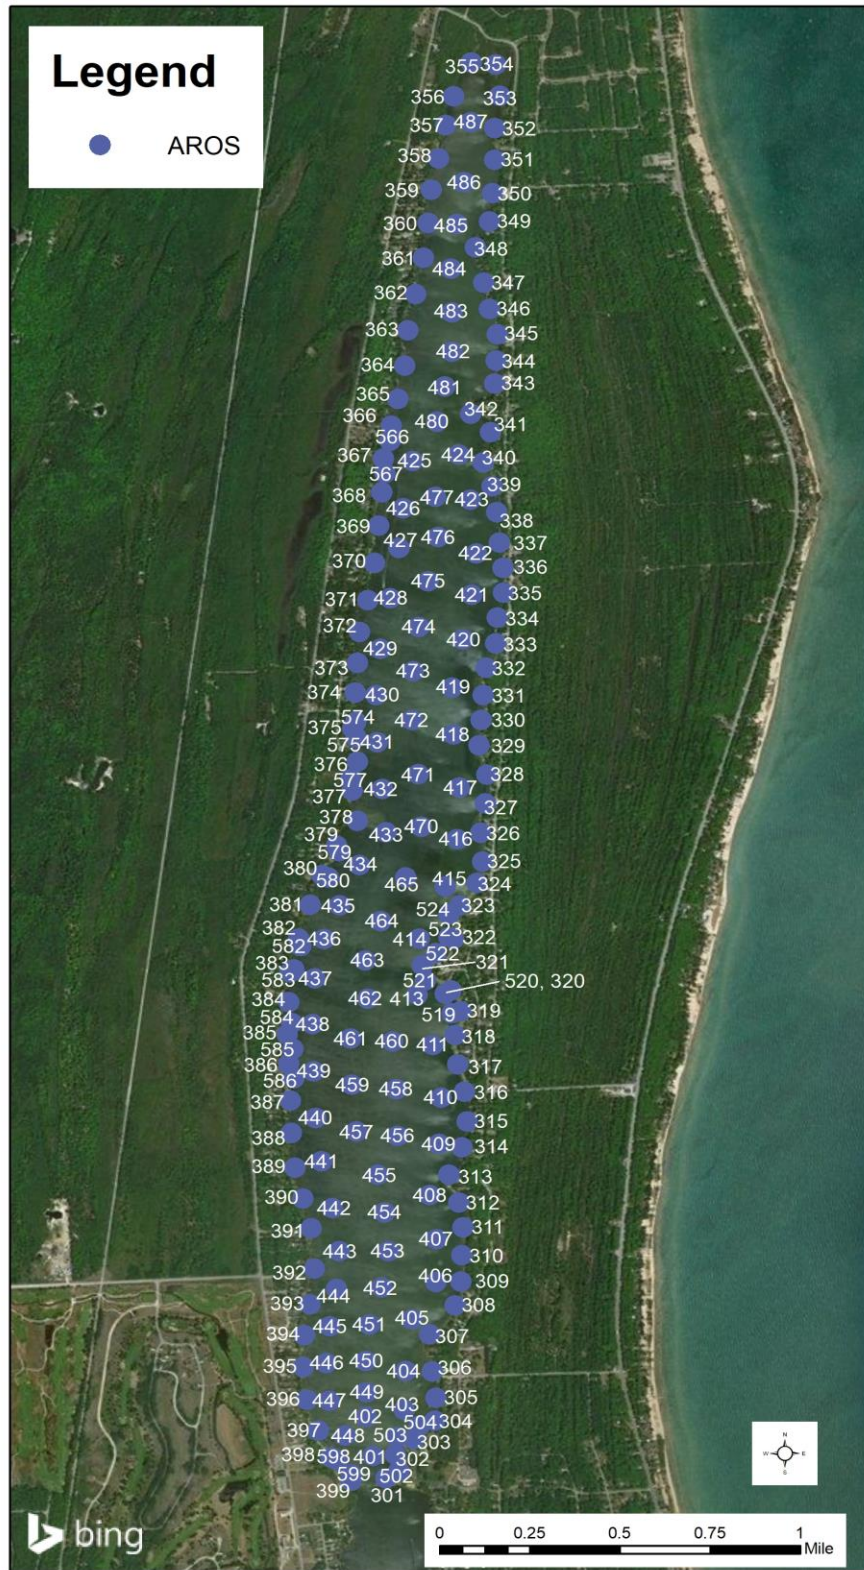
Figure 1 - Map of Aquatic Resource Observation Sites (AROS)

The LakeScan™ analysis involves collecting data over two vegetation surveys during the critical summer recreational season. These surveys are based on a system where the lake is first divided into biological tiers (see Table 1) and then further subdivided into Aquatic Resource Observation Sites (AROS)(see Figure 1). For each survey, field personnel record the density, distribution, and position in the water column of each aquatic plant species in each AROS, as well as noting any present nuisance conditions. Dissolved oxygen profiles and temperature profiles are recorded. Surveys may also collect additional data such as water quality samples.

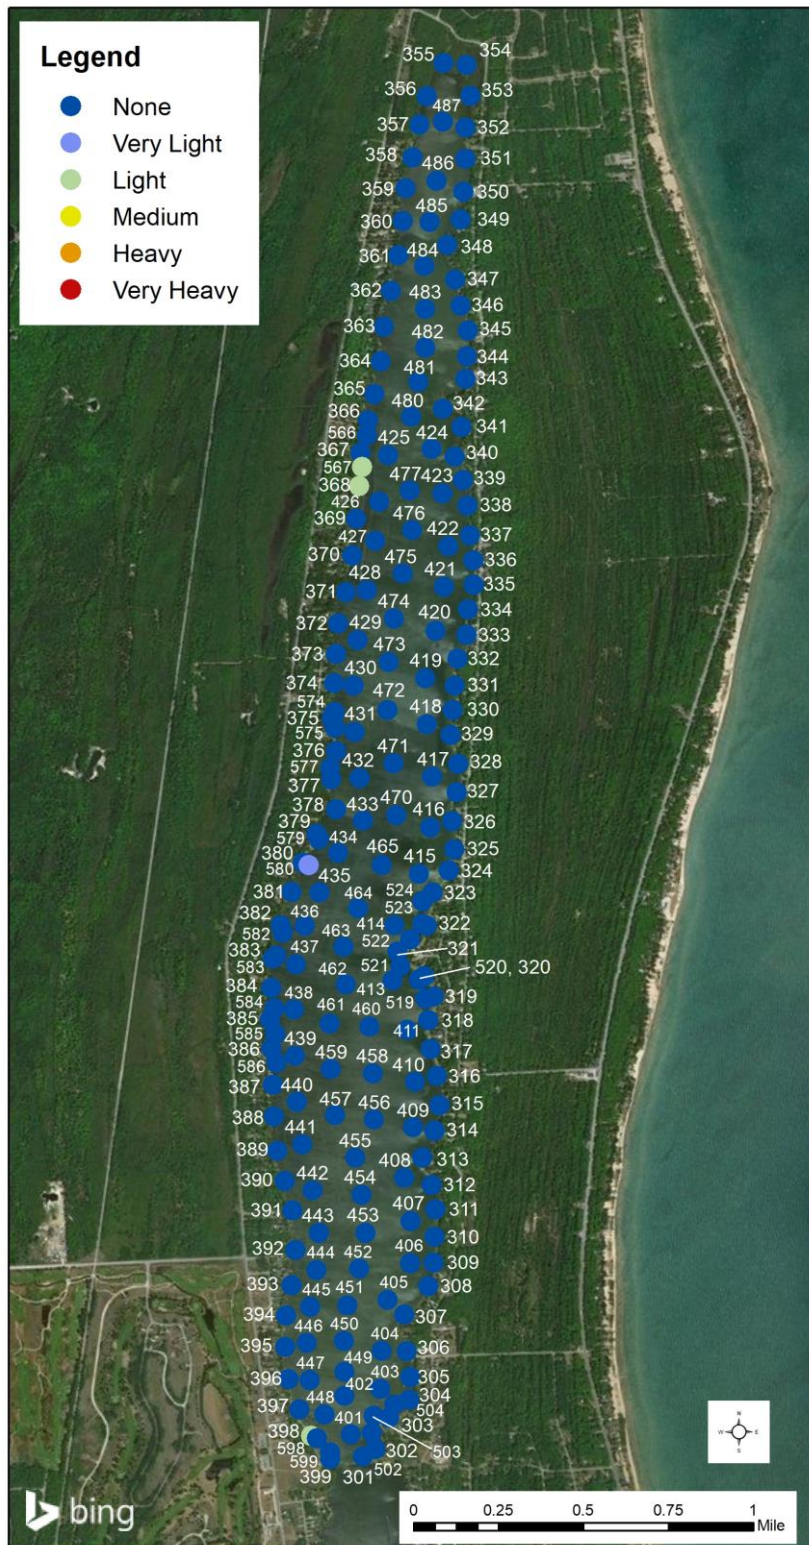
Figure 5 – Early season (June 30th & July 1st) Eurasian Watermilfoil and Hybrids coverage (a combination of the LakeScan™ density and distribution observations).

The only ecological nuisance species detected during the early-season survey was Ebrid watermilfoil (*Myriophyllum spicatum x sibiricum*). This species was observed most commonly in the northern portion of Cedar Lake, limited to the deep, west-side trenches. AROS where Ebrid watermilfoil was observed include: 398, 580, 368 and 567, some of which appeared to be dead but upon closer examination, green shoots were visible (Figure 5).

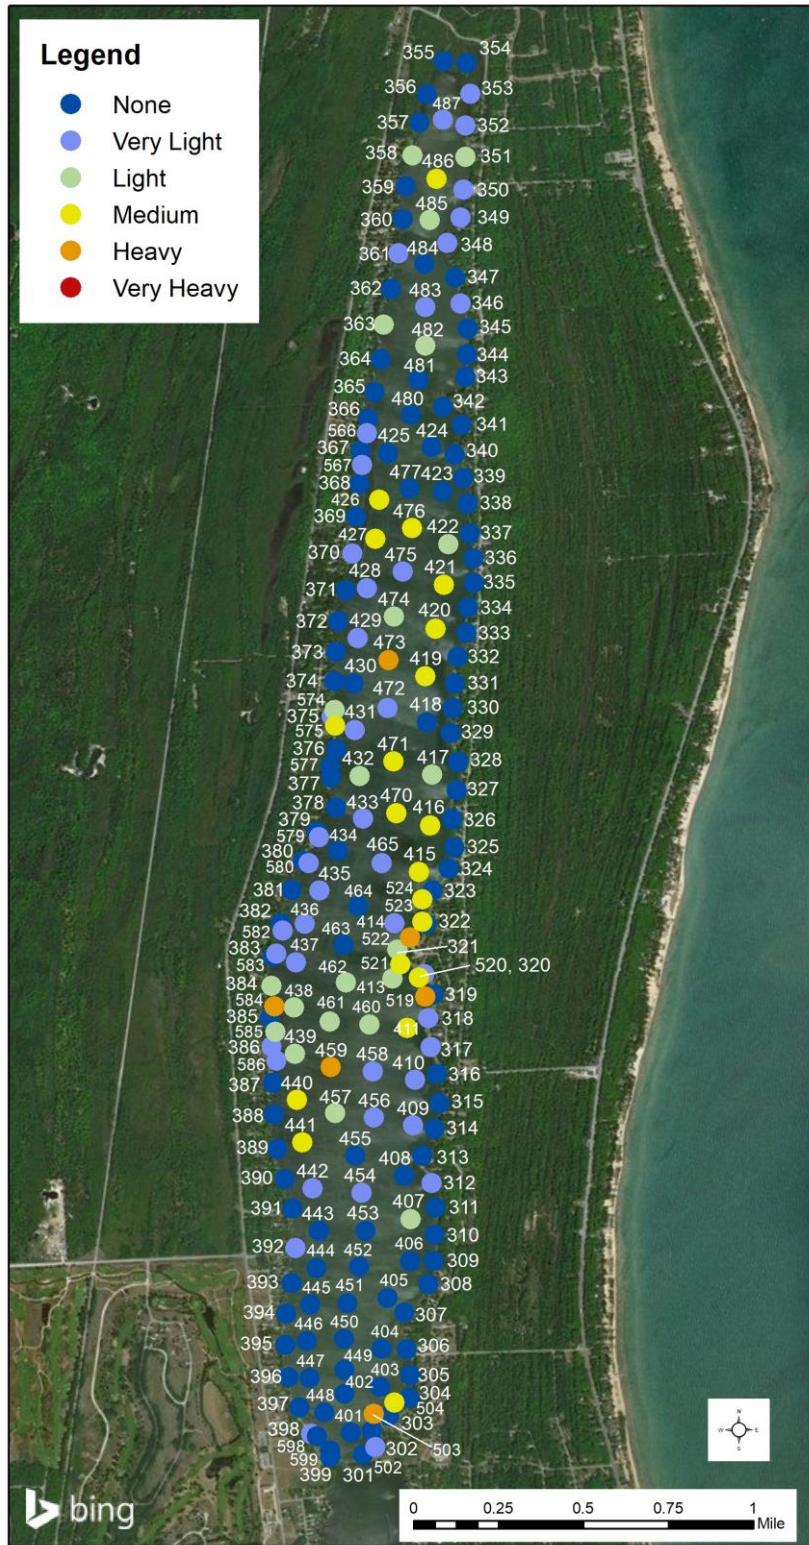
Figure 6 – Early season (June 30th & July 1st) Variable Watermilfoil coverage.

Desirable native aquatic vegetation observed during the early-season survey included Chara (*Chara sp.*), variable pondweed (*Potamogeton gramineus* L.), variable watermilfoil (*Myriophyllum heterophyllum* Michaux), clasping leaf pondweed (*Potamogeton richardsonii* (Benn.) Tydb.), and naiad (*Najas sp.*). Variable watermilfoil exhibited dense growth and medium to heavy coverage, creating recreational nuisance conditions in Tier 3, 4, and 5 AROS (Figure 6). Pondweeds exhibited some recreational nuisance conditions in a few of the Tier 3 and 4 AROS.

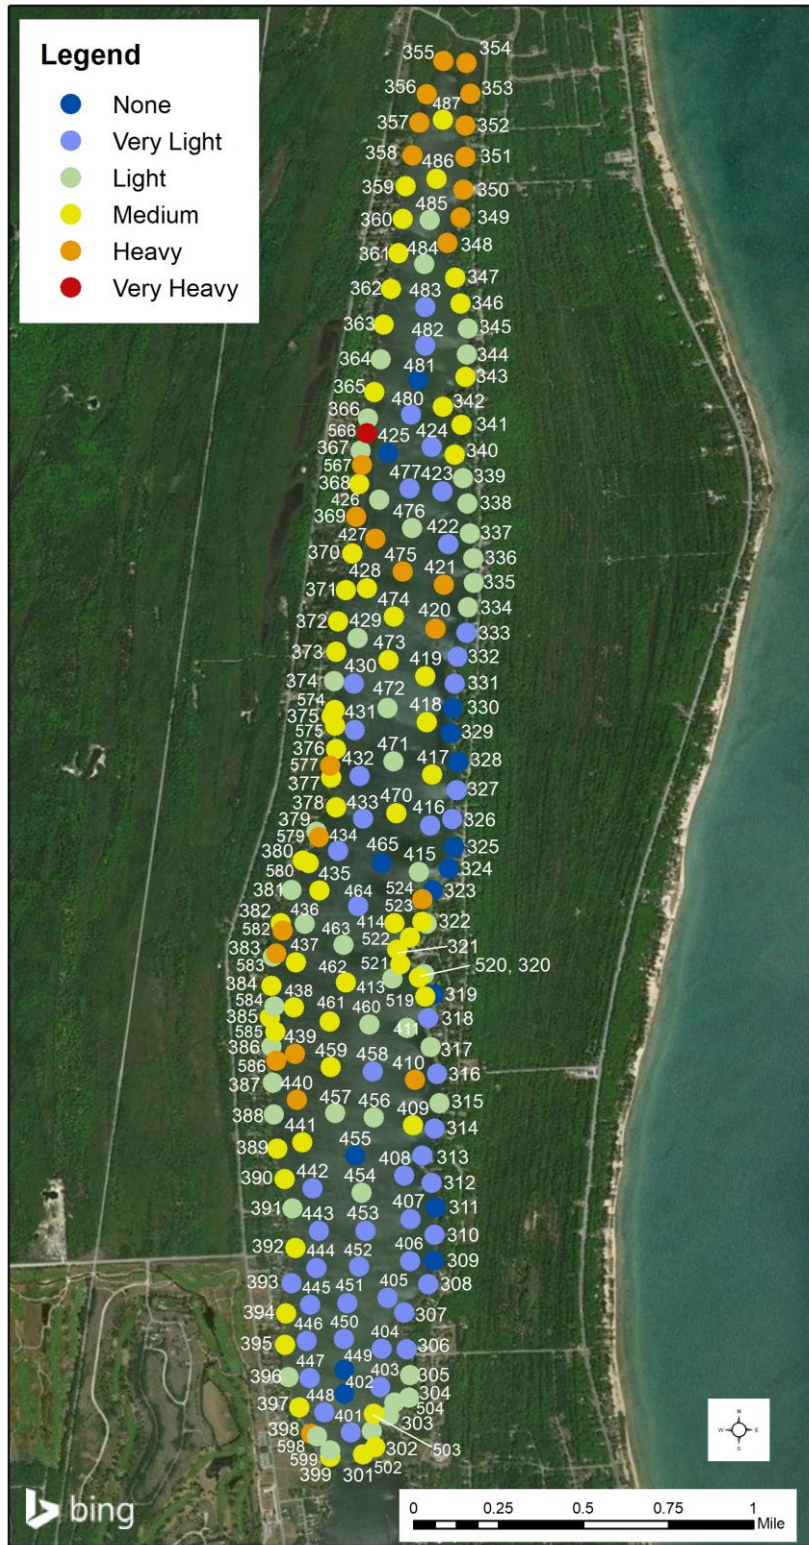
Figure 7 – Late season survey (August 19th & 20th) vegetation 3D Density (a function of all species observed vegetation density, distribution and height observations).

The late-season LakeScan™ vegetation survey of Cedar Lake North was conducted on August 19th and 20th. Air temperatures were approximately 70°F on August 19th, with south to east-southeastern winds varying from 3-10mph, with good visibility. Air temperatures were approximately 80°F on August 20th, with south-southwestern winds increasing throughout the day to a max of 14mph. Water temperatures ranged from 74.8°F at the surface to 73.6°F at 9 feet bottom depth. Visibility through the water column was fair, becoming poorer in the afternoon, with a recorded Secchi disk depth of 8.2ft. Figure 7 depicts data on all combined species using three-dimensional density, which reflects a combination of vegetation density, distribution and height observations of all species observed on Cedar Lake North during the late-season survey.

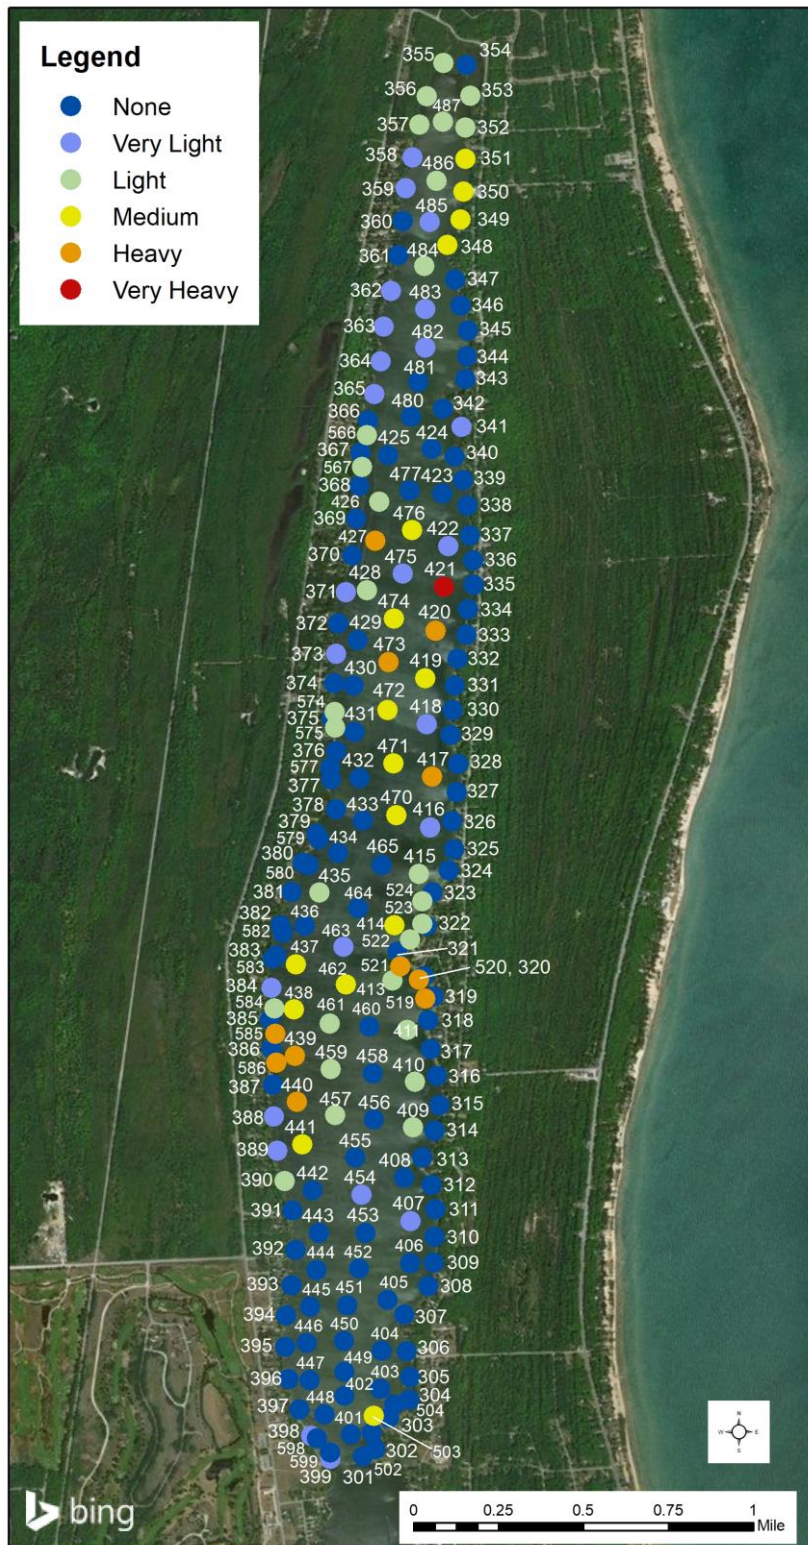
Figure 8 – Late season (August 19th & 20th) Variable Watermilfoil coverage (a combination of the LakeScan™ density and distribution observations).

Variable watermilfoil was observed throughout Cedar Lake North at widely varying densities and distributions, from small single patches to very large groupings (Figure 8). Variable watermilfoil observed in Tier-3 AROS tended to exhibit light to medium coverage. In the Cedar Lake North trenches, variable watermilfoil was observed at medium-heavy coverage in AROS 503, 585, 586, and 519-521. Outside of the trenches, the highest variable watermilfoil coverage observations were located in AROS 417, 420, 421, 427, 440, and 473. Variable watermilfoil was not observed to be growing at the surface of the water in any AROS, although this was likely influenced in part by the substantial wave action occurring during the survey.

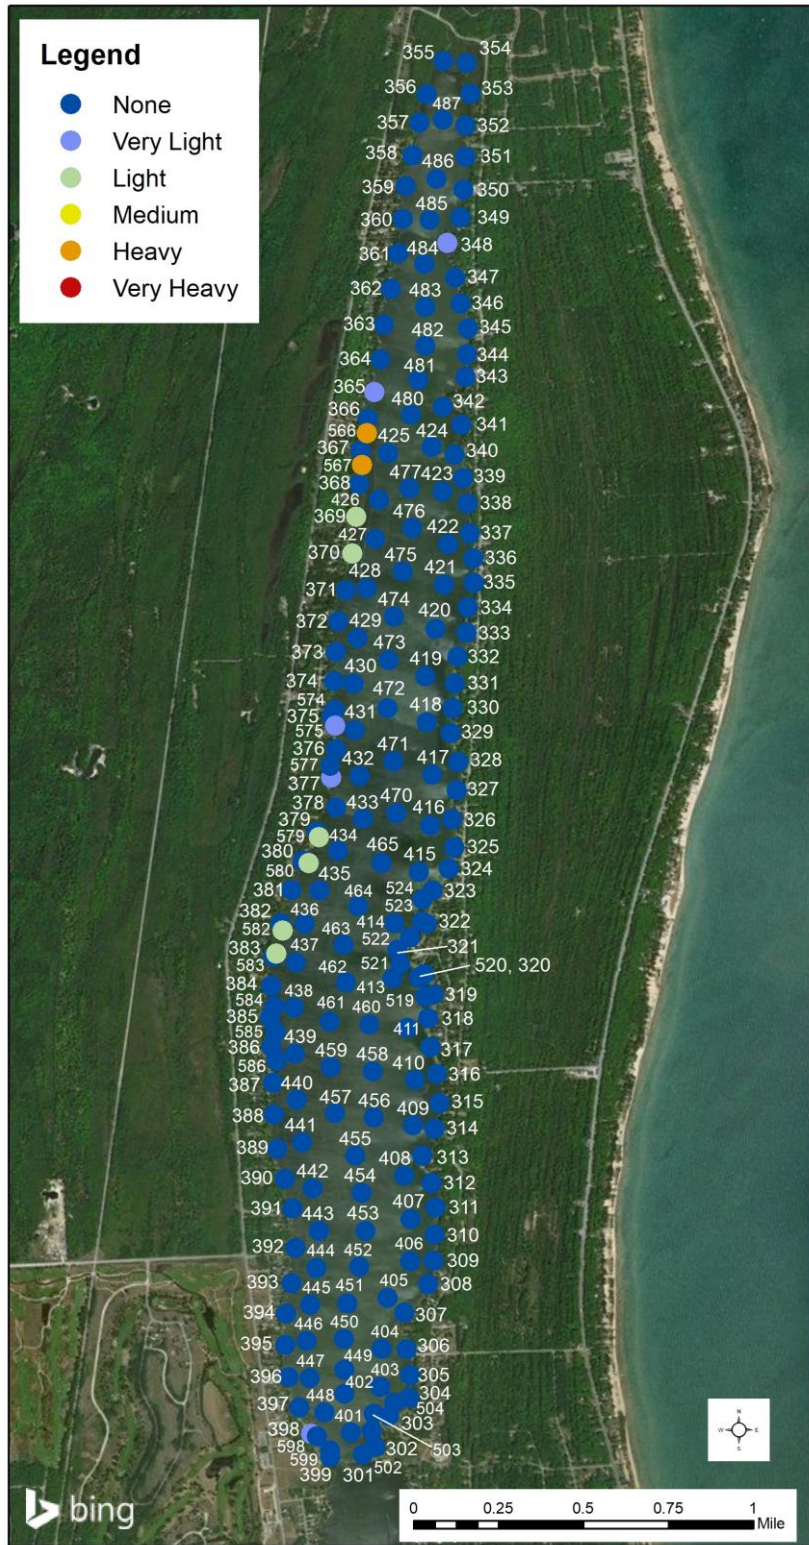
Figure 9 – Late season (August 19th & 20th) Eurasian Watermilfoil and Hybrids coverage

Ecological nuisance species detected during the survey includes Ebrid watermilfoil (Figure 9). Ebrid watermilfoil was found in several of the Cedar Lake North west-side trenches. Ebrid watermilfoil was found at heavy coverage in AROS 566 and 567 (northern-most west-side trench), dominating other species and topped-out, causing a recreational nuisance. Much smaller patches of Ebrid watermilfoil were also observed, intermixed with other species, at very-light to light coverage in AROS 369-370, 575, 579-580, and 582-583.

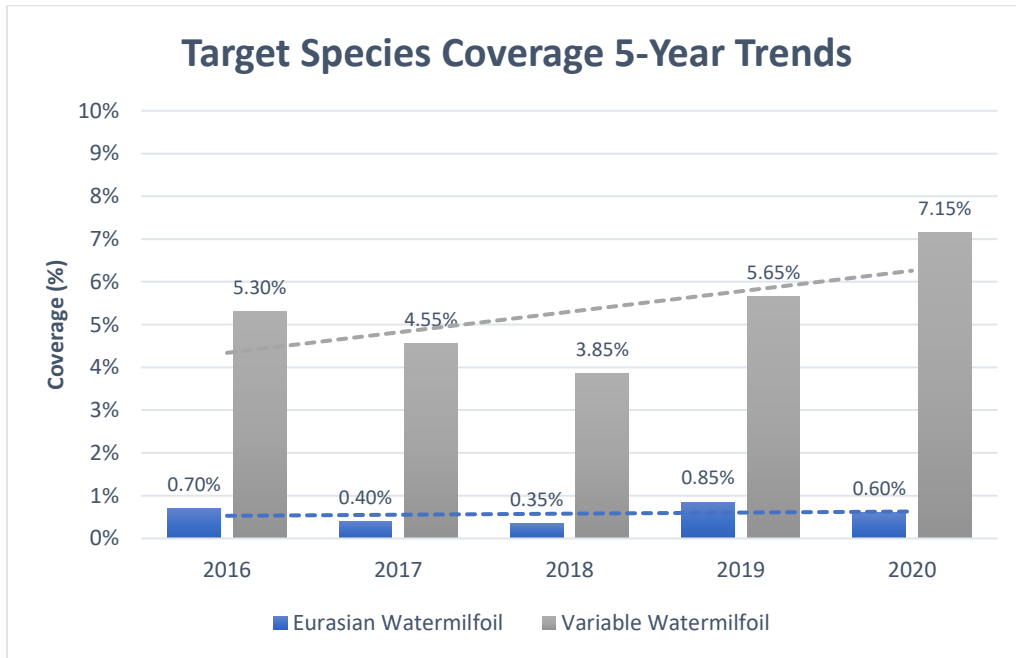
Figure 12 – Target Species Coverage 5-Year Trends.

Over the last five years, the FQI score for Cedar Lake North has exhibited a positive trend, which indicates an increase in desirable, native plant species and a decrease in undesirable, non-native plant species (Figure 11). For the last two years, Cedar Lake North’s FQI score exceeded the management goal of 20. Furthermore, Cedar Lake North’s Ebrid watermilfoil coverage has exhibited no significant trend for the last five years (Figure 12), suggesting that management activities are not decreasing Ebrid watermilfoil populations, but do appear to be suppressing any additional Ebrid watermilfoil population expansion. Variable watermilfoil, on the other hand, has exhibited a substantial increase over the last

five years (Figure 12), suggesting that periodic management activities have not kept in check nuisance coverage for this particular species.

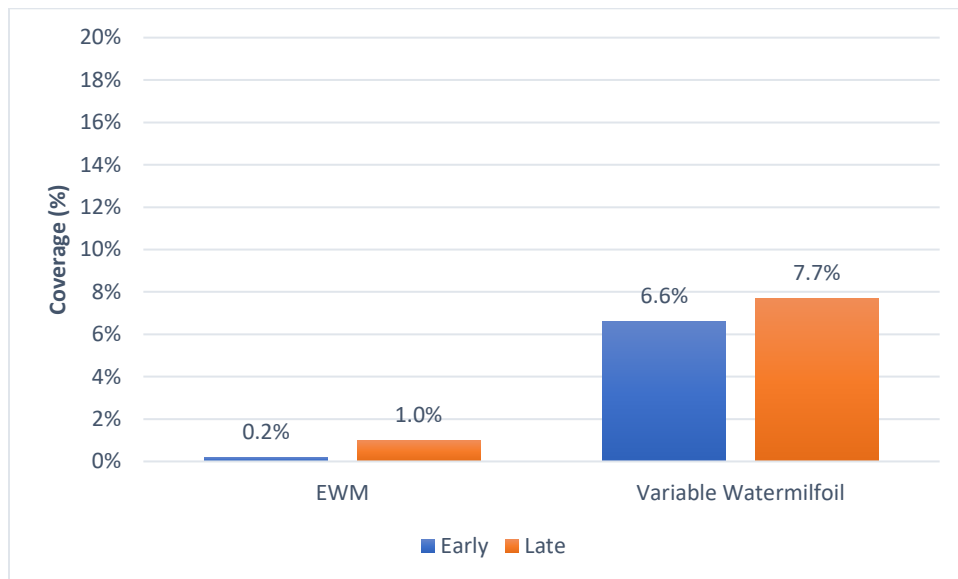
Figure 13 – Changes in coverage across both 2020 surveys for targeted species.

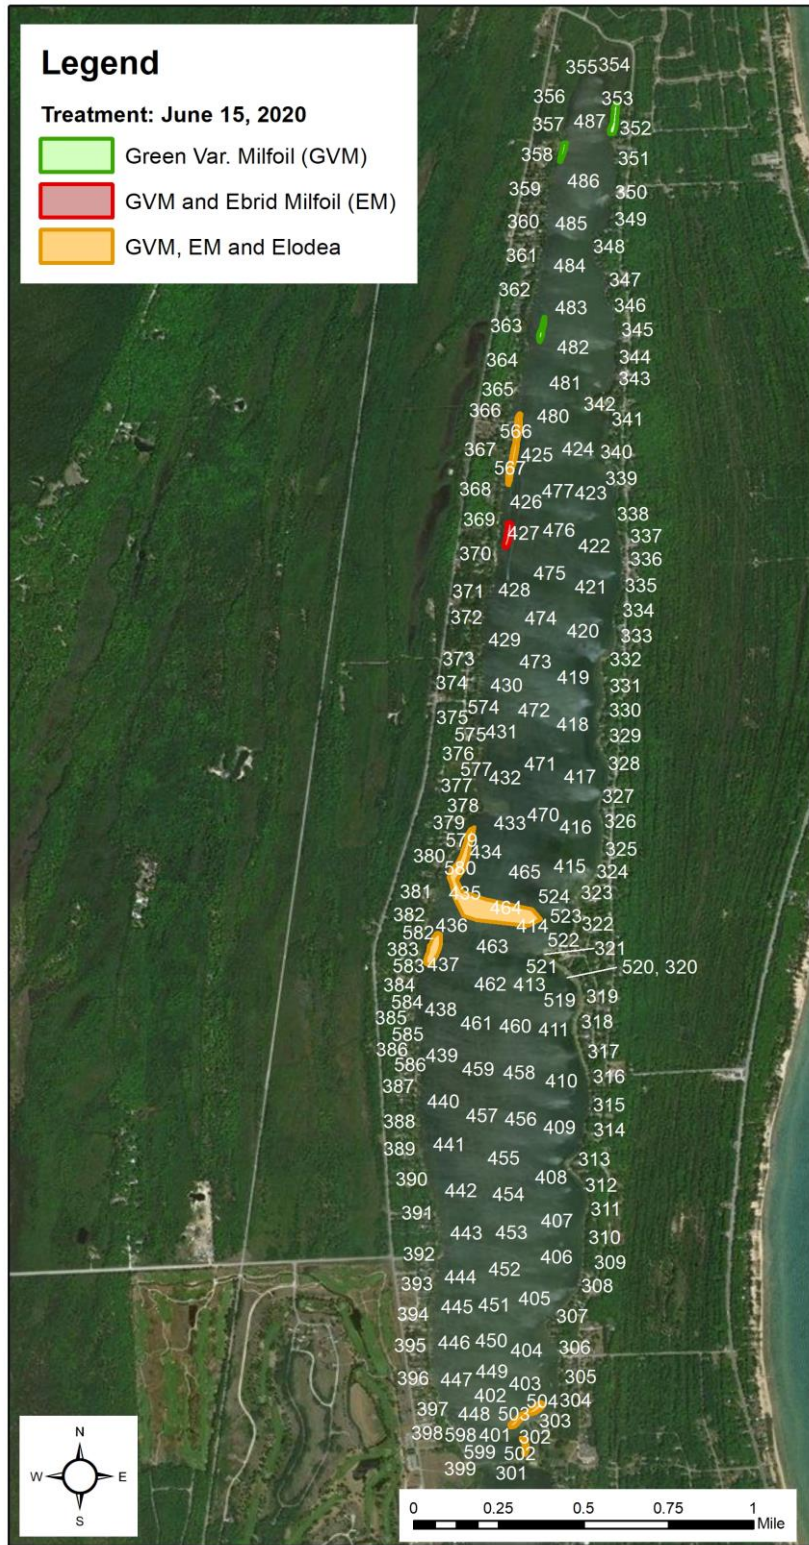
Figure 14 – June 15th, 2020 Herbicide Application Map.

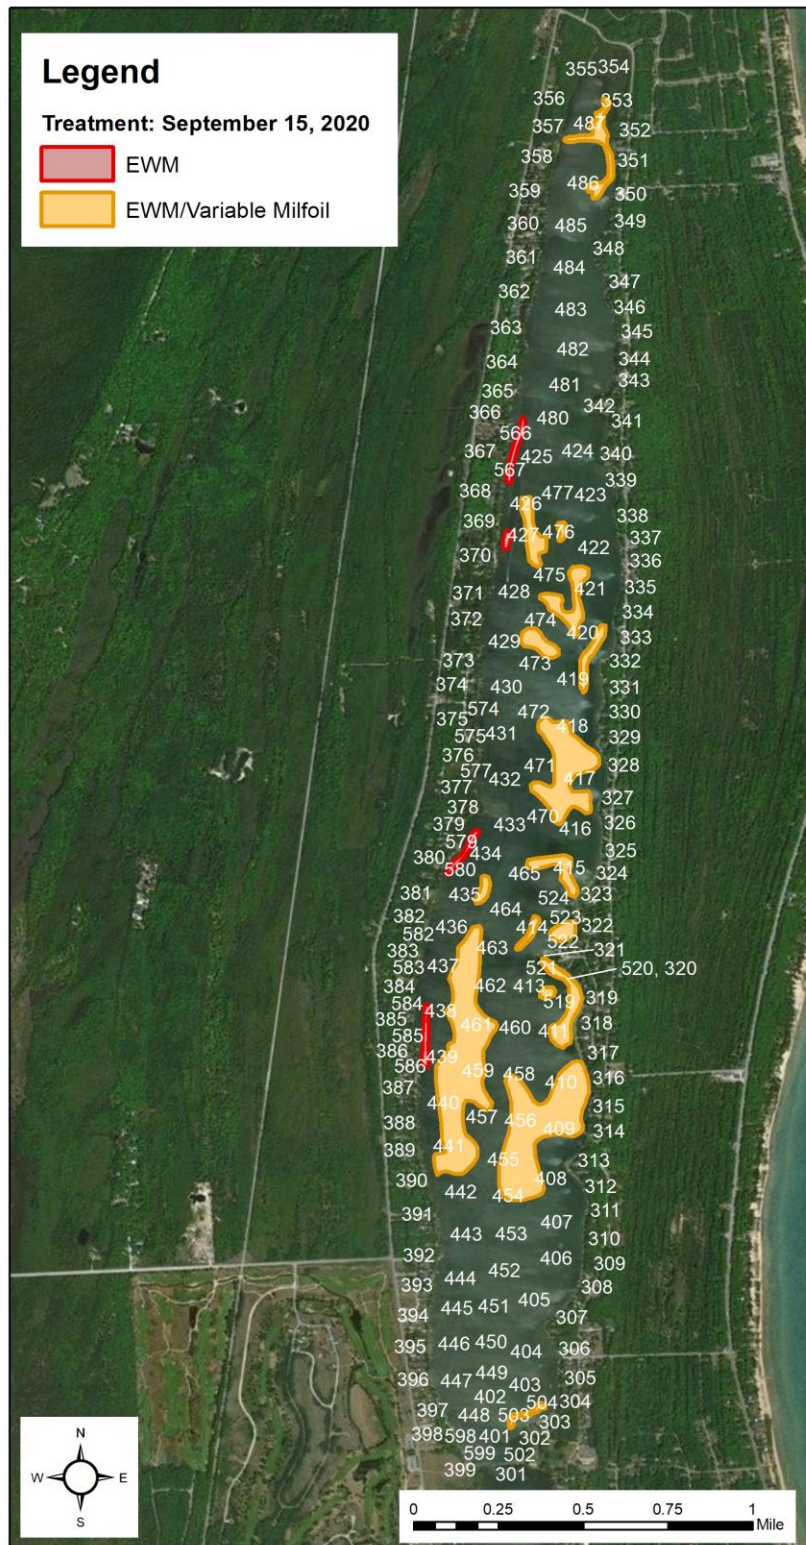
Figure 15 – September 15th, 2020 Herbicide Application Map.

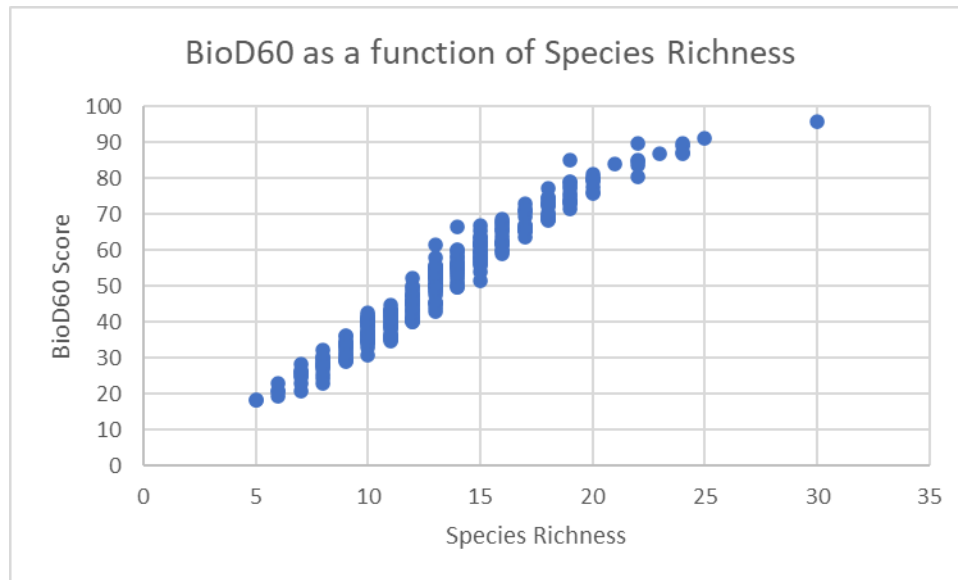
Figure A1 – BioD60 graphed as a function of Species Richness.

Our secondary concern with the BioD60 index lies with its functionality. Biodiversity indices are typically a combination of species richness (the number of different species present in an ecosystem) and species evenness (how evenly these species are distributed throughout the ecosystem). For example, an ecosystem with 20 species would have a very low evenness if one species accounted for 99% of the individuals in the ecosystem. Expanding on this point, it would be difficult to claim that a lake had good biodiversity if 99% of its plants were milfoil, no matter how many other species comprised the remaining 1%. Dr. Pullman created the BioD60 metric in part because he felt that the commonly used Shannon index weighed evenness too heavily. However, in K&A's opinion, BioD60 has skewed things back too far towards species richness, to the point where species richness is almost entirely responsible for the BioD60 score (see Figure A1 below).

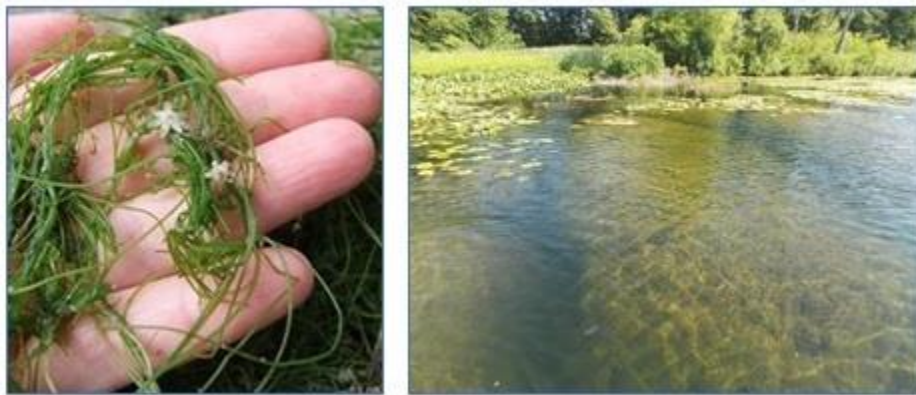
Figure B2: Example starry stonewort images from the 2019 LakeScan™ field crew.

Starry stonewort chemical treatments using copper-, diquat- and endothall-based algaecides have produced mixed results and long-term management has yet to be achieved using chemical biocides alone.¹⁴ While starry stonewort is susceptible to most selective algaecides, the dense mats of vegetation are very difficult to penetrate and provide reasonable biocide exposure. Consequently, multiple algaecide applications may be required to “whittle down” dense starry stonewort growth if the mats reach sufficient height.

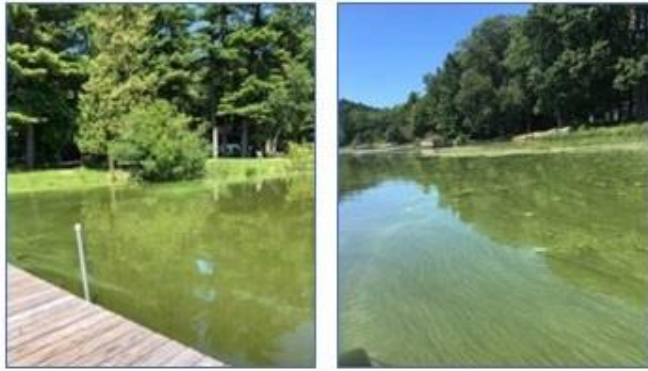
Figure C1: Example blue green algae images from the 2019 LakeScan™ field crew.

Blue green algae are really a form of bacteria known as cyanobacteria. They are becoming an important issue for lake managers, riparian property owners and lake users because studies have revealed that substances made and released into the water by some of these nuisance algae can be toxic or carcinogenic. They are known to have negative impacts on aquatic ecosystems and can potentially poison and sicken pets, livestock, and wildlife. Blue green algae can have both direct and indirect negative impacts on fisheries. Persons can be exposed to the phytotoxins by ingestion or dermal absorption (through the skin). They can also be exposed to toxins by inhalation of aerosols created by overhead irrigation, strong winds, and boating activity.
