A Summary of Findings from LakeScan™
Guided Surveys and Analysis of:

Cedar Lake North

2025 DATA AND ANALYSIS SUMMARY REPORT WITH MANAGEMENT RECOMMENDATIONS

March 24, 2026

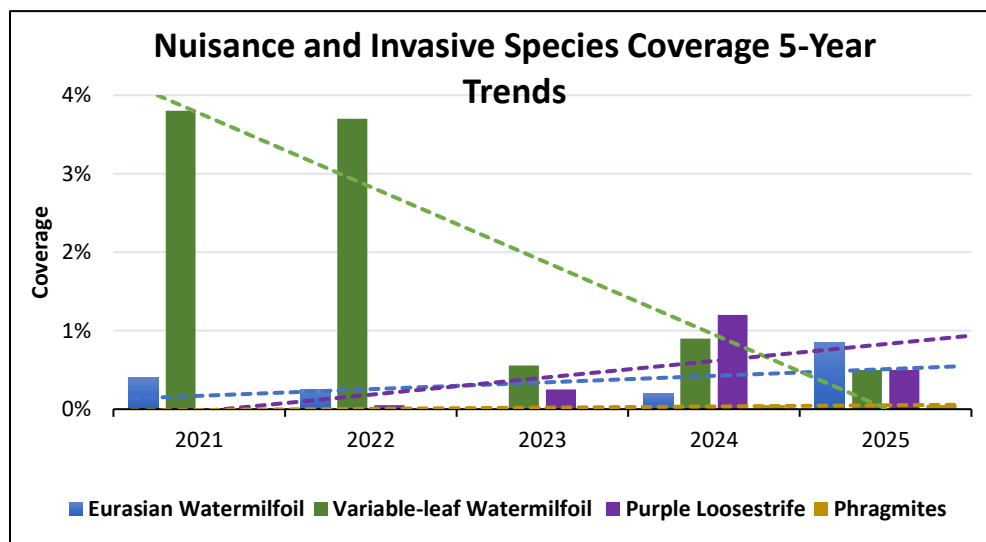
Over the last five years, coverage of variable-leaf watermilfoil (*Myriophyllum heterophyllum*), a native species known to cause nuisance concerns on the lake, has exhibited a declining trend. Coverage of Eurasian watermilfoil, purple loosestrife, and *Phragmites* have, however, exhibited increasing trends (Figure ES-1). Coverage of variable-leaf watermilfoil has decreased by 3% since 2021, remaining consistently under 1% coverage across the last three years. Invasive Eurasian watermilfoil coverage has likewise remained consistently under 1% over the past five years, but the coverage increased by 0.6% in the last year, and was at its highest observed average coverage since 2019. It is important to note that the early-season survey occurred before the first herbicide treatment, which could have influenced the calculated increase in average coverage observed in 2025. If Eurasian watermilfoil coverage continues to increase in future surveys, alternative management options may need to be explored. Although the trendlines indicate coverage increases, purple loosestrife and *Phragmites* have remained at relatively low coverages with purple loosestrife declining 0.5% from 2024 (despite no targeted treatments), and *Phragmites* having almost negligible coverage of 0.05% across the last two years. *Phragmites* spot treatments started in late 2024 and were expanded in 2025.

Figure ES-1 – Nuisance and invasive species average yearly coverage 5-year trends.

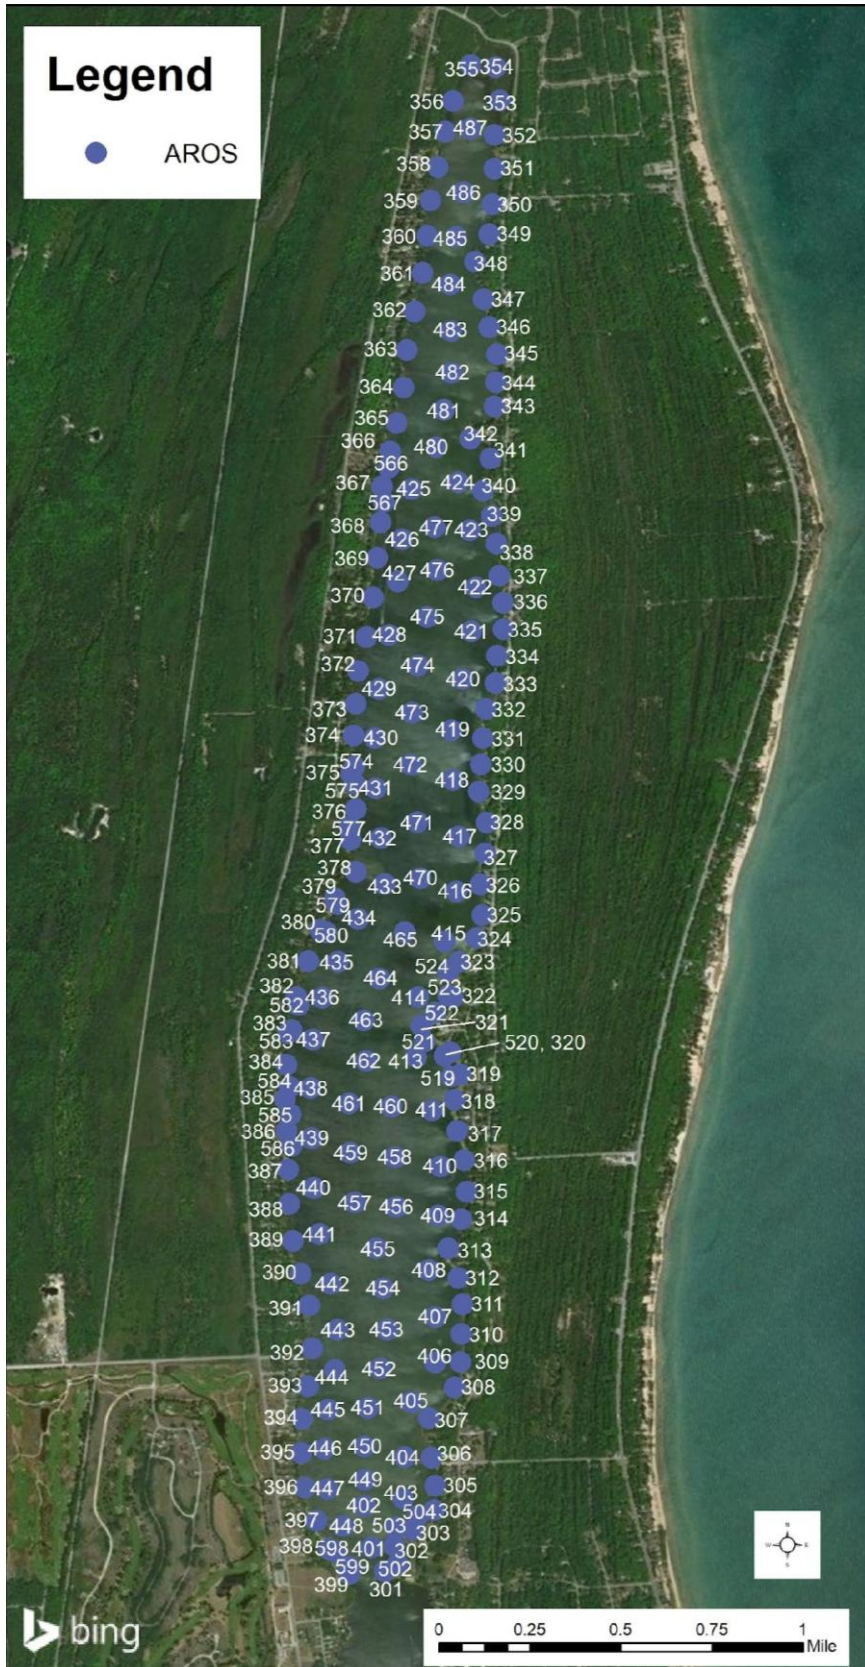
The LakeScan™ analysis involves collecting data over two vegetation surveys during the critical summer recreational season. These surveys are based on a system where the lake is first divided into vegetation growth areas based on bathymetry then further subdivided into Aquatic Resource Observation Sites (AROS; Figure 1). AROS numbers on Cedar Lake are represented with 300s at the shoreline, 400s off the shoreline, and 500s in excavated trenches or holes.

Figure 1 - Map of Aquatic Resource Observation Sites (AROS).

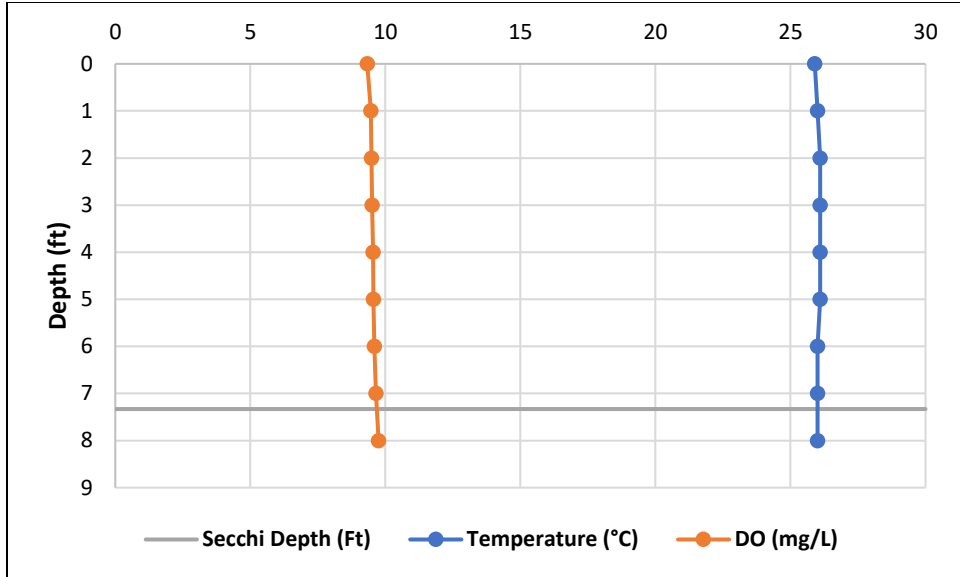
Secchi disk clarity on Cedar Lake North decreased from 7.3 ft to 6.5 ft between the early and late-season surveys. This decrease in water clarity could likely be attributed to a slight increase in lake productivity later in the growing season, wave and sunlight conditions, and/or an increase in turbidity caused by sediment disturbance from swimming, boating, and other recreational activities increasing throughout the summer. The DO and temperature profiles remained consistent across the two surveys with no notable stratification (Figures 2 and 3). This is to be expected due to the shallow depths of the lake. The only notable difference between the two profiles was the 5 °C lower temperatures observed in the late-season.

Figure 2 – Early-season survey (7/2/25) dissolved oxygen and temperature profiles with Secchi depth.

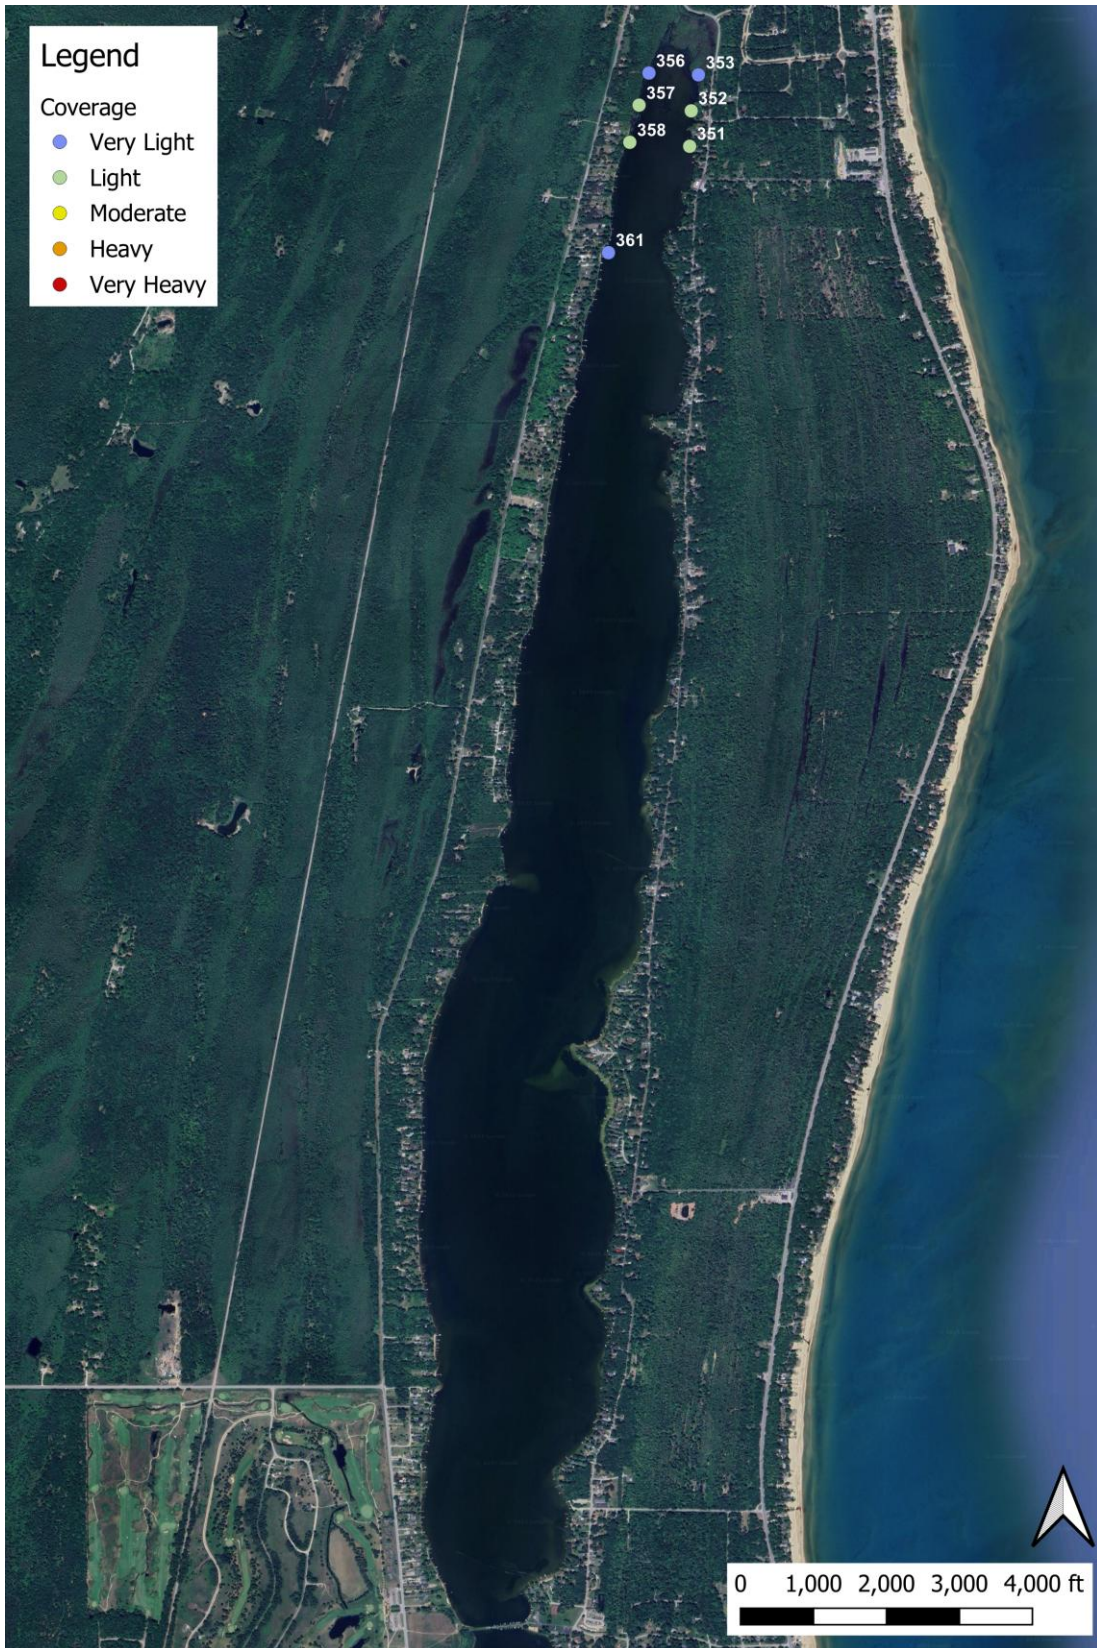
Broadleaf pondweed and Richardson's pondweed were observed at moderate densities around the lake, often flowering, but typically not dense enough to cause any nuisance concerns. In some shoreline and nearshore AROS, flowering pondweeds may have caused some minor recreational nuisance conditions, but were expected to likely drop from the water column after flowering. Vegetation growth was the densest in the excavated trenches (#500 AROS) which were typically dominated by *Chara*, American elodea (*Elodea sp.*), naiad (*Najas sp.*), sago pondweed (*Stuckenia pectinatus*), and Richardson's pondweed (Figure 4). Variable-leaf watermilfoil, which has caused nuisance concerns on the lake in the past, was noted sporadically across the northern portion of the lake in low densities (Figure 5).

Figure 5 – Early-season (7/2/25) Variable-leaf watermilfoil coverage (a combination of the LakeScan™ density and distribution observations).

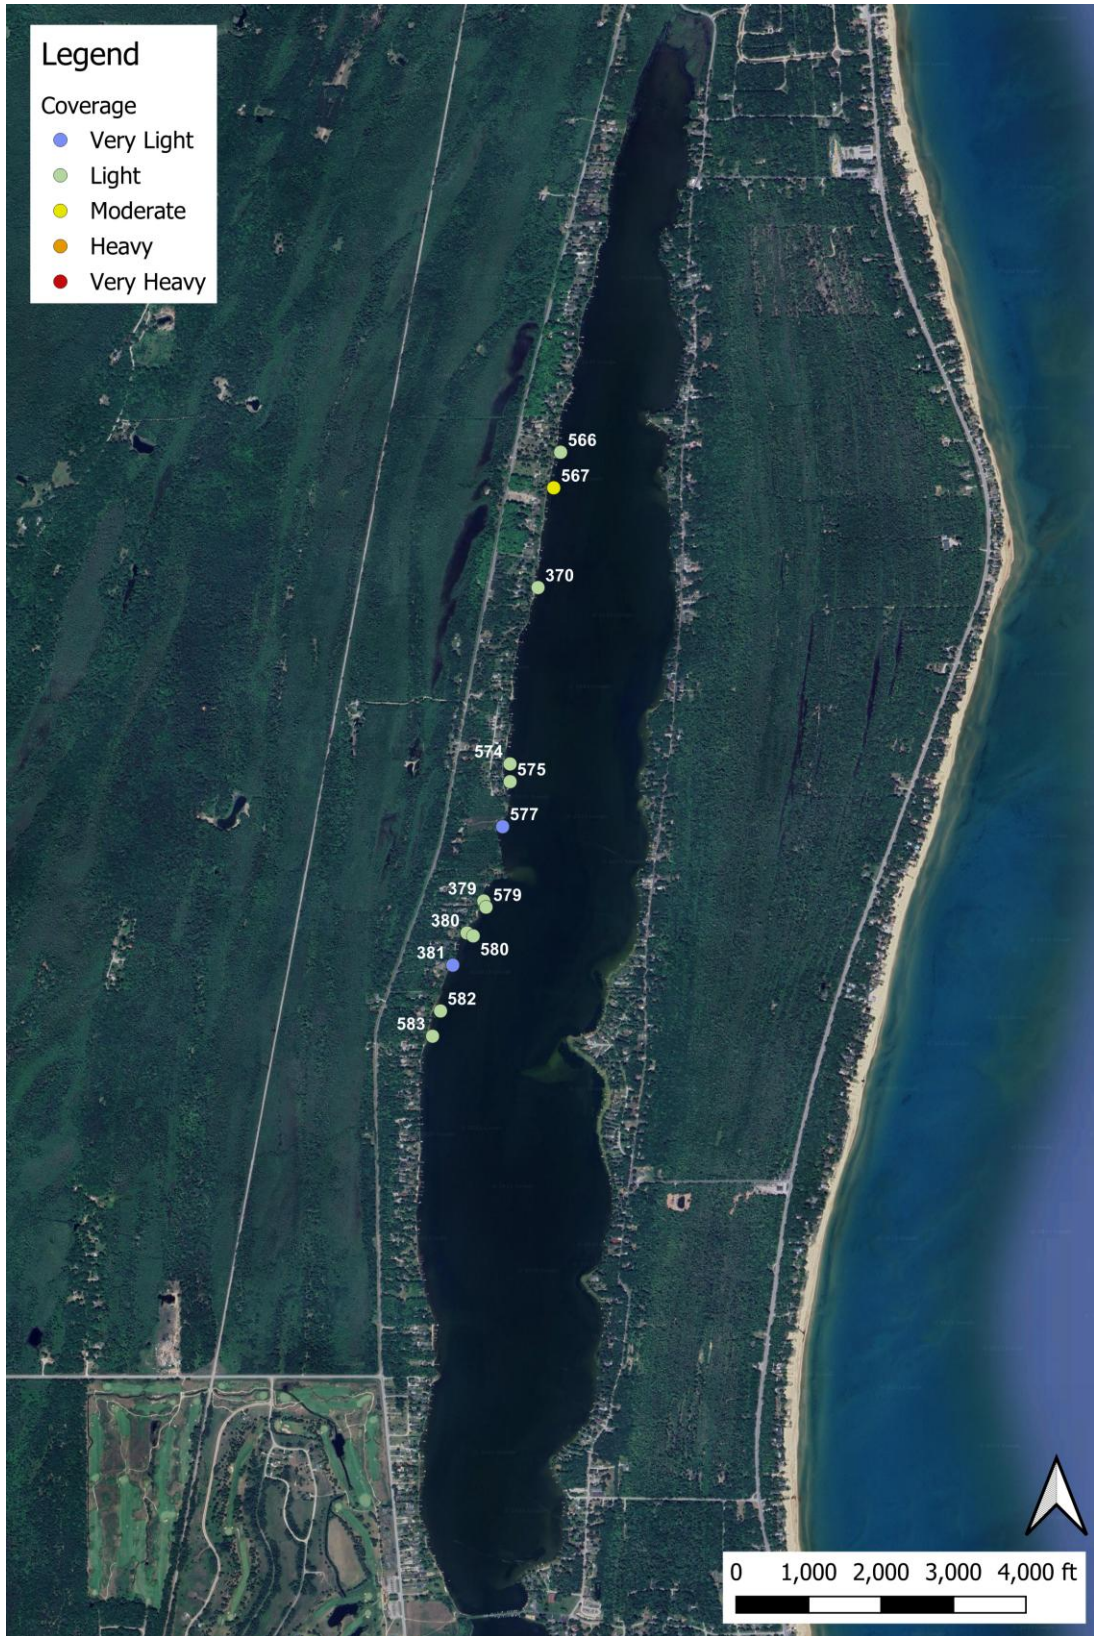
The only submerged aquatic invasive species observed in Cedar Lake North during the 2025 early-season survey was hybrid Eurasian watermilfoil. Hybrid Eurasian watermilfoil was found in single stand-alone clusters in AROS 370 and 379-381. In AROS 379-381 the milfoil appeared to be advancing shoreward out of the AROS 579-580 trench. Eurasian watermilfoil was additionally found in the trenches along the western portion of the lake (AROS 566, 567, 574, 575, 577, 579, 580, 582, 583; Figure 6). It is important to note that these observations occurred before the first herbicide application of the year, so treatment impacts on the species were not yet observed.

Figure 6 – Early-season (7/2/25) hybrid Eurasian watermilfoil coverage.

Eurasian watermilfoil coverage has remained under 1% in across the last 3 years, indicating that although there have been some minor coverage increases, current management interventions appear to be effective at suppressing growth and reducing the cumulative coverage of nuisance presence on a broader temporal scale. Despite less than 1% coverage in 2025, Eurasian watermilfoil displayed a slight increase in coverage over the past year, indicating the possibility of species rebound. A late-season rebound of Eurasian watermilfoil was also observed in the trenches following treatment. Based on these observations, it is recommended that the Cedar Lake Improvement Board explores management options similar to the ones implemented in 2024 where Eurasian watermilfoil was less evident in the trenches following treatment.

In previous years, ProcellaCOR applications in Cedar Lake North appeared to have been an effective strategy for the management of nuisance hybrid Eurasian watermilfoil. However, applications in 2025 did not include ProcellaCOR and post-treatment rebound of the species was observed in the trenches, indicating that the herbicide combination used in 2025 may be less effective than what has been used previously on the lake.

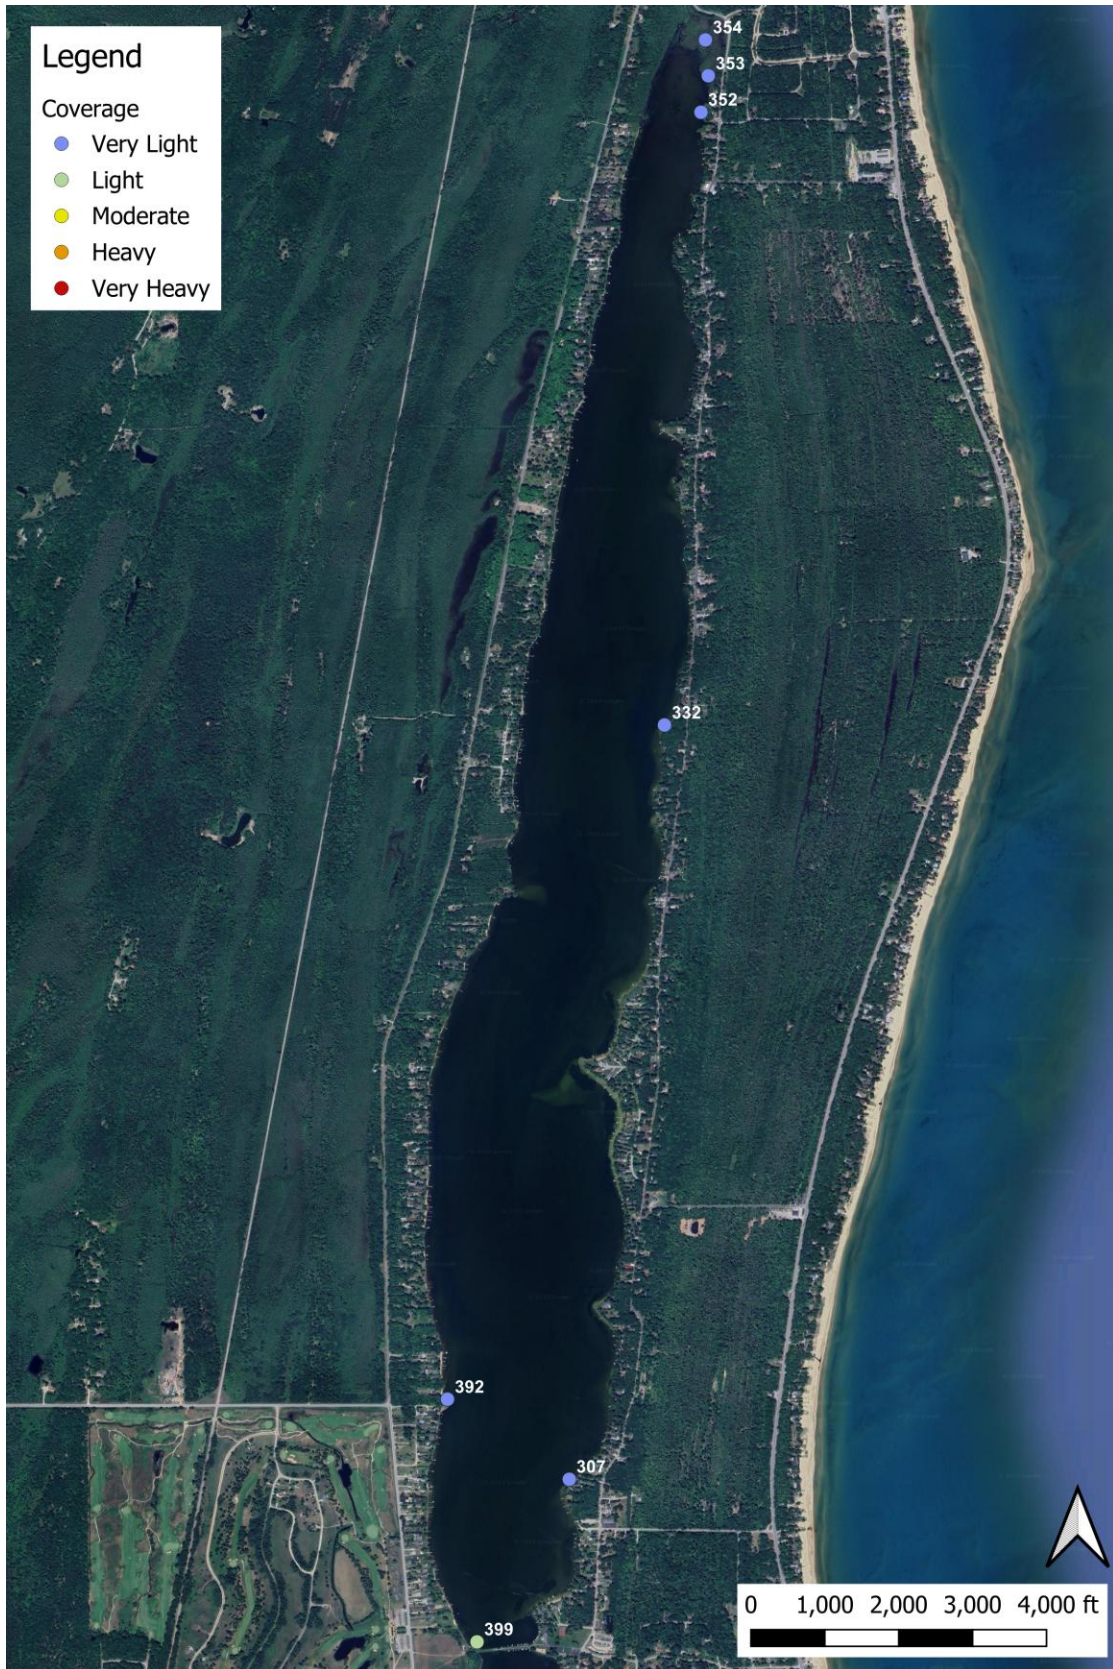
The emergent wetland invasive species purple loosestrife was found in scattered patches in AROS 307, 332, 352-354, 392, and 399, not causing management concerns at the time of the survey (Figure 7). No observations of *Phragmites* (*Phragmites australis*) could be reasonably identified from the boat survey.

Figure 7 – Early-season (7/2/25) purple loosestrife coverage.

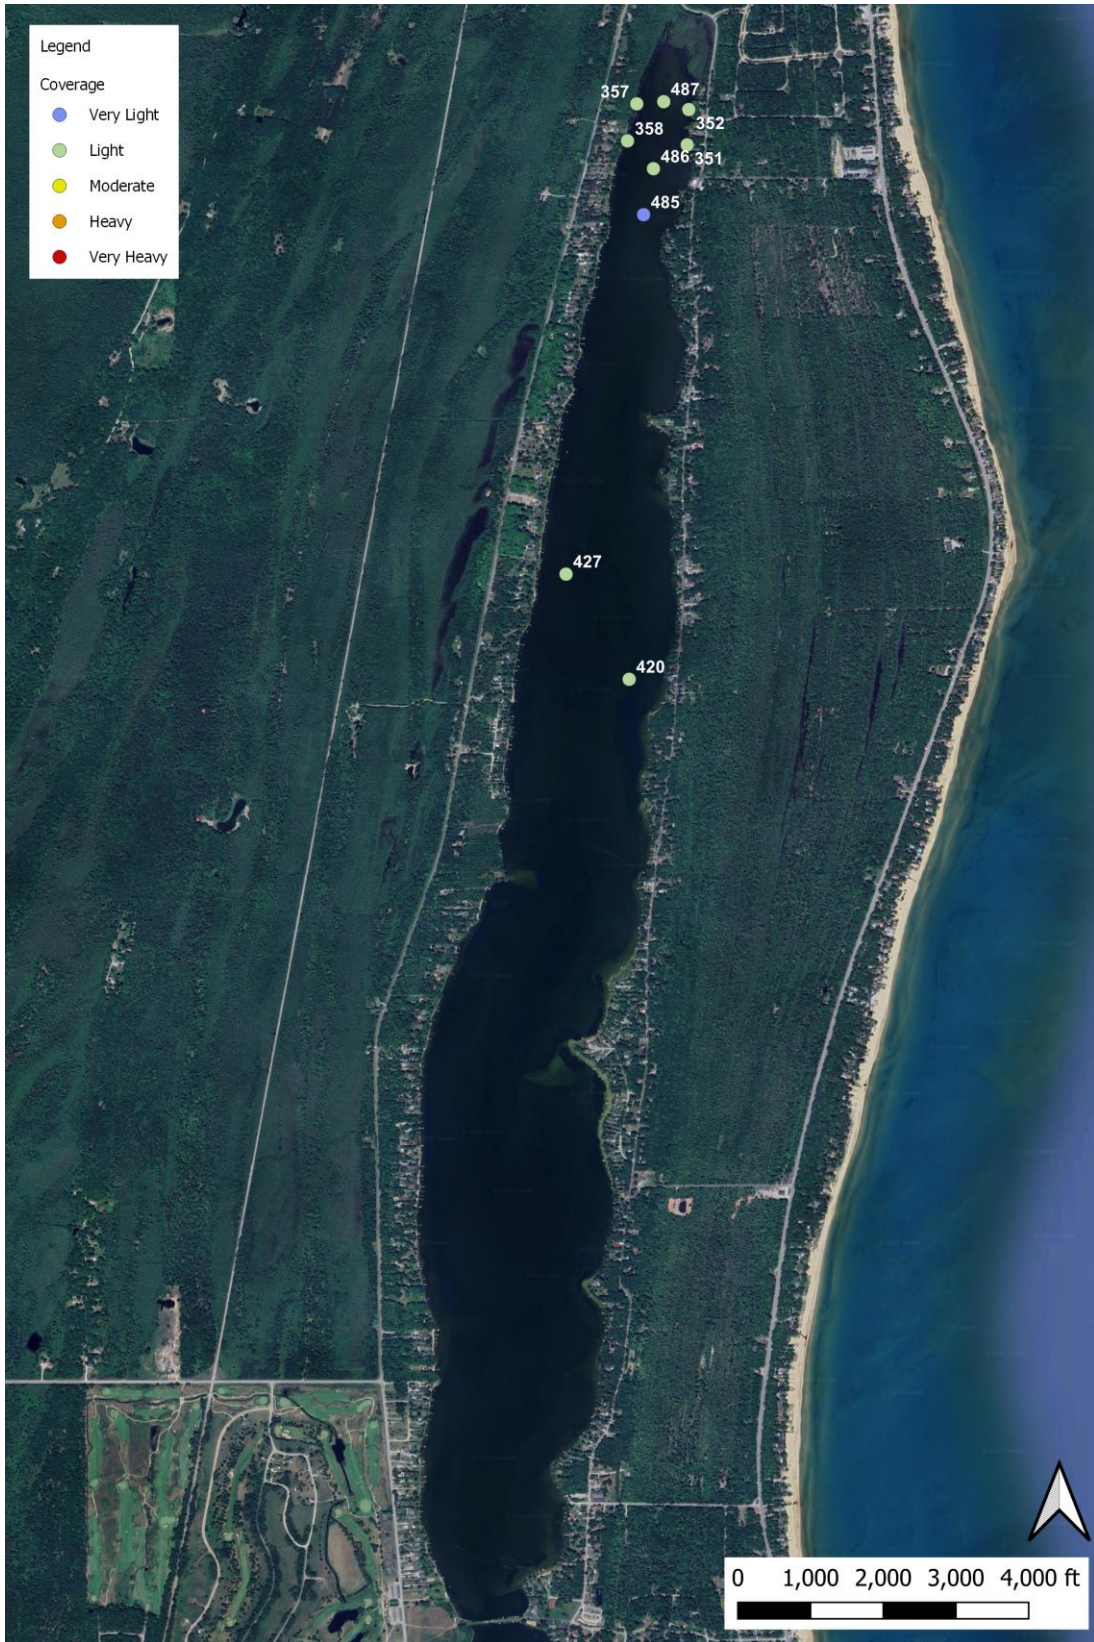
Variable pondweed, wild celery, and Richardson's pondweed were commonly found flowering throughout the lake which were noted as possible sources of minor recreational nuisance concerns; however, the species were again expected to likely to drop from the water column after flowering. Vegetation growth was again the densest in the excavated trenches (#500 AROS) which were typically dominated by *Chara*, naiad (*Najas sp.*), and Richardson's pondweed (Figure 8). Variable-leaf watermilfoil was found scattered in the northern portion of the lake in a similar distribution as the early-season survey (Figure 9).

Figure 9 – Late-season (8/26-27/25) variable-leaf watermilfoil coverage (a combination of the LakeScan™ density and distribution observations).

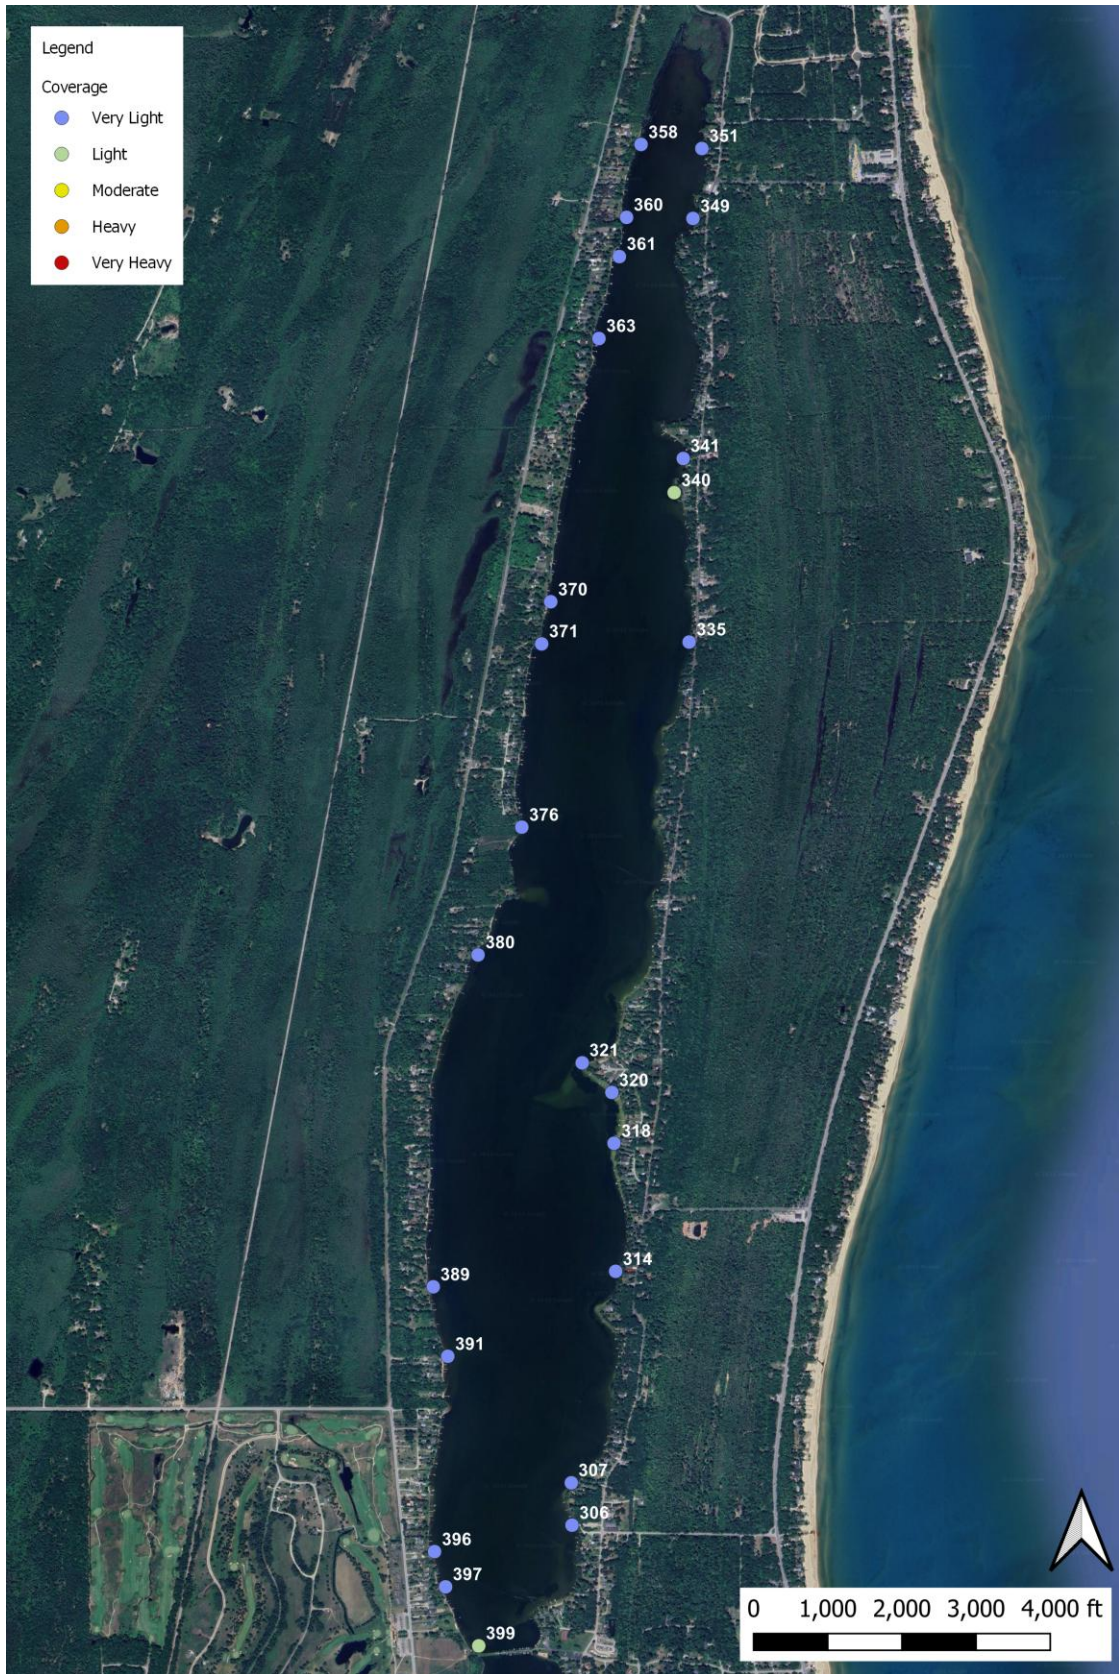
The emergent wetland invasive species purple loosestrife was found in scattered patches across the shoreline and was the densest in the natural shoreline areas at AROS 391 and 340 (Figure 11). Observations of *Phragmites* were made in AROS 377 and 361 (Figure 12). A suspected stalk of *Phragmites* was observed at AROS 343 but could not be reasonably identified from the boat.

Figure 11 – Late-season (8/26-27/25) purple loosestrife coverage.

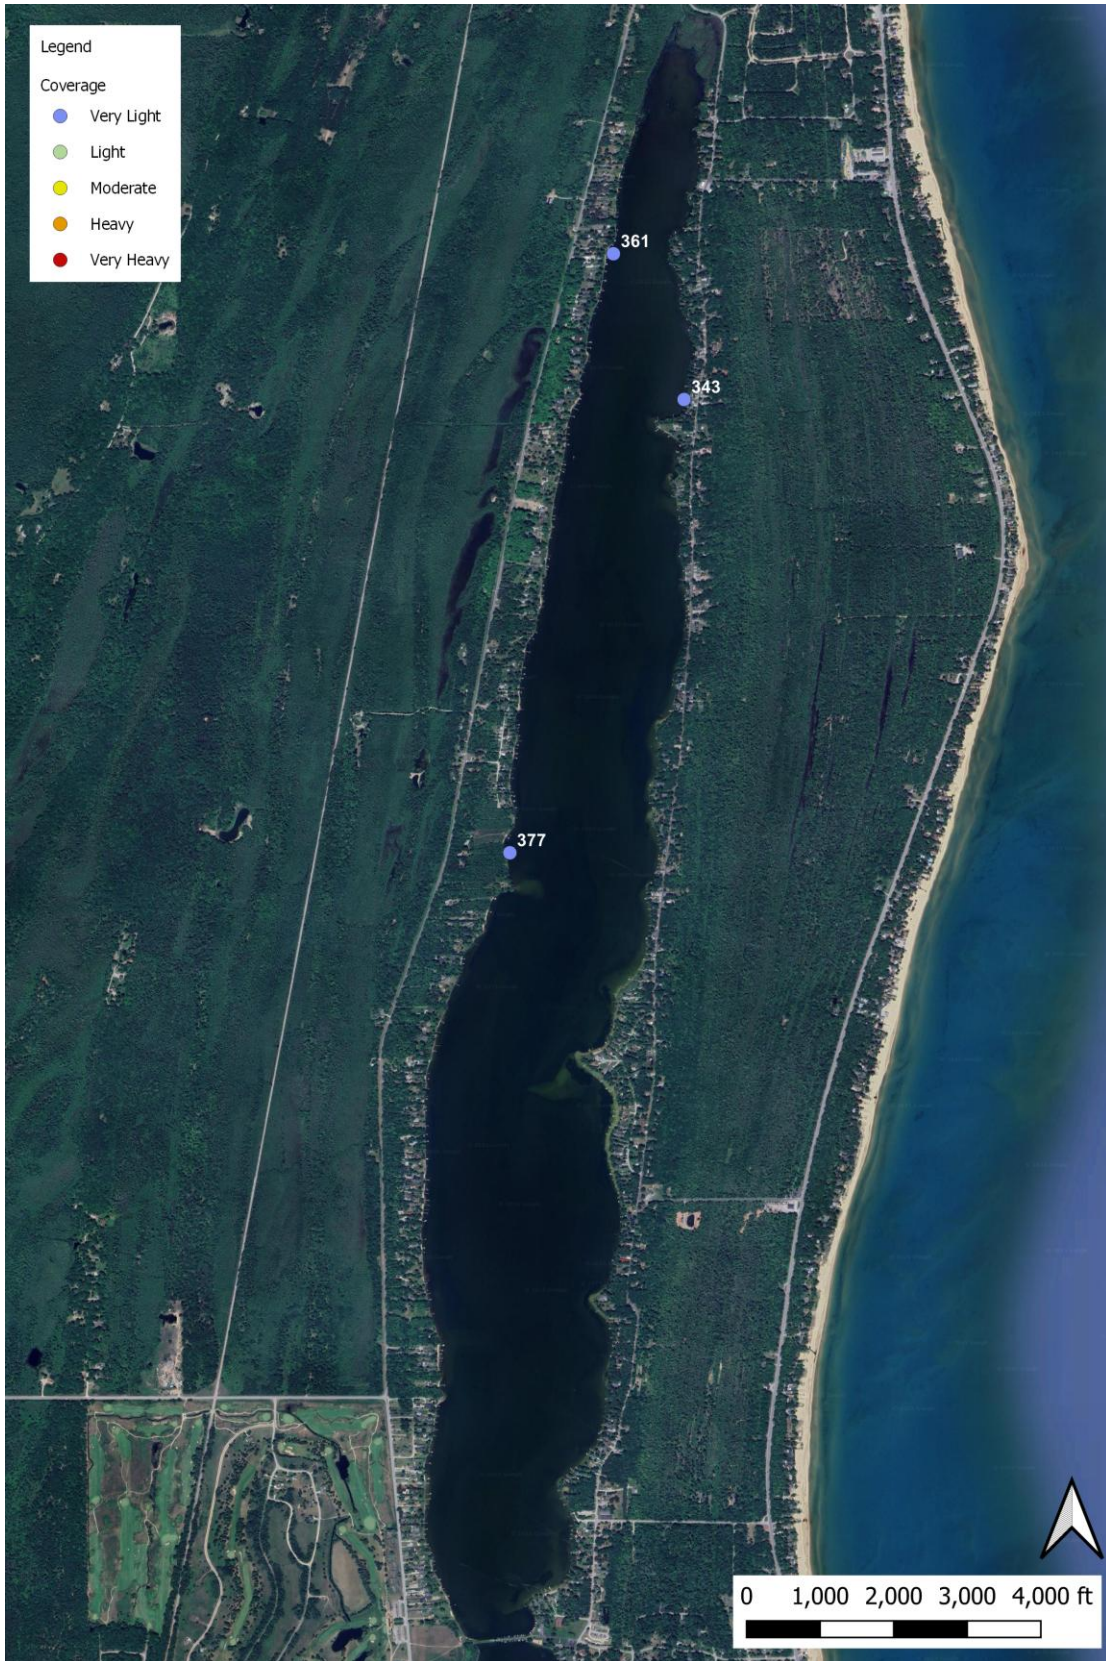
Figure 12 – Late-season (8/26-27/25) Phragmites coverage.

It will be crucial to monitor and document *Phragmites* coverage in Cedar Lake North following the treatment on September 18, 2024. Close monitoring will reveal the effectiveness of the treatment and inform if follow-up treatments are warranted. An additional on-the-ground survey of the treated areas might be pursued by the lake board to achieve reliable and accurate monitoring data on *Phragmites* populations across the landscape opposed to only along the shoreline. Given an increasing shoreline distribution of purple loosestrife (though lower in 2025 than 2024), it is recommended that the lake board consider the use of biocontrols over a few seasonal applications to manage the spread of the species following 2026 survey observations.

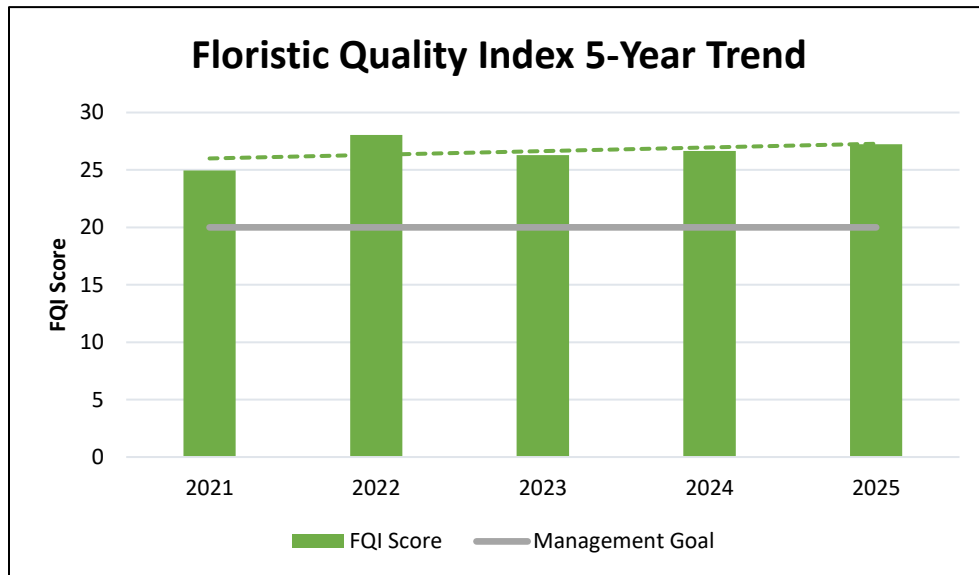
2025 marked the highest FQI score on Cedar Lake North since 2022, indicating improving trends in the ratio between native and invasive species in the lake (Figure 13). Cedar Lake North has met the FQI management score of 20 for the past the last five years, displaying a high level of floristic quality that is being maintained from year-to-year by the current management regimen.

Figure 13 – Floristic Quality Index 5-Year Trend.

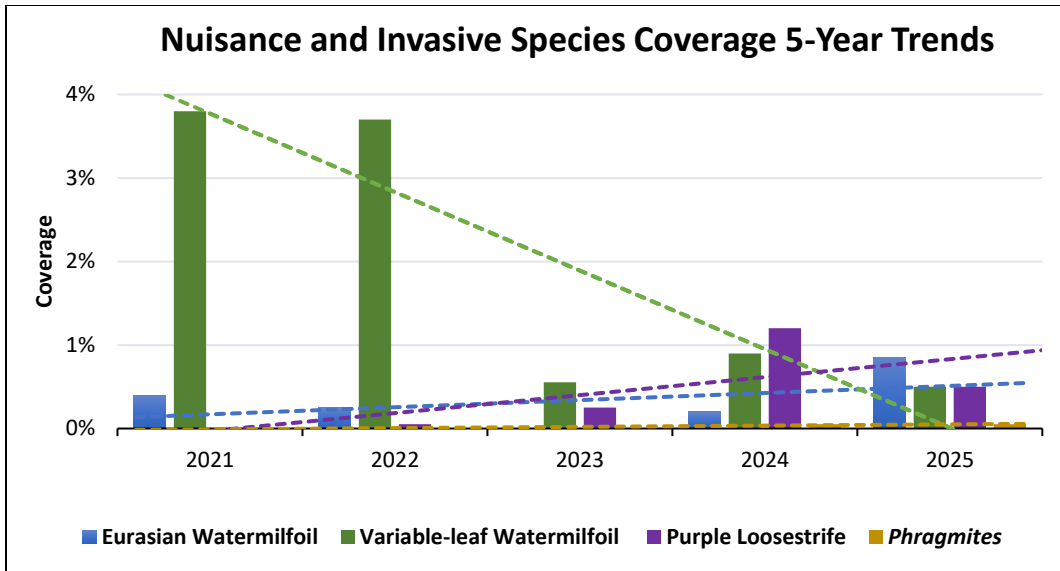
Over the last five years, coverage of variable-leaf watermilfoil has exhibited a notable declining trend. Coverage of Eurasian watermilfoil, purple loosestrife, and *Phragmites* have, however, exhibited increasing trends (Figure 14). Coverage of variable-leaf watermilfoil decreased by 3% since 2021, remaining consistently under 1% coverage across the last three years. Invasive Eurasian watermilfoil coverage has remained consistently under 1% over the past five years, but the species increased in coverage by 0.6% in the last year, and was at its highest observed average coverage since 2019. It is important to note that the early-season survey occurred before the first treatment, which could have influenced the increase in coverage observed in 2025. If Eurasian watermilfoil coverage continues to increase in future surveys, alternative management options may need to be explored. Although the trendlines indicate coverage increases, purple loosestrife and *Phragmites* have remained at relatively low coverages with purple loosestrife declining 0.5% from 2024 and *Phragmites* having almost negligible coverage of 0.05% across the last two years.

Figure 14 – Nuisance and invasive species average yearly coverage 5-year trends.

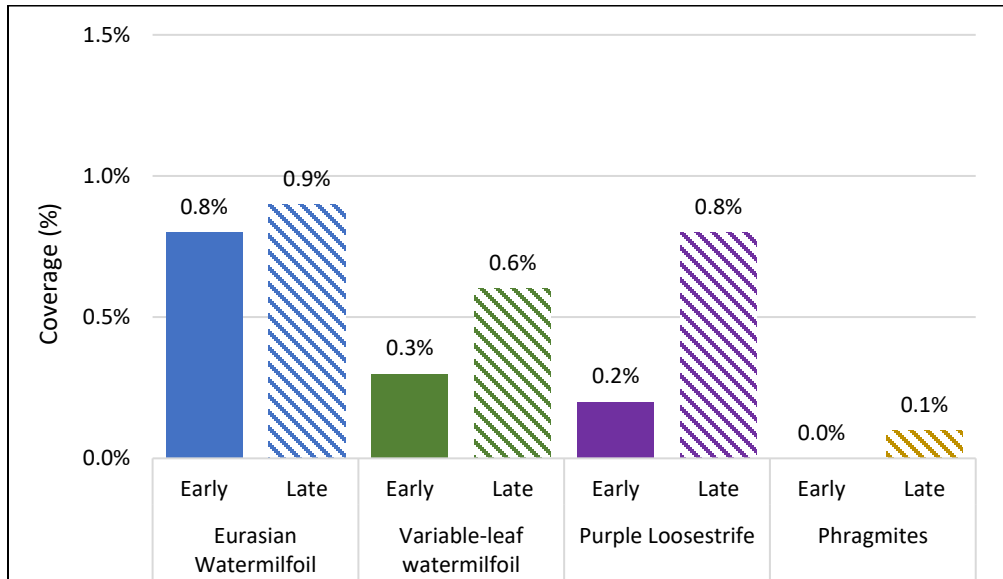
Each species of interest on Cedar Lake North increased in coverage from the early-season to the late season survey (Figure 15). The increase in Eurasian watermilfoil across the two surveys may indicate that management activities conducted on Cedar Lake in 2025, may not have had a high level of treatment

efficacy. This was also made evident by the persistence of Eurasian watermilfoil in the trenches that had been treated on July 8, 2025. No management actions were taken on the Variable-leaf watermilfoil, purple loosestrife, or phragmites prior to the surveys, so increases in species coverage could be attributed to higher plant productivity later in the growing season or the species becoming more conspicuous during the late-season survey as they flower.

Figure 15 – Changes in 2025 coverage across both surveys for targeted species.

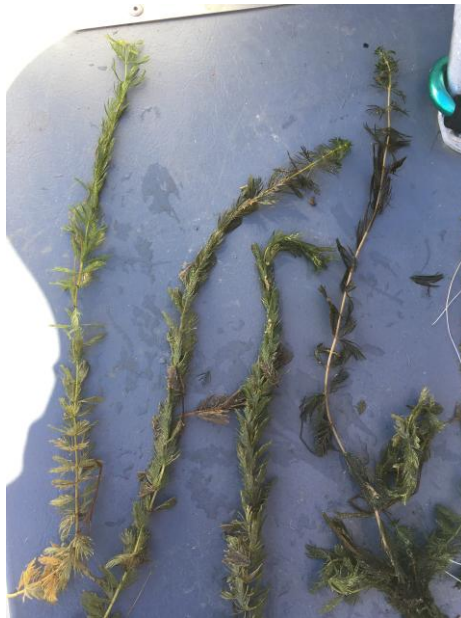
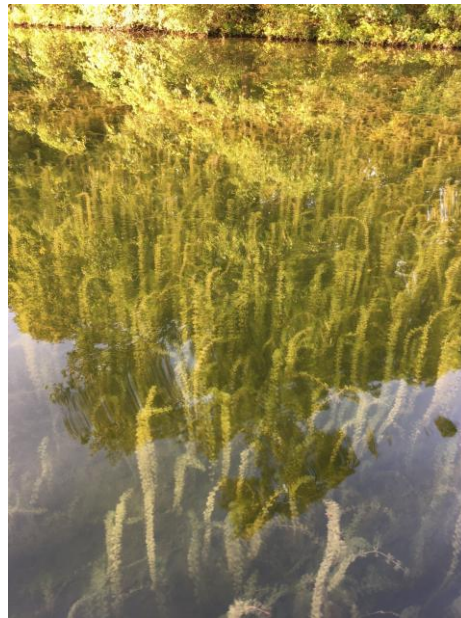
Figures A3 & A4 - Examples of Hybrid Eurasian Watermilfoil taken by K&A field staff in 2019.

Background: Anecdotal evidence suggests that hybrid milfoil has been found in Michigan inland lakes since the late 1980's. Experience has proven that it is usually not possible to determine whether the milfoil observed is either Eurasian or hybrid genotype based on phenology alone (Figures A3 and A4). However, because they play such similar roles in lake ecology, they are simply “lumped together” and referred to collectively as hybrid Eurasian watermilfoil.

Management: Lake disturbance, such as weed control, unusual weather, and heavy lake use can destabilize the lake ecosystem and encourage the sudden nuisance bloom of weeds, like Eurasian watermilfoil. Eurasian watermilfoil is a threat to the stable biological diversity of the lake ecosystem. Species selective, systemic herbicide combinations have been used to suppress the nuisance production of Eurasian watermilfoil and support the production of more desirable flora. However, the species is becoming more resistant to herbicidal treatments. Herbicide resistant Eurasian watermilfoil and hybrid watermilfoil have been observed in many lakes throughout the Midwest.^{9,10} Continued chemical applications can select for herbicide resistant plants, resulting in hybrid watermilfoil.¹¹ Some research suggests this resistance can be counteracted with the use of microbiological system treatments. Eurasian watermilfoil community genetics are dynamic and careful monitoring is needed to adapt to the expected changes in the dominance of distinct Eurasian watermilfoil genotypes. Some of these genotypes may be more herbicide resistant than others and treatment strategies must be adjusted to remain effective in different parts of the lake.

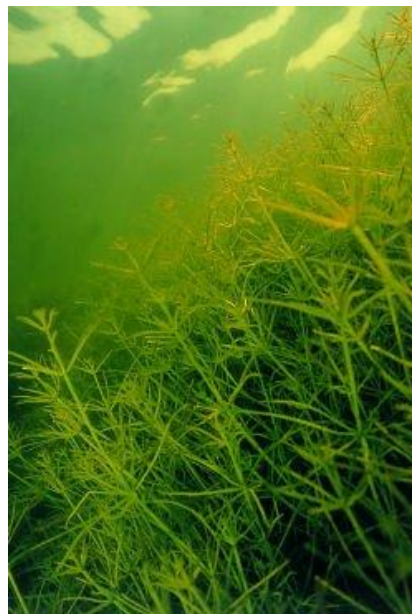
Figure A5 - Example of Starry Stonewort underwater growth, taken by K&A field crew in 2020.

Background: Starry stonewort, a macroalgae native to northern Eurasia, invaded North American inland lakes after becoming established in the St. Lawrence Seaway/Great Lakes system. Starry stonewort has likely been present in Michigan's inland lakes since the late 1990's. Since then, this invasive species has spread throughout Michigan (Figure A5). Able to spread by both fragmentation and asexual reproduction, starry stonewort has thrived in Michigan's high-quality oligotrophic and mesotrophic lakes, particularly those with marl sediments. Once established, this opportunistic species will bloom and impose a deleterious impact on many ecosystem functions. Bloom events are often unpredictable and can happen at any time of the year. In some years, starry stonewort can become a nuisance while it can be inconspicuous in others. The species can come along with other similar species and be very difficult to find when it is not blooming.

Management: Starry stonewort is difficult to control due to its asexual reproductive structures (bulbil) which embed in lake sediments.¹² While many strategies have been employed to manage starry stonewort, no single strategy has emerged as a panacea for controlling infestations. Diver-assisted suction harvesting (DASH) or diver-assisted hand-pulling of small starry stonewort infestations could reduce populations over time, but these methods are expensive and labor-intensive which require long-term commitments.^{13,14} These strategies may not be viable for large-scale infestations, however, due to their labor-intensive nature and their potential for increasing distribution of the target plant species through fragmentation during removal.

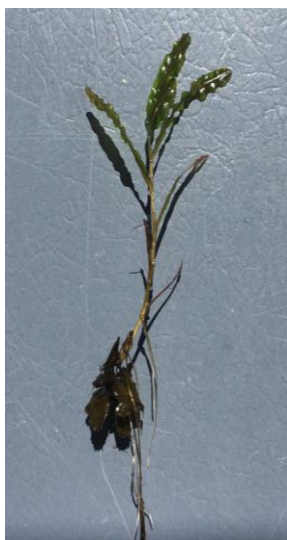
Figure A6 - Example curly leaf pondweed image from the 2021 LakeScan™ field crew.

Curly-leaf pondweed can create problems such as recreational nuisances, ecological nuisances (by outcompeting native species and reducing light availability to other plants), and degraded fish spawning habitat. Curly-leaf pondweed is easily detectable in early-spring because it is one of the few plants readily growing and often the first submersed plant to reach the surface. This gives it a competitive advantage and can grow 4 to 5 feet tall before other plants begin germinating from the bottom sediments. As water temperatures rise in late-June and early-July, curly-leaf pondweed stems begin to die, break down, and can be completely gone by mid-July.¹⁷

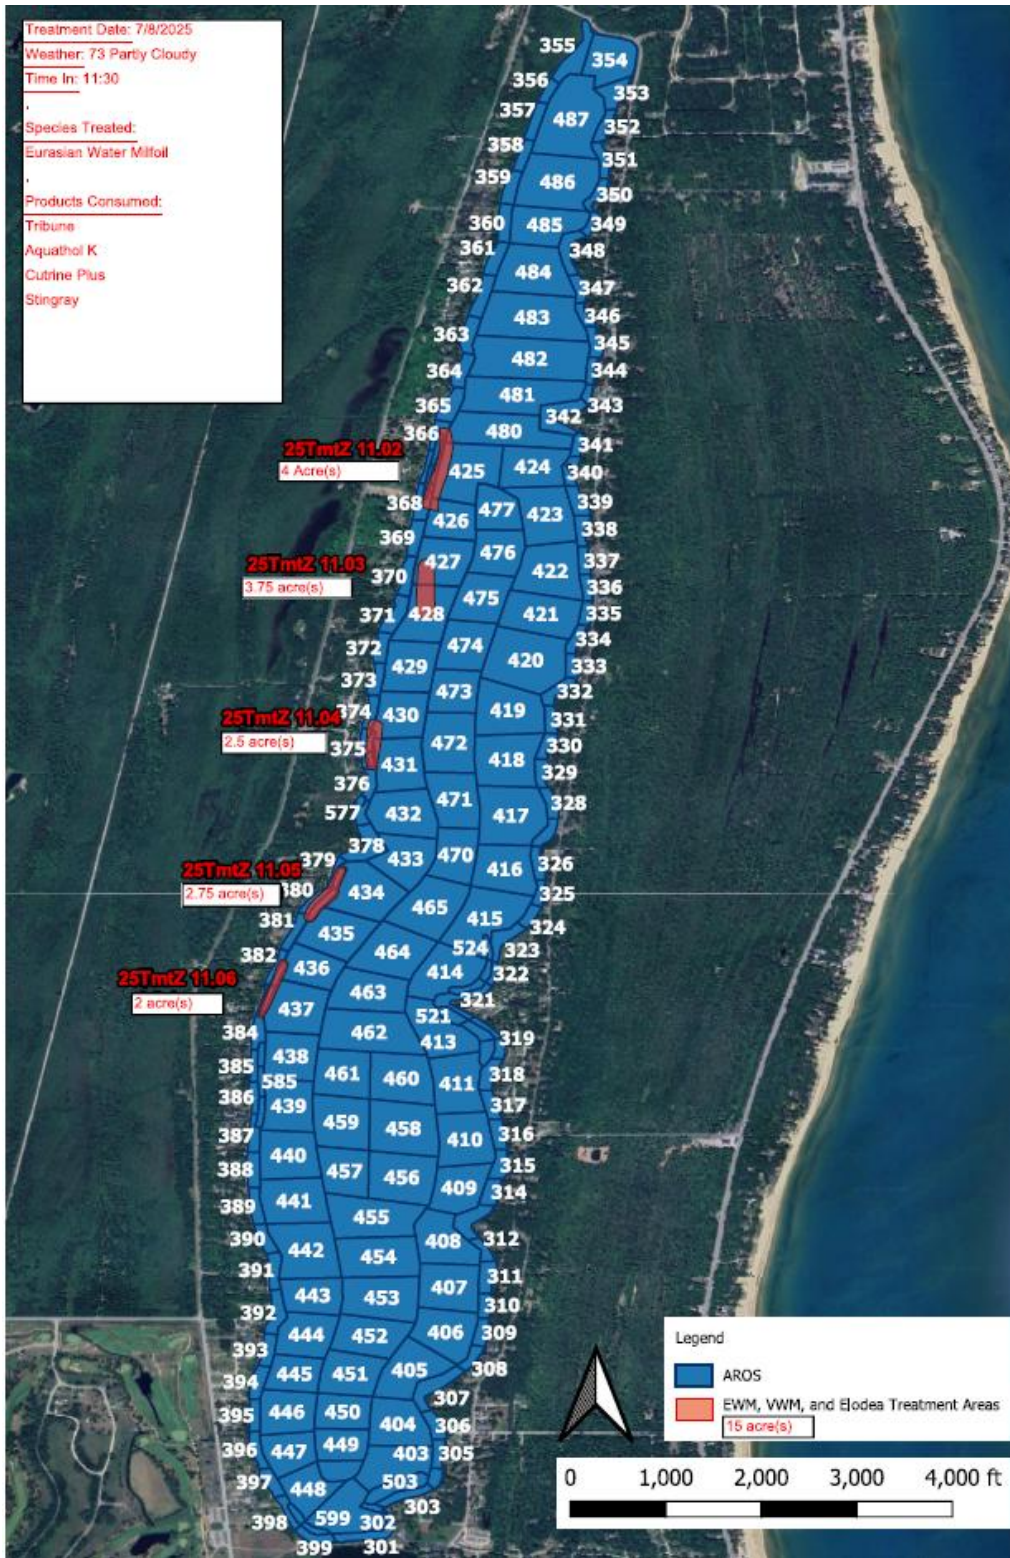
Figure B1. Herbicide applicator map and data provided by SOLitude Lake Management from the Cedar Lake North treatment on July 8, 2025.

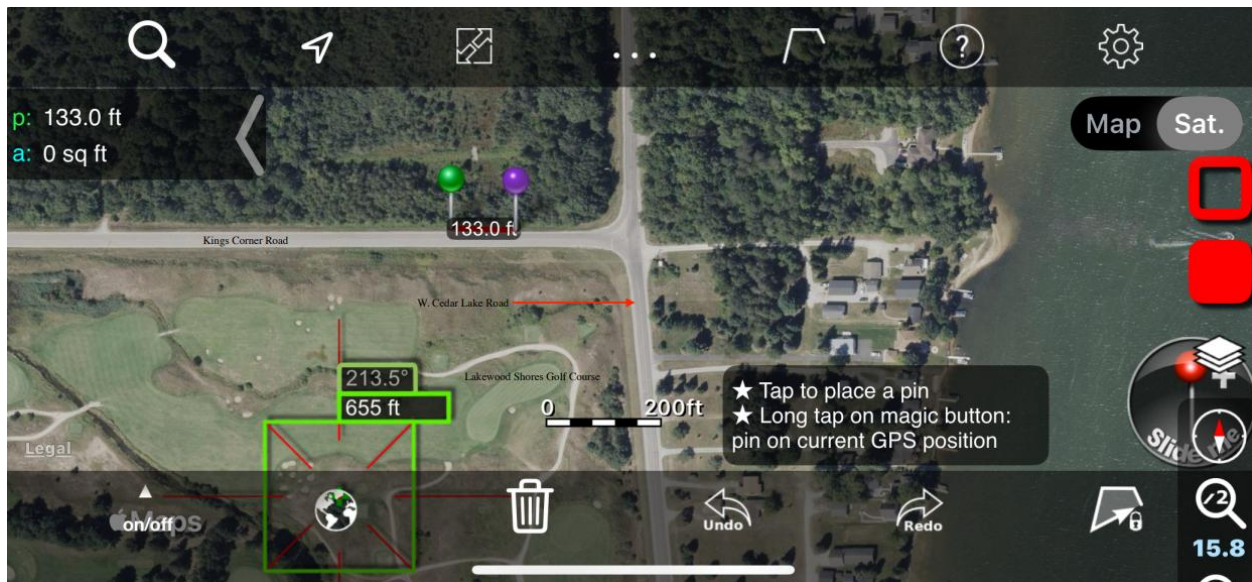
Figure B3. 133 lineal ft of terrestrial Phragmites treatment area provided by the Cedar Lake Board for treatment on September 18, 2025.
