A Summary of Findings from LakeScan™
Guided Surveys and Analysis of:

Cedar Lake North

2025 DATA AND ANALYSIS SUMMARY REPORT WITH MANAGEMENT RECOMMENDATIONS

March 24, 2026

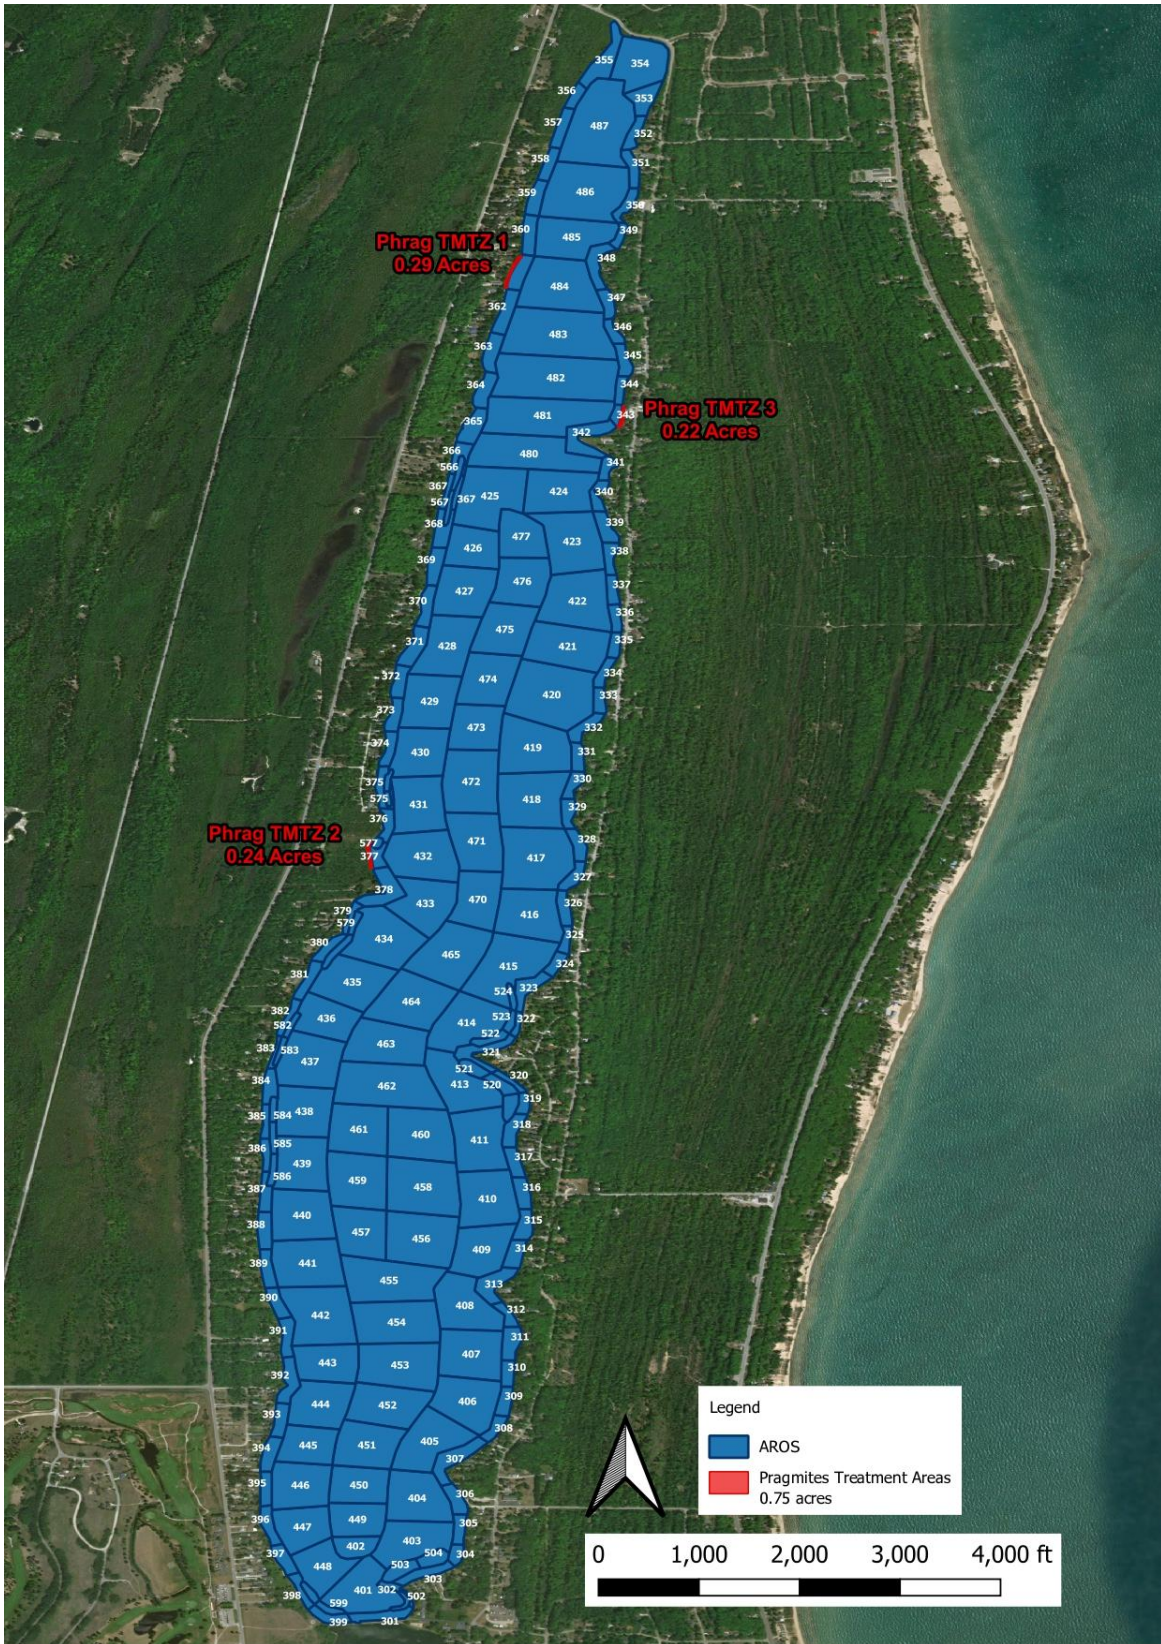
In addition to the submerged aquatic species, a treatment on *Phragmites* was also performed on September 18, 2025. The treatment targeted three shoreline areas where *Phragmites* was found during the late-season survey (AROS 361, 343, and 377). An off-lake area of *Phragmites* was additionally targeted near Kings Corner Road, but the area is not included in routine K&A lake monitoring. No information of the *Phragmites* treatment was made publicly available or directly supplied to the Lake Board. Aquatic Nuisance Control (ANC) permits submitted to the state only require the submission of *Phragmites* treatment data if the species was treated in standing water. A conversation with the applicator from SOLitude who performed the application, indicated that the treatment used a combination of Aquaneat, Habitat, and Cygnet Plus. In absence of publicly available documentation, maps supplied by K&A and the Lake Board for *Phragmites* treatment are included in Appendix B.

Figure B4. Shoreline Phragmites treatment areas provided by K&A for the Cedar Lake North treatment on September 18, 2025.
