Asbestos

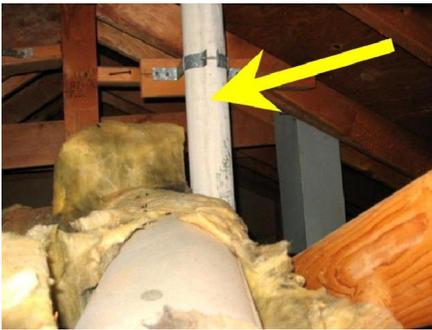
Figure 1. Possible asbestos insulation on furnace exhaust flue in attic.

Asbestos can also be found in some types of attic insulation and some types of ceiling acoustic tiles, as well as many other places depending on when the home was built. Another very common area where asbestos still exists in our homes is as insulation on exhaust flues on forced air furnaces (typically in the attic; see Figure 1) and water heaters (see Figure 2). Asbestos exhaust flue insulation, also called asbestos pipe wrap, is one of the more hazardous uses of asbestos because it is less stable than other forms of asbestos materials due to the heat from the exhaust flues. Generally it is safe to assume that insulated pipes contain some sort of asbestos pipe insulation material. Because asbestos pipe insulation is prone to deterioration, most authorities consider it a friable asbestos material and a health hazard.

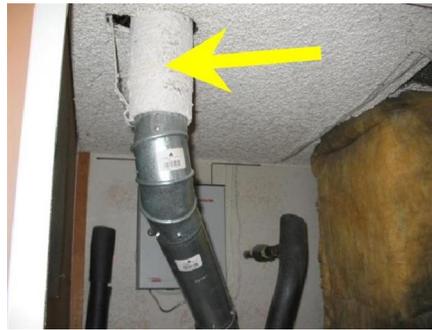
Figure 2. Possible asbestos insulation on water heater exhaust flue.
