Testing 1950s concrete-encased steel for reuse

The Project

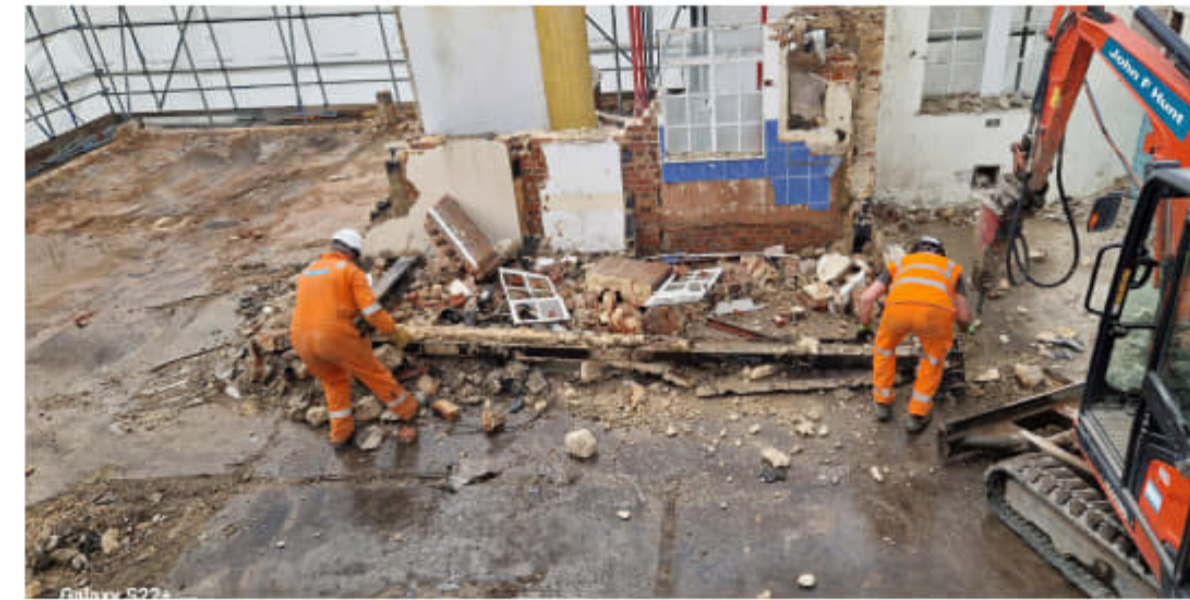
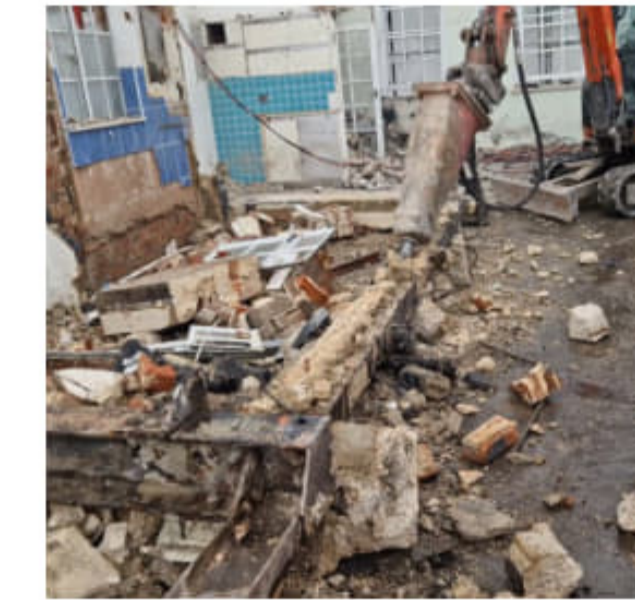
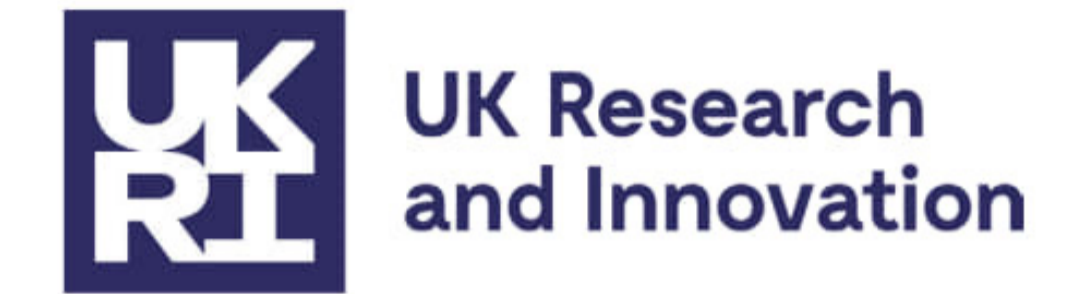
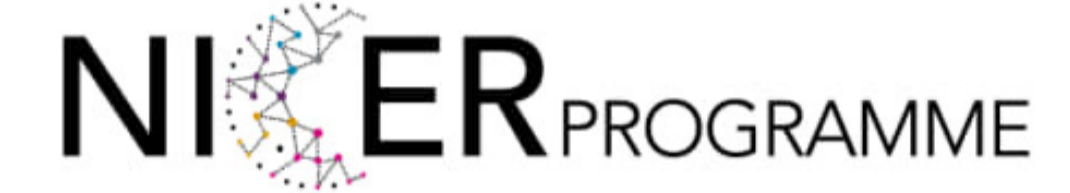
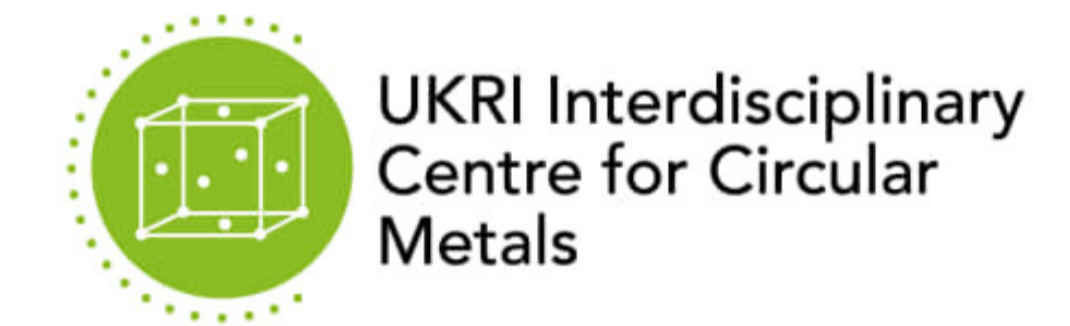
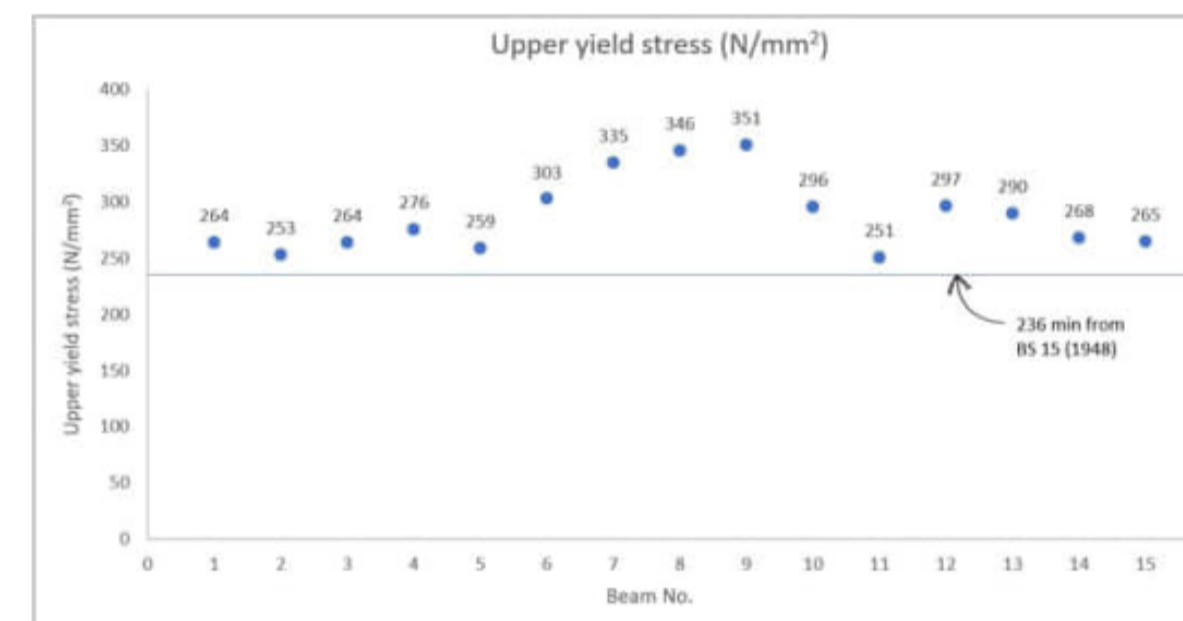
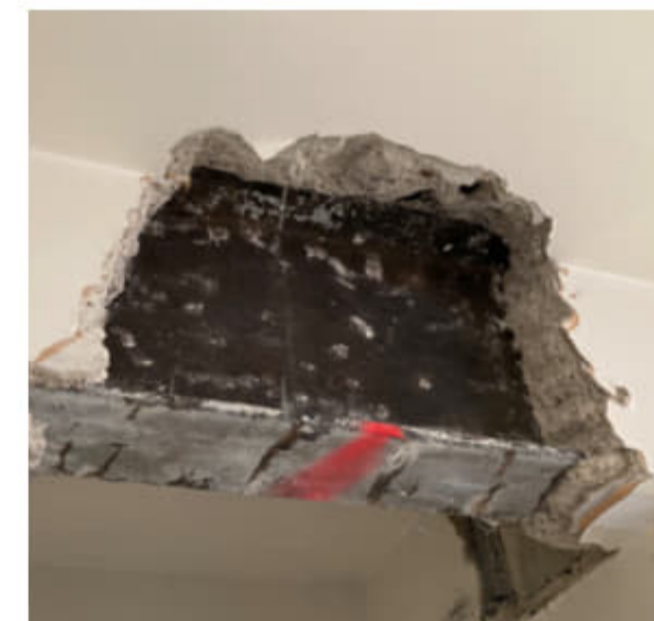
Phase 1 – Encasement removal in-situ

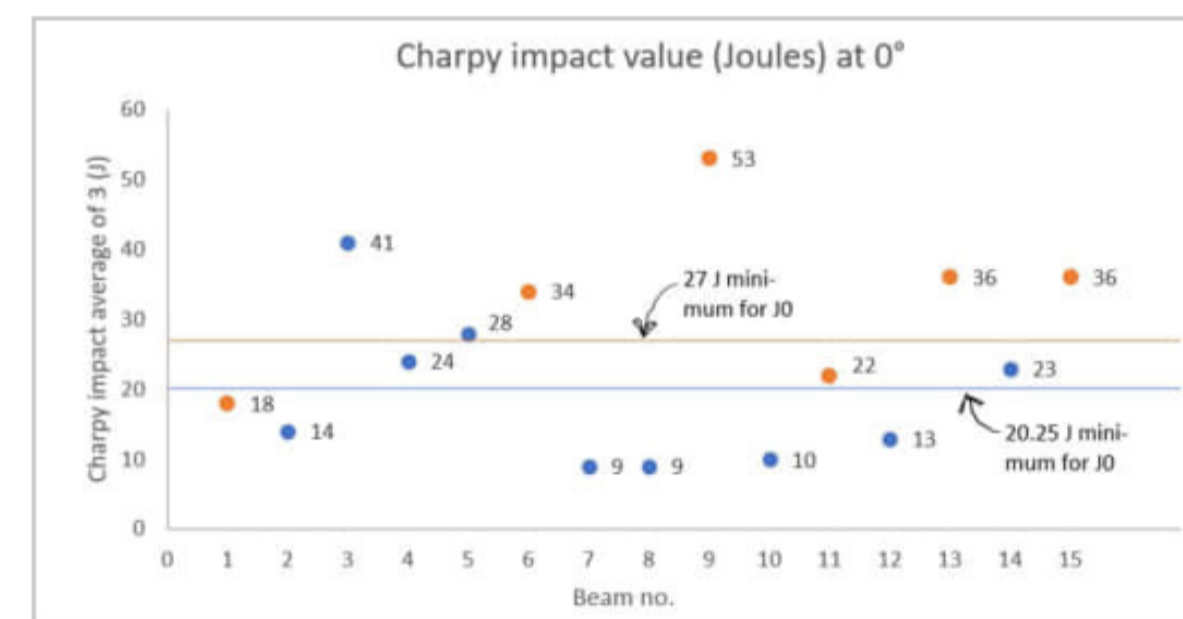
Phase 1 – Selection of results

- + Yield strength = 248 N/mm²
- + Tensile strength = 388 N/mm²
- + Elongation = min 25.8%
- + Charpy impact = not all samples met J0
- + Chemical content = P and S below max

Conclusion: S235 steel with a lower ultimate tensile strength (388 N/mm²) to be used where f_u controls the design (e.g. net tension)

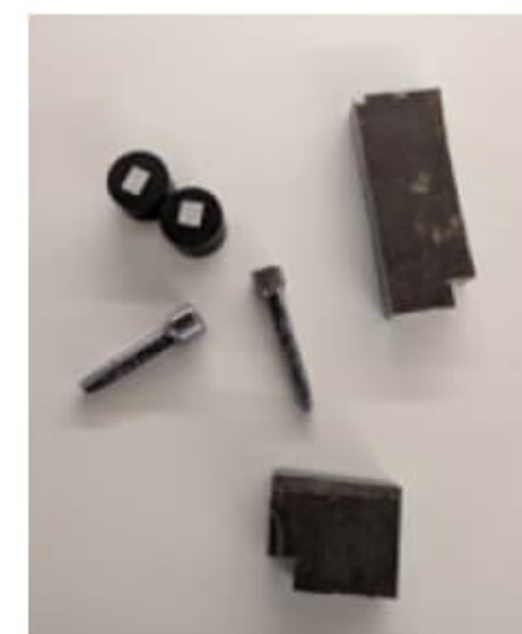
Phase 1 – Samples after testing

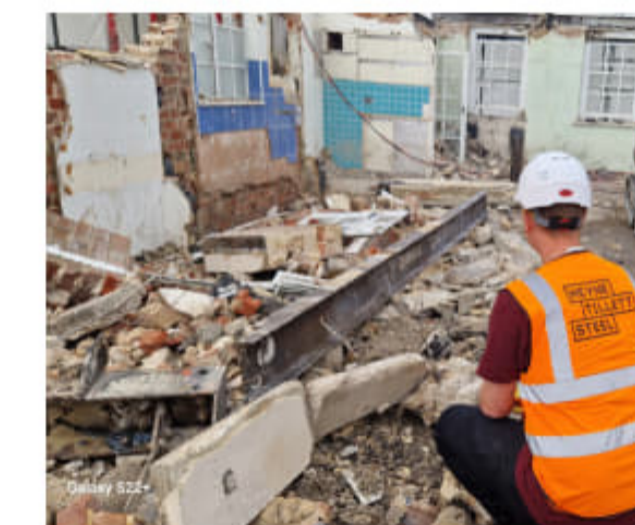
Concrete encasement removed by machine (for 9 out of 10 beams):

- + Encasement removed with a hydraulic hammer
- + Connection bolts / supporting column were cut with a flame cutting torch
- + The beams were lifted and placed on the floor or pulled and free dropped on the floor

Phase 2 – Site photographs during deconstruction

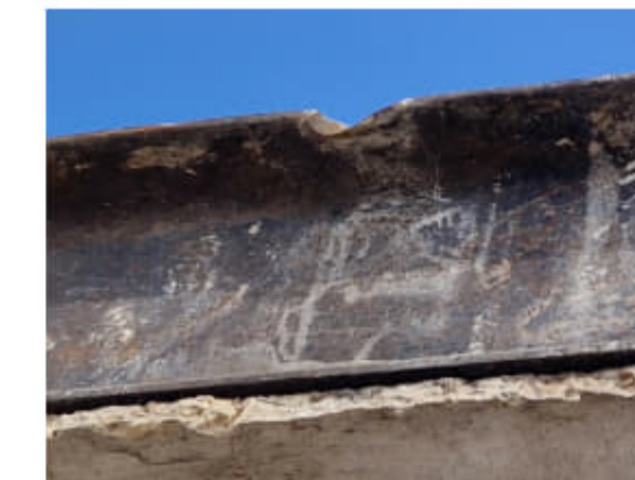
Concrete encasement removal by hand (for 1 out of 10 beams):

- + Encasement was removed using an electric hammer
- + The connection bolts were cut with a flame cutting torch
- + The beam was lifted and lowered on the floor.

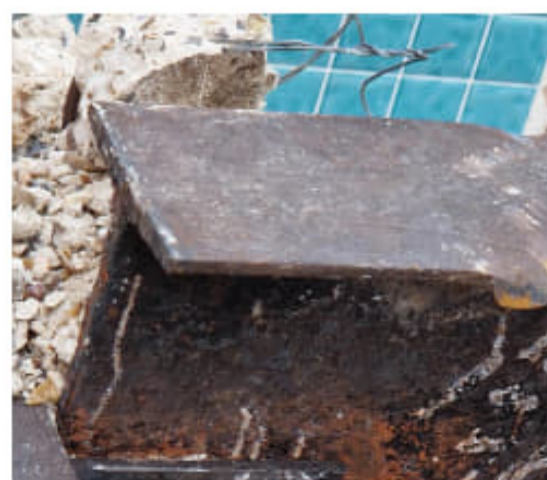
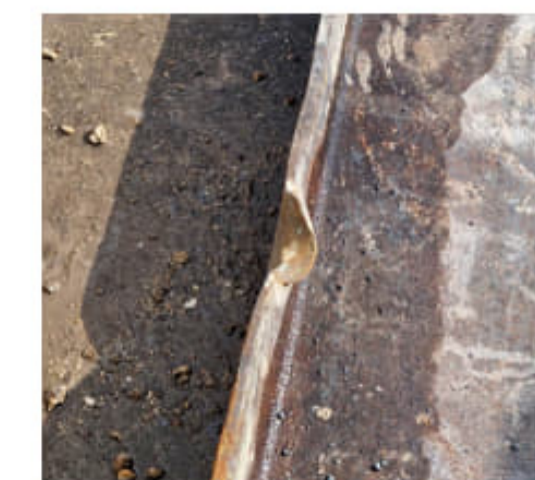
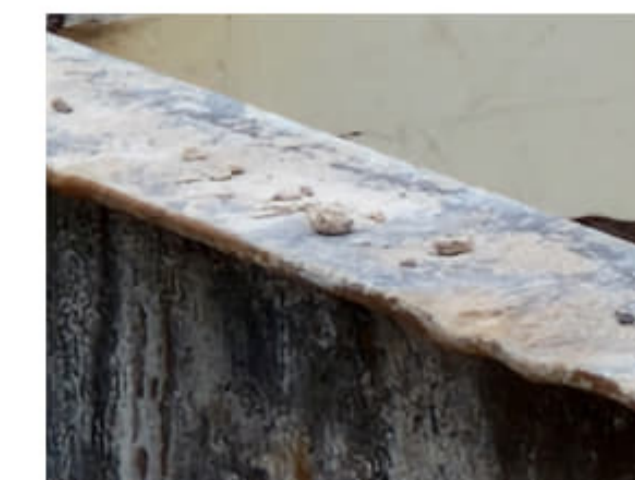
Phase 3: Damage assessment and initial visual condition assessment

- + Most major damage occurred to the top flange due to concrete encasement removal with the hydraulic hammer.
- + Web and bottom flange damage is minor.
