Inspection Report

Sample Report

Sample
Kenai AK 99611

Wisdom and Associates, Inc

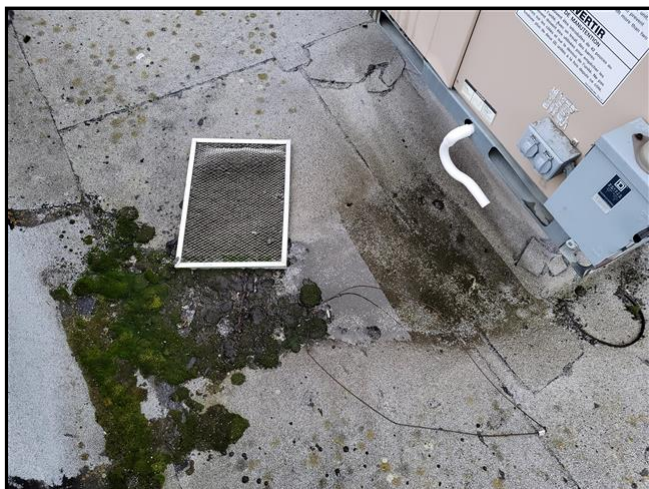
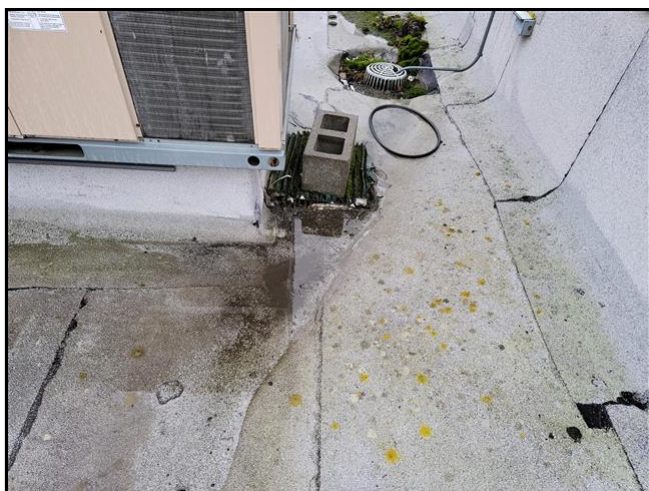
(1) Several low spots are present on the roof which has resulted in standing water and growth in the lower areas. Standing water and growth can lead to premature roof wear or leakage. Recommend that growth be removed and drainage improved.

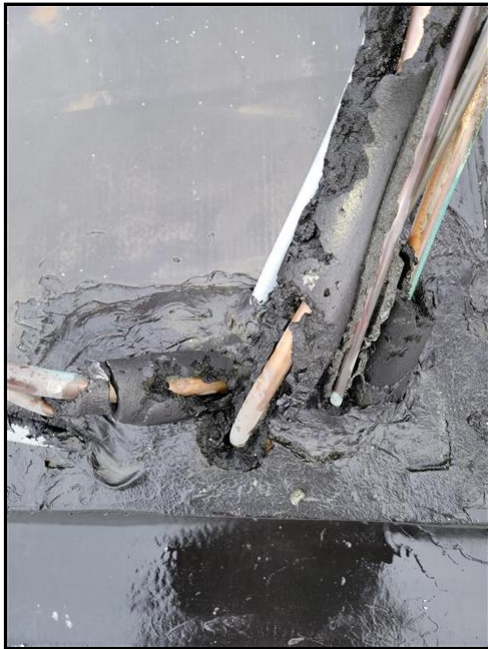
1.0 Item 4(Picture)

(2) Past leakage is present at the roof covering where refrigerant lines enter the attic space. Water stains are visible in the attic space below and on the ceiling tiles.

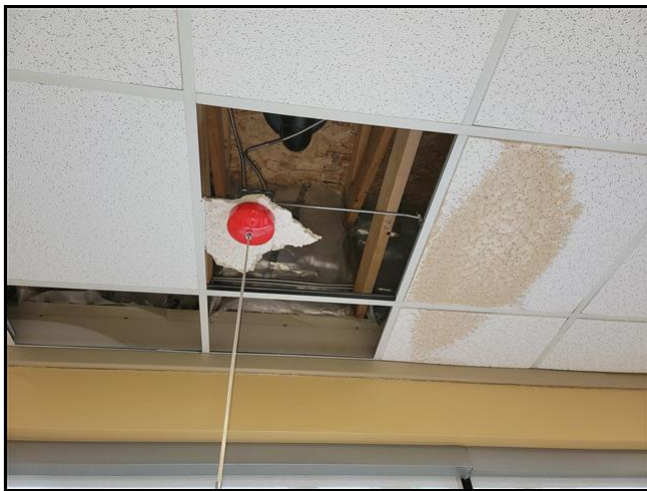
1.0 Item 5(Picture)

(3) There is water damage at the ceiling tiles from a past roof drain leak on the south side of the building.

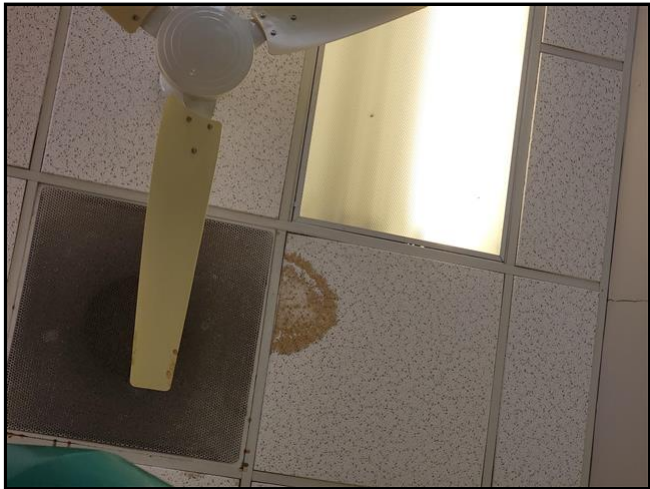
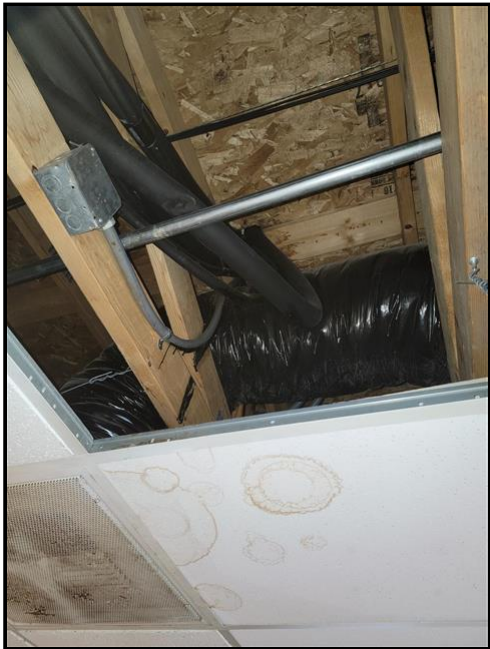
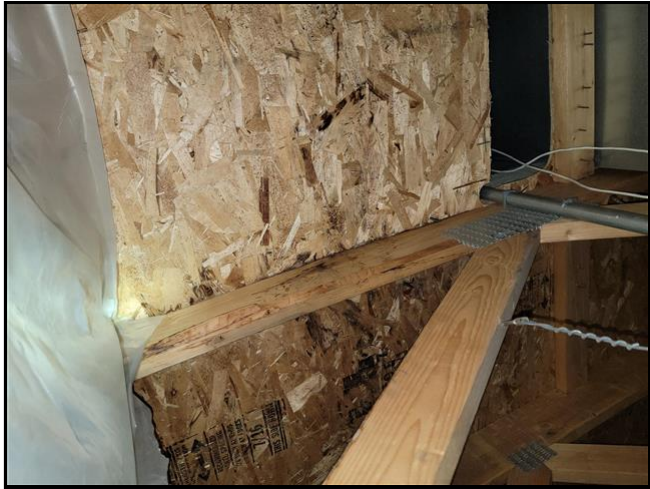
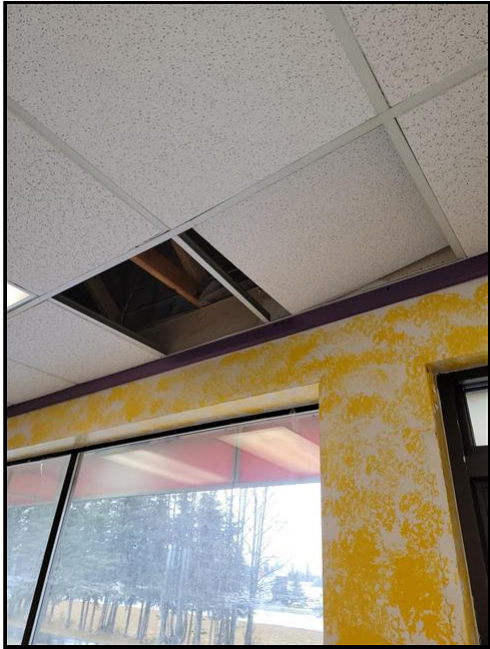
(4) There is water damage to the ceiling tiles on the south side of the play room from a previous leak around the roof top furnace unit. This past leakage appears to have affected the drywall finish around the south exterior door causing tape joints to come undone.

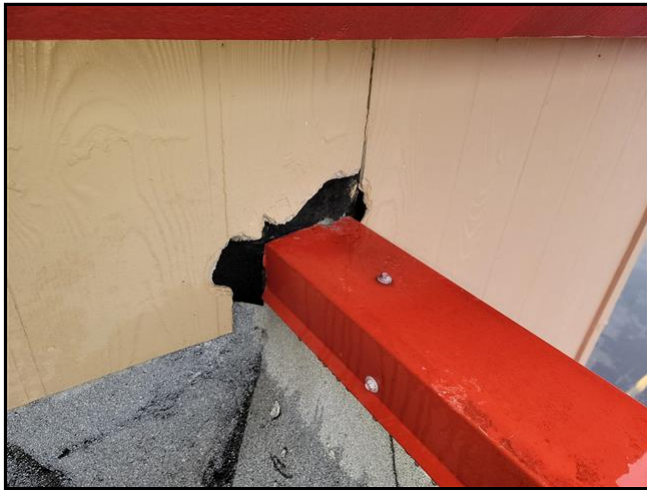
(1) The siding/flashing at the intersection of the southeast roof parapet wall with the upper level play area roof is damaged and needs repair to maintain water tight integrity.

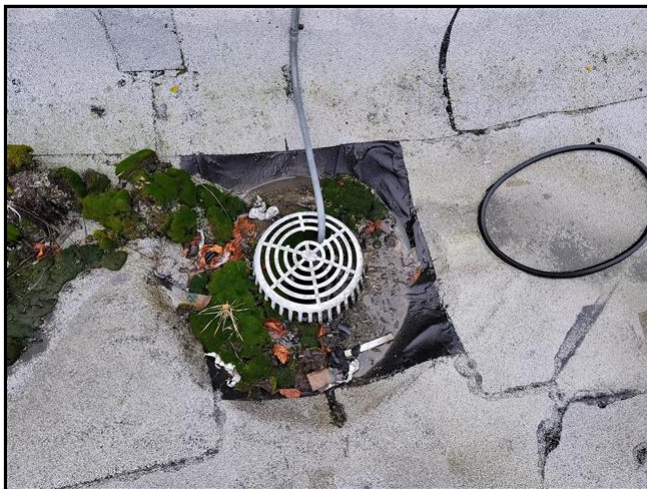
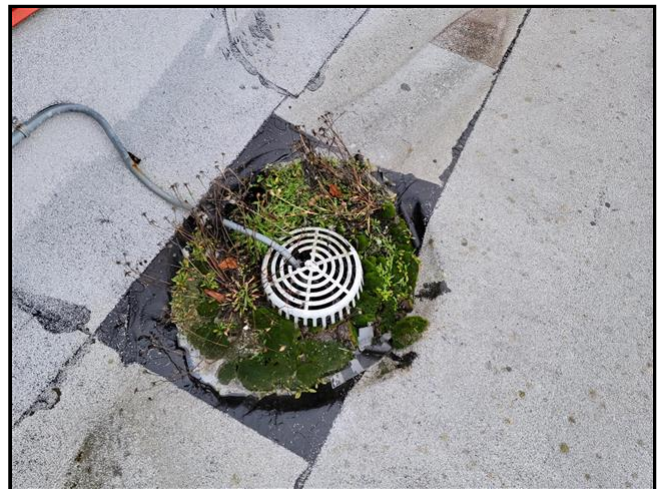
(1) The roof drains are obstructed with growth and debris and need cleaned for proper roof drainage and to prevent water accumulation on the roof.

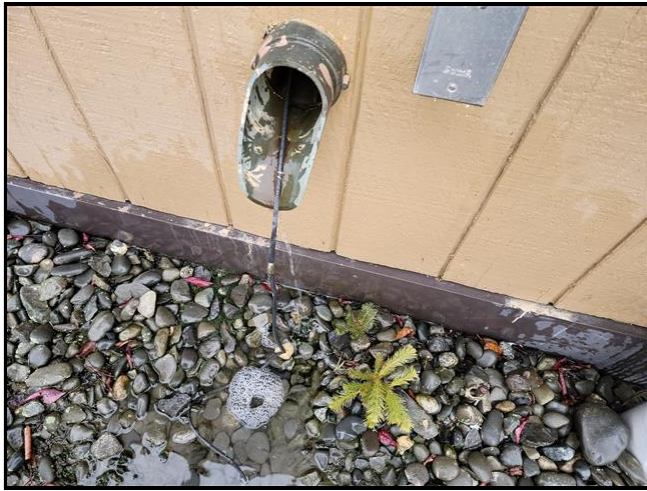
2.0 Item 1(Picture)

(1) Water splash from the roof drainage discharge on the west side of the building is starting to deteriorate the adjacent siding.

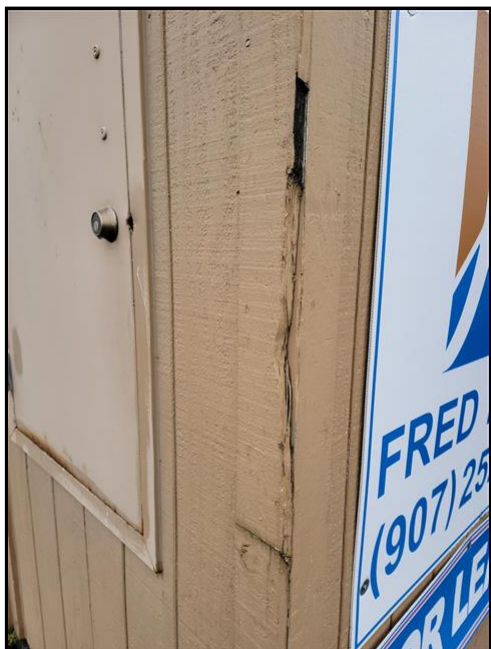
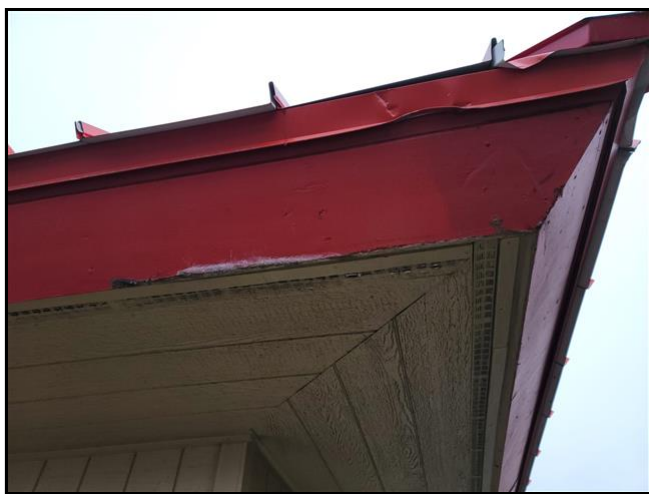
(2) Damaged exterior trim and soffit on the north and south corners of the west side of the building needs repaired or replaced.

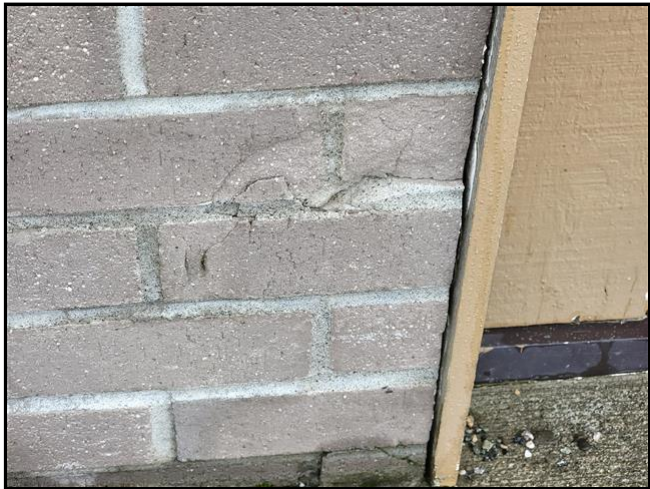
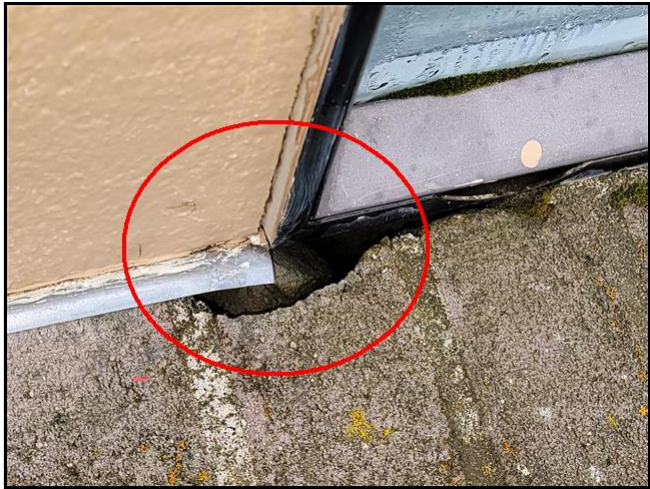
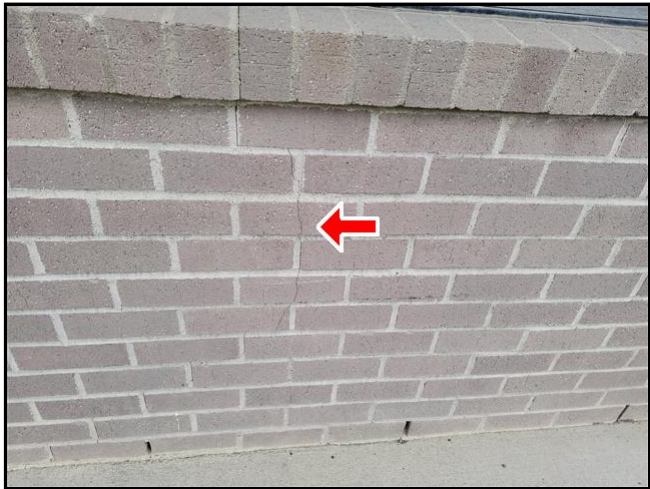
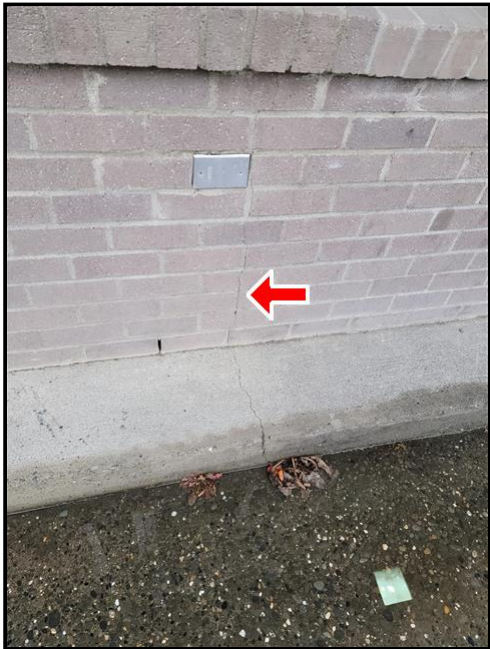
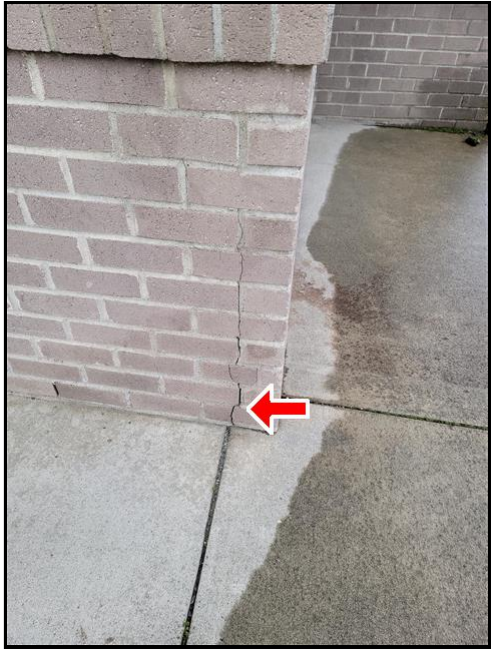
(3) The exterior brick veneer is cracked in multiple locations and there is some deterioration, further evaluation of the cause and repair of the deterioration is needed.

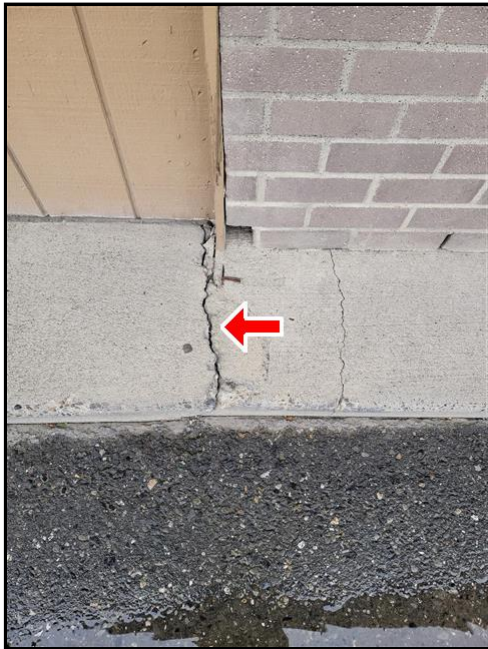
2.0 Item 12(Picture)

(4) Concrete curbing has cracked on the south side of the building along the drive-through lane and repair is needed.

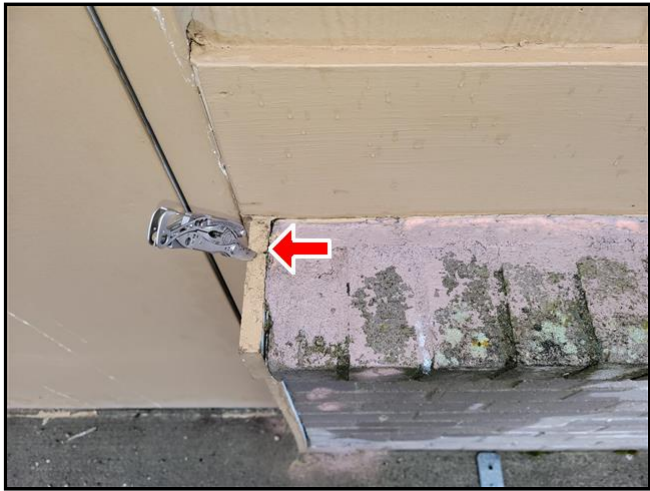
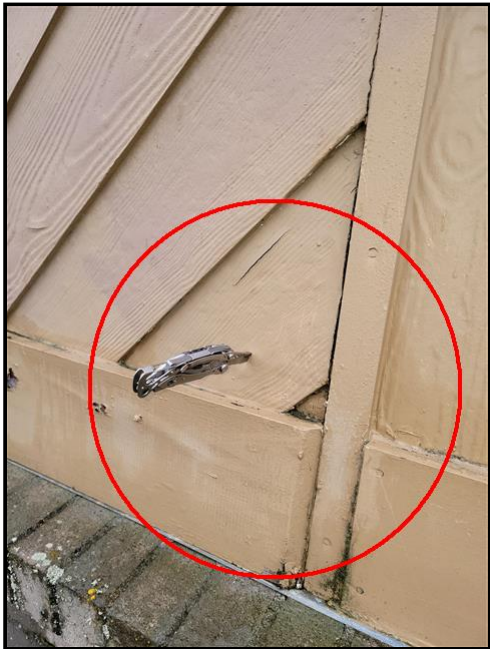
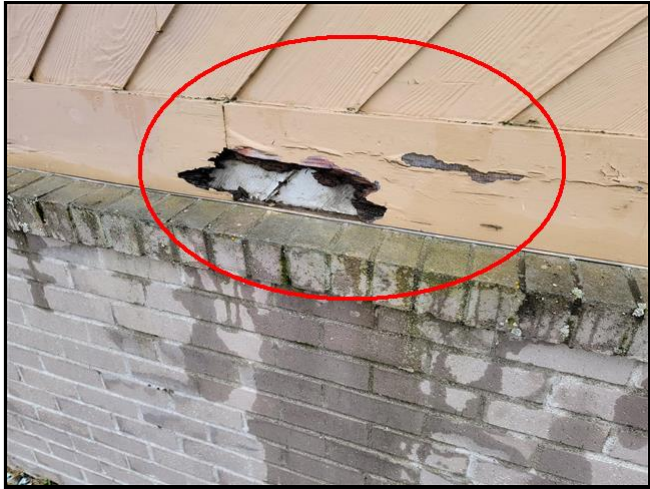
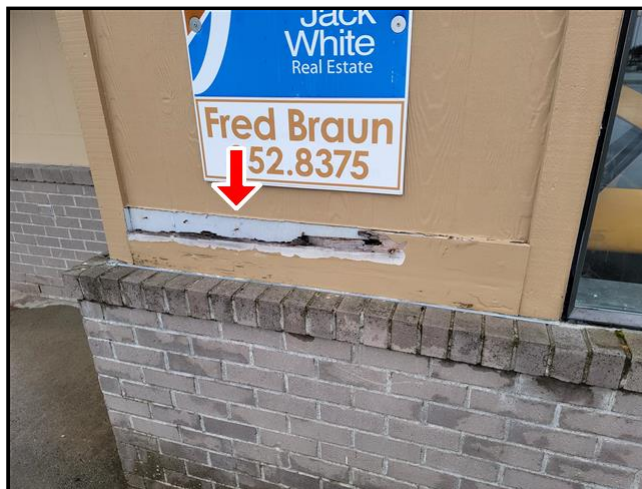
(5) Significant water damage is present at the exterior siding, particularly on the north side of the building. A full survey and repair as necessary is needed by a licensed contractor as damage may be present inside the walls where not visible during an inspection.

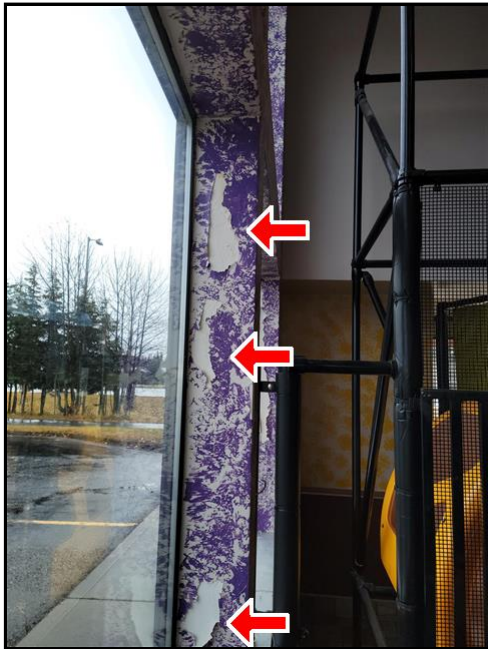
2.0 Item 19(Picture)

(6) There is evidence of past leakage around the play area windows, the drywall finish is deteriorated and there are moisture stains on the sides and sills of the windows. Windows may leak only during certain weather conditions or wind directions. Recommend re-caulking the exterior trim and siding around the windows.

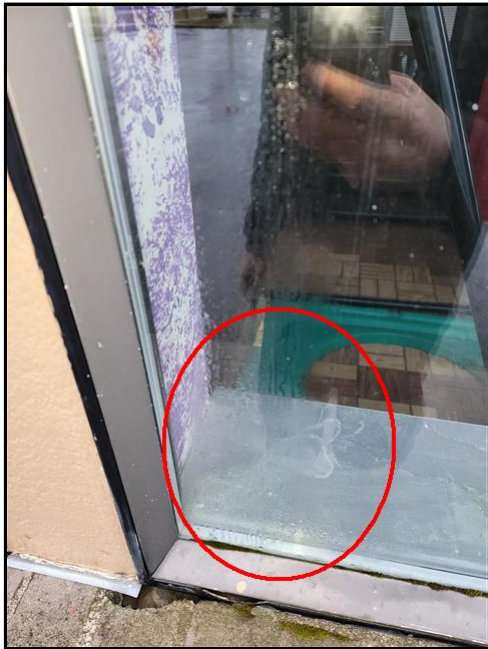
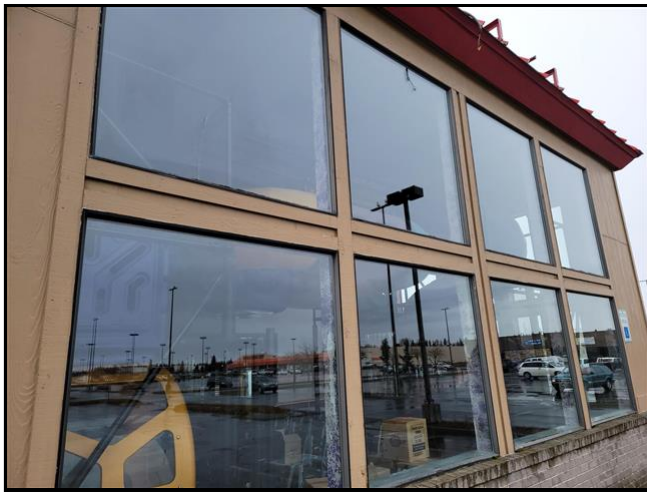
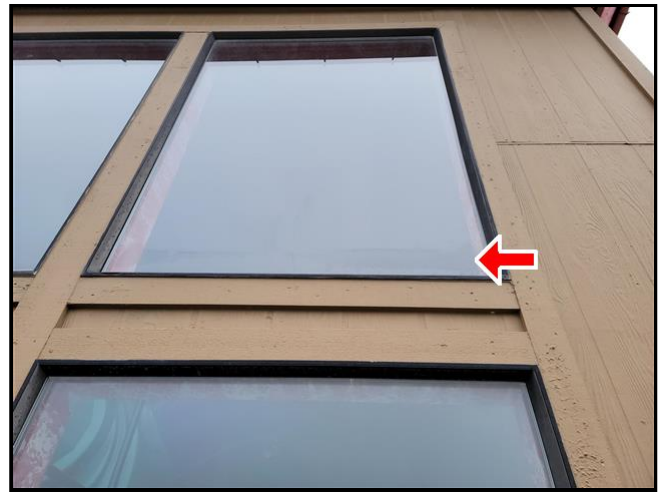
Most of the windows in the play area on the east and north facing sides were observed to have fogging between the panes which indicates a failed seal and need for replacement. Identification of failed seals can be difficult depending on the weather conditions, a full survey and replacement as necessary by a qualified person is recommended.

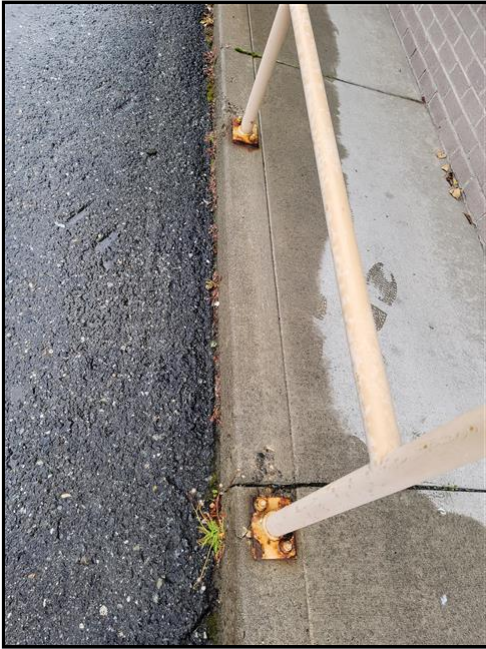
2.4 Item 1(Picture)

The sidewalk railing on the south side of the building is rusting through at the base connections.

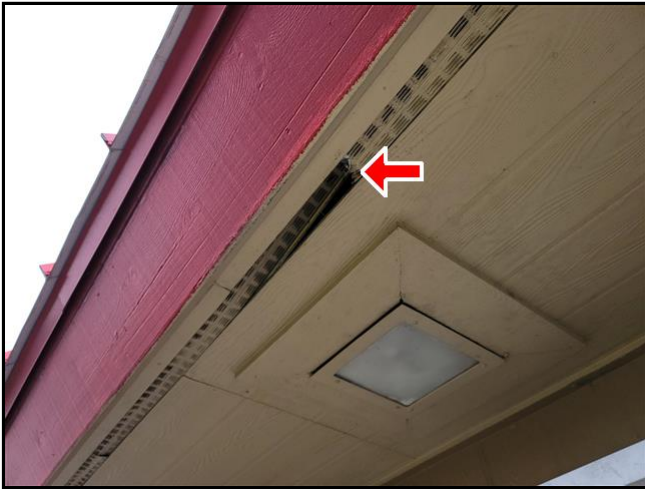
Damaged sections of soffit vent on the south side of the building need replaced.

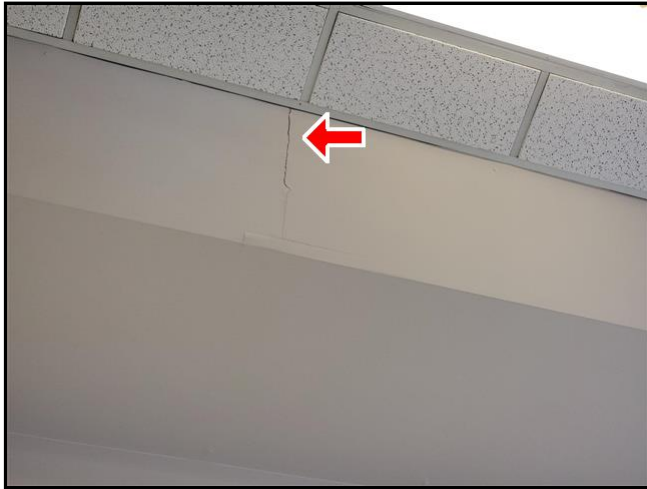
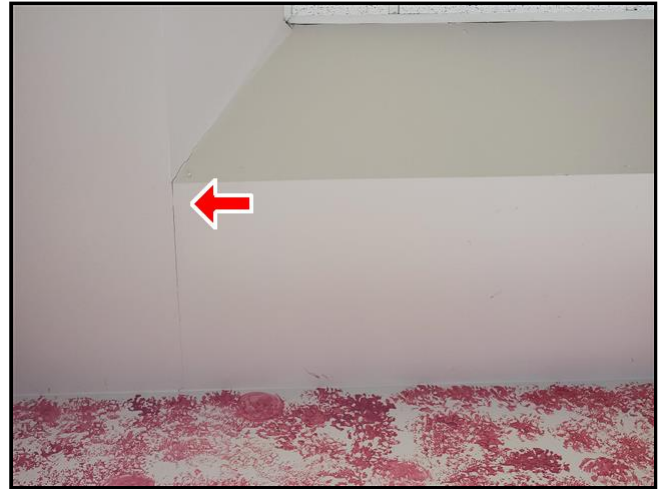
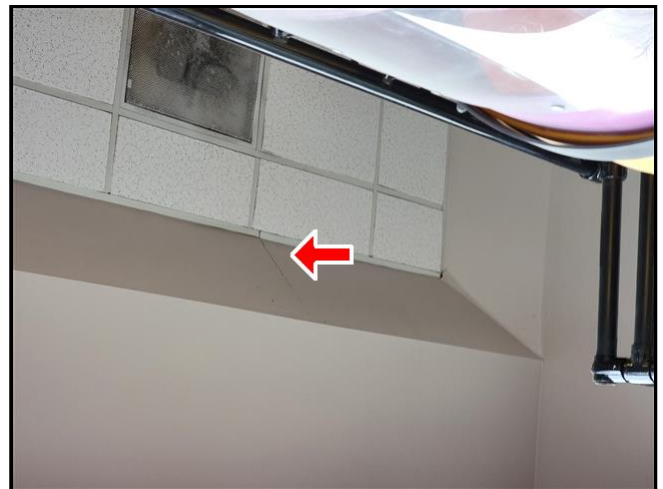
There are numerous drywall cracks in the ceiling of the play area. Due to the height of the ceiling, storage, and the play equipment the area above the ceiling panels could not be reached for further inspection. Recommend further investigation to determine the cause of cracking and if repair is necessary.

inspection. Recommend further investigation to determine the cause of cracking and if repair is necessary.

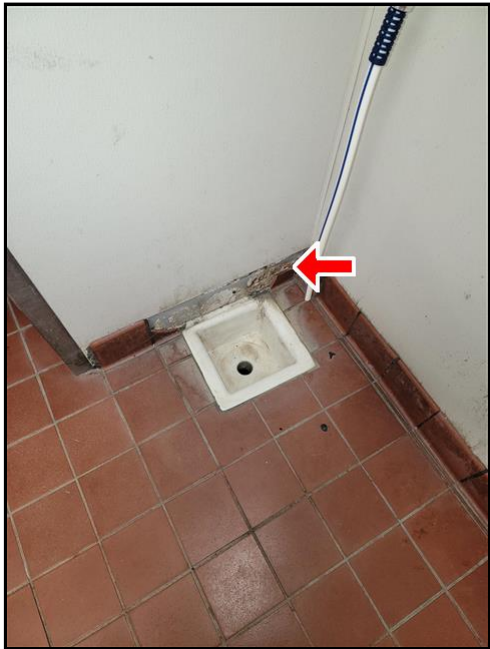
3.1 Item 1(Picture)

(1) Wall adjacent to the floor sink is deteriorated from moisture.

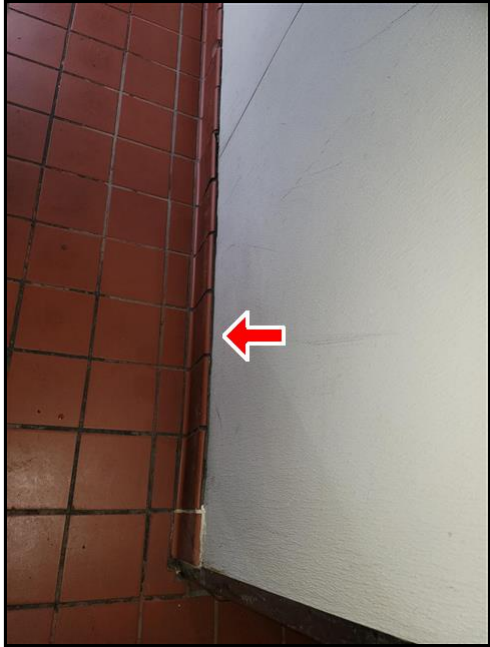
3.1 Item 2(Picture)

(2) Wall base tile is coming loose off of the north wall of the southwest drive-through area.

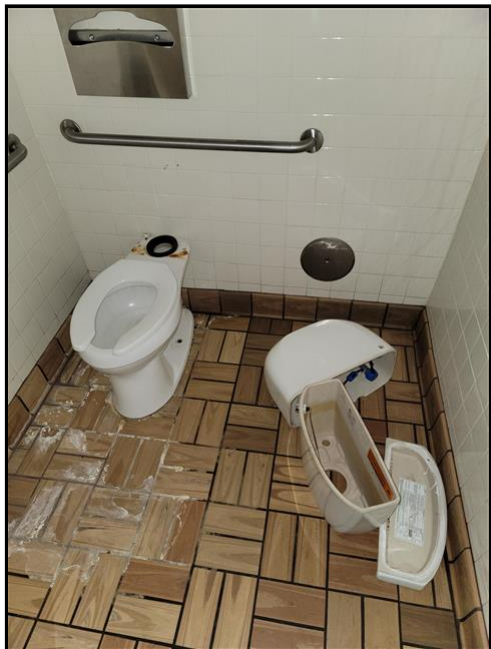
5.0 Item 2(Picture)

(2) The men's bathroom toilet is disassembled at the time of the inspection.

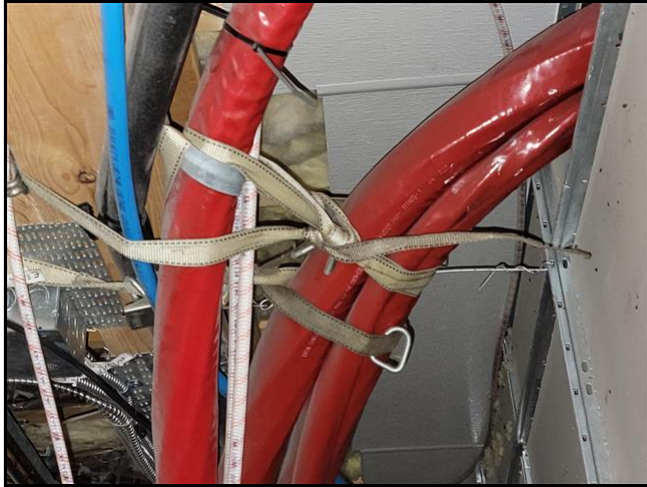
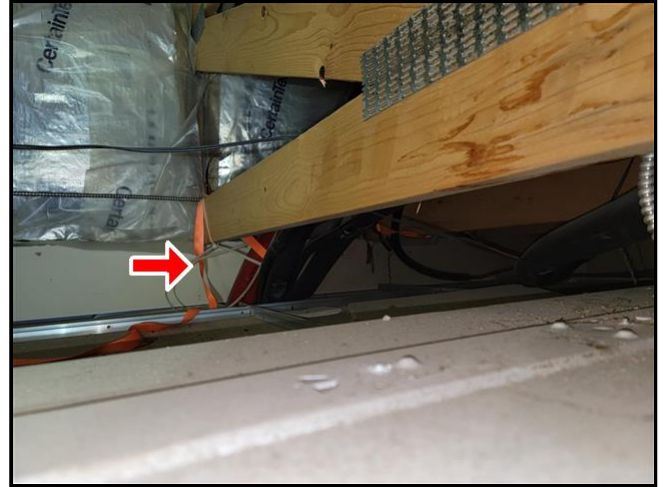
5.1 Item 1(Picture)

(1) Plumbing supply lines in the ceiling space for what may have been the soda fountain are not properly secured or supported.

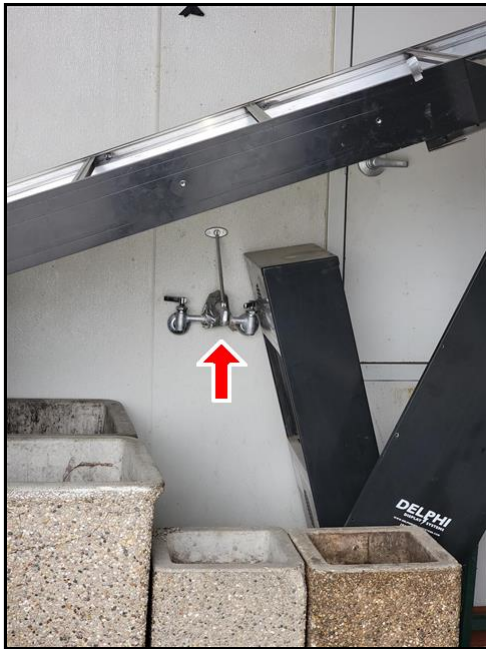
5.1 Item 3(Picture)

(2) The garage bay faucet was not reachable due to storage, but is duct taped and it is suspected not to work properly.

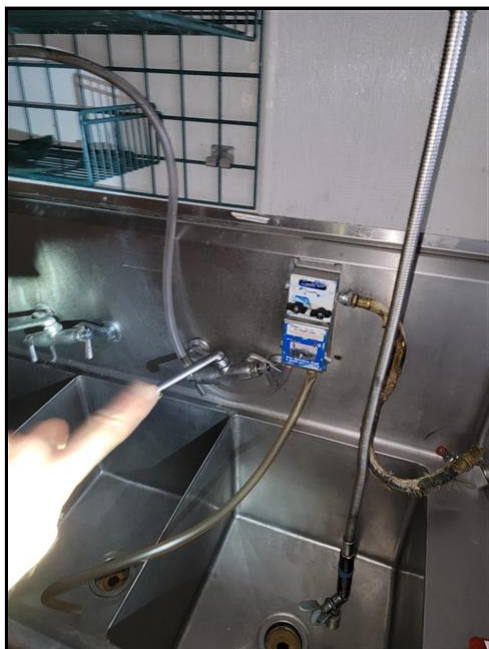
5.1 Item 4(Picture)

(3) Right hand triple sink faucet was loose on the wall and not functional when tested.

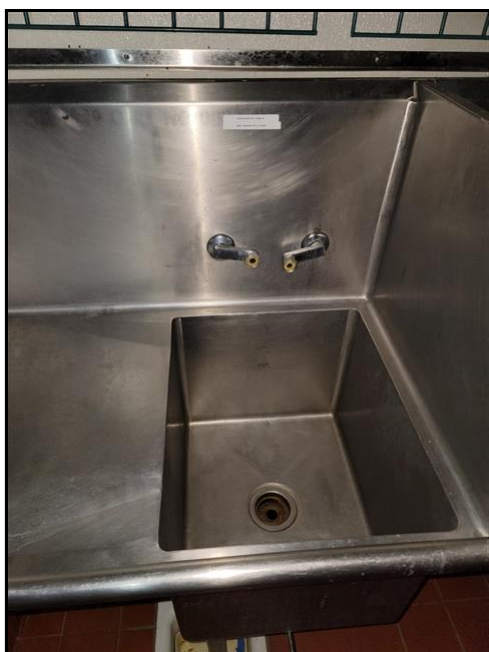
5.1 Item 5(Picture)

(4) Far left kitchen sink faucets not functional at the time of the inspection.

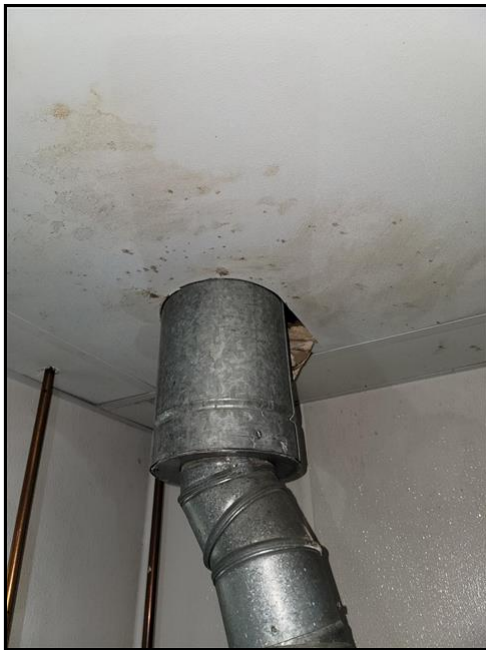
5.2 Item 2(Picture)

(2) The domestic water heater chimney is too close to the combustibile ceiling panel where is passes through the ceiling, a minimum 1 inch clearance for type b double wall vent is needed.

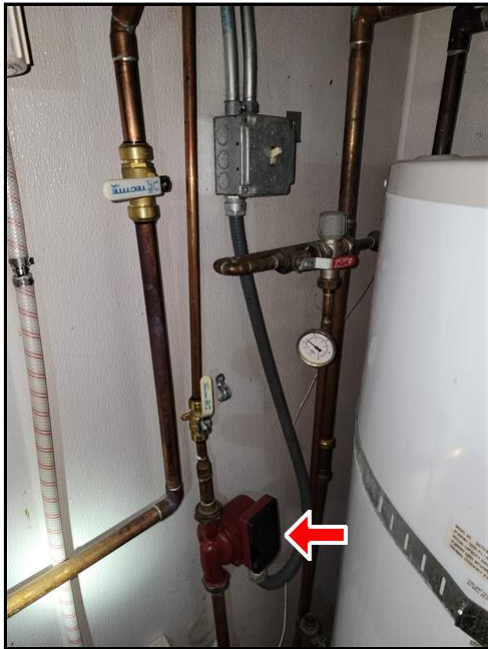
5.2 Item 4(Picture)

(3) The domestic hot water circulation system was not operable and was shut off at the time of the inspection.

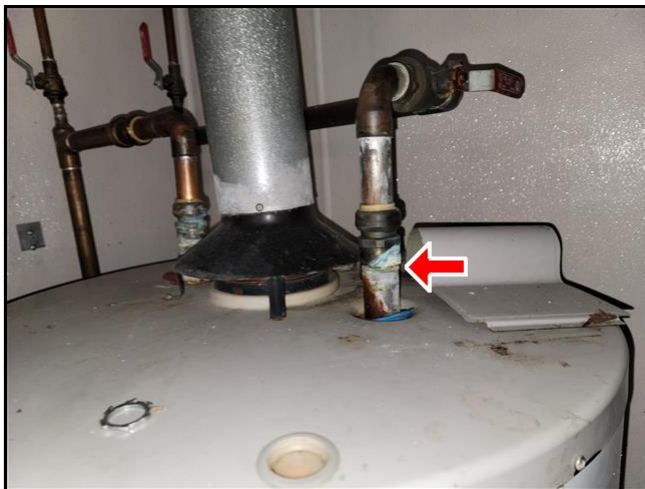
5.2 Item 6(Picture)

(4) Corrosion is present at the water feed lines at the top of the domestic hot water tank, needs checked by a licensed heating contractor.

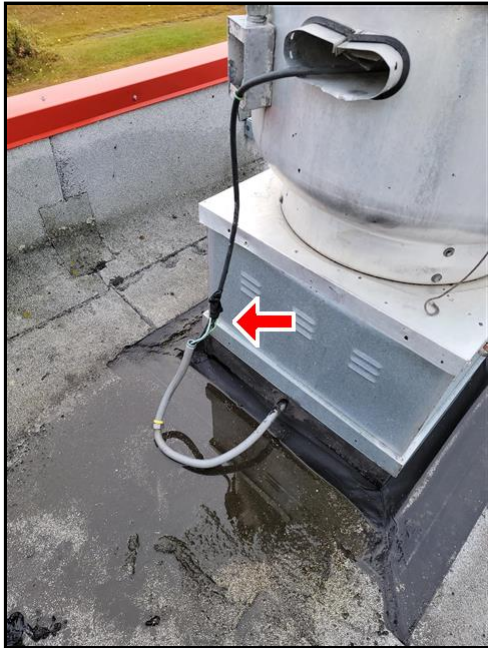
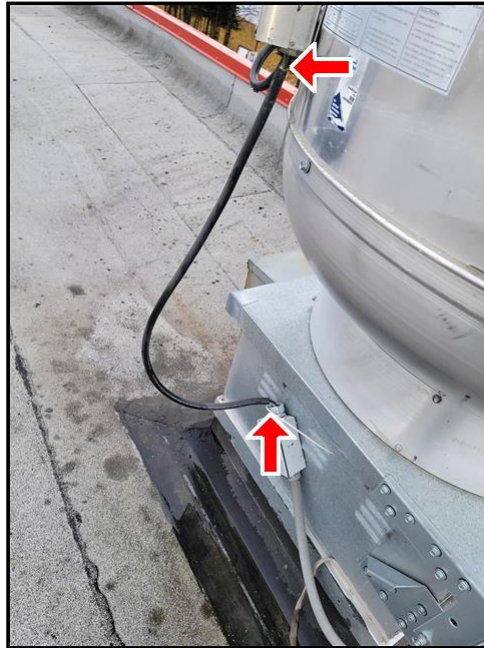
6.3 Item 1(Picture)

(1) Exposed wiring and wiring junctions at the rooftop exhaust units needs properly covered/protected.

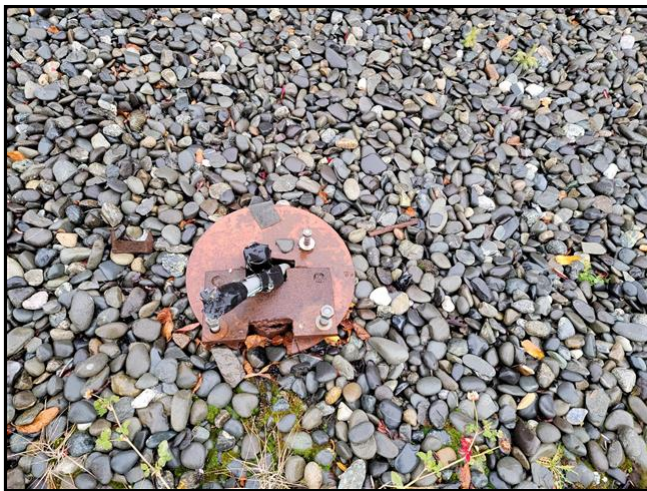
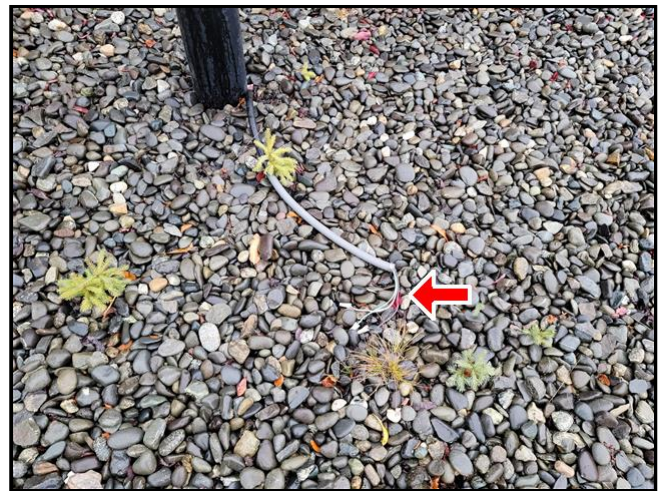
(2) Open electrical terminations at the former drive-through kiosk need properly terminated in covered, weather-tight junction boxes.

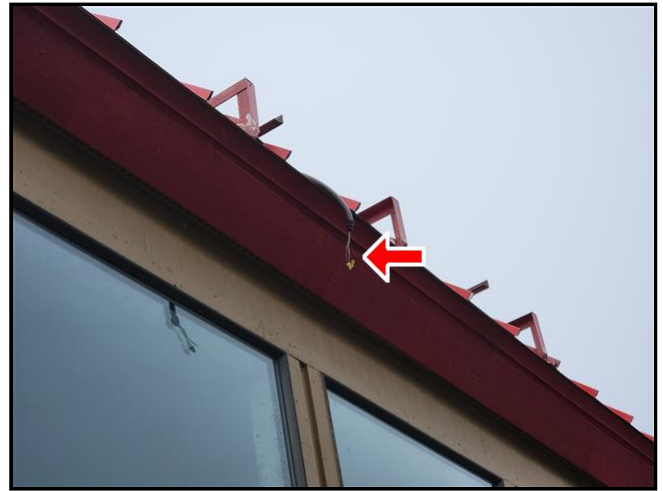
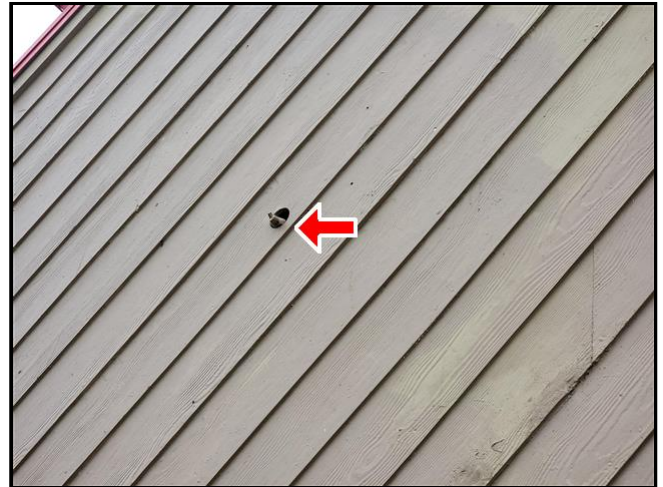
(3) Open wiring terminations at the exterior of the building need properly terminated in covered, weather-tight junction boxes.

6.3 Item 6(Picture) East side of building.

6.3 Item 8(Picture) North side of building.

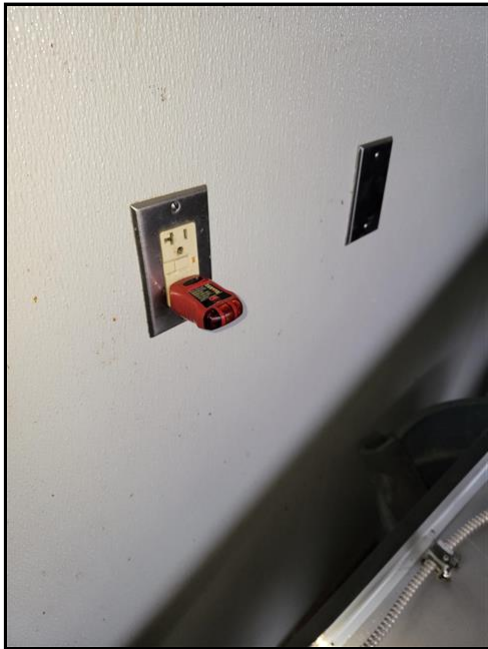
6.3 Item 9(Picture)

(4) No power is present at the garage bay receptacle on the south wall, receptacle will not reset.

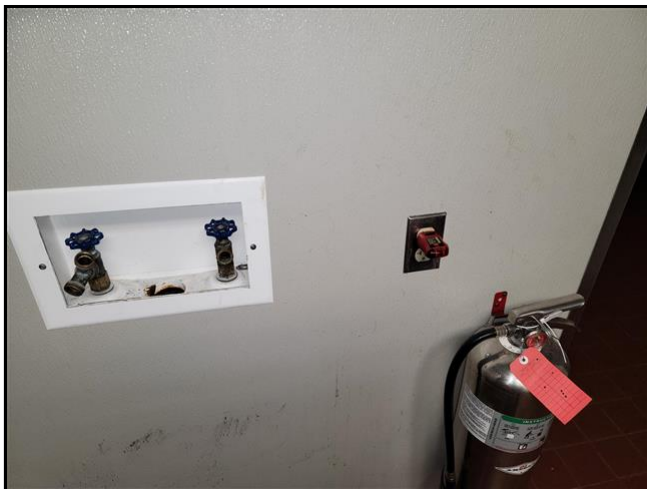
6.3 Item 10(Picture)

- (5) Garage bay lighting switch could not be located during the inspection for testing.
- (6) No power was present at the receptacle next to the washer hookups.

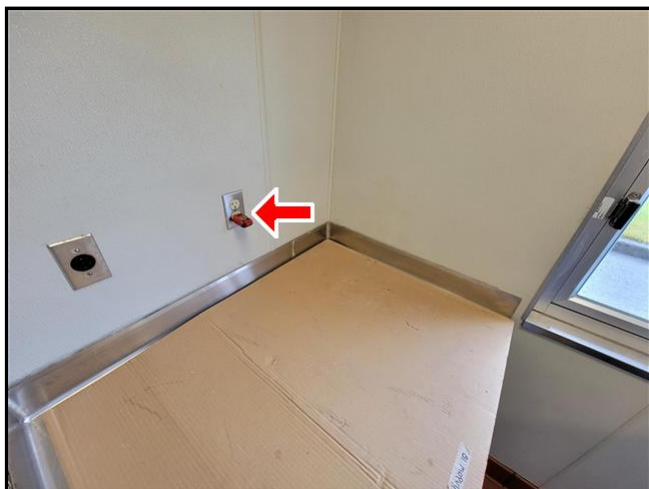
6.3 Item 11(Picture)

- (7) No power was present at the 2nd drive through counter top receptacle.

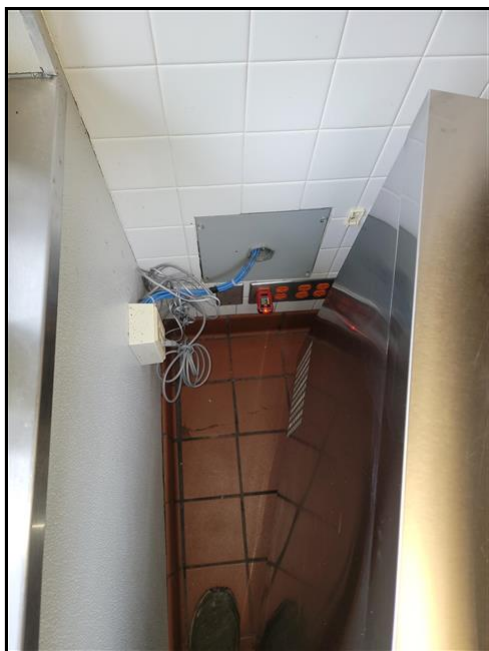
6.3 Item 12(Picture)

(8) Open grounds were present at the west wall of the 2nd drive through area, repair needed for safety.

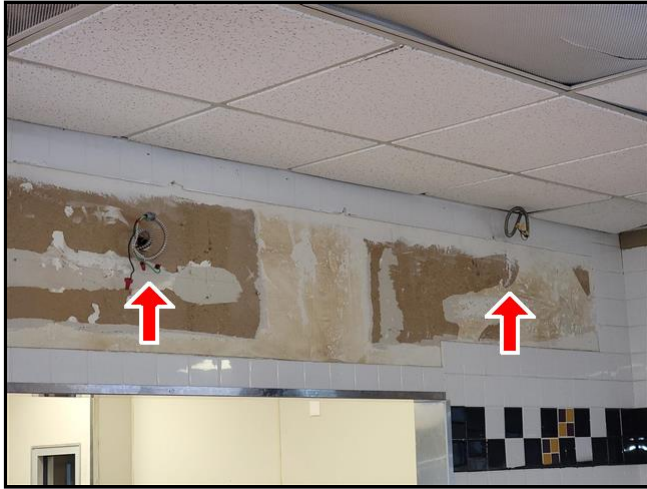
6.3 Item 13(Picture)

(9) Open wiring junctions above the retail counter needs properly terminated in covered junction boxes.

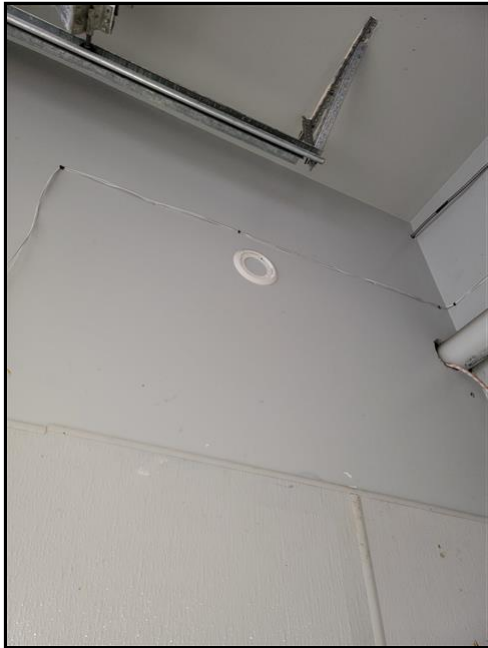
6.6 Item 1(Picture)

Garage bay smoke detector is missing. Recommend smoke and fire detection requirements be reviewed with the city building department prior to occupancy for any needed changes.

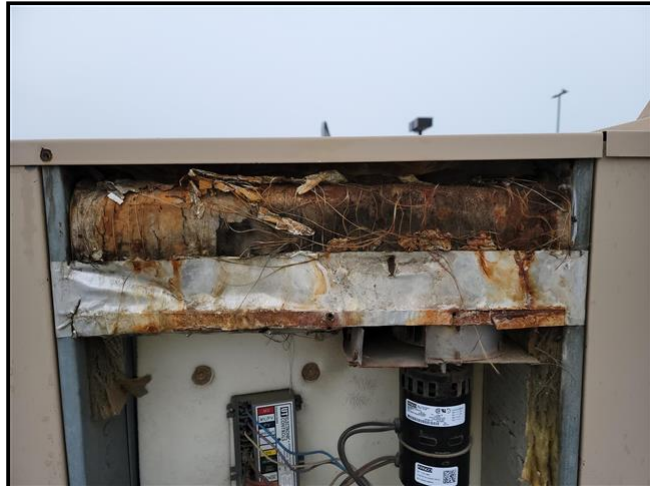
(1) Rooftop heaters were functional at the time of the inspection, but due to age and visible condition inside the units service and cleaning by a licensed heating contractor is recommended.

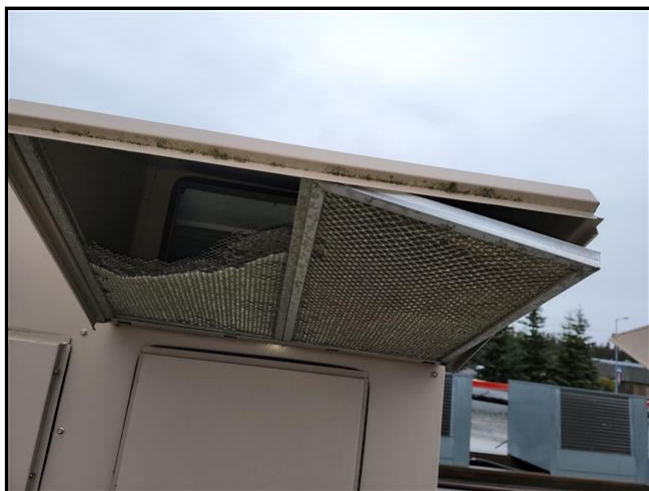
7.0 Item 5(Picture)

(2) Rooftop unit filters are deteriorated and need replaced.

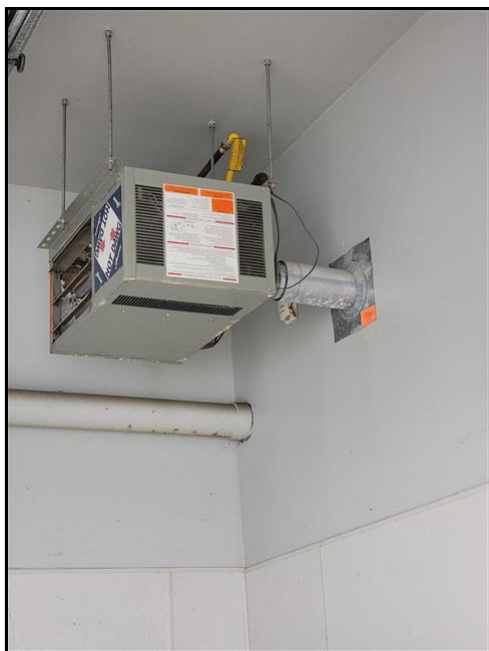
7.0 Item 6(Picture)

(3) The garage bay heater cycled repeatedly but never fired or came on during the inspection, needs checked by a licensed heating contractor.

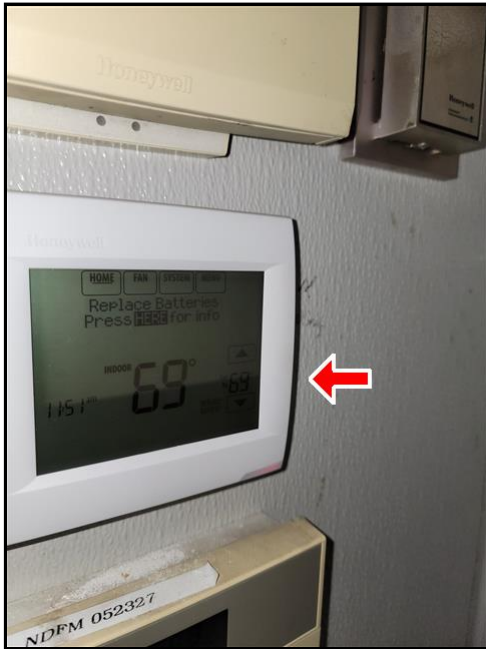
7.1 Item 1(Picture)

Newer digital heating system control has a low battery which needs replaced. Battery replacement is critical for this type of thermostat which may default the unit off or on if the battery goes dead.

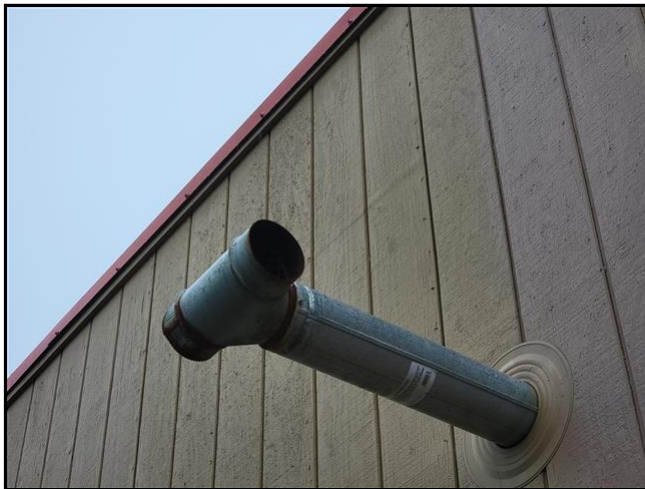
7.5 Item 1(Picture)

The garage bay unit heater vent is rusting at the exterior, rusted sections need replaced.

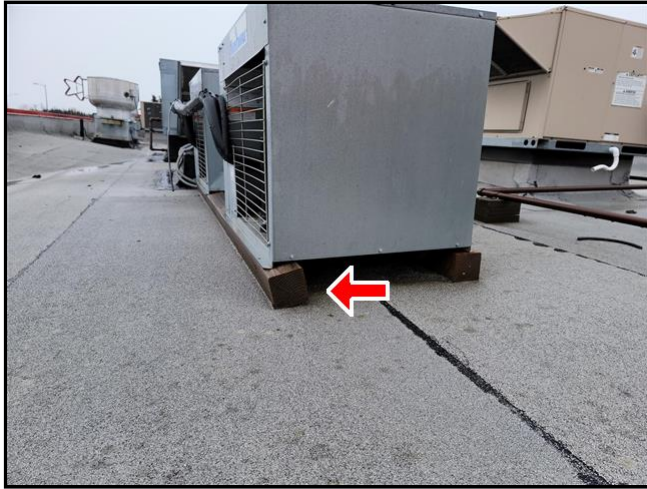
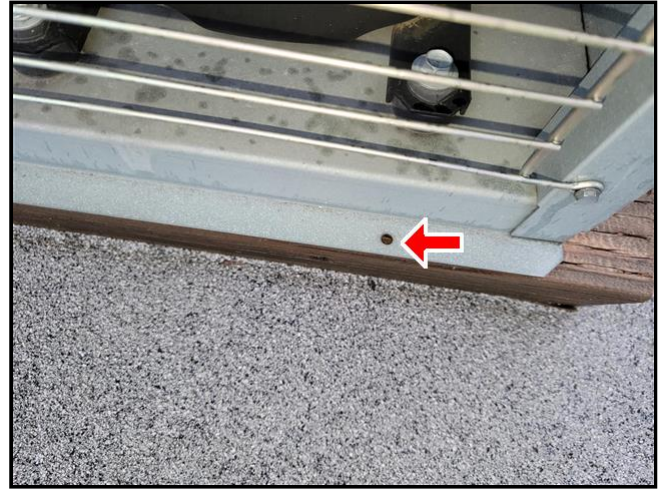
- (1) The function of the air conditioning systems was not tested due to cold outdoor temperatures which may damage the units. Recommend inspection and testing of the air conditioning by a qualified person.
- (2) South side rooftop condenser units are not fastened to the roof and the south skid is rolling over, repair needed.

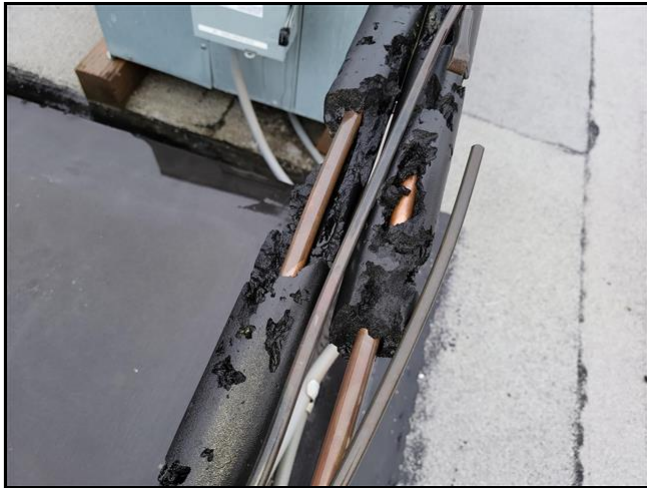
7.6 Item 3(Picture)

(3) Condenser line insulation on the rooftop is in poor condition and needs replaced for efficiency. Several of the lines have been cut off for unknown reasons and repair may be necessary.

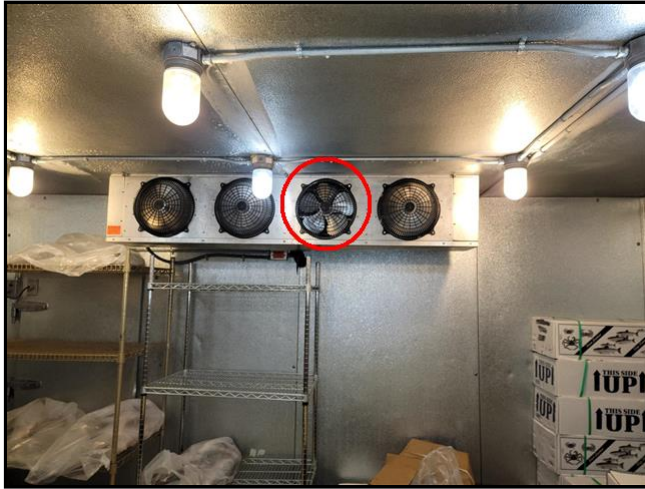
7.6 Item 4(Picture)

(4) The large walk-in cooler was functioning at the time of the inspection, but one of the evaporator fans was not working. Repair needed.

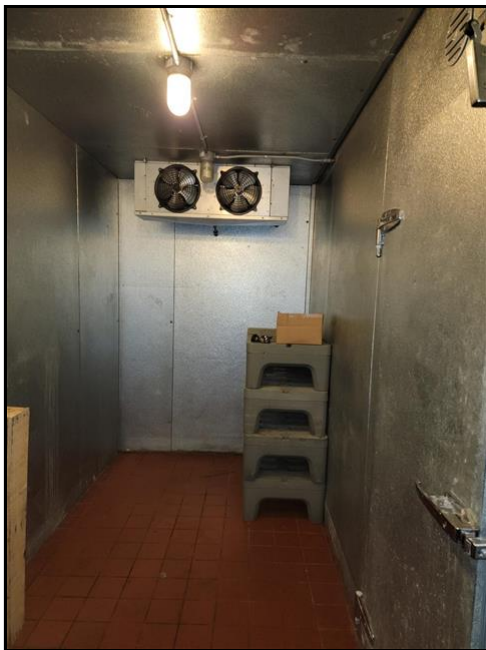
7.6 Item 5(Picture)

(5) Smaller walk in cooler was not operating at the time of the inspection.
