Inspection Report

Sample Report

Sample
Kenai AK 99611

Wisdom and Associates, Inc

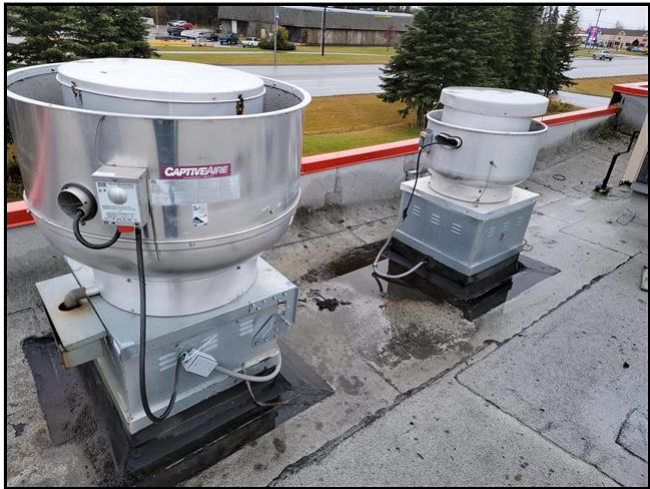
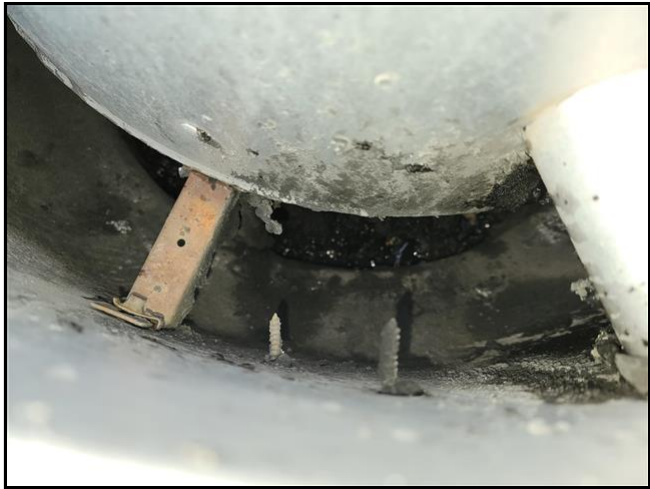
(1) Rooftop exhaust units were observed to have heavy grease buildup and need cleaned.

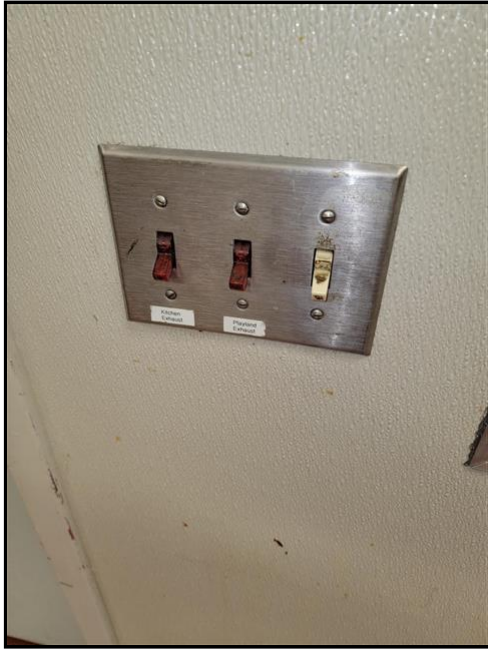
8.3 Item 5(Picture)

(2) Kitchen and play area exhaust did not operate when switched on.

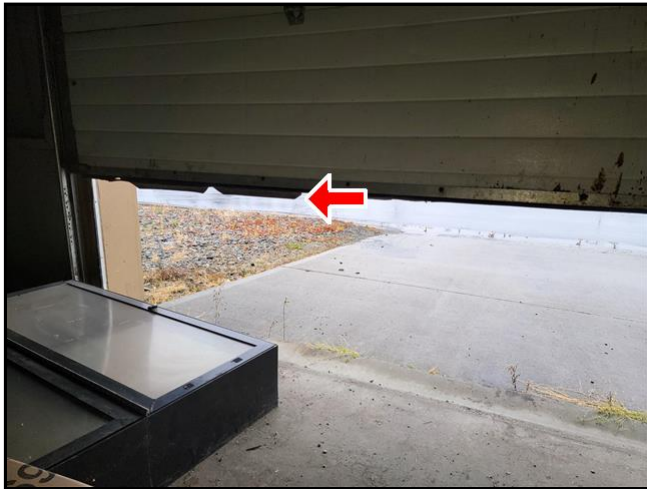
10.3 Item 1(Picture)

(1) The bottom garage overhead door trim is damaged.

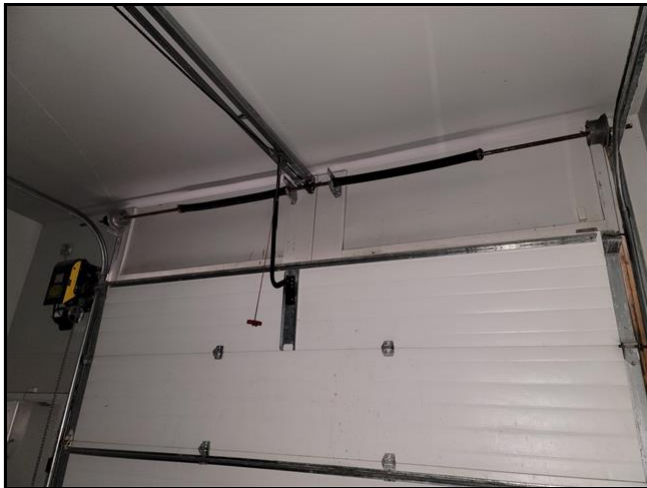
10.3 Item 2(Picture)

(2) The garage overhead door is loose and daylight is visible at the sides and top in the closed position. Improving the weather stripping and fit is recommended for energy efficiency and to prevent weather intrusion.
