# Inspection Report

## Sample Report

123 Anywhere  
Soldotna AK 99669

**Wisdom and Associates, Inc**

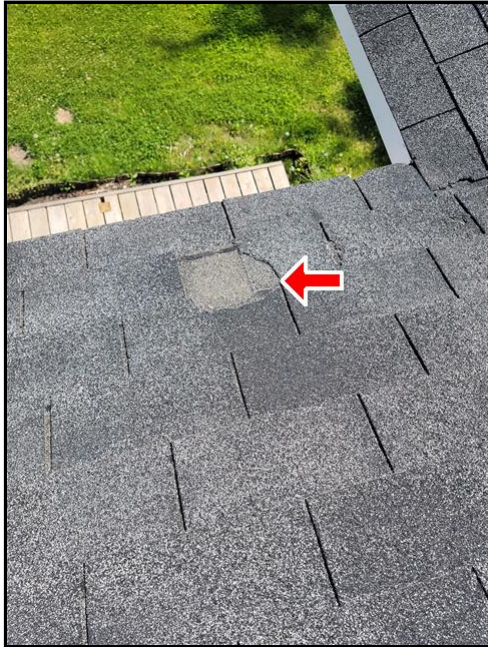
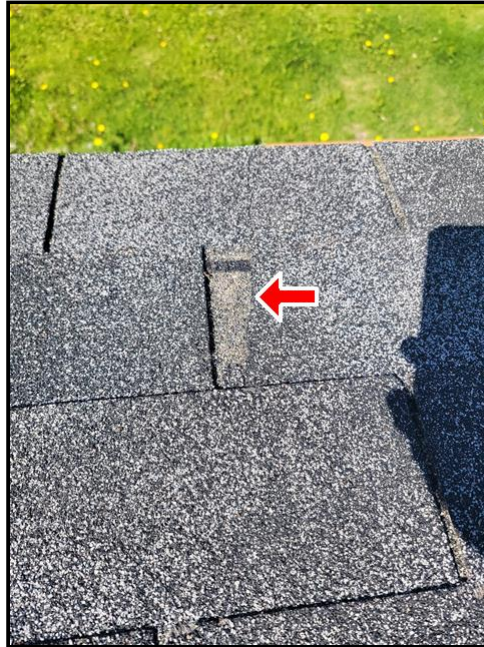
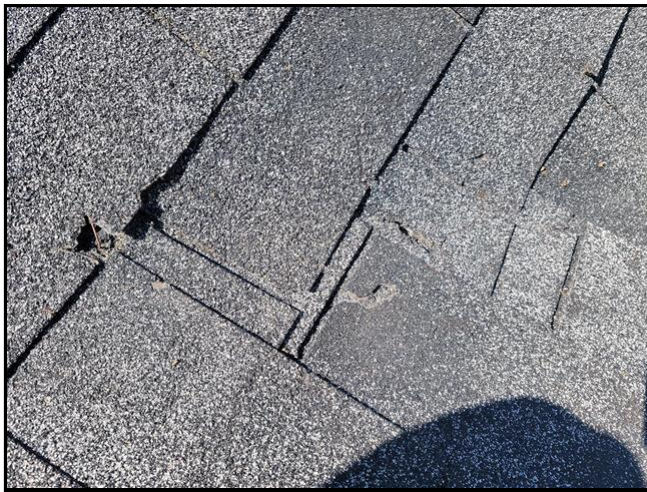
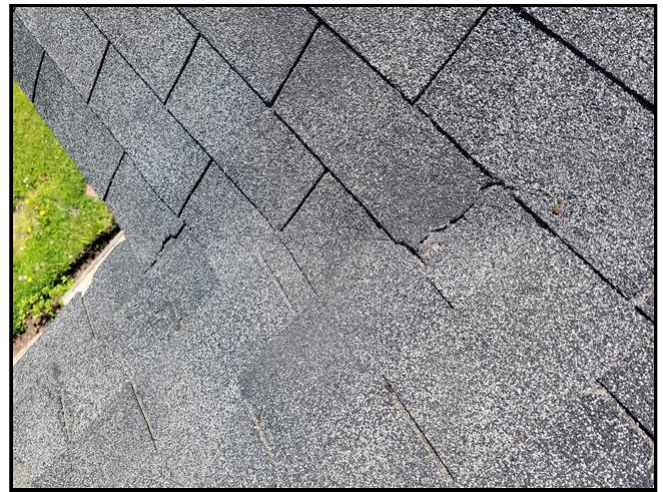
Minor shingle damage is present at the bottom of the roof valleys, and there are two torn shingles. Repair needed.

Water damage is present at the roof sheathing at the bottom of both roof valleys. Water damaged materials need removed and replaced. Recommend installation of ice and water shield in the bottom part of the valleys to prevent future leakage.

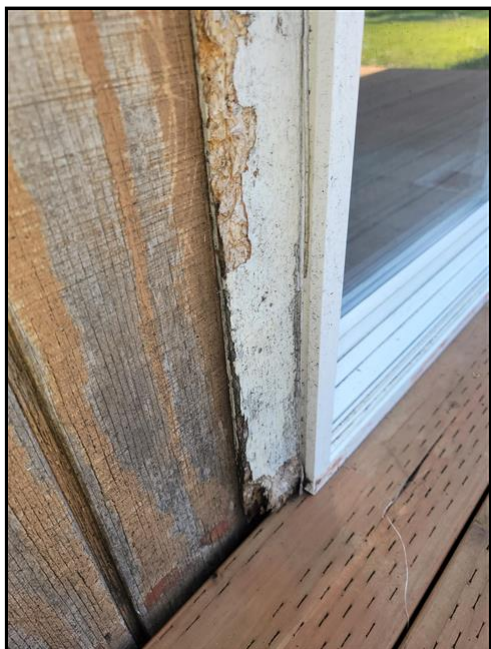
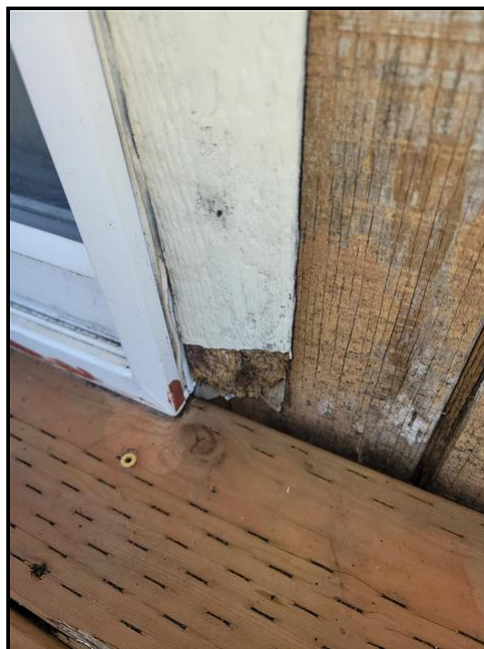
(1) Exterior trim at the bottom of the sliding glass door is water damaged and needs replaced.

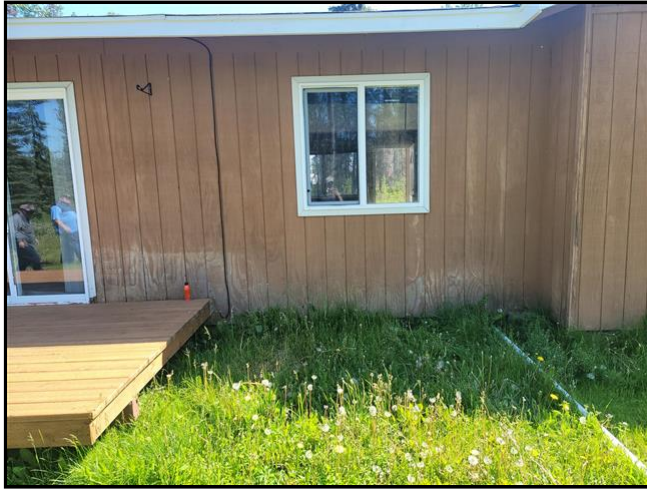
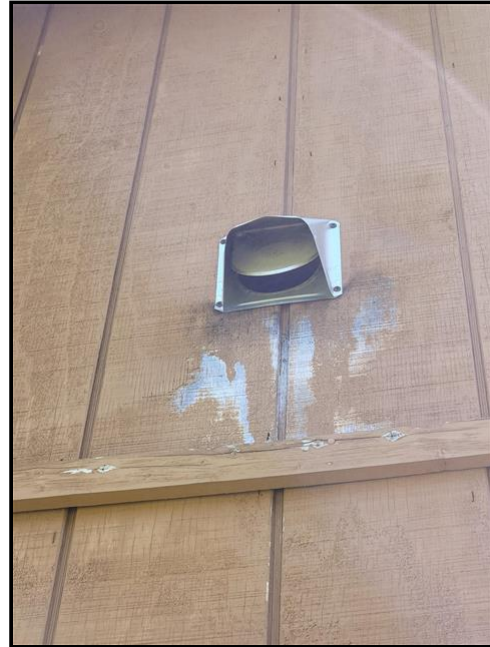
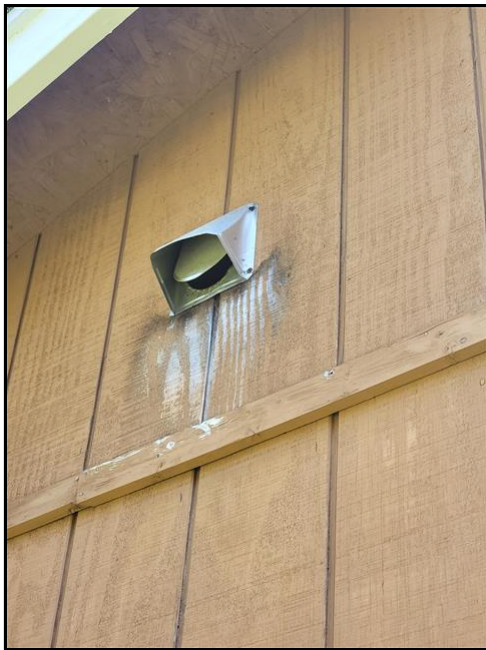
(2) Exterior siding finish is deteriorating in areas, siding will need re-finished in the near future to prevent decay.

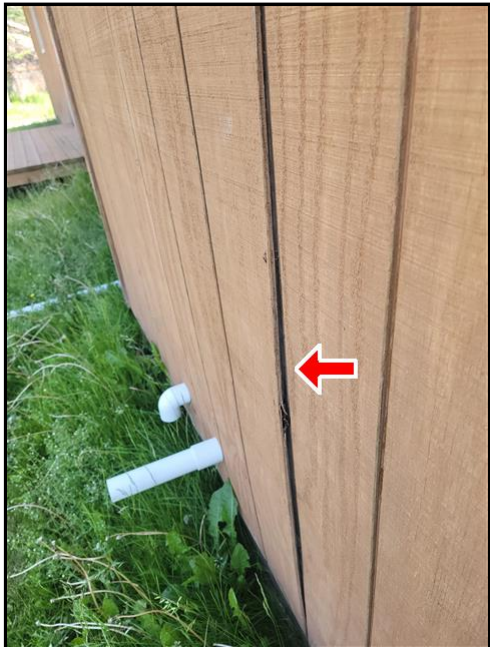
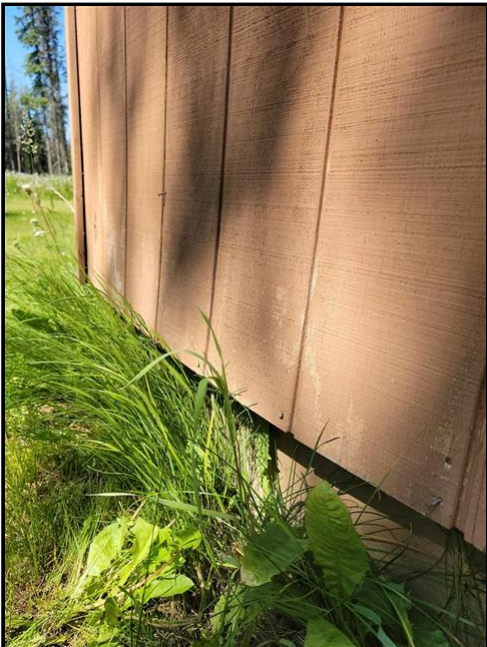
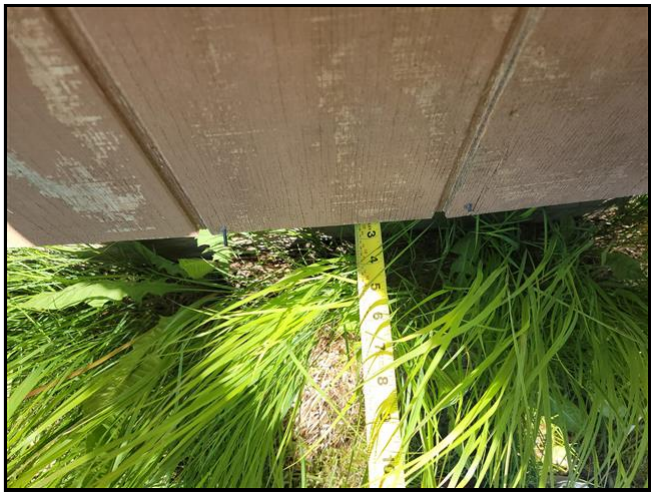
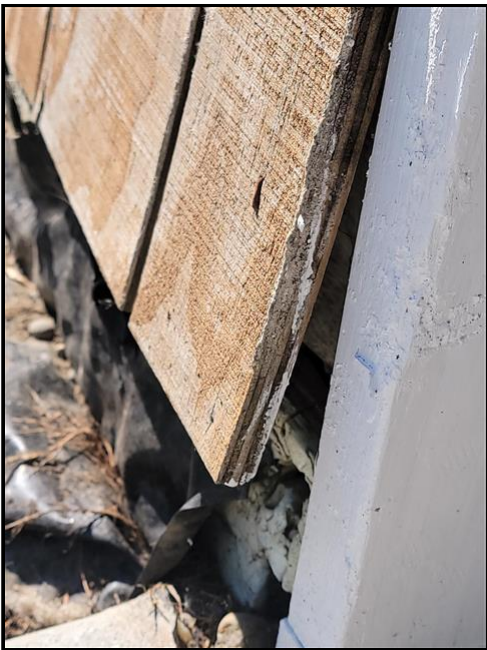
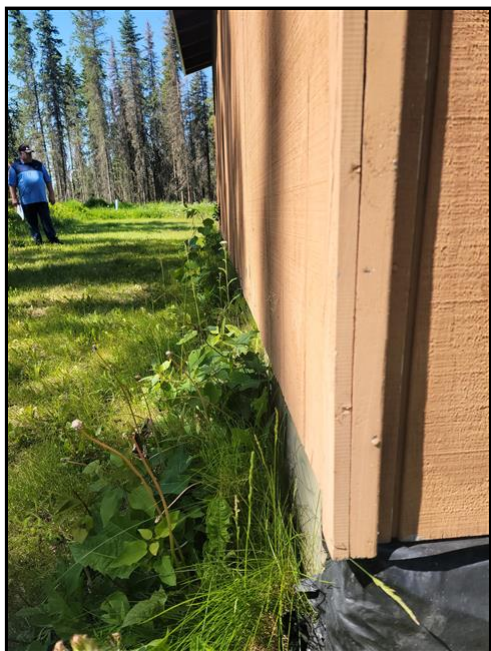
(3) Siding is loose in several areas around the exterior, siding needs re-fastened. Recommend having a contractor check the exterior wall to foundation connection on the south side of the house as there is a substantial overhang that may indicate something more serious such as foundation displacement.

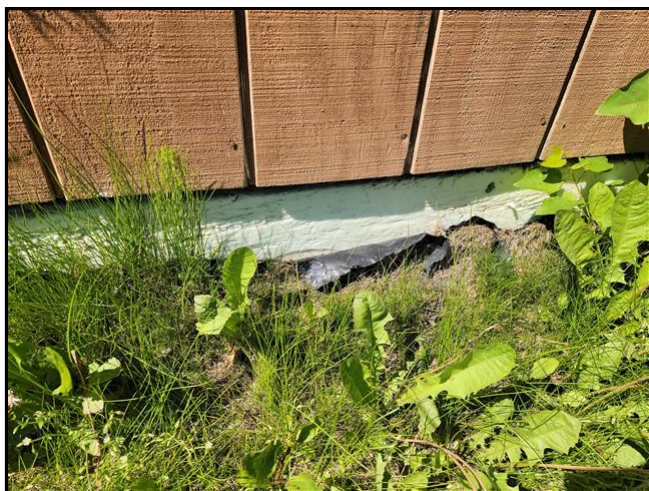
2.0 Item 11(Picture)

(4) Exposed foam insulation at the exterior needs covered to prevent damage and UV decay from sunlight.

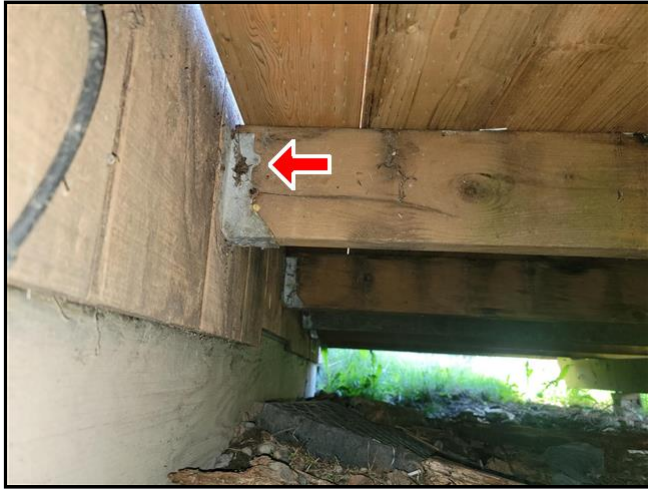
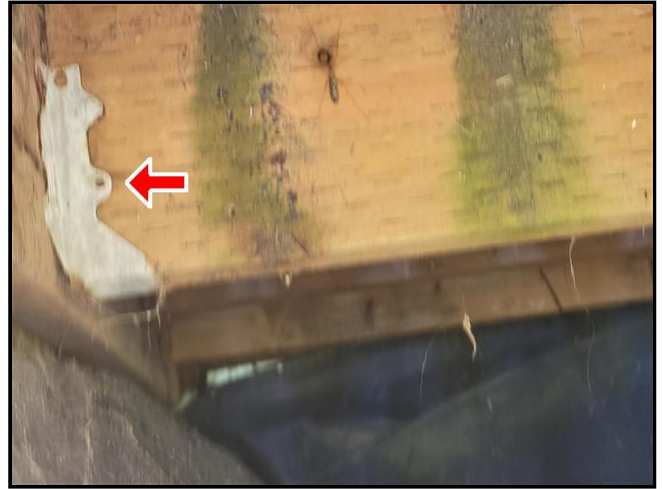
(1) Missing fasteners at deck joist hangers on both sides of the home need installed.

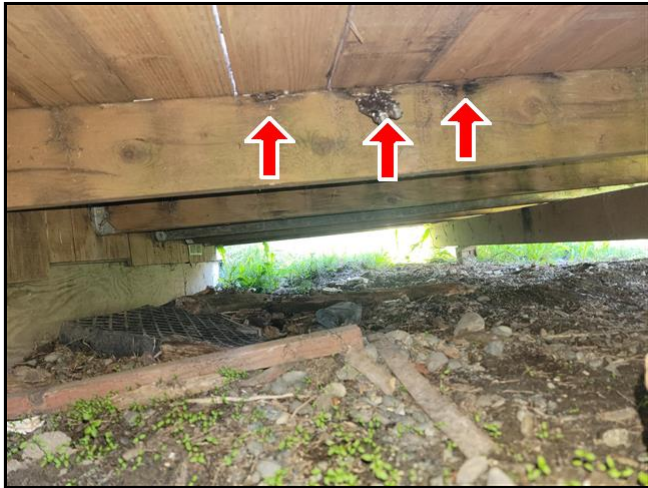
2.3 Item 3(Picture)

(2) Water damage is present at some of the deck joists at the west facing deck, water damaged boards need replaced.

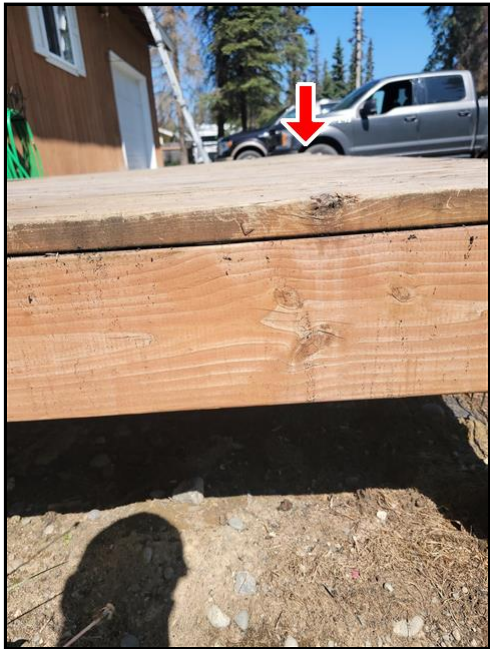
2.3 Item 4(Picture)

(3) There is some elevation in the surface of the east deck at the northeast corner, likely from frost heave.

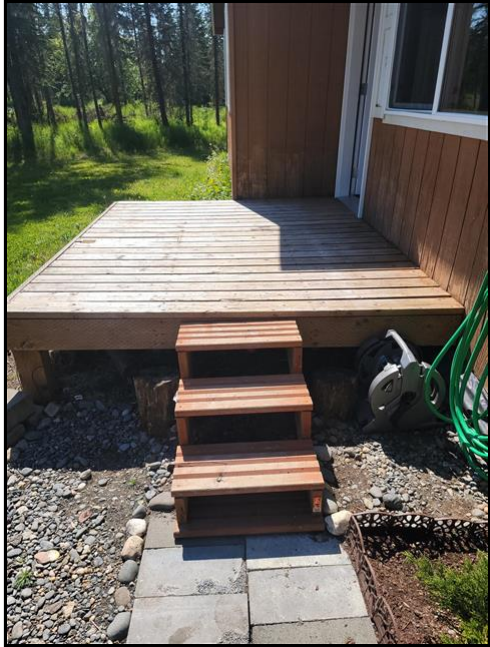
2.3 Item 5(Picture)

(4) A handrailing is needed at one side of the east deck steps for fall protection.

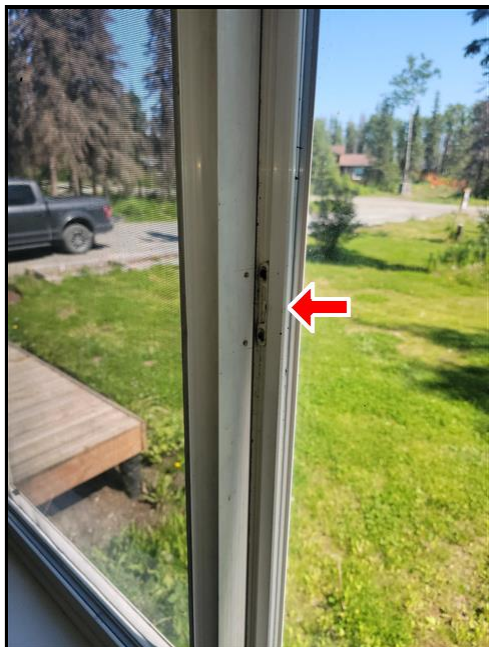
3.6 Item 1(Picture)

North bedroom on the east side of the home is missing the latch.

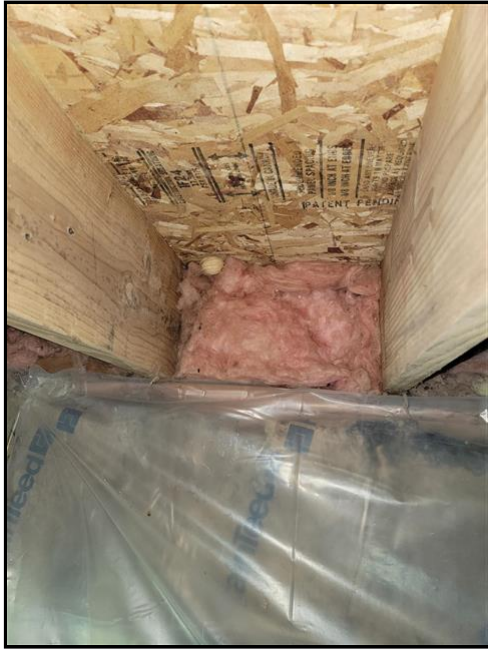
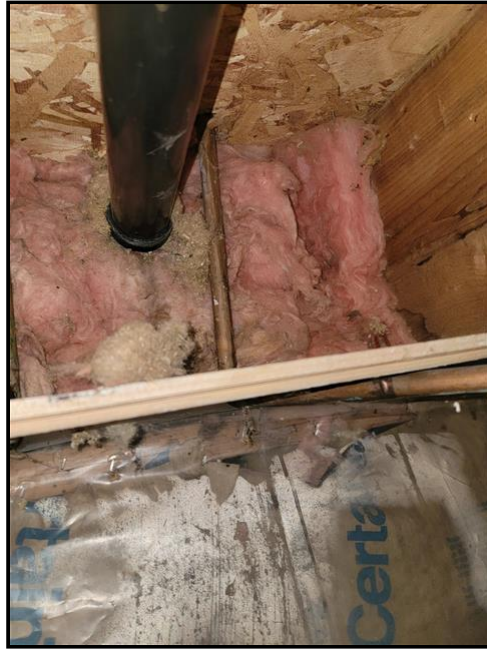
There is evidence of carpenter ants and/or other pests in the crawlspace, needs checked by a licensed pest contractor.

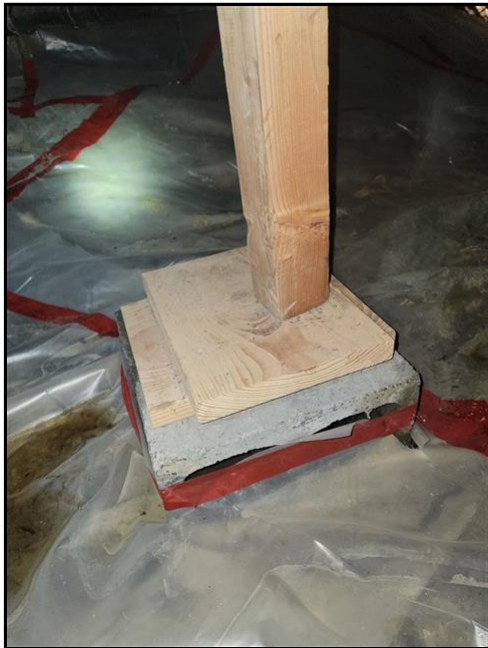
4.2 Item 1(Picture)

(1) Many of the support columns in the crawlspace are not anchored or secured to the footings, recommend securing the posts to prevent displacement during an earthquake.

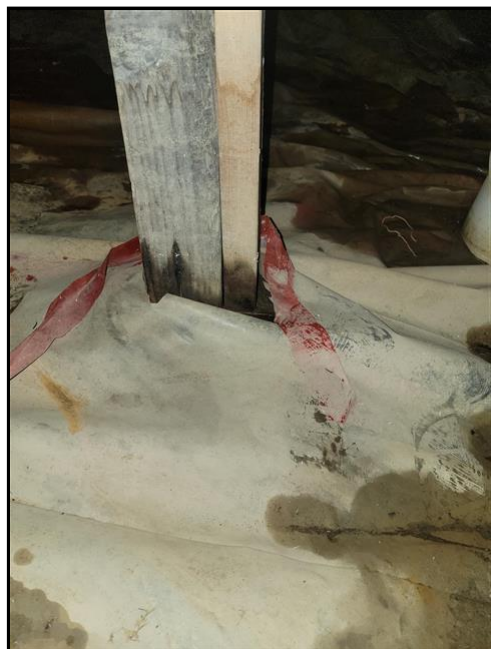
4.2 Item 2(Picture)

(2) Post supports in the crawlspace are not pressure treated and will likely be subject to decay over time due to the amount of water on the crawlspace floor.

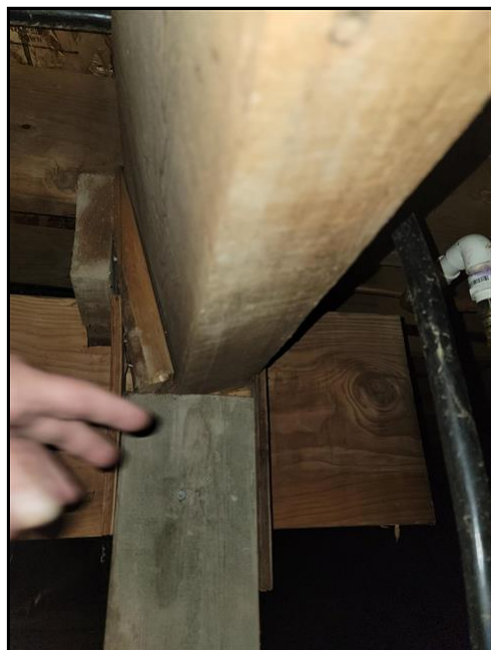
4.3 Item 1(Picture)

(1) Floor support beam in the crawlspace is significantly twisting, repair needed by a licensed contractor.

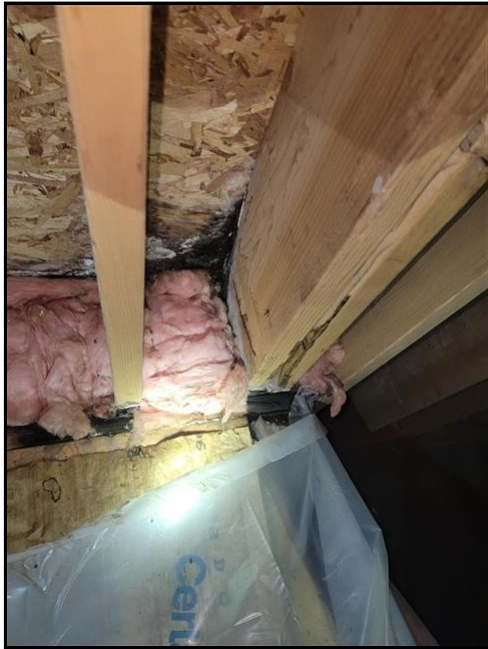
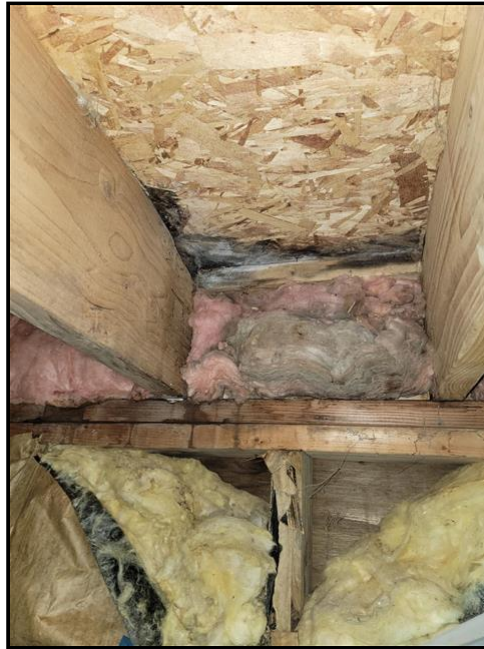
(2) Water damage is present at the east wall of the crawlspace in the floor system and rim joist below the exterior entry. Water damaged wood needs removed and replaced, source of moisture needs identified and corrected.

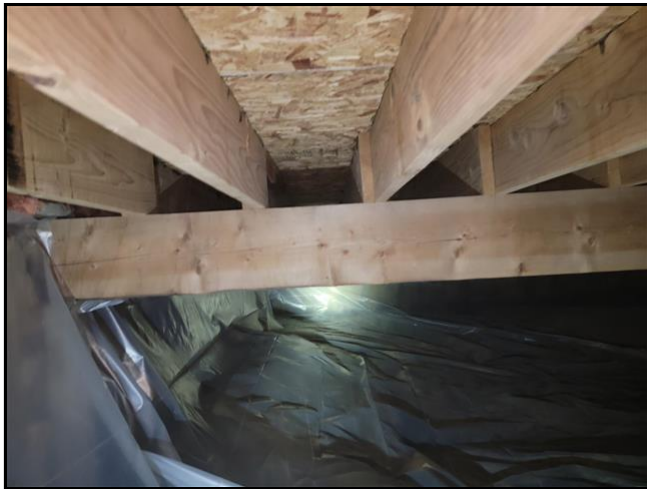
4.3 Item 4(Picture)

(3) Solid blocking is missing where the floor joists cross over the bearing beam in the crawlspace.

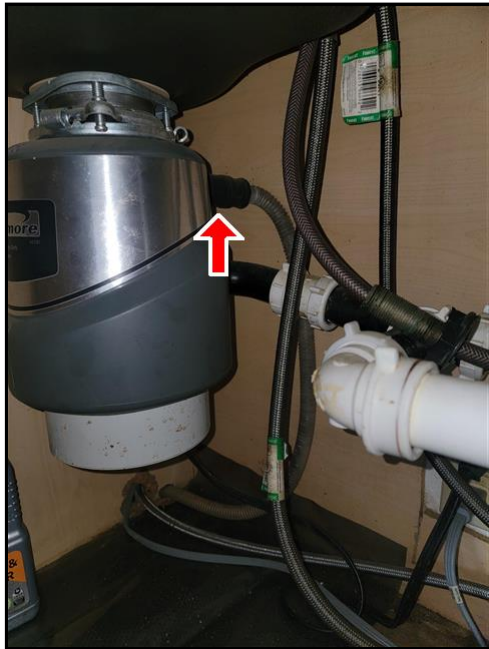
5.0 Item 1(Picture)

(1) Dishwasher drain is connected directly to the sink drain which is sanitary hazard. An air gap fitting or high loop needs installed to prevent cross contamination.

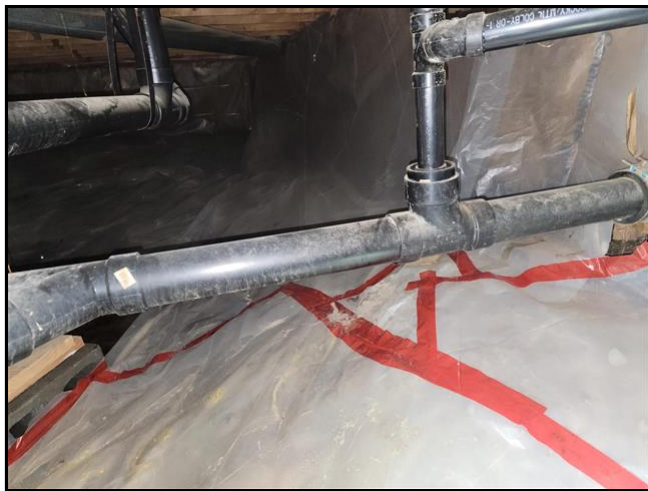
5.0 Item 2(Picture)

(2) The main building drain does not appear to have adequate downward slope where exiting the building which may result in clogging and backups.

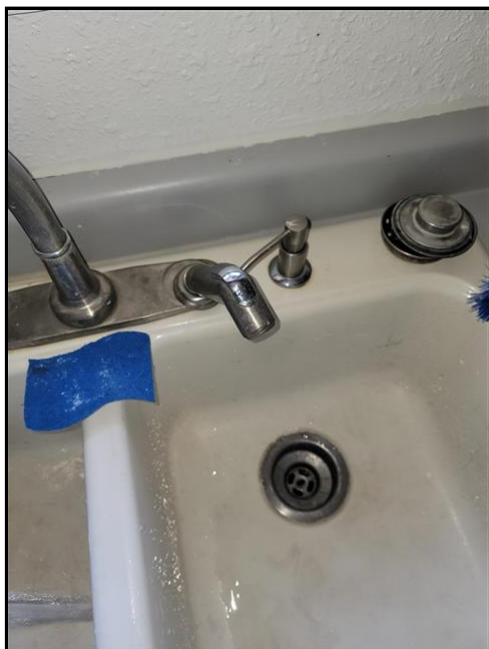
5.1 Item 1(Picture)

(1) The kitchen sink sprayer handle is loose.

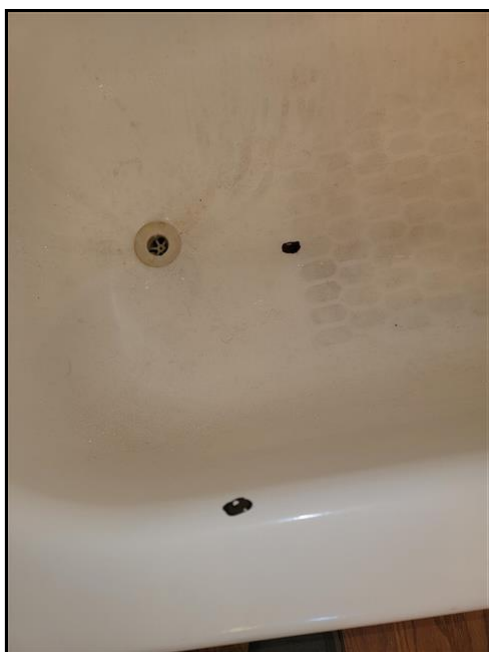
5.1 Item 2(Picture)

(2) The hallway bathroom tub enamel is chipped which may lead to premature rusting of the tub.

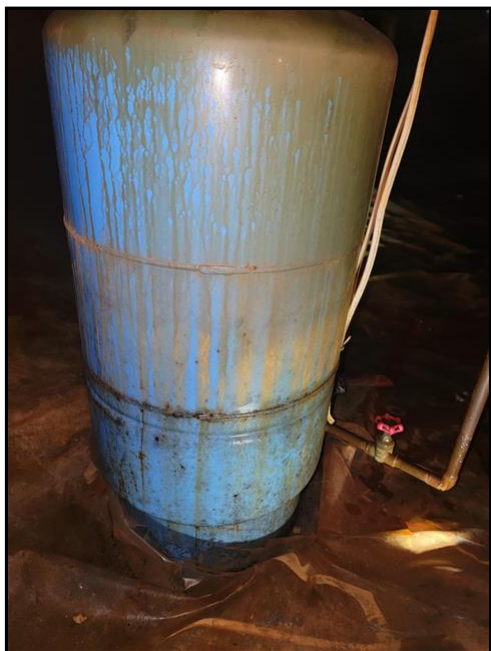
5.1 Item 3(Picture)

(3) The well pressure tank in the crawlspace is rusting and may need replaced in the near future.

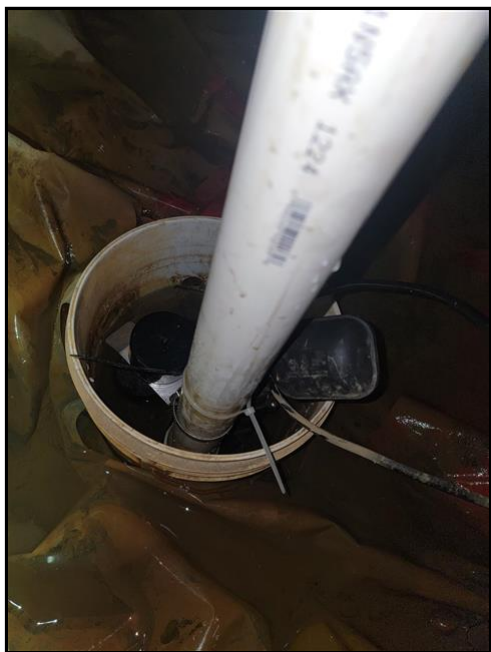
5.6 Item 1(Picture)

(1) Standing water is present on the crawspace floor, sump pump needs adjusted to evacuate all standing water above floor level.

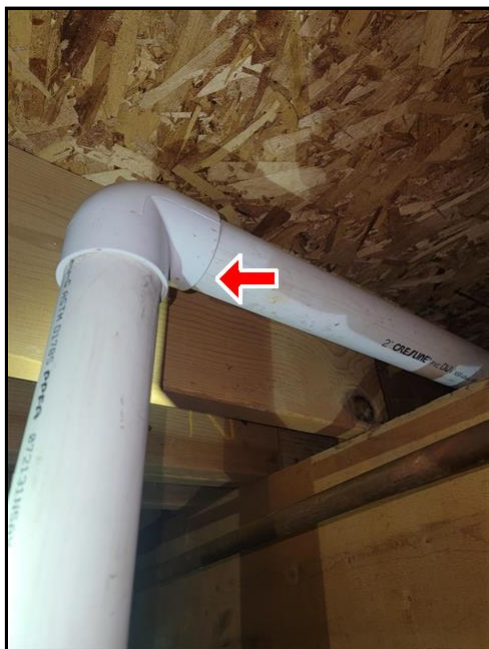
5.6 Item 2(Picture)

(2) Leak was noted at the joint above the sump pump in the crawlspace when pump was tested.

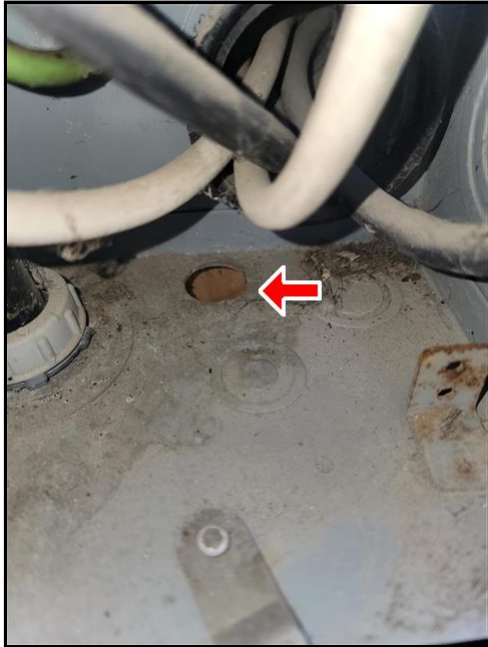
6.1 Item 1(Picture)

(1) Open knock-out at the base of the exterior electrical disconnect box needs covered to prevent pest entry.

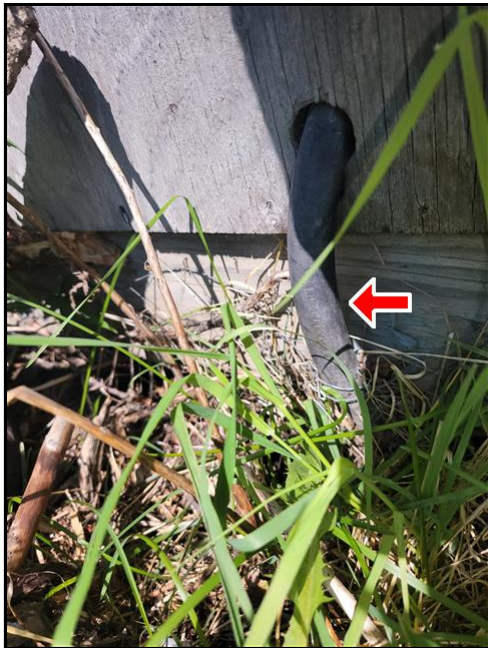
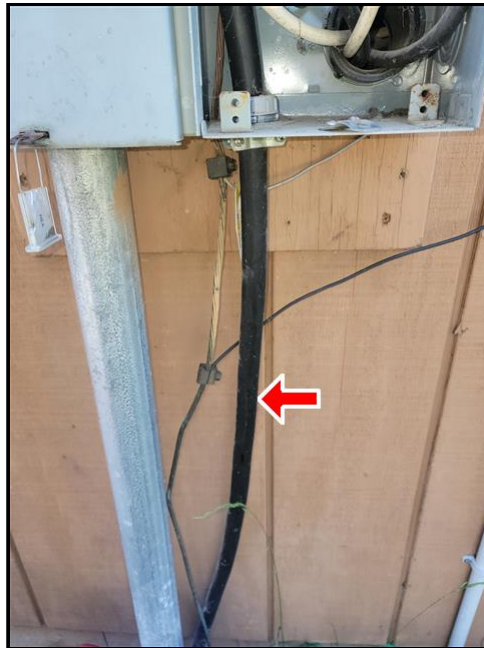
(2) Exterior electrical cabling serving the detached shed needs placed in conduit for protection against damage.

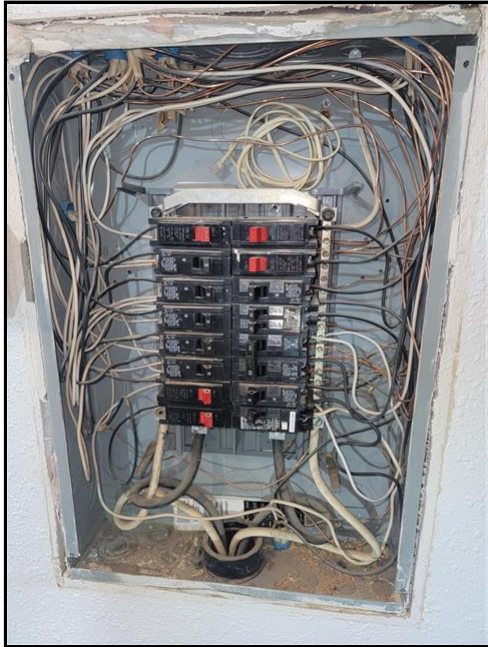
6.1 Item 4(Picture)

(3) Grounding of the electrical panel enclosure could not be determined during the inspection, recommend further evaluation by a licensed electrician.

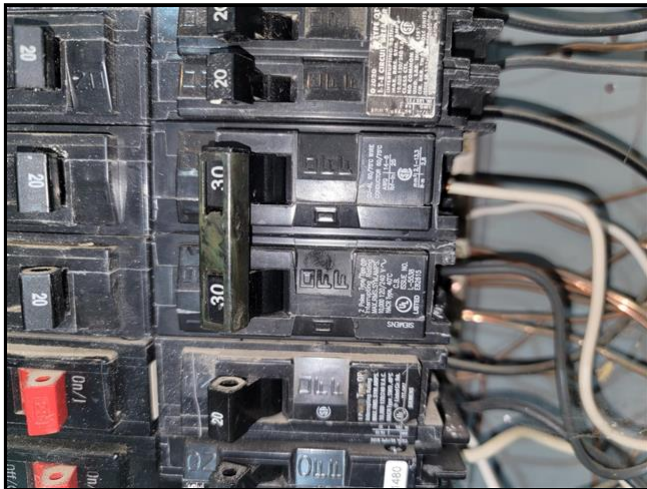
6.2 Item 1(Picture)

30 amp breaker in the electrical panel is oversized for the connected wiring, needs replaced with correct size by a licensed electrician.

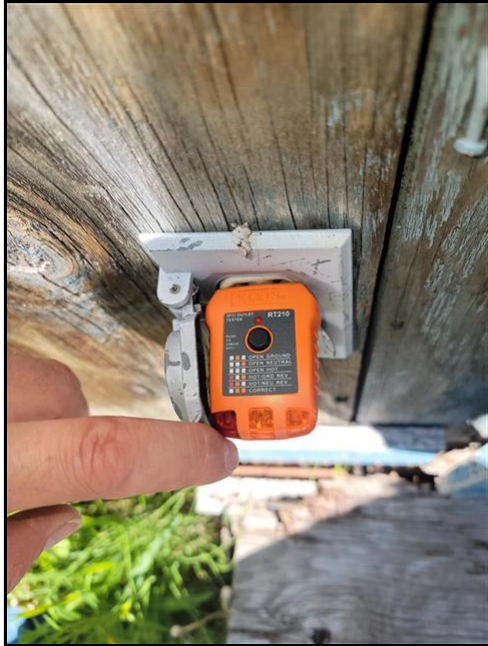
6.3 Item 1(Picture)

(1) Open neutral is present at the detached shed receptacle, repair needed. No access is present to the inside of the shed for further inspection.

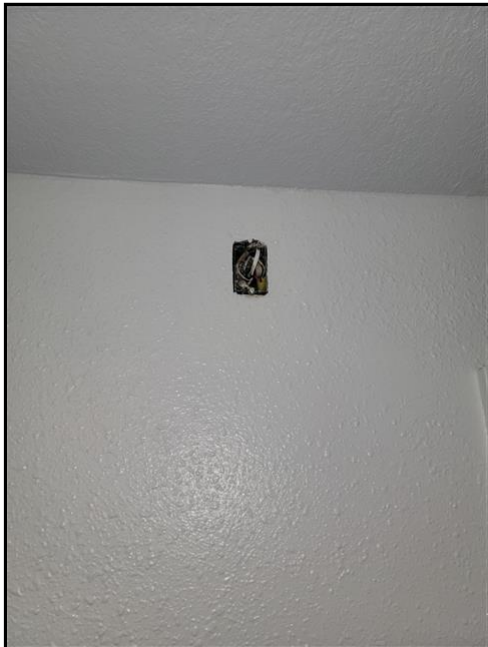
6.6 Item 1(Picture)

Missing smoke alarms need replaced.

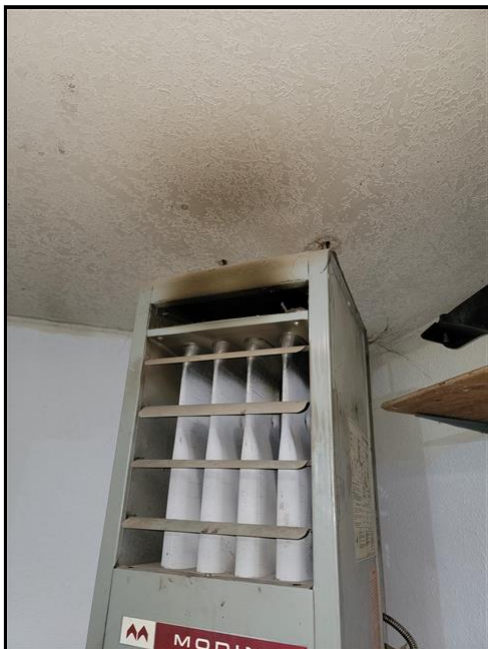
7.0 Item 1(Picture)

(1) Heavy sooting is present at the top of the unit heater draft diverter, service is needed by a licensed heating contractor.

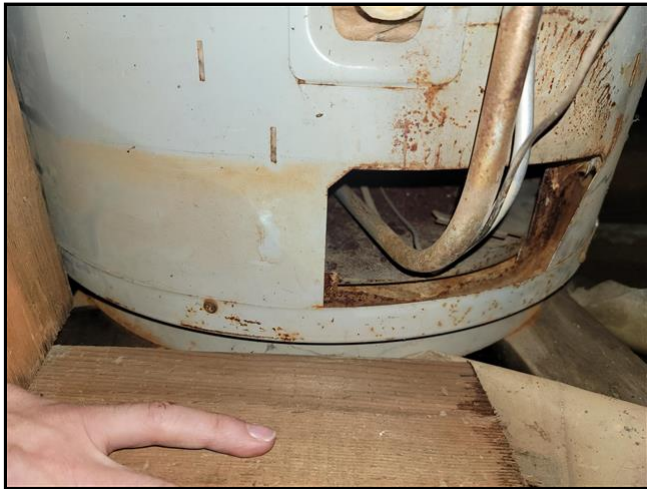
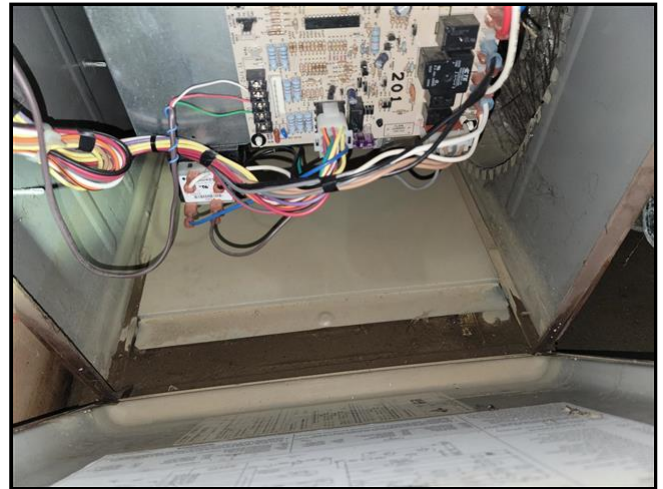
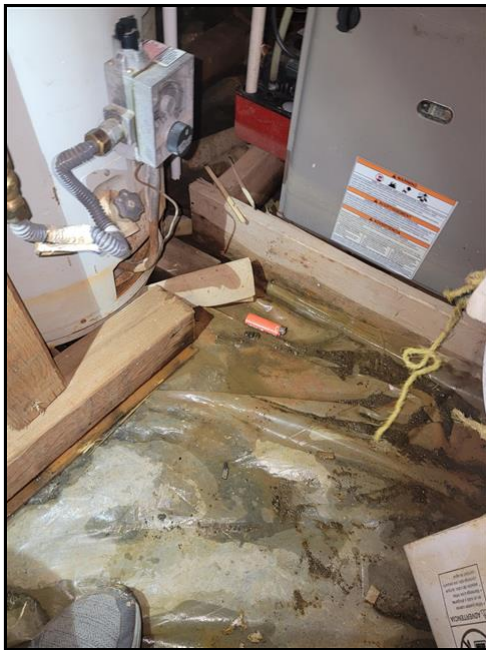
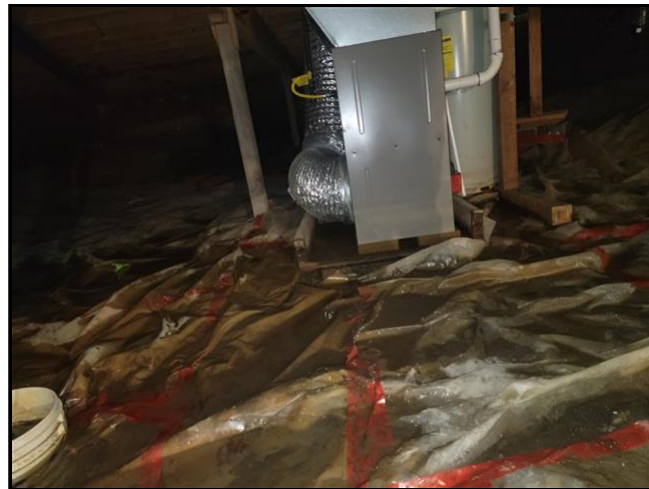
(2) The water heater and furnace have a high water mark on the side indicating that these appliance have been flooded at some point. Both appliances need checked and serviced by a licensed heating contractor. These appliances need placed on permanent, decay resistant platforms above the grade level of the crawlspace.

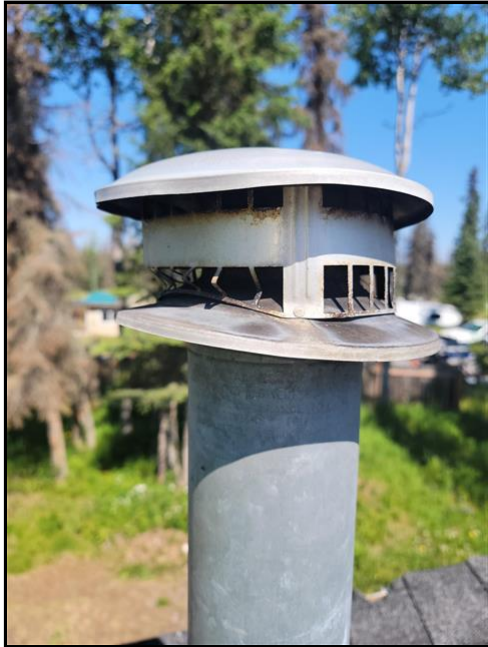
7.5 Item 1(Picture)

(1) Unit heater chimney cap is damaged and needs replaced.

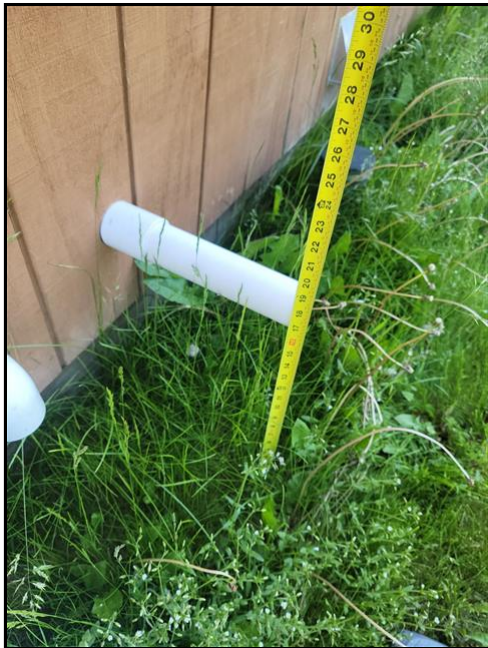
7.5 Item 2(Picture)

(2) Recommend elevating the furnace air intake and exhaust to at least 24 inches above grade level to prevent potential snow closure.

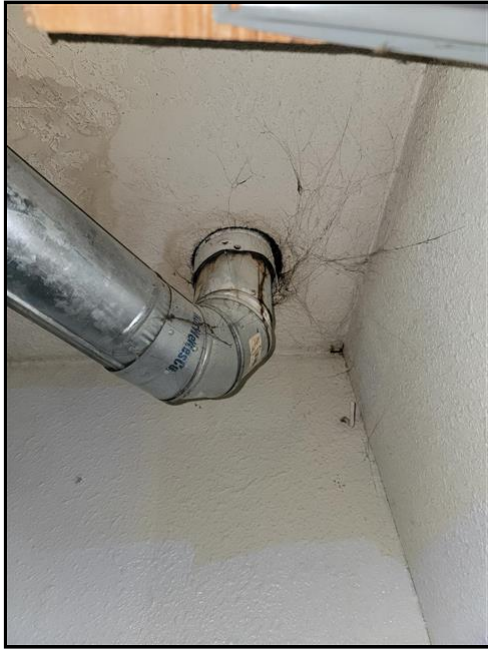
7.5 Item 3(Picture)

(3) The unit heater chimney is too close to combustible material (drywall) where it passes through the garage ceiling. A minimum 1 inch clearance is needed along with a firestop.

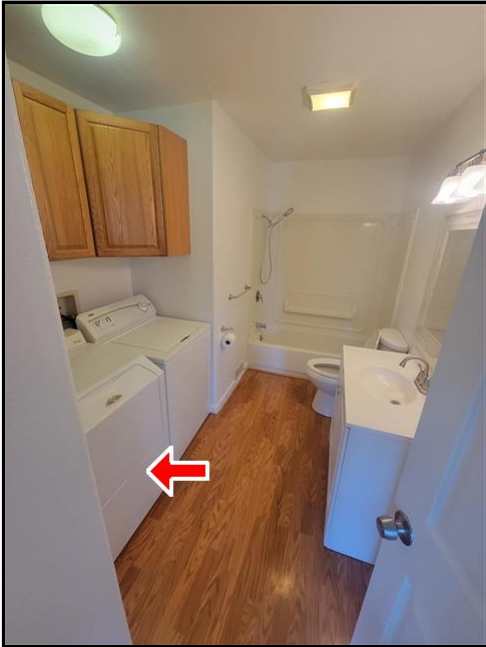
8.5 Item 1(Picture)

(1) A gas fired clothes dryer is located in the bathroom. Open combustion appliances which take air from the room in which they are located are considered a safety hazard in bedrooms or bathrooms as these are rooms where the door is normally closed during occupancy and there is potential for carbon monoxide or other hazards.

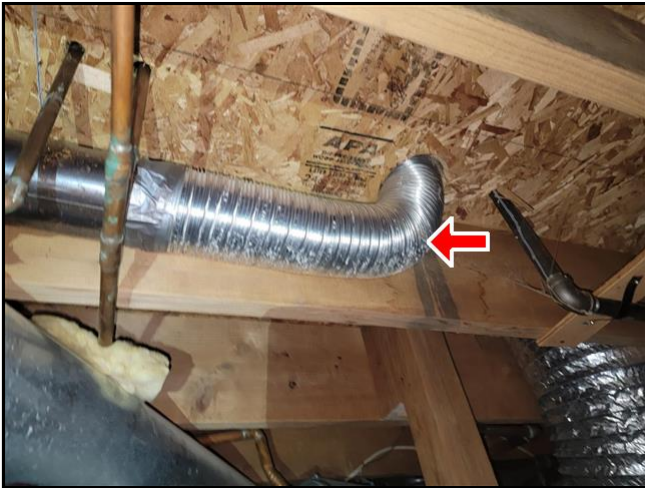
8.5 Item 2(Picture)

(2) Flexible ducting has been used to vent the clothes dryer in the crawlspace. Flexible ducting is only permitted from the unit to the floor or wall. Flexible ducting needs replaced with a smooth walled metal duct which will not trap lint. Ducting should be sealed at the joints.

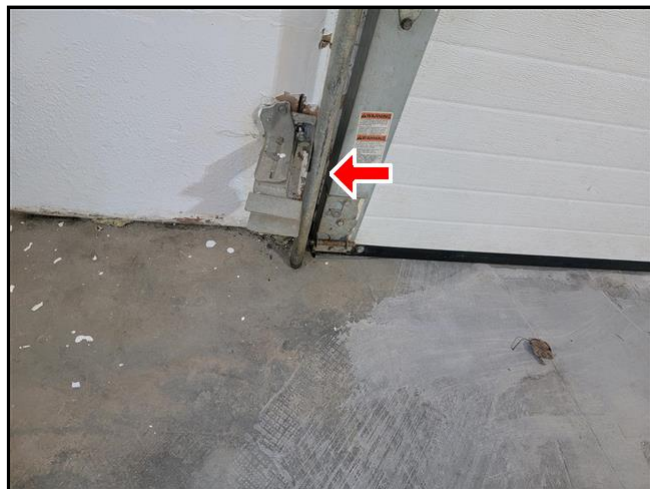
10.6 Item 1(Picture)

- 10.6 GARAGE INTERIOR**  
**Inspected, Repair or Replace**  
The left side garage overhead door safety eye is missing and needs replaced.
