# Windstorm Mitigation Affidavit Report

Eastwood Pines Townhomes  
2944-62 Pine Cone Cir  
Clearwater, FL 33760

Prepared Exclusively for Eastwood Pines Townhomes Association, Inc.  
As of 08-06-2026 | FPAT File# MUD2626355

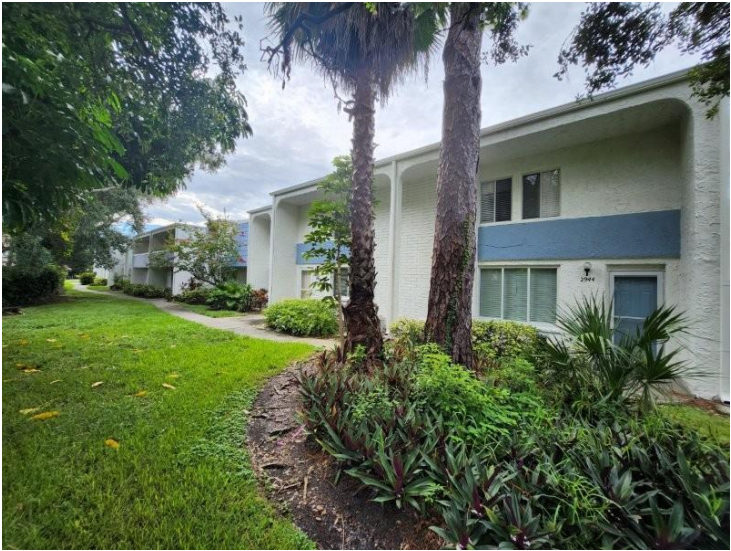
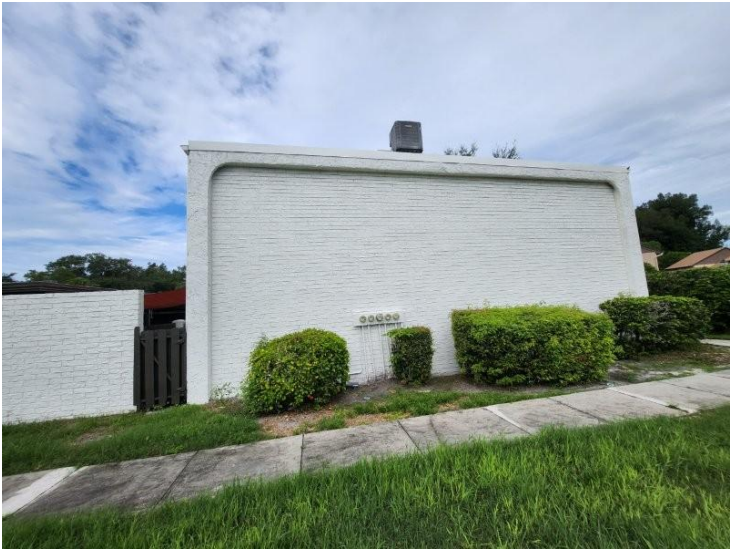
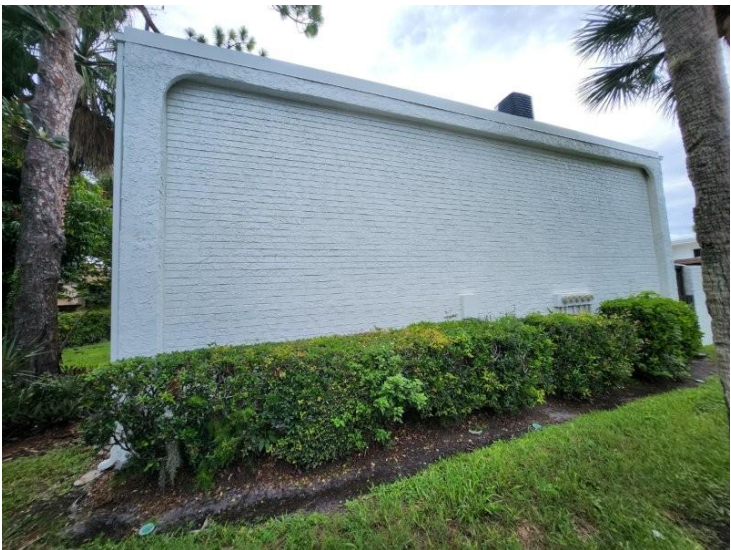
Exterior Elevation

| <b>9. Opening Protection:</b><br>Comments: | <b>X. None or Some Glazed Openings</b><br>Inspection verified some opening protection. Not all glazed openings were protected with impact resistant coverings. |

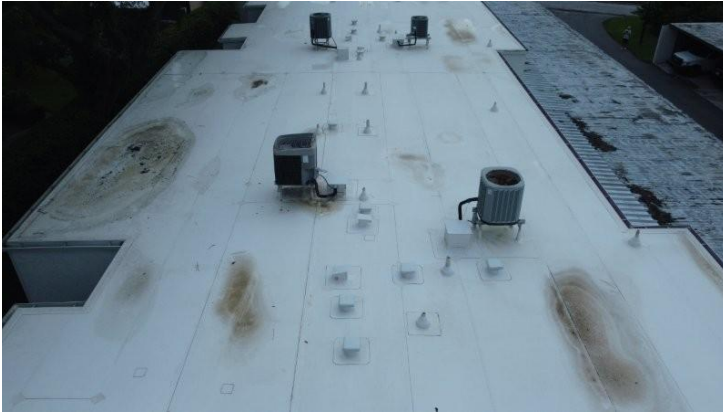
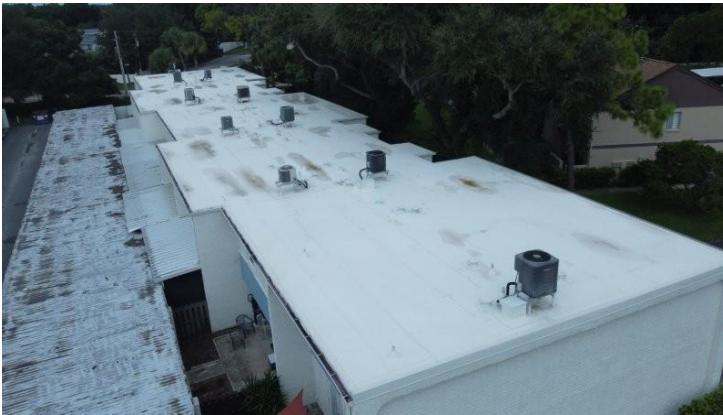
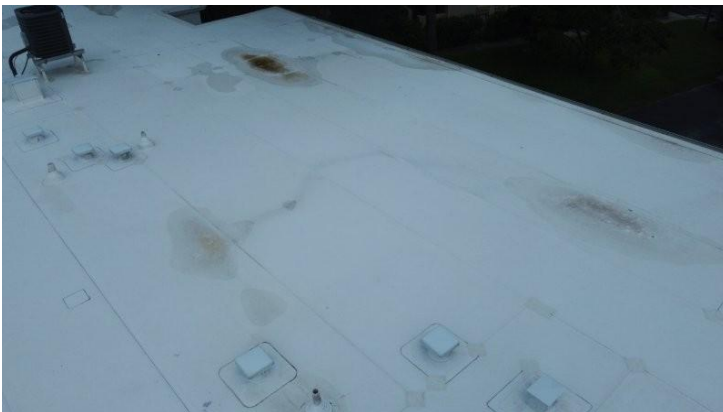
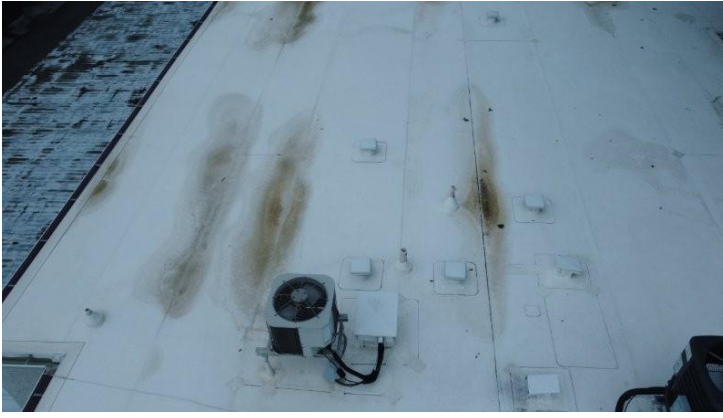
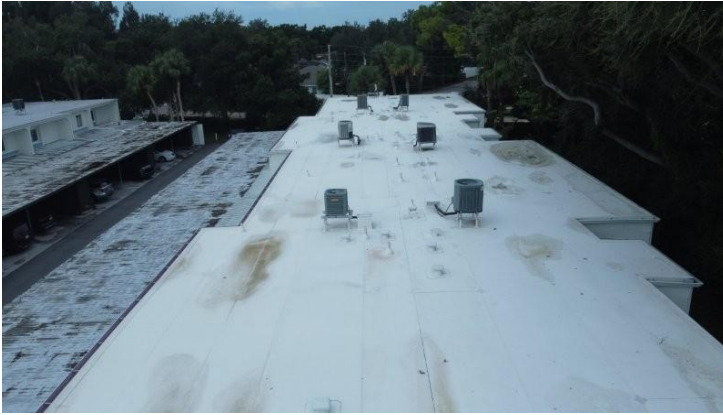
Roof Construction

| <b>4. Roof Covering:</b><br>Comments: | <b>A. FBC Equivalent</b><br>The roof covering was replaced in 2020. The roof permit was confirmed and the permit number is CW20-13160. This roof was verified as meeting the building code requirements outlined on the mitigation affidavit. |
| <b>7. Roof Geometry:</b><br>Comments: | <b>B. Flat Roof</b><br>Inspection verified flat roof shape, refer to attached photographs. |

Online Building Permit RFRFLT  
RE-ROOF ENTIRE ROOF: BLDG 7 2944- 2962 PINE CONE  
CIRCLE. TEAR ROOF DOWN TO DECK, INSTALL 1/8" PER  
FOOT ISO INSULATION AND MULE HIDE TPO FL APPROVAL  
CODE 10702.1
