# Uniform Mitigation Verification Inspection Form

| Owner Name: EASTWOOD PINES TOWNHOMES | | Contact Person: |
| Address: 1831-1845 PINE CONE CIR | | Home Phone: |

# Owens Construction & Inspection Services LLC

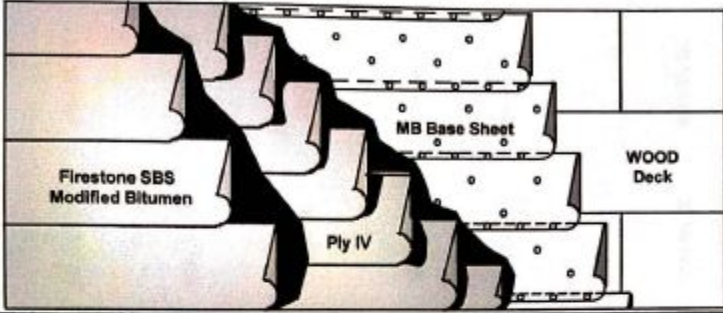
| Typical Assembly | | |

| <b>Slope:</b> Positive drainage up to 1 Inch per foot. For slopes above 1 Inch per foot, backnailing of the Ply IV sheets and cap sheet is required. | | |
| <b>Deck:</b><br>Min. 1/2" plywood/OSB<br><br><b>Base Sheet:</b><br>Firestone MB Base: Mechanically fasten in accordance with Firestone Technical Specifications or Florida code which ever is more stringent.<br><br><b>Interply:</b><br>2 plies Firestone Type IV Glass Ply. Apply in a continuous mopping of hot steep asphalt.<br><br><b>Cap Sheet:</b><br>1 ply Firestone SBS Modified Bitumen cap sheet: Apply in a continuous mopping of hot steep asphalt. | <b>Flashing:</b><br>Firestone SBS cap sheet over SBS base sheet. Apply in a continuous mopping of hot steep asphalt.<br><br><b>Surfacing:</b><br>None required for mineral surfaced membrane.<br><br><b>Asphalt:</b><br>ASTM D-312. Type IV asphalt by Anchor-Matcon.<br><br><b>Warranty:</b><br>This assembly when installed to Firestone's technical specifications and by a Firestone certified contractor qualifies for a full system labor and material warranty for up to 15 years. | |
