Prairie Home Inspections

SUMMARY REPORT

Client: Sample Sample
Inspection Address: 123 456th st, Anytown, MN
Inspection Date: 7/1/2020 Start: 9:00 am End: 12:00 pm
Inspected by: Daniel Geving

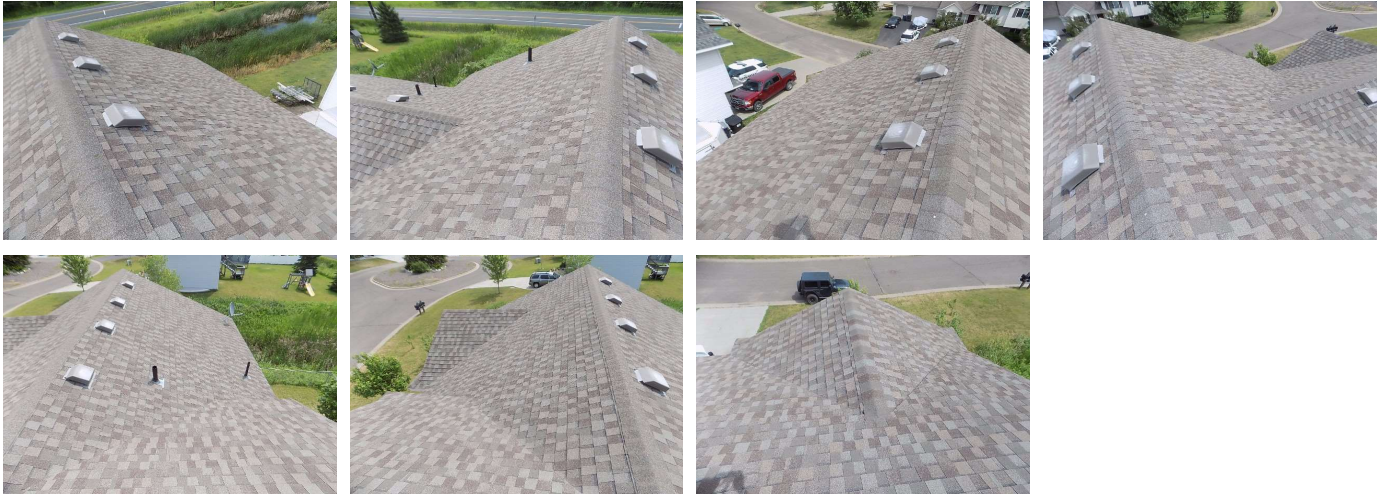
- * The asphalt shingle roof was inspected by walking on it.

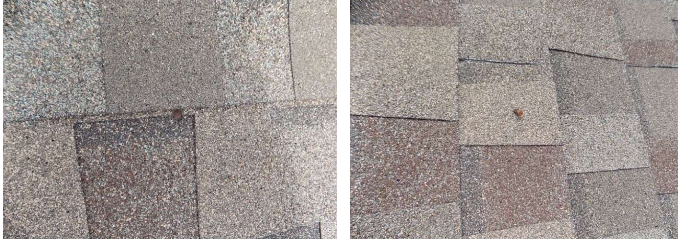
- * There are roofing nails lifting or protruding through the asphalt shingles. This may allow water to leak into the building. You should have a qualified roofer make repairs.

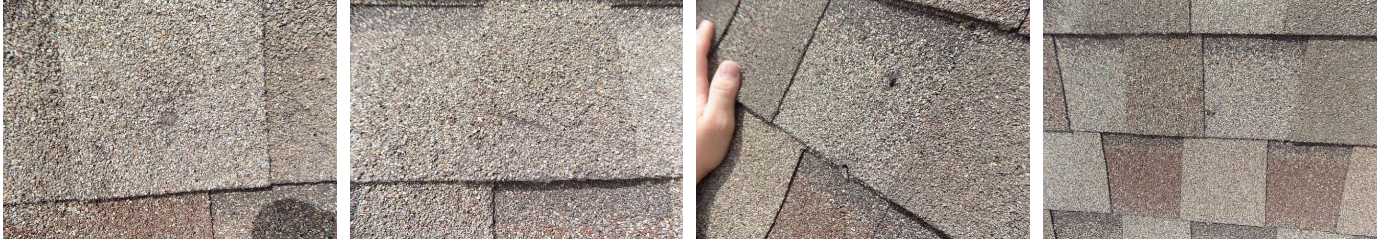
- There is minor damage to the asphalt shingle roofing. This has caused some loss of the protective granules and could shorten the life of the affected material. You should monitor this area for any future deterioration.

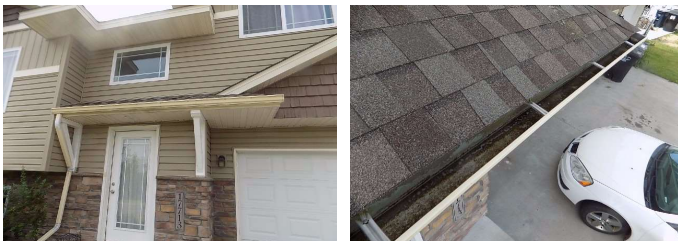
- * The gutters do not slope properly to the downspouts. This can cause them to overflow and dump water close to the building. The gutters should be realigned to allow the water to flow toward the downspouts. .

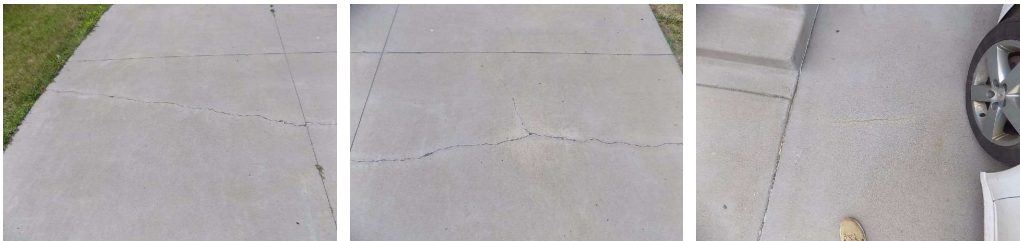
- * There are cracks in the driveway. The cracks will allow moisture to seep into the surface and through freeze/thaw action this will deteriorate the surface. These cracks should be sealed to help extend the life of the driveway.

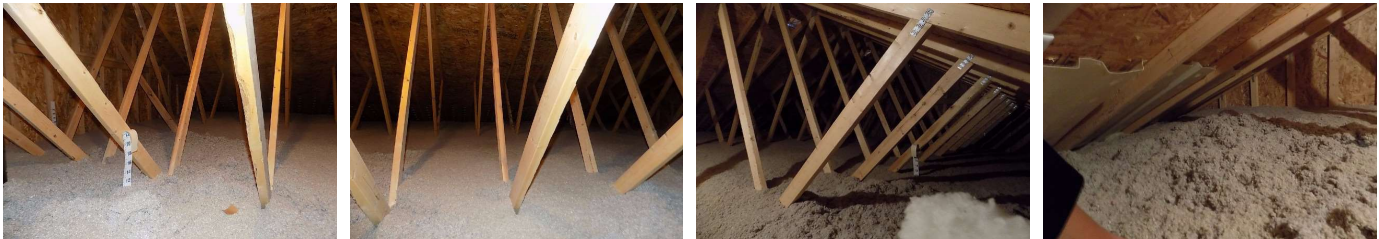
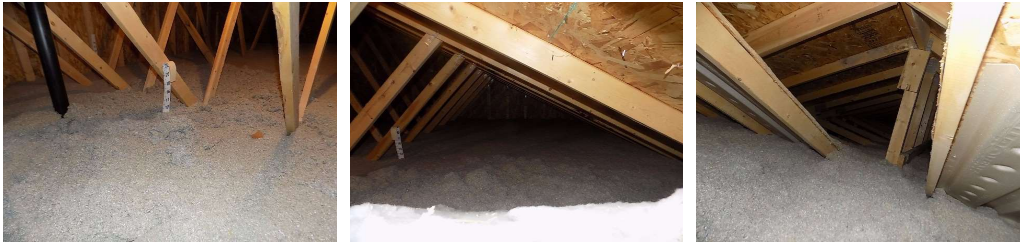
- * Most buildings have an attic area below the roof and above the living space. Attics are sometimes accessible through a flight of stairs but in most cases the attic is accessible through a "scuttle" located in a closet or through a set of "pull down" stairs or in rare cases through a roof hatch. The amount of useful space in the attic depends upon the type of roof construction. Roofs that are constructed with rafters may provide significant areas of open storage. But, roofs that are supported by pre-fabricated trusses offer little, if any usable space. Your primary interest in the attic should be in the ceiling insulation and in the means of ventilating the attic.

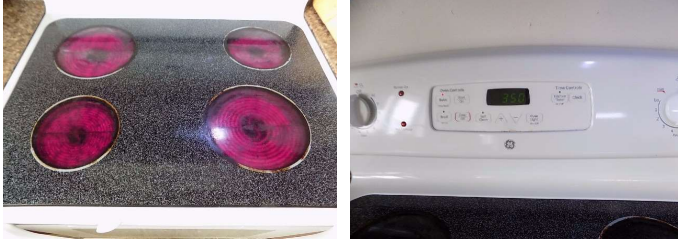
- * The electric range appears to be functional.

- The range is not secured to the wall. This is a safety hazard because the range could tip over and cause burns or injury. You should have the range secured to the wall according to manufacturer's recommendations.
