Officials mute on possible contamination at Everett Crowley Park

Everett Crowley Park – toxic landfill to urban wilderness

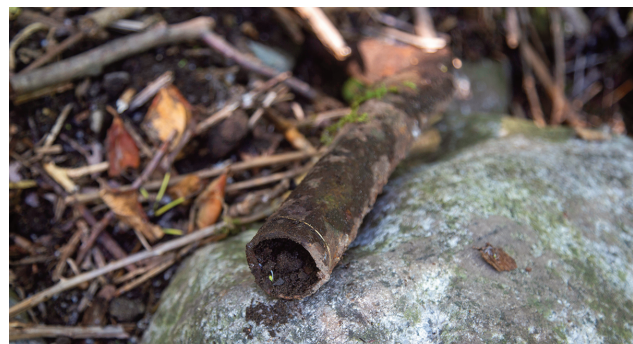
Construction waste like this corroded pipe is not uncommon to find adjacent to the mulched trails that meander through the park.

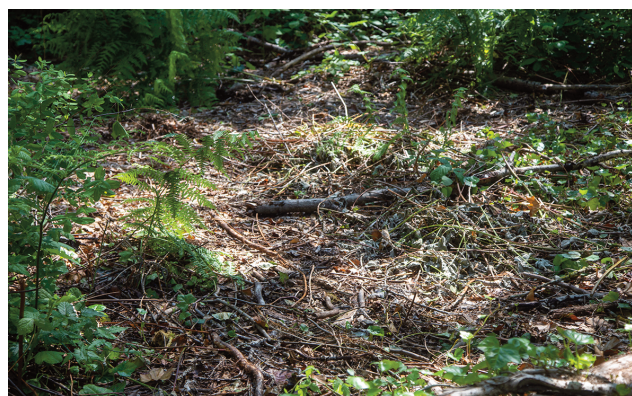
- uneven terrain and 'garbage' at surface along the bank of the new Kinross Creek;
- poor growing "hot spot areas" in the park, due to landfill gas venting;
- significant iron fouling within the storm sewer drains connected to the interception drain and at surface in its vicinity.

Amidst the tangle of invasives species (morning glory) that proliferate throughout the park, dead zones, possible "hot spots of venting menthane, are still apparent.

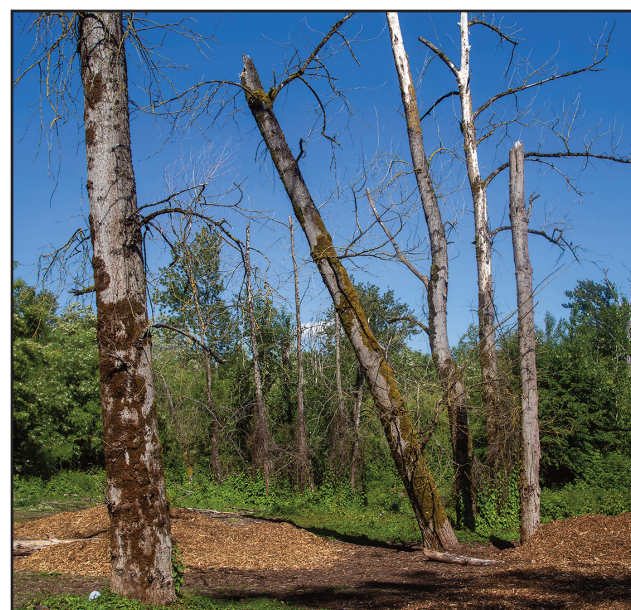
*Tree dieback in the park (as shown above) is likely caused by landfill contamination just beneath the surface.
- All photos by Bibianna Husar-Geddes*
