Magnify Home Inspection, Inc.
(239) 785-0708
NE Naples
Naples, FL 34120

**180 12th Avenue NE
Naples , Florida 34120**

Inspector: Kip McKesson
Inspection Date: 9/6/2019

Date: 9/6/2019	Time: 9:30 AM	Report ID: 19090611CSM
Property: 180 12th Avenue NE Naples , Florida 34120		Real Estate Professional: Na

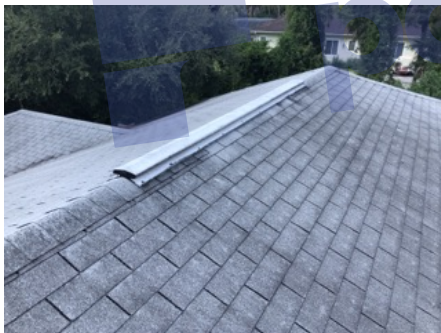
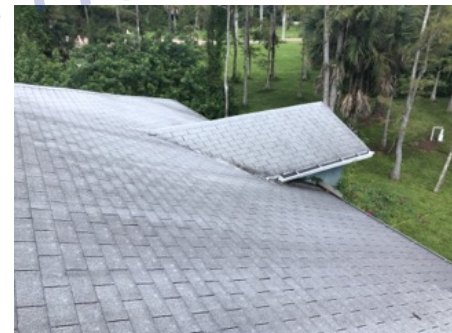
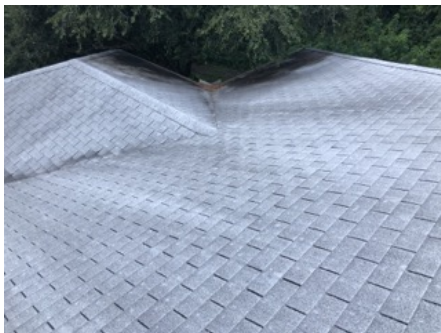
1.01.1 • The roof and its components were inspected by walking the roof.

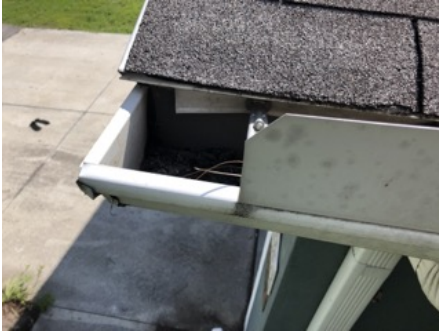
1.03.1 • The roof had one layer of roof covering material installed at the time of the inspection.

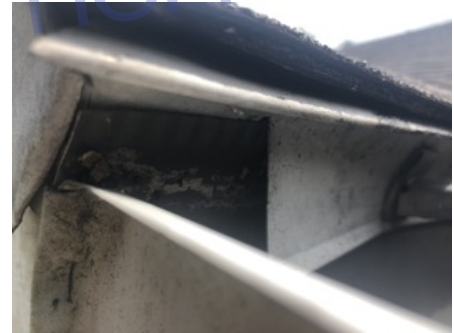
1.05.1 • All edge flashing used to protect areas of the roof from moisture intrusion appeared to be properly installed and in serviceable condition at the time of the inspection.

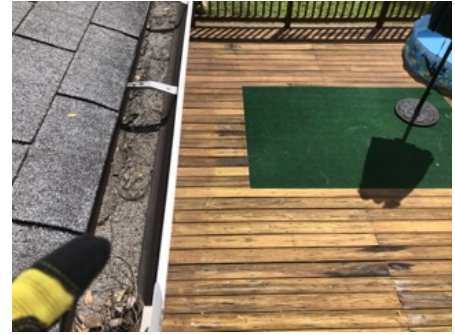
1.07.1 • Although the asphalt composition shingles covering the roof of this property had visible granule loss and areas in which hairline cracks were visible, they appeared to be adequately protecting the underlying property structure at the time of the inspection.

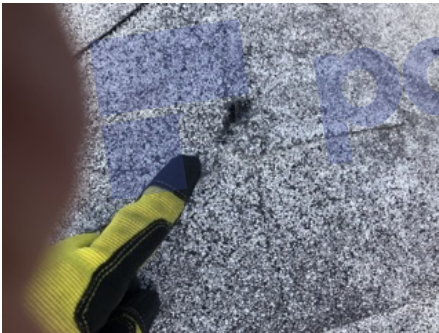
1.08 Flashings - Ridge

1.08.2 • Some ridge shingles used to protect areas of the roof from moisture intrusion had minor damage in areas. A qualified roofing contractor should inspect and repair as necessary.

1.08.2 • The ridge shingles used to protect areas of the roof from moisture intrusion were damaged in areas. A qualified roofing contractor should inspect and repair as necessary.

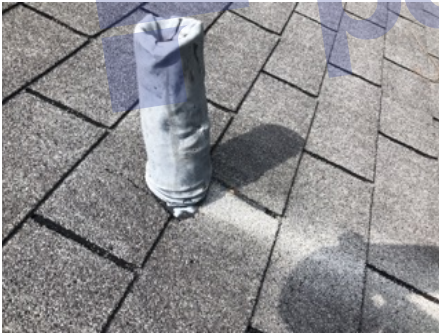
1.10 Flashings - Vent **Inspected**

1.10.1 • All vent flashing used to protect areas of the roof from moisture intrusion appeared to be properly installed and in serviceable condition at the time of the inspection.

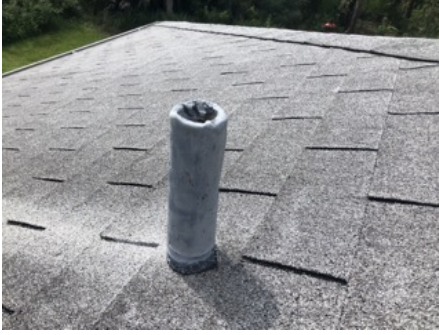
1.12 Plumbing Vents **Inspected**

1.12.1 • All rubber boot flange seals at vent pipe(s) used to protect areas of the roof from moisture intrusion appeared to be properly installed and in serviceable condition at the time of the inspection.

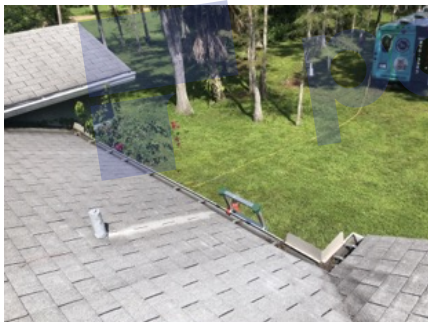
1.19.1 • The roof drainage system consisted of conventional gutters hung from the roof edges feeding downspouts, which route run-off away from the property foundation. The roof drainage system appeared to be in serviceable condition at the time of the inspection. The gutters appear intact, but due to the lack of recent rain, determining if gutters leak at seams or spill water was not possible at the time of the inspection. Gutters are full of organic material. Suggest cleaning by a qualified professional to prevent moisture intrusion.

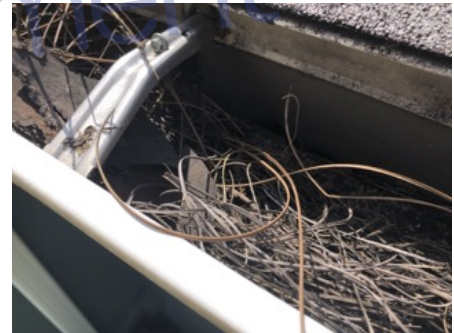
1.19.2 • Gutters full of debris. Recommend cleaning by qualified technician.

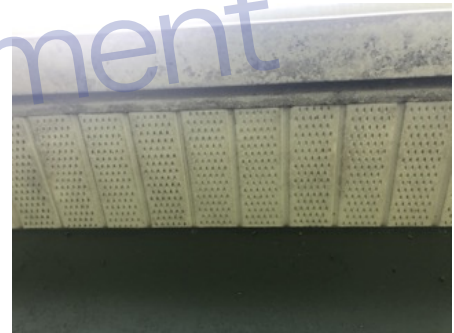
2.04.1 • The attic ventilation appeared to be satisfactory, and was provided by ridge vents and soffit vents.

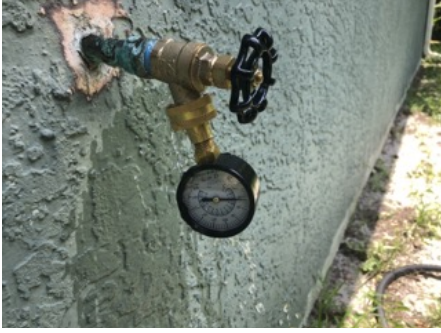
3.14.1 • The outside water faucet at the right side of the house drips at the knob when turned on. A qualified contractor should evaluate and repair or replace as necessary according to current standards.

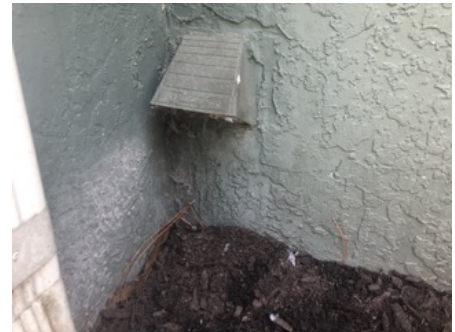
3.18 Vent Covers **Inspected**

3.18.1 • The exterior vent covers were secured to wall, not obstructed, and in generally serviceable condition at time of inspection.

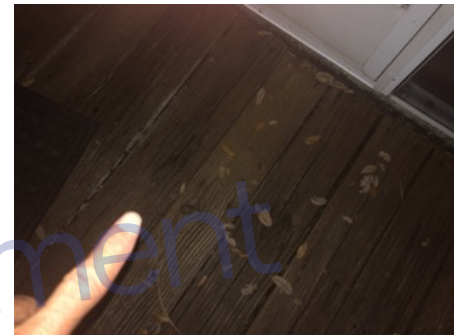
3.21.1 • Rear deck containing several rotting or damaged floor boards. Recommend having qualified contractor repair or replace.

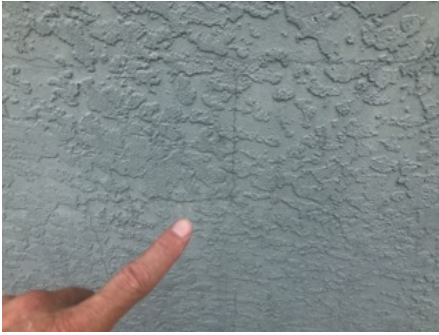
3.21.2 • Some floor joists were deteriorated at the deck rear. A qualified contractor should evaluate and repair or replace as necessary and according to current standards.

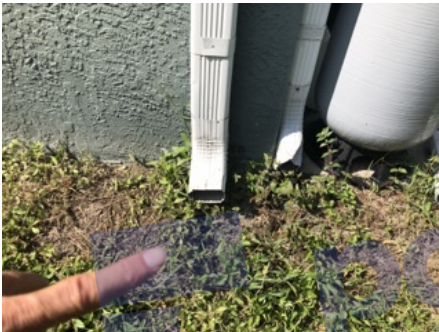
3.23.1 • Downspout(s) around the property are missing extensions. This condition may cause problems by introducing excessive amounts of moisture to the soil beneath the foundation. Excessive moisture in soil supporting the foundation can affect its ability to support the weight of the structure above and may cause foundation damage from soil movement. When moisture is introduced into the foundation it could also cause possible mold growth. A qualified contractor should evaluate and repair or replace as necessary and according to current standards.

3.23.1 • Downspout(s) around the property are missing extensions. This condition may cause problems by introducing excessive amounts of moisture to the soil beneath the foundation. Excessive moisture in soil supporting the foundation can affect its ability to support the weight of the structure above and may cause foundation damage from soil movement. When moisture is introduced into the foundation it could also cause possible mold growth. A qualified contractor should evaluate and repair or replace as necessary and according to current standards.

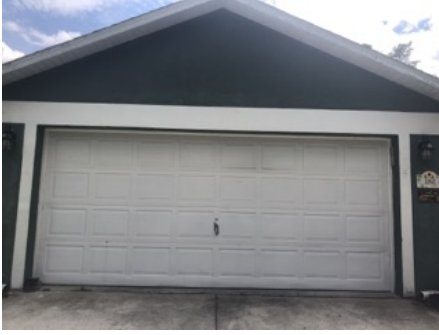
- 3.24.1 • The exterior of garage doors appeared to be in serviceable condition at the time of the inspection. Inspection of exterior garage doors typically includes examination of door exterior surface condition, weather-stripping condition and jamb condition.

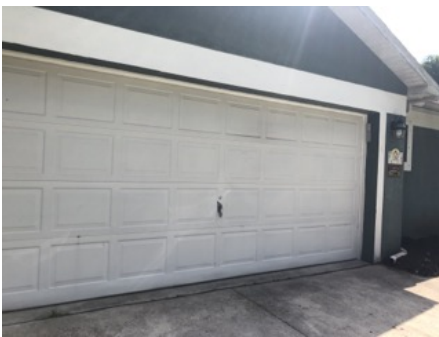
- 4.01.1 • The property had a(n) attached, two-car garage, accessible from the front of the home.

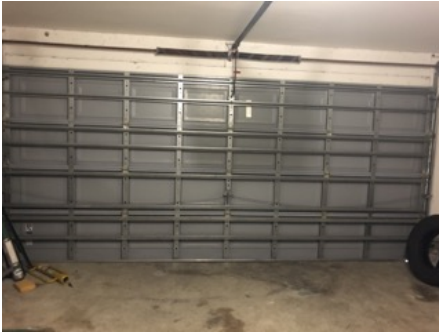
4.06.1 • The garage had one automatic metal overhead vehicle door(s). Inspection of garage doors typically includes examination for presence, serviceable condition and proper operation of the following components: door condition, mounting brackets, track and rollers, manual disconnect, lock and door springs. The garage door(s) were operated and appeared to be in serviceable condition at the time of the inspection.

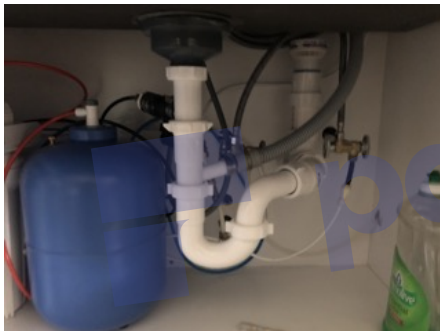
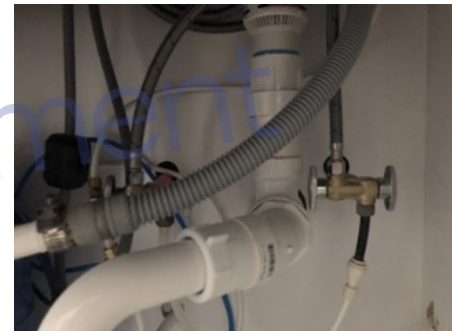
5.08 Plumbing Drain and Vent Systems **Inspected**

5.08.1 • The visible drain, waste and vent piping material for the kitchen was in satisfactory condition and was functioning as designed and intended. The drains from all functional fixtures were tested during this inspection, and each emptied in a reasonable amount of time and did not overflow when other fixtures were drained simultaneously.

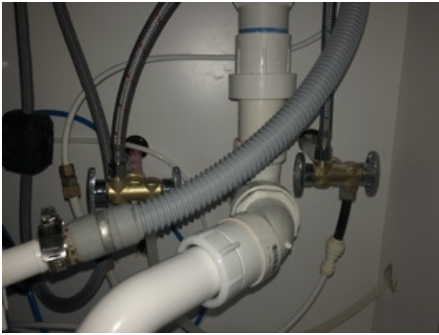
5.10 Plumbing Water Supply and Shutoff Valves **Inspected**

5.10.1 • The visible water supply piping for the kitchen was in satisfactory condition and was functioning as designed and intended. The water shutoff valves for the kitchen sink appeared to be in serviceable condition at the time of the inspection. They were not operated but were visually inspected.

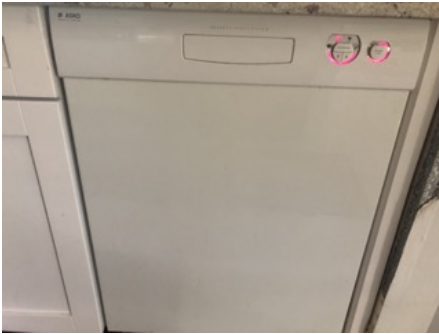
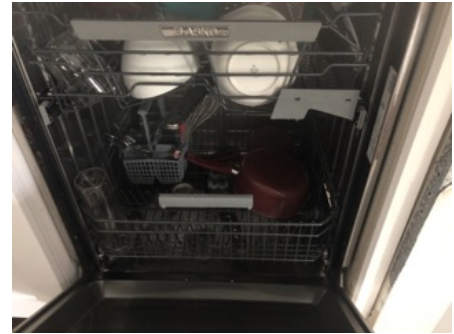
5.14.1 • The Asko dishwasher was operated and no leaks were visible at time of inspection. Inspection of appliances, such as the dishwasher, is outside the scope for a general home inspection. However, as a courtesy to our clients we will operate the dishwasher to confirm that it is working and there are no visible leaks during the time of the inspection. This operation of the dishwasher does not serve as a certification that the dishwasher is properly installed up to current codes/standards, but is meant to give the client additional information that the dishwasher operated and no leaks were visible at the time of the inspection. It is common for appliances to fail over time and the dishwasher should be monitored as needed to ensure proper operation in the future. If the client would like a more intensive inspection of the dishwasher or any other appliance they should contact a qualified contractor to further evaluate before the inspection objection deadline.

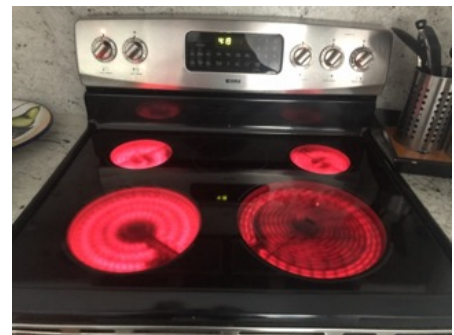
5.15 Ranges/Ovens/Cook Tops Inspected

5.15.1 • The property had a Kenmore freestanding electric range installed. All elements/burners were tested and were operational at the time of the inspection.

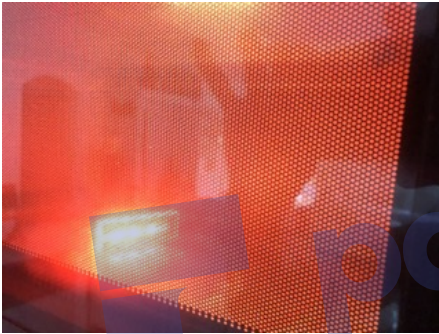
5.17 Microwave Inspected

5.17.1 • The Whirlpool over-range mounted microwave was installed securely, was tested and operational at time of inspection.

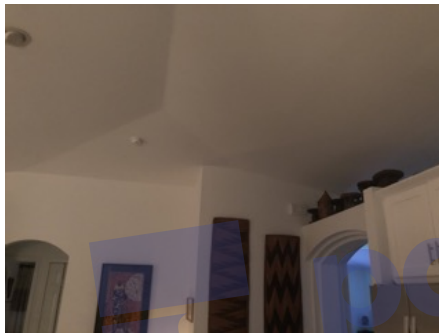
5.20 Presence of Installed Heat Source **Inspected**

5.20.1 • There is no installed heat source for the kitchen.

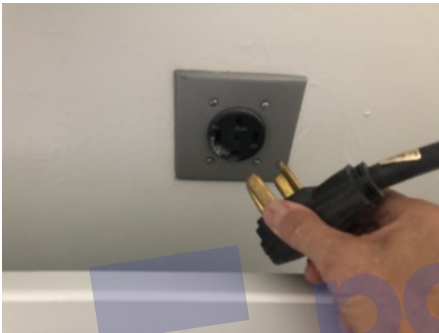
6.09 220 Volt Dyer Outlet **Inspected**

6.09.1 • The 220-volt 4-pronged dryer electrical outlet was inspected and appeared to be in serviceable condition at the time of the inspection.

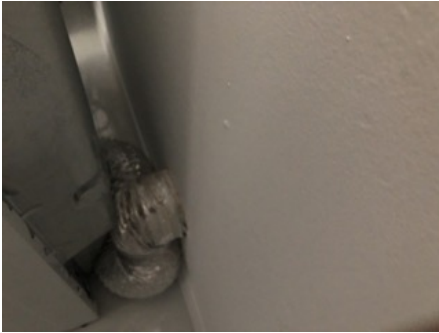
6.12 Dryer Vent Piping **Inspected**

6.12.1 • A flexible foil dryer vent connection was installed in the laundry area. The dryer vent connection was examined visually only. A visual examination will not detect the presence of lint accumulated inside the vent, which is a potential fire hazard. The inspector recommends that you have the dryer vent cleaned at the time of purchase and annually in the future to help ensure that safe conditions exist. Lint accumulation can occur even in approved, properly installed vents.

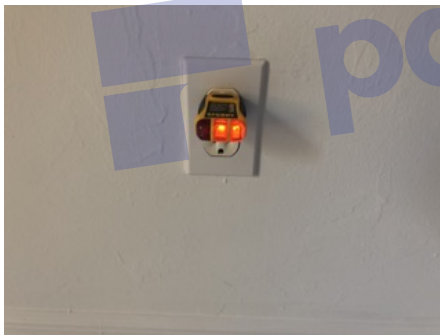
7.06.2 • Two electrical receptacles in Pink bedroom have a top plug that is not useable. Suggest contacting qualified technician to repair or replace.

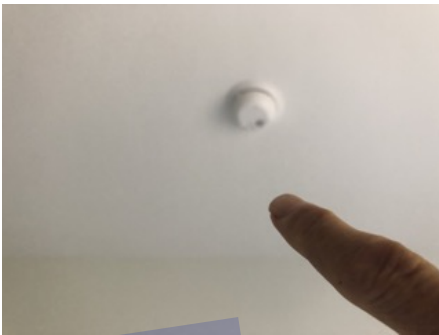
- 7.09.1 • The existing smoke detectors were tested, and responded to the test button, but they are only noted as to presence and operation as of date of inspection. Smoke detectors may work today but not work when you need them to work. This is why it is important for you to test them on a regular basis, monthly at least. Smoke detectors are recommended by the U.S. Product Safety Commission to be installed inside each bedroom and adjoining hallway and on each living level of the property and basement level.

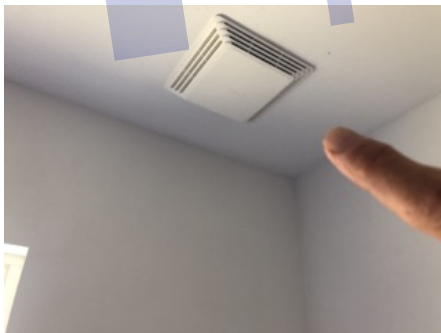
8.1.02.1 • The fan only exhaust fan in the master bathroom did not vent to outside. A qualified contractor should evaluate and repair or replace as necessary.

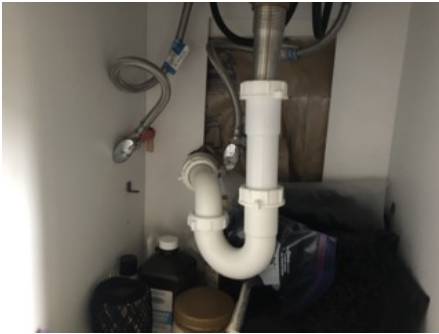
8.1.11.1 • The visible drain, waste and vent piping material in this bathroom was in satisfactory condition and was functioning as designed and intended. The drains from all functional fixtures were tested during this inspection, and each emptied in a reasonable amount of time and did not overflow when other fixtures were drained simultaneously.

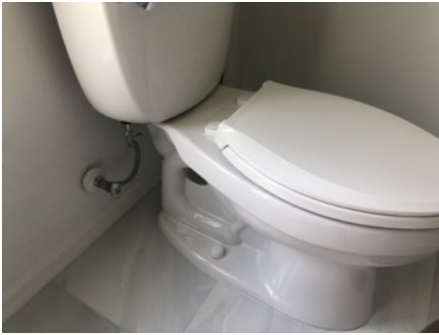
8.1.14.1 • The visible components of the toilet in this bathroom were in satisfactory condition and were functioning as designed and intended. The toilet was secured properly to the floor, no visible evidence of leaking was present and toilet(s) emptied in a reasonable amount of time.

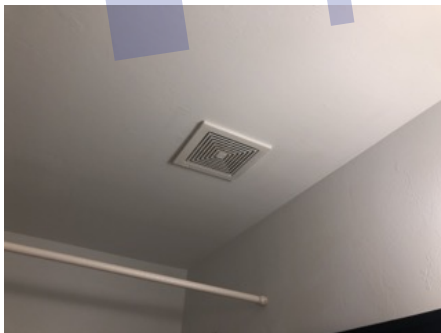
8.2.02.1 • The fan only exhaust fan in this bathroom operated properly and appeared to be in serviceable condition at the time of the inspection.

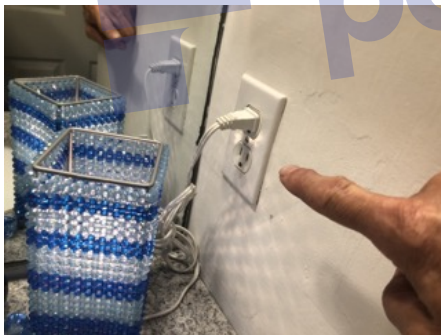
Although GFCI protection of bathroom circuits may not have been required at the time in which this property was built, as general knowledge of safe building practices has improved with the passage of time, building standards have changed to reflect current understanding. The inspector recommends updating the existing bathroom electrical circuits to include GFCI protection.

1. Replacing the current standard outlets with GFCI outlets.
2. Replacing the first circuit outlet located closest to the main electrical service panel with a GFCI outlet.
3. Replacing the breaker currently protecting the electrical circuit that contains these outlets with a GFCI breaker.

A qualified electrical contractor should inspect and repair as necessary.

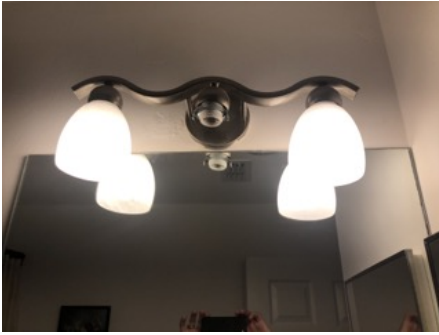
8.2.08.1 • Light fixture(s) in the guest bathroom was missing. A qualified contractor should evaluate and repair or replace as necessary.

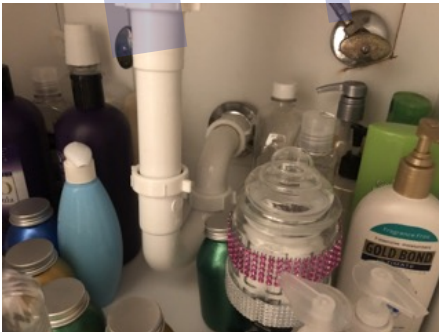
8.2.11.1 • The visible drain, waste and vent piping material in this bathroom was in satisfactory condition and was functioning as designed and intended. The drains from all functional fixtures were tested during this inspection, and each emptied in a reasonable amount of time and did not overflow when other fixtures were drained simultaneously.

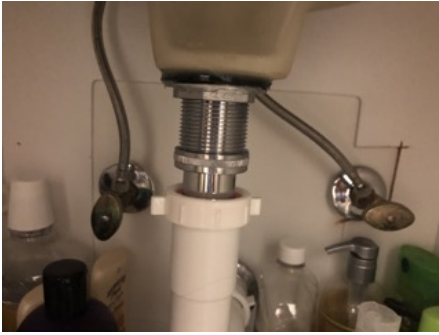
8.2.12.1 • The water shut-off valves for this bathroom sink appeared to be in serviceable condition at the time of the inspection. They were not operated but were visually inspected.

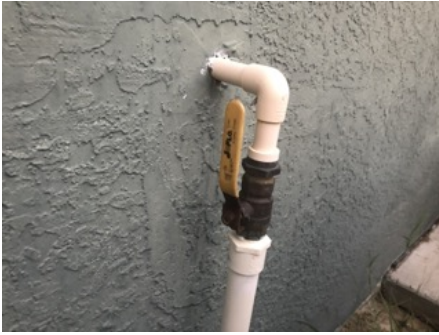
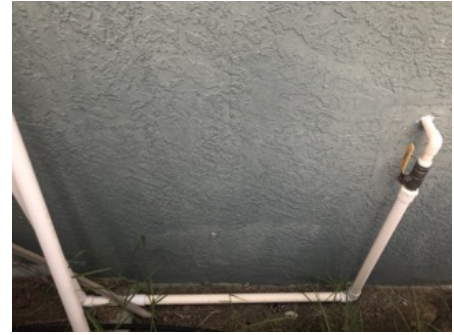
9.01.1 • The main water shutoff is the yellow lever on the valve that was located Outside on left side exterior garage wall. It appeared to be in serviceable condition, but testing the operation of this valve is not within the scope of a property inspection. Operation of the valve from time to time will keep it functional and maximize its useful life.

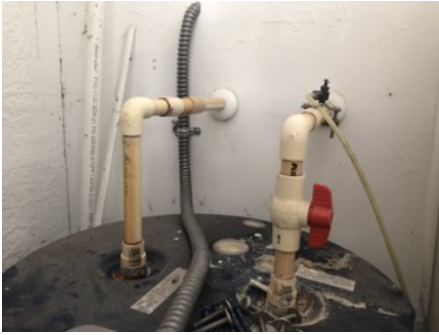
10.05.1 • Water pipe fittings connected to the water heater appeared to be in serviceable condition at the time of the inspection.

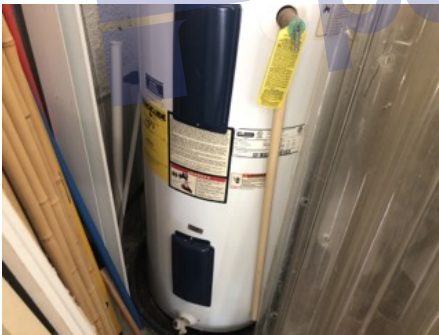
10.08.1 • The water heater was equipped with a T&P (Temperature and Pressure) relief valve and a properly-configured T&P relief valve discharge pipe which was connected to the T&P relief valve and terminated within 6 inches from the floor. This device is an important safety feature and should not be altered or tampered with, and was not tested as part of the inspection. No adverse conditions were observed.

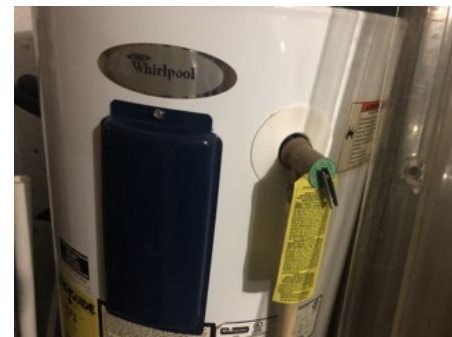
10.15.1 • The water heater responded to the demand for hot water.

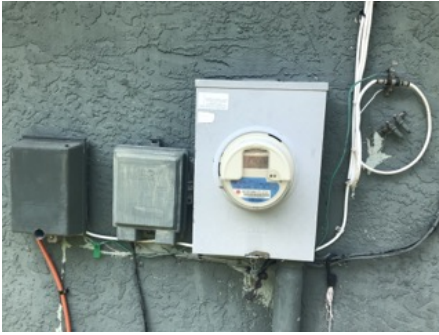
11.01.1 • The electric meter was located left side of home. The meter was installed at a proper height, with the center of the meter measuring between 4 feet and 6 feet above the walking surface. The electric meter was securely fastened to the property, appeared to be properly grounded and appeared to be in serviceable condition at the time of the inspection. Electric meters are installed by utility companies to measure property electrical consumption.

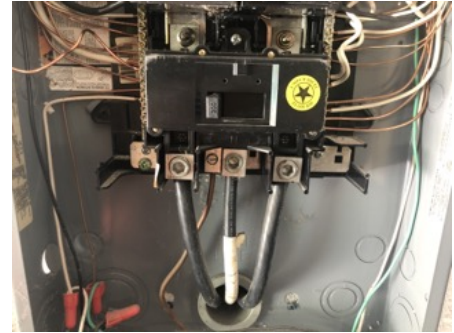
11.05.1 • The 120-240 volts service entrance conductors were 3/0 copper rated at 225 amps. The service entrance conductors appeared to be in satisfactory condition at the time of the inspection.

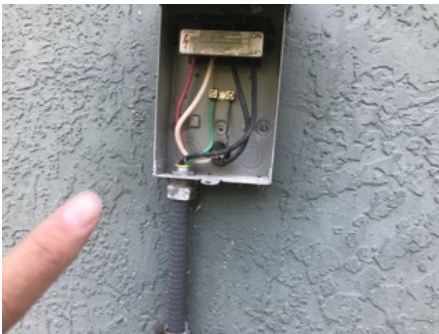
12.03.1 • The electrical disconnect was located in the electrical panel within sight of the condensing unit. Although it was not operated, it appeared to be in serviceable condition at the time of the inspection.

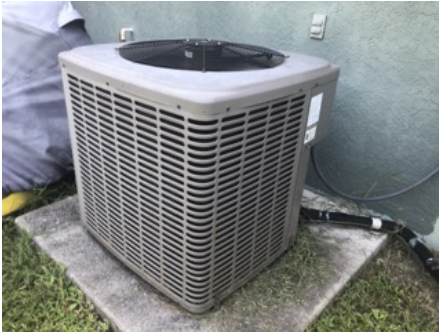
12.05.1 • The air-conditioner compressor housing exterior appeared to be in serviceable condition at the time of the inspection.

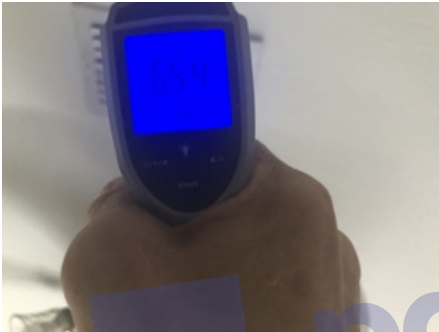
12.06.1 • An ambient air test was performed to determine if the difference in temperatures of the supply and return air was between 14 degrees and 22 degrees, which indicates that the unit was cooling as intended. The supply air temperature was 63 degrees, and the return air temperature was 79 degrees. Air temperature measured at supply and return registers had a difference that fell within the acceptable range of between 14 and 22 degrees F.

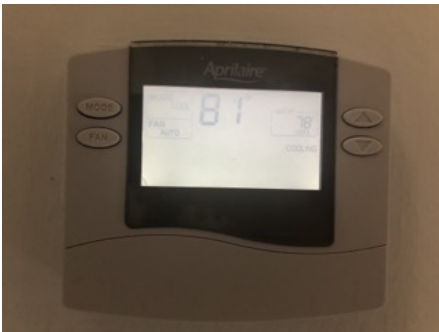
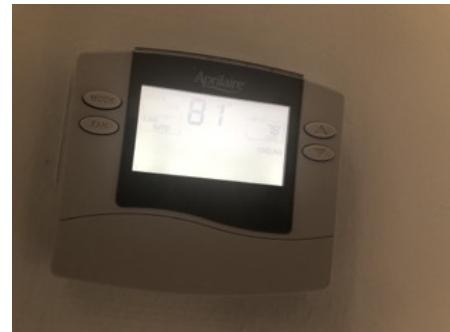
12.07.1 • The air conditioning was controlled by one programmable thermostat(s). The thermostat(s) was installed at a location in the property, which appears to be adequate to operate the HVAC system efficiently. The thermostat(s) was fastened securely to the wall, activated the HVAC unit, and appeared to be in serviceable condition. The inspector takes two pictures of the thermostat. The first picture is to show all of the settings on the thermostat before the inspector operates it and the second picture shows that the inspector has reset the thermostat back to the original settings after operation.

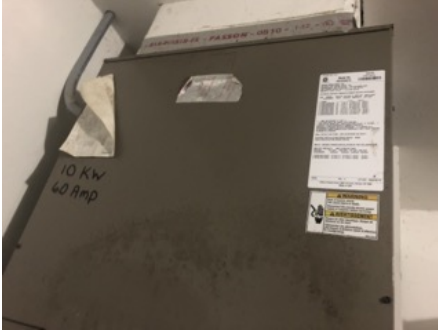
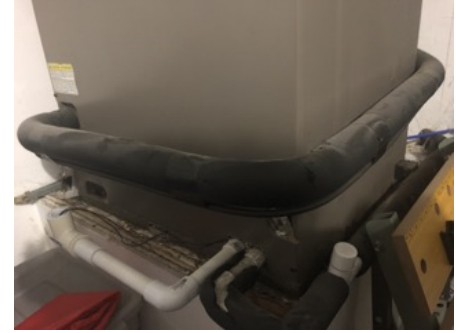
13.01.1 • The heating system included one electric, high-efficiency (90% - 95%), forced-air furnace(s).

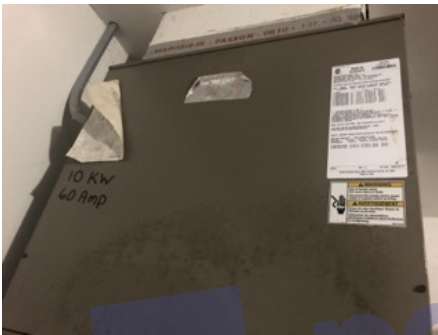
13.02.1 • Information from the heating system data plate is shown in the photo. The heating system was manufactured by York. The approximate year of manufacture was 2011.

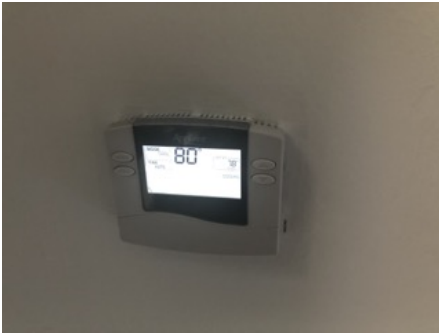
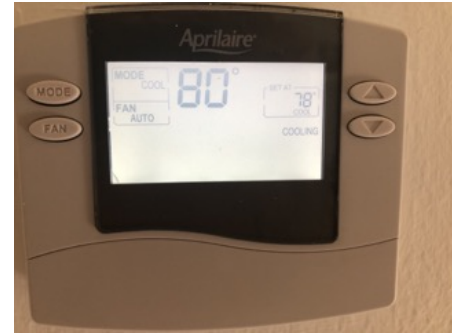
13.11.1 • The heating system was controlled by one programmable thermostat(s). The thermostat(s) was installed at a location in the property which appears to be adequate to operate the heating system efficiently. The thermostat(s) was fastened securely to the wall, activated the heating system and appeared to be in serviceable condition. The inspector takes two pictures of the thermostat. The first picture is to show all of the settings on the thermostat before the inspector operates it and the second picture shows that the inspector has reset the thermostat back to the original settings after operation.

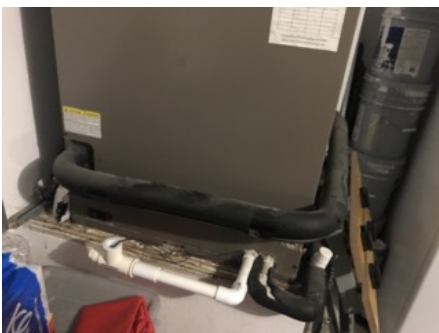
13.13 Heating System Operation

13.13.1 • When thermostat was cycled to heat the vents began to blow smoke. Smoke alarms activated. Suggest service by qualified have technician prior to further use.
