Magnify Home Inspection, Inc  
.NE Naples, Florida 34120  
(239) 785-0708

# Summary Report

180 12th Avenue NE  
Naples , Florida 34120

Inspector: Kip McKesson  
Inspection Date: 9/6/2019

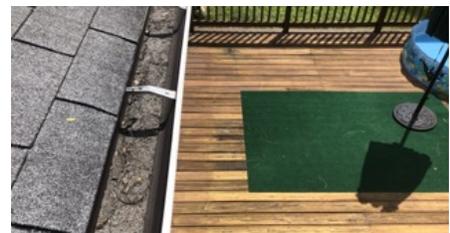
1.07.1 • Although the asphalt composition shingles covering the roof of this property had visible granule loss and areas in which hairline cracks were visible, they appeared to be adequately protecting the underlying property structure at the time of the inspection . Roof appears to be near expected lifetime.

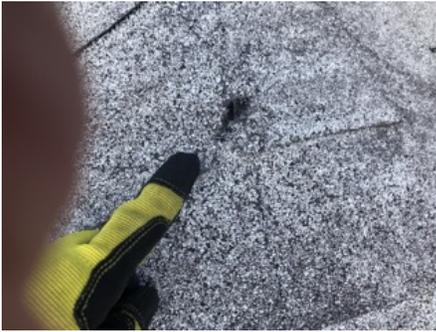
1.08.1 • All ridge shingles used to protect areas of the roof from moisture intrusion appeared to be properly installed and in serviceable condition at the time of the inspection.

1.08.2 • The ridge shingles used to protect areas of the roof from moisture intrusion was damaged in areas. A qualified roofing contractor should inspect and repair as necessary.

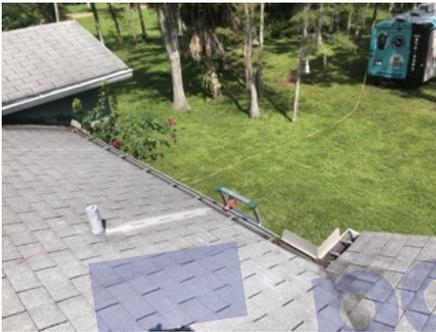
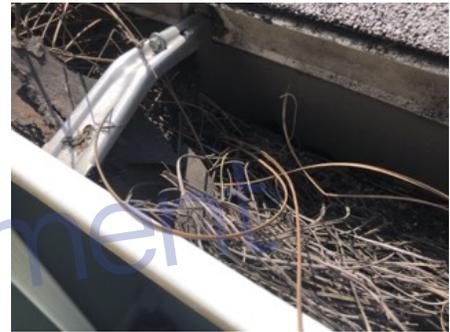
1.19.1 • The roof drainage system consisted of conventional gutters hung from the roof edges feeding downspouts, which route run-off away from the property foundation. The roof drainage system appeared to be in serviceable condition at the time of the inspection. The gutters appear intact, but due to the lack of recent rain, determining if gutters leak at seams or spill water was not possible at the time of the inspection. Gutters are full of organic materials. Suggest cleaning by a qualified professional to prevent moisture intrusion

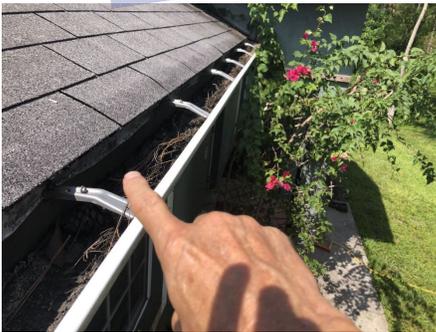
1.19.2 • Gutters full of debris. Recommend cleaning by qualified technician.

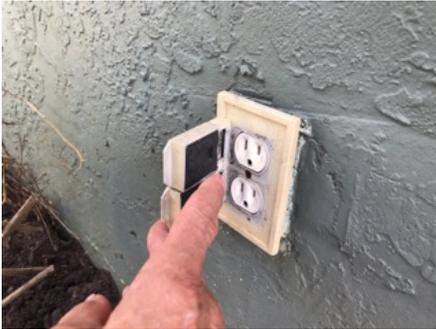
3.06.1 • No Ground Fault Circuit Interrupter (GFCI) protection was provided for the exterior electrical outlets.

Although GFCI protection of exterior circuits may not have been required at the time in which this property was built, as general knowledge of safe building practices has improved with the passage of time, building standards have changed to reflect current understanding. The inspector recommends updating the existing exterior electrical circuits to include GFCI protection.

This can be achieved by

1. Replacing the current standard outlets with GFCI outlets.
2. Replacing the first circuit outlet located closest to the main electrical service panel with a GFCI outlet.
3. Replacing the breaker currently protecting the electrical circuit that contains these outlets with a GFCI breaker.

A qualified electrical contractor should inspect and repair as necessary.

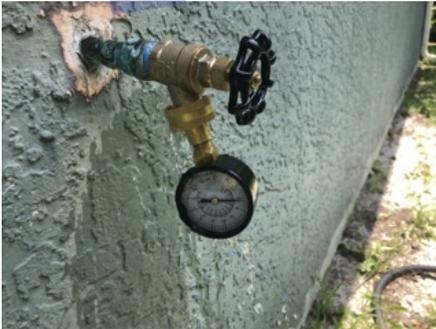
3.14.1 • The outside water faucet at the right side of the house drips at the knob when turned on. A qualified contractor should evaluate and repair or replace as necessary according to current standards.

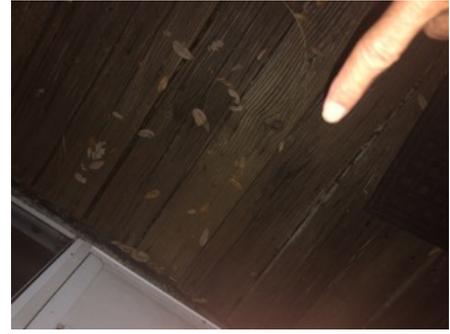
3.21.1 • Rear deck containing several rotting or damaged floor boards. Recommend having qualified contractor repair or replace.

3.21.2 • Some floor joists were deteriorated at the deck rear. A qualified contractor should evaluate and repair or replace as necessary and according to current standards.

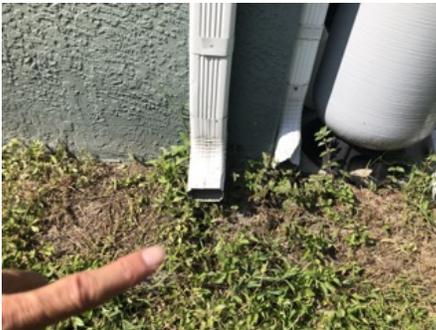
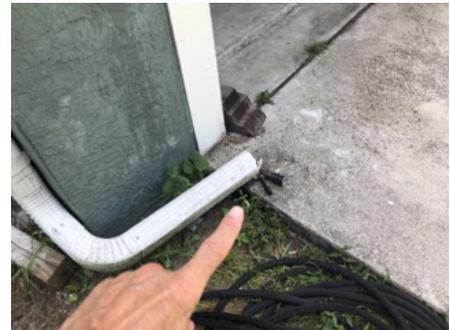
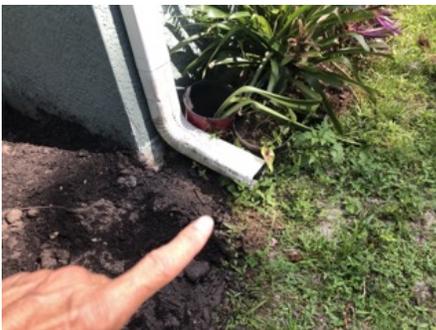
3.23.1 • Downspout(s) around the property are missing extensions. This condition may cause problems by introducing excessive amounts of moisture to the soil beneath the foundation. Excessive moisture in soil supporting the foundation can affect its ability to support the weight of the structure above and may cause foundation damage from soil movement. When moisture is introduced into the foundation it could also cause possible mold growth. A qualified contractor should evaluate and repair or replace as necessary and according to current standards.

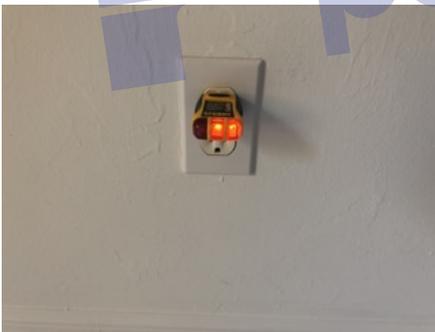
7.06.1 • Electrical outlets in the property appeared to be in serviceable condition at the time of the inspection. Notable exceptions will be listed in this report. A representative number of accessible outlets were inspected.

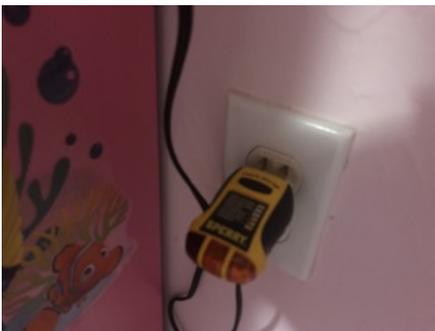
7.06.2 • Two electrical receptacles in Pink bedroom have a top plug that is not useable. Suggest contacting qualified technician to repair or replace.

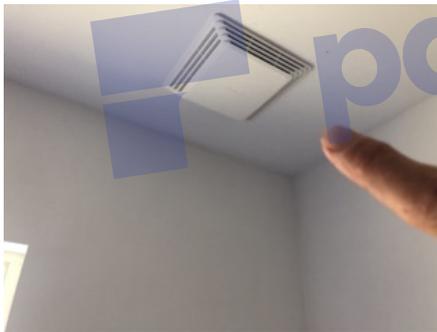
- 8.1.02.1 • The fan only exhaust fan in the master bathroom did not vent to outside. A qualified contractor should evaluate and repair or replace as necessary.

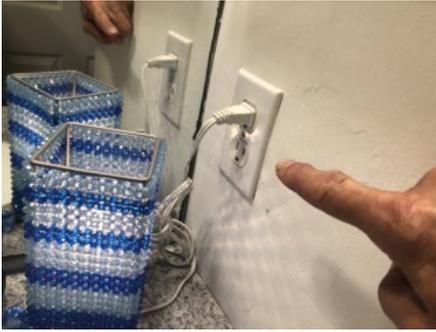
8.2.07.1 • No Ground Fault Circuit Interrupter (GFCI) protection was provided for bathroom electrical outlets.

Although GFCI protection of bathroom circuits may not have been required at the time in which this property was built, as general knowledge of safe building practices has improved with the passage of time, building standards have changed to reflect current understanding. The inspector recommends updating the existing bathroom electrical circuits to include GFCI protection.

This can be achieved by

1. Replacing the current standard outlets with GFCI outlets.
2. Replacing the first circuit outlet located closest to the main electrical service panel with a GFCI outlet.
3. Replacing the breaker currently protecting the electrical circuit that contains these outlets with a GFCI breaker.

A qualified electrical contractor should inspect and repair as necessary.

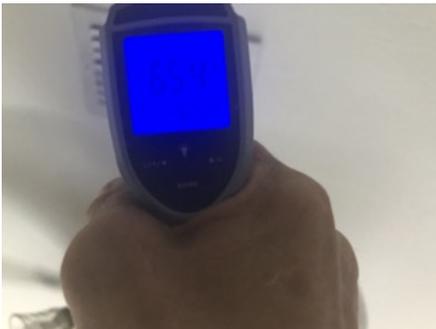
- 12.06.1 • An ambient air test was performed to determine if the difference in temperatures of the supply and return air was between 14 degrees and 22 degrees, which indicates that the unit was cooling as intended. The supply air temperature was 63 degrees, and the return air temperature was 79 degrees. Air temperature measured at supply and return registers had a difference that fell within the acceptable range of between 14 and 22 degrees F.

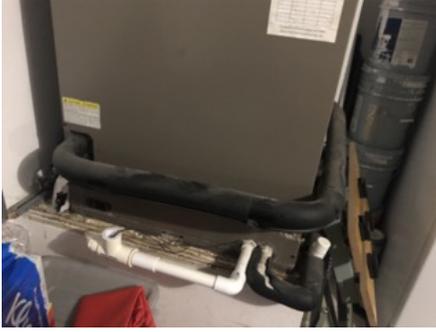
- 13.13.1 • When thermostat was cycled to heat the vents began to blow smoke. Smoke alarms activated. Suggest service by qualified have technician prior to further use.
