PROJECT STATUS REPORT

REPORT DATE	PROJECT NAME	PREPARED BY
August 27, 2025	Phase Restoration	Frank Frois

The Sandcastle I phase 2 restoration project commenced August 4th with the mobilization of equipment by WKM. Phase 2 will involve 3 construction areas of the building by WKM construction crews as well as sub-trades. Phase 2 work is schedule to be completed by the middle of January 2026 if no severe down time is experienced due to major weather events or any other circumstances.

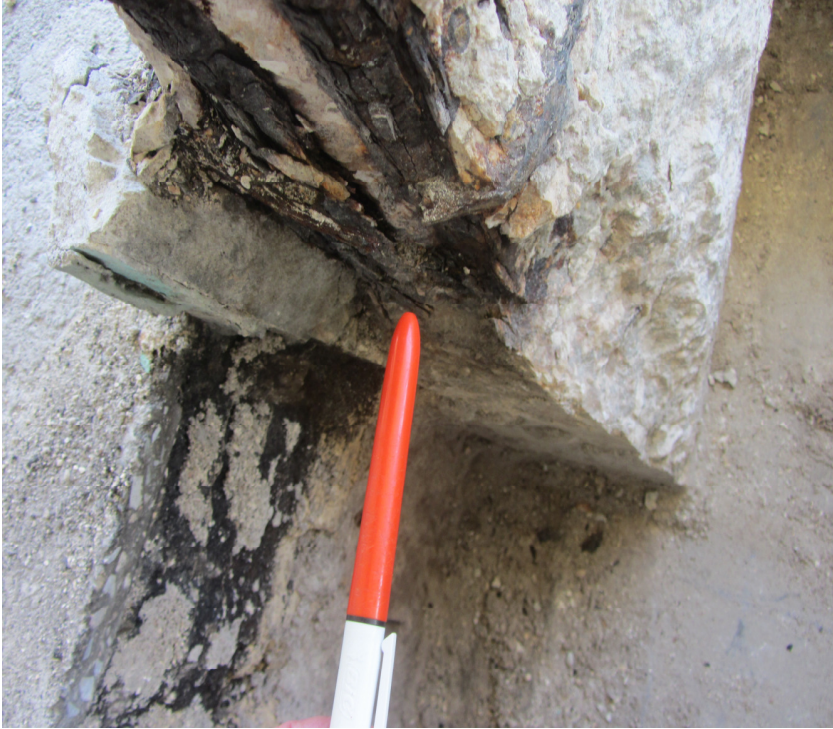
Extensive damage & corrosion to the re-bar cage as well as cables. This columns will most likely have to be re-built.

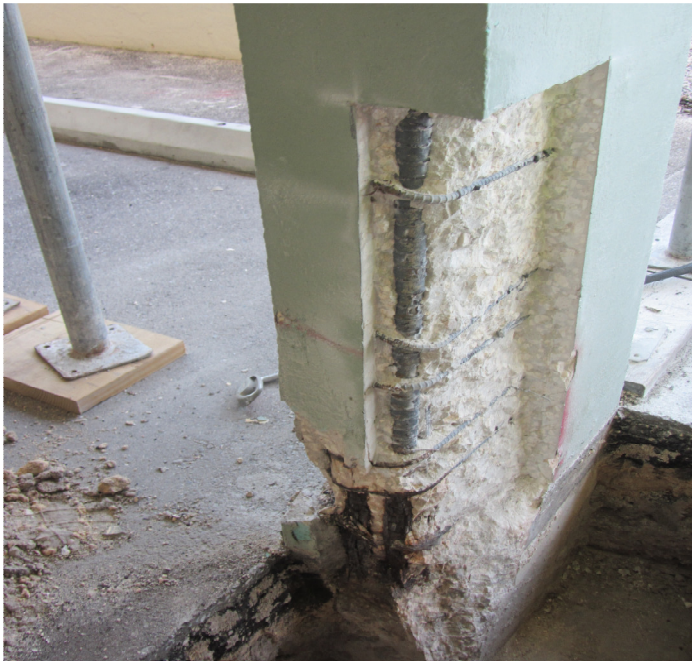
Significant corrosion below grade. This column had several spall cracks at ground level. Moisture was allow to penetrate and Corrode the re-bar and rods.

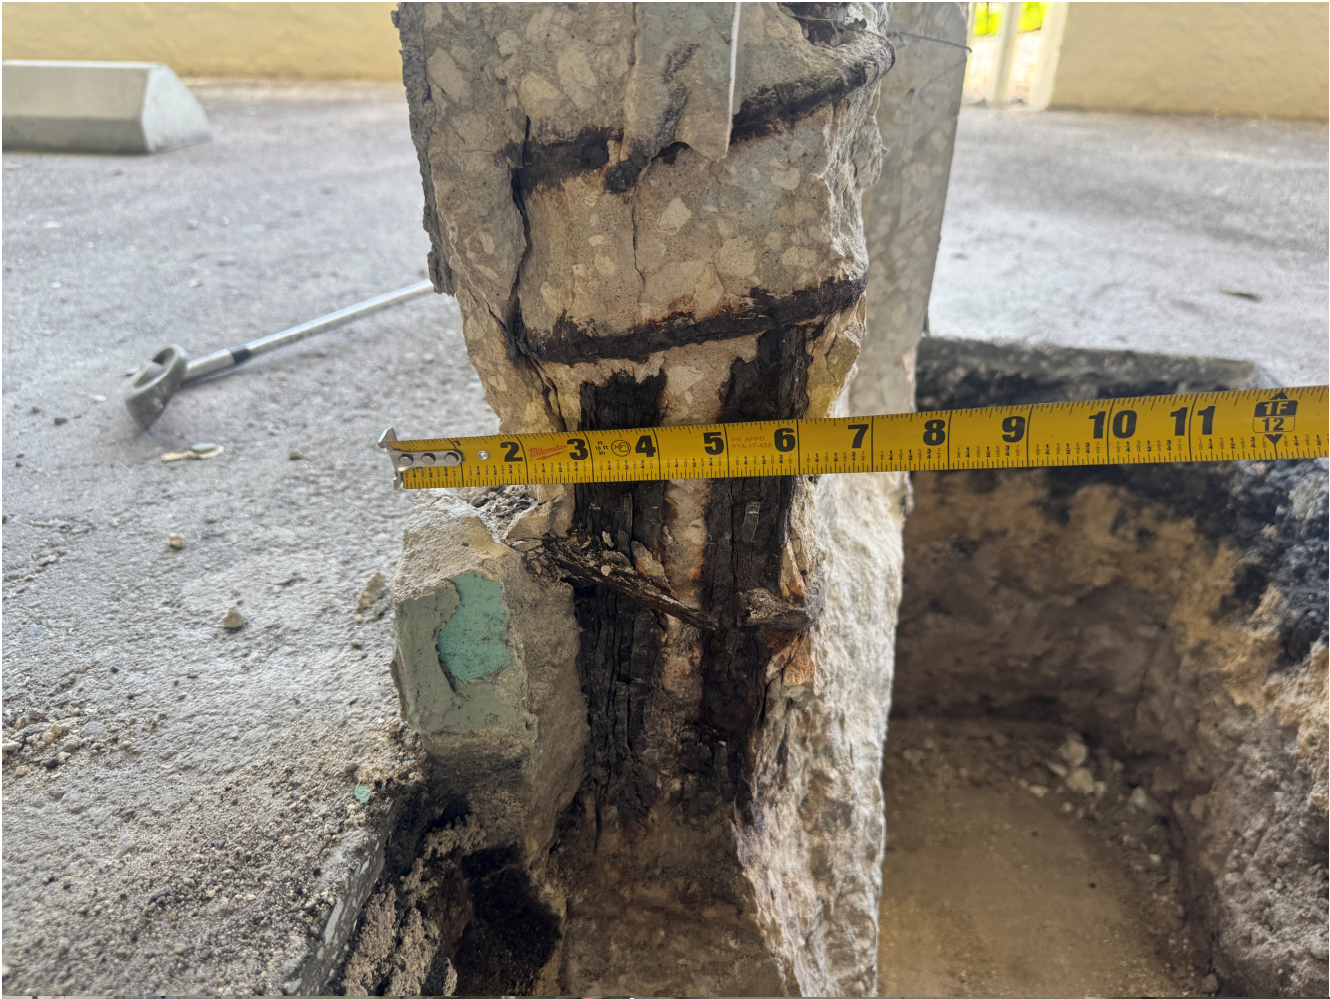
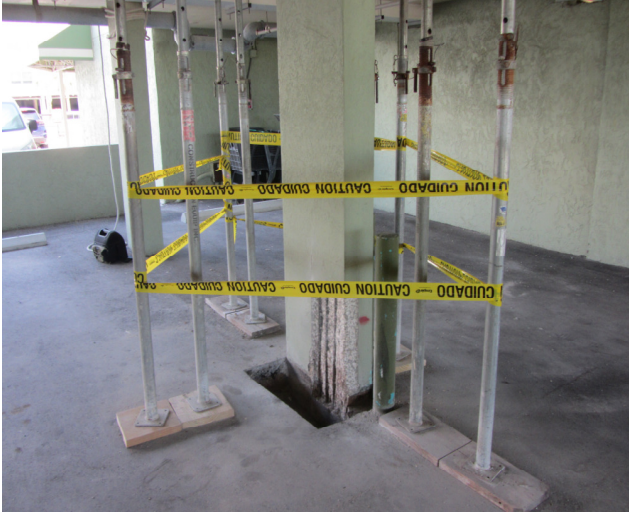
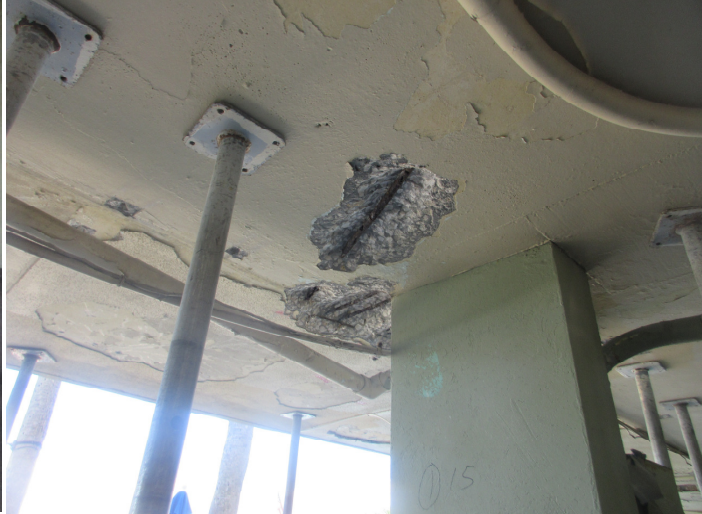
Shoring of severely damaged columns will probably extend to units above to support the weight load of the building.

Weight Load Shoring: The engineer will have to prepare shoring plans/diagrams for WKM to properly shore the affected areas. Depending on the condition of the column, owners of units above the columns will need to be notified that their unit ceiling will need shoring. This will involve installing shoring posts to reduce the weight load on the column. The number of floors that will require shoring support will be determined by the engineer after load calculations are performed.
