PROJECT STATUS REPORT

REPORT DATE	PROJECT NAME	PREPARED BY
September 30, 2025	Phase 2 Restoration	Frank Frois

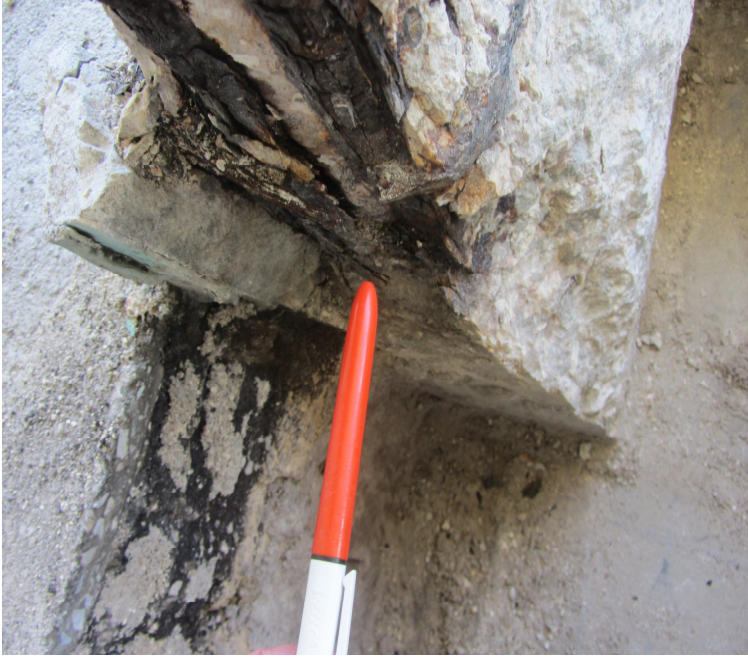
Damage to the 02 stack column.

There is also another column directly below the 02 stack in the garage that is also in poor condition; however, shoring this column is not feasible, so the engineer is preparing a plan to sleeve the column. This would add another 4-5 inches to the width of the column on either side. Currently most parking stalls have a 4" round bollard on either side of the column. These

bollards will be removed and a safety rubber bumper will be installed. The repair to this column will only be done after the 07 stack column is done. No work on other columns can be done until these 2 columns are repaired. The contractor will be working Saturdays from now on to try to catch up on garage repairs.

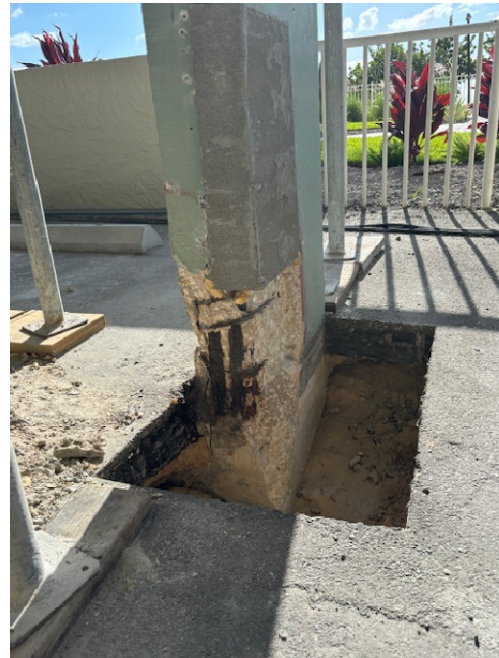
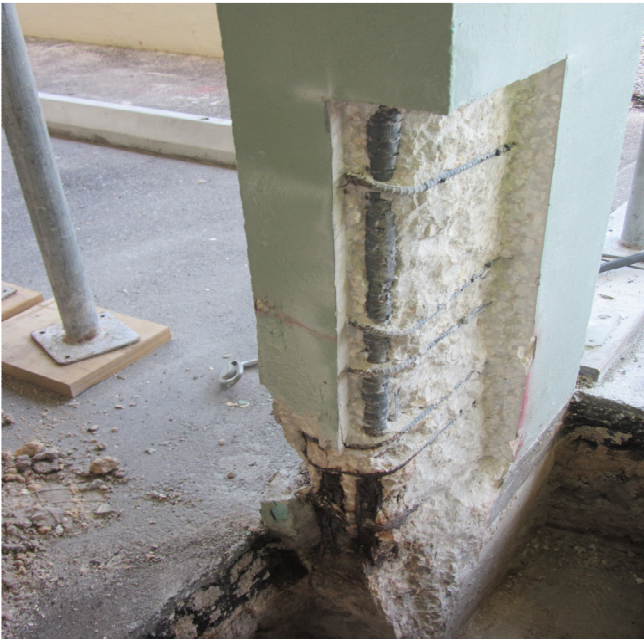
Condition of one of the columns supporting the 02 stack

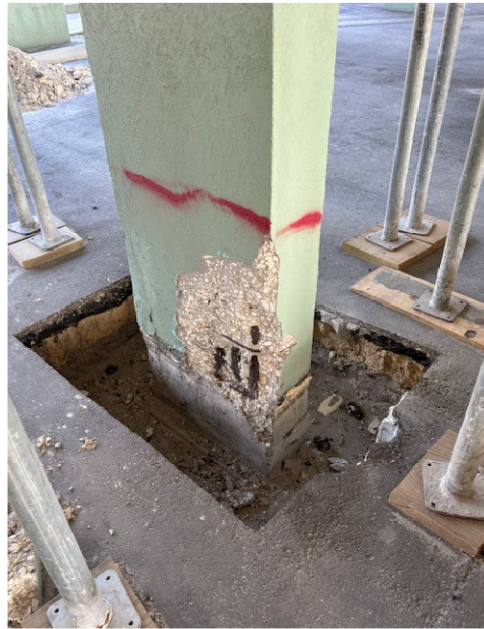
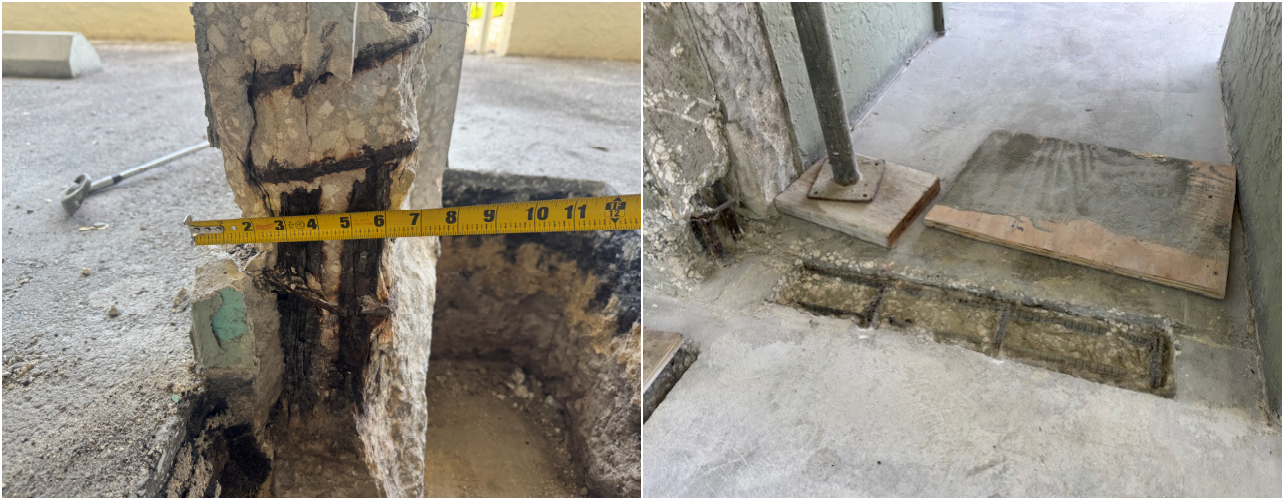
Condition of the column below the 06/07 stacks and concrete damage on various elevator lobbies

Garage: The work in the garage has come to a standstill until the contractor installs shoring posts on the balcony and living rooms of units 206,207,306,307,406 and 407. This is required to ease the load of the garage column that needs to be re-built. The column has extensive damage and in order to repair it, the load it carries must be supported. The engineer prepared a shoring plan and is confident that we will not have to shore above the 4th floor. The repair of the garage column will take one week.

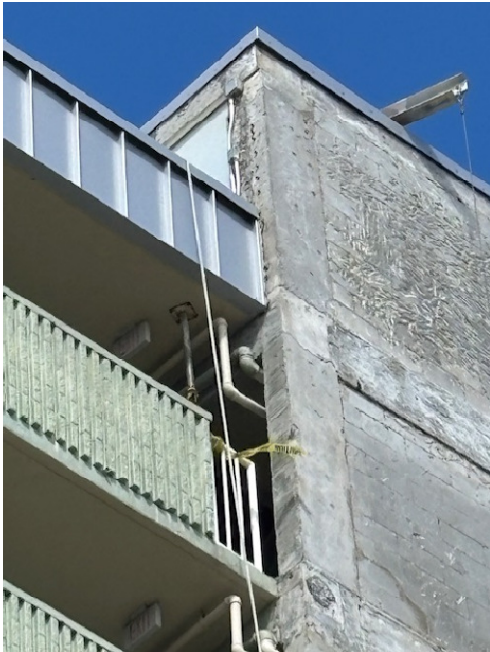
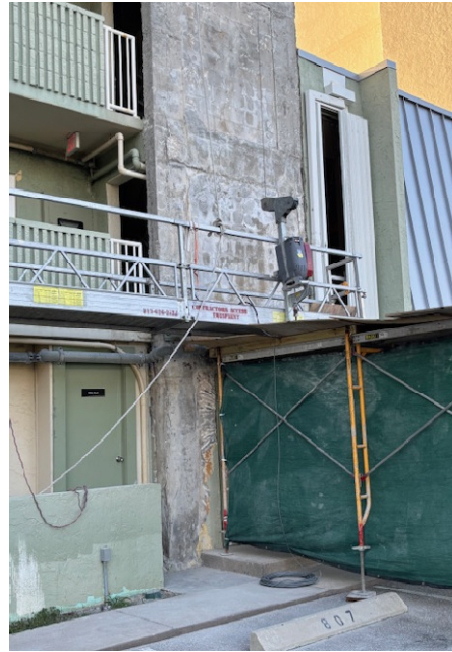
All stucco has been removed from the north tower face due to severe delaminating.

Stucco Repairs: Our contractor is currently working on the north wall performing stucco repairs in areas identified by our engineer. There's considerable de-bonding/delaminating of the stucco on the north tower facing east. The entire stucco coating had to be removed because it was more economical to strip the entire face of the tower and apply a fresh stucco coating. Stucco work continuous on the south wall and the stage will be moved from the north tower to the centre tower. Once the stage is set-up to start work on the centre tower, the ground floor awning will be removed. This should be done by mid-month. The contractor will erect a safety platform above the front entrance to protect the entrance doors. When work on the centre tower is ongoing, owners/guests will be asked to use the Recreation Room entrance to get to the 2nd. Floor to use to use the elevators.

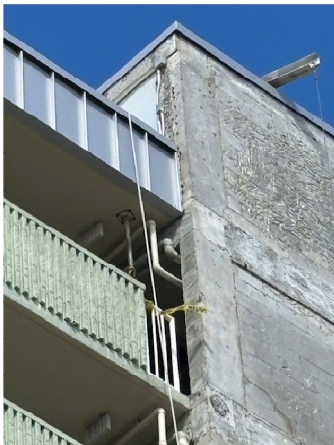
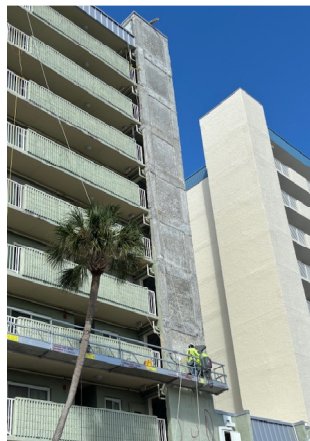
North tower stucco completely removed due to de-bonding.
