MEMORANDUM

TO: **Friends of Beaver Lake**

SUBJECT: **Results of the August 6, 2015 aquatic plant surveys**

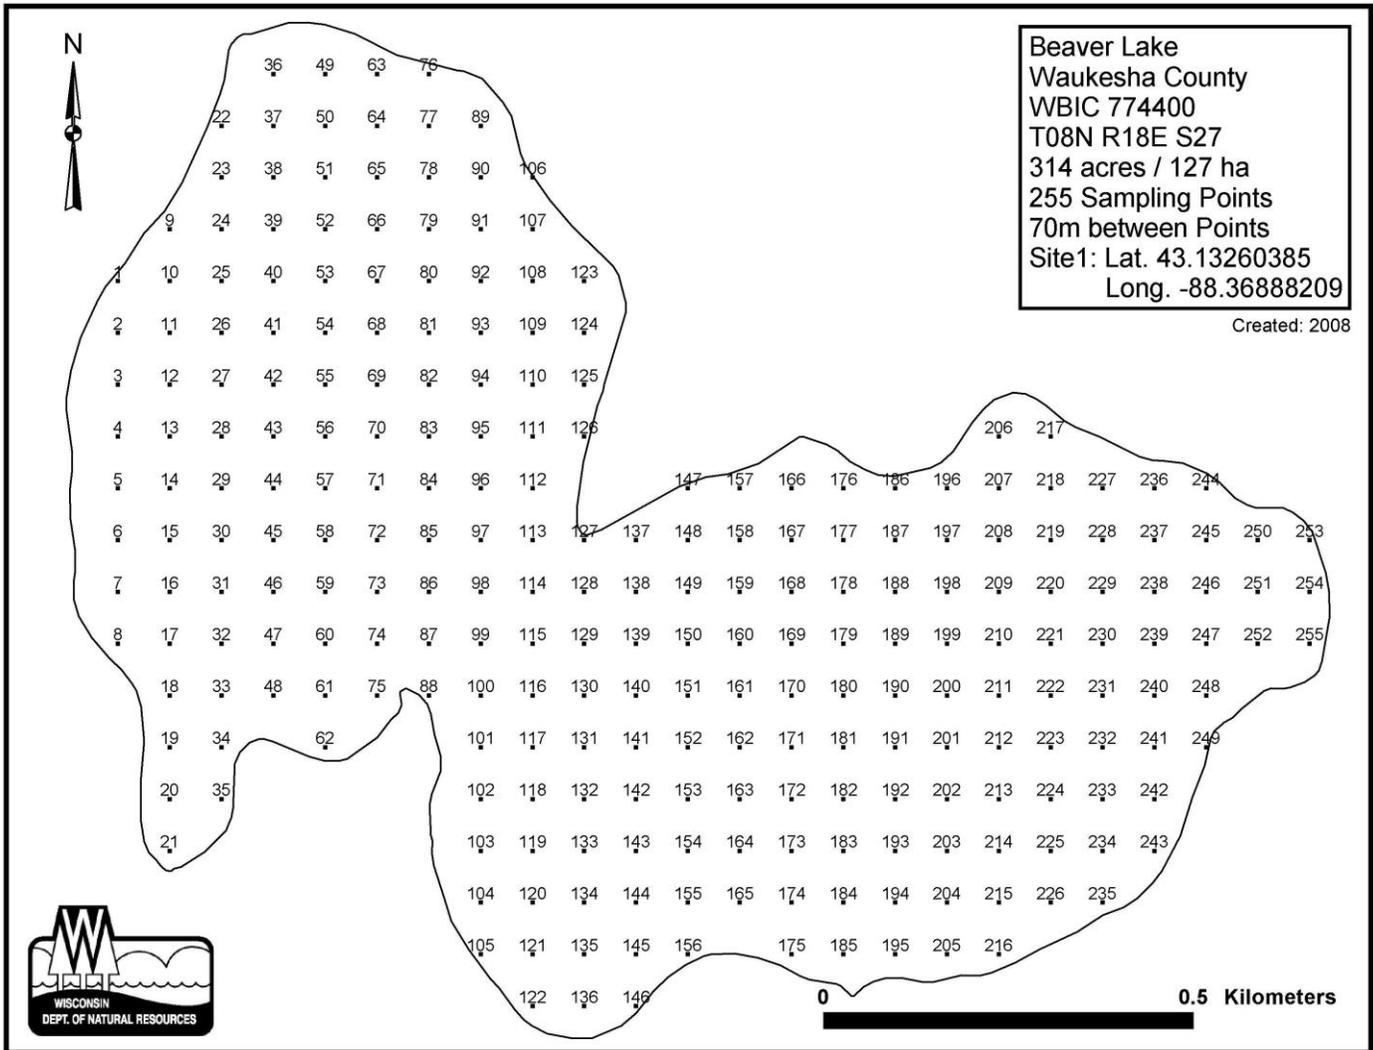
Figure 1. Point-intercept aquatic plant survey map for Beaver Lake, Waukesha County, Wisconsin.

On August 6, 2015, a point-intercept survey of Beaver Lake was conducted in the same manner as the baseline survey conducted in 2012. At each of 255 grid points plotted across the lake (**Figure 1**), aquatic plant samples were collected from a boat with a single rake tow. The rake used consisted of two short-toothed garden rake heads welded together and attached to a rope. All plant samples collected were identified to *genus* and *species* whenever possible, and the information was recorded. An abundance rating was also given for each species. In addition to the plant data, water depths were recorded for each location. Data collected was used to determine species composition, percent frequency and relative abundance. Chi-square statistical analysis was used to determine if significant change took place between the 2012 and 2015 plant surveys.

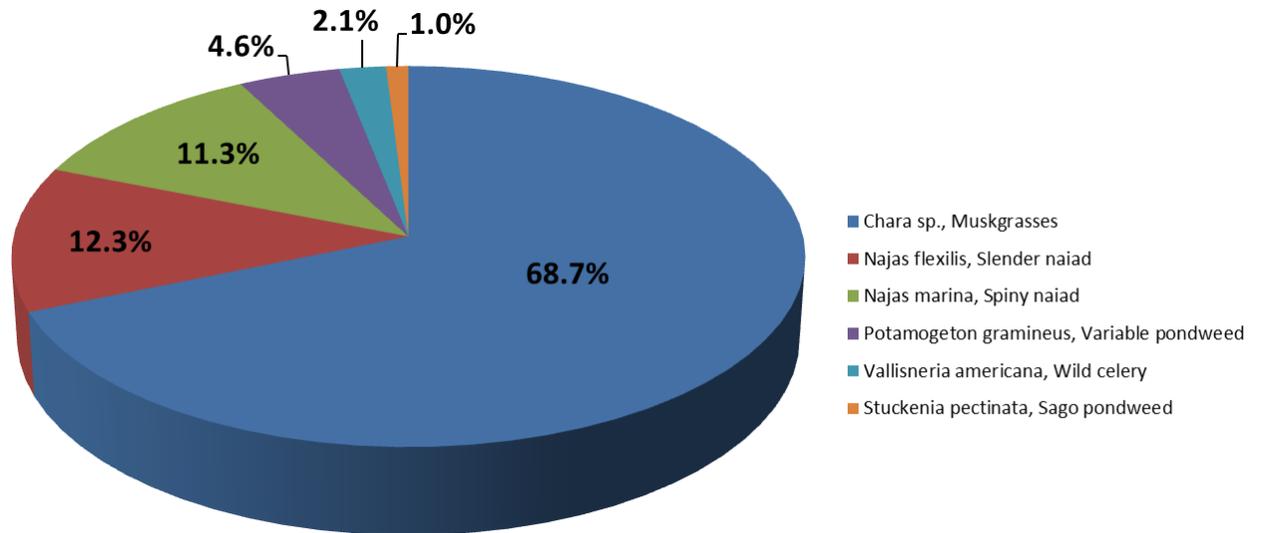
Figure 2. Submergent aquatic plant community composition on August 6, 2015 in Beaver Lake, Waukesha County, Wisconsin.

A total of 148 locations had vegetation during the point-intercept survey. In 2012, during a similar survey, vegetation was found at 160 sites. Vegetation was found growing down to 24.8 feet in 2015 and 24.9 feet in 2012. A total of 10 aquatic plant species were found during the 2015 survey (**Table 1, Figure 2**). In 2012, 14 species were identified. The state-wide average is 13 species. Beaver Lake lies within the Southeastern Till Plain Forests region of Wisconsin. The average number of species found in lakes in this region is 14.

Table 1 shows the frequency of occurrence for plant species in the lake. Percent frequency values reflect the relationship between the number of locations where a particular species was found versus the total number of locations sampled shallower than maximum depth of plants. **Figure 2** shows the composition of the plant community. Percent composition values reflect the abundance of a particular species in relation to all other species found.

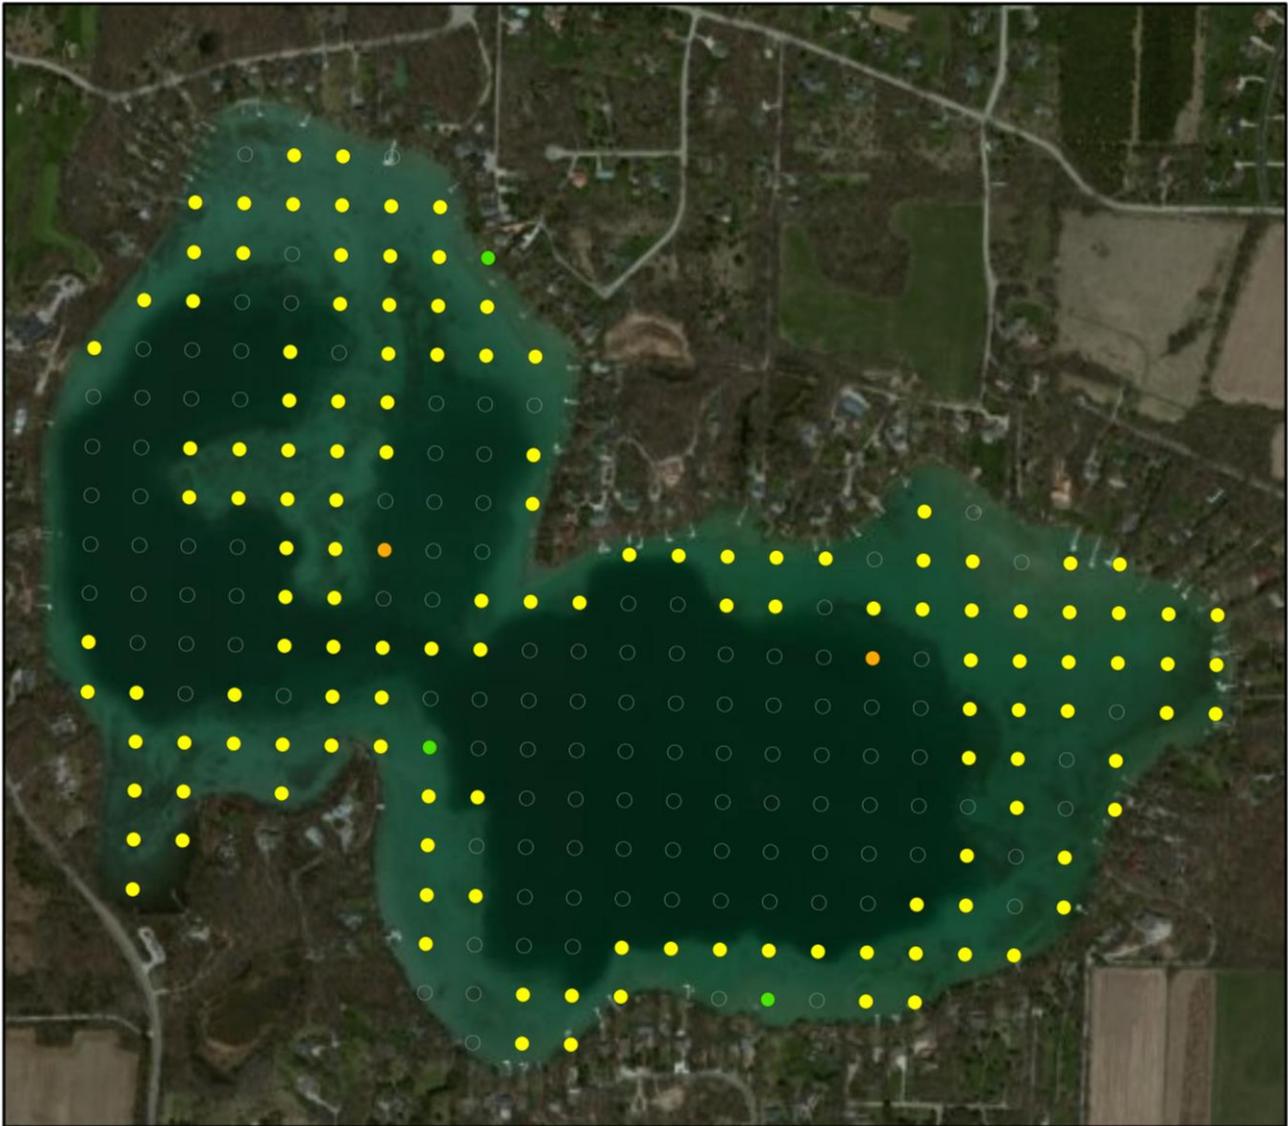
Chara

Figure 3. Distribution of muskgrass (*Chara* spp.), on August 6, 2015 on Beaver Lake, Waukesha County, WI.

The most abundant plant species encountered in Beaver Lake during the 2015 survey were muskgrass (*Chara* spp.), a type of complex algae, slender naiad (*Najas flexilis*), and spiny naiad (*Najas marina*). Muskgrass was also the most abundant species in 2012. Muskgrass was found at nearly 75% of the locations with vegetation. **Figures 3-5** show the distribution of these three species throughout Beaver Lake.

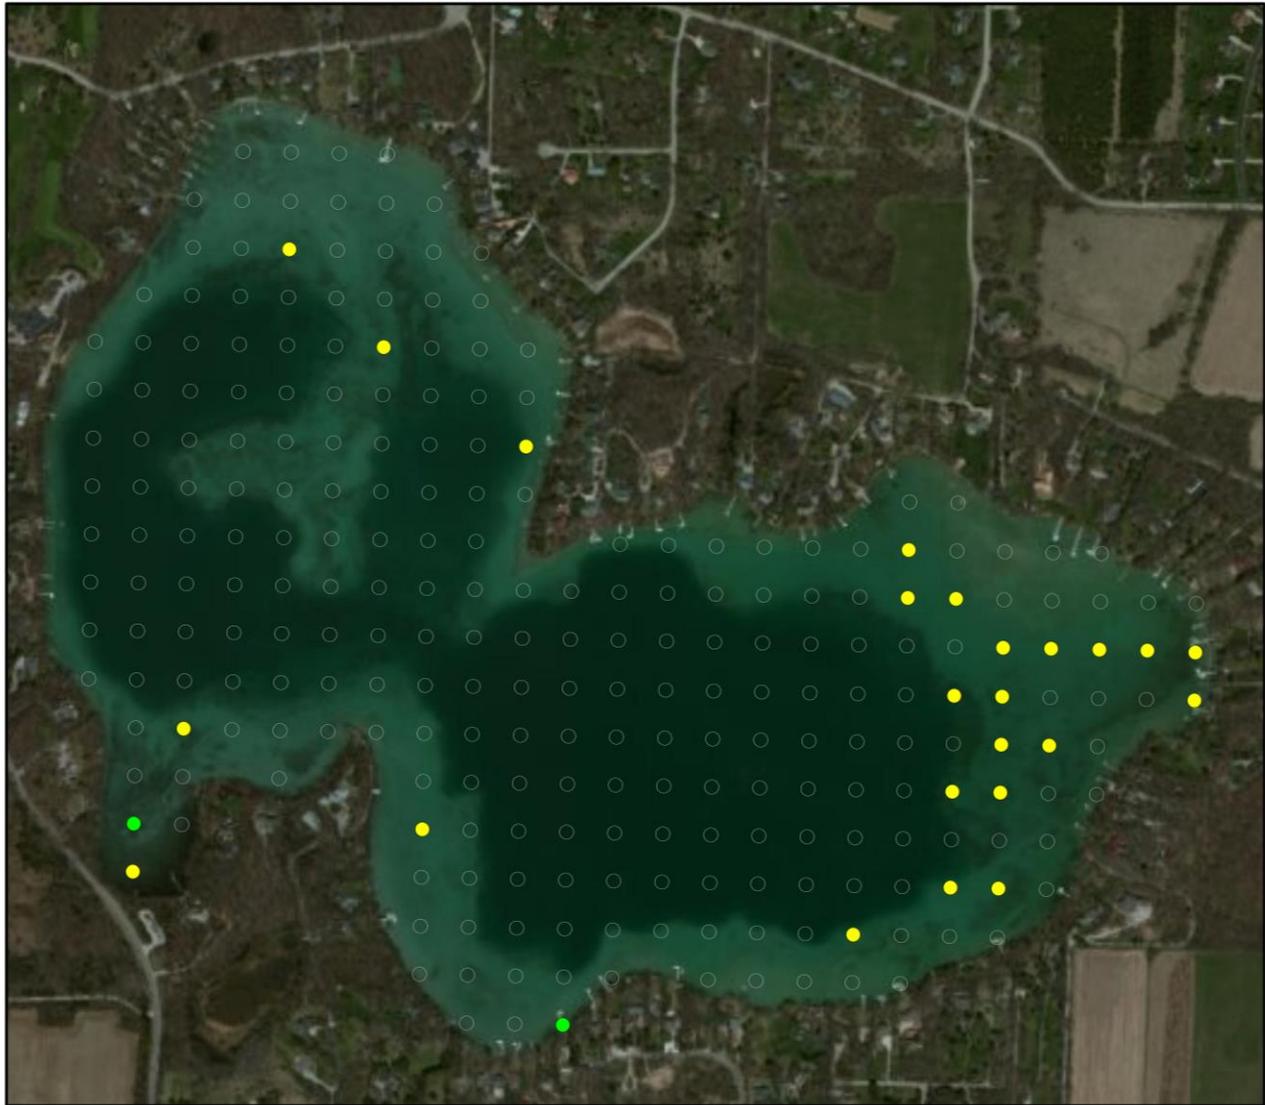
Slender Naiad

Figure 4. Distribution of slender naiad (*Najas flexilis*), on August 6, 2015 on Beaver Lake, Waukesha County, WI.

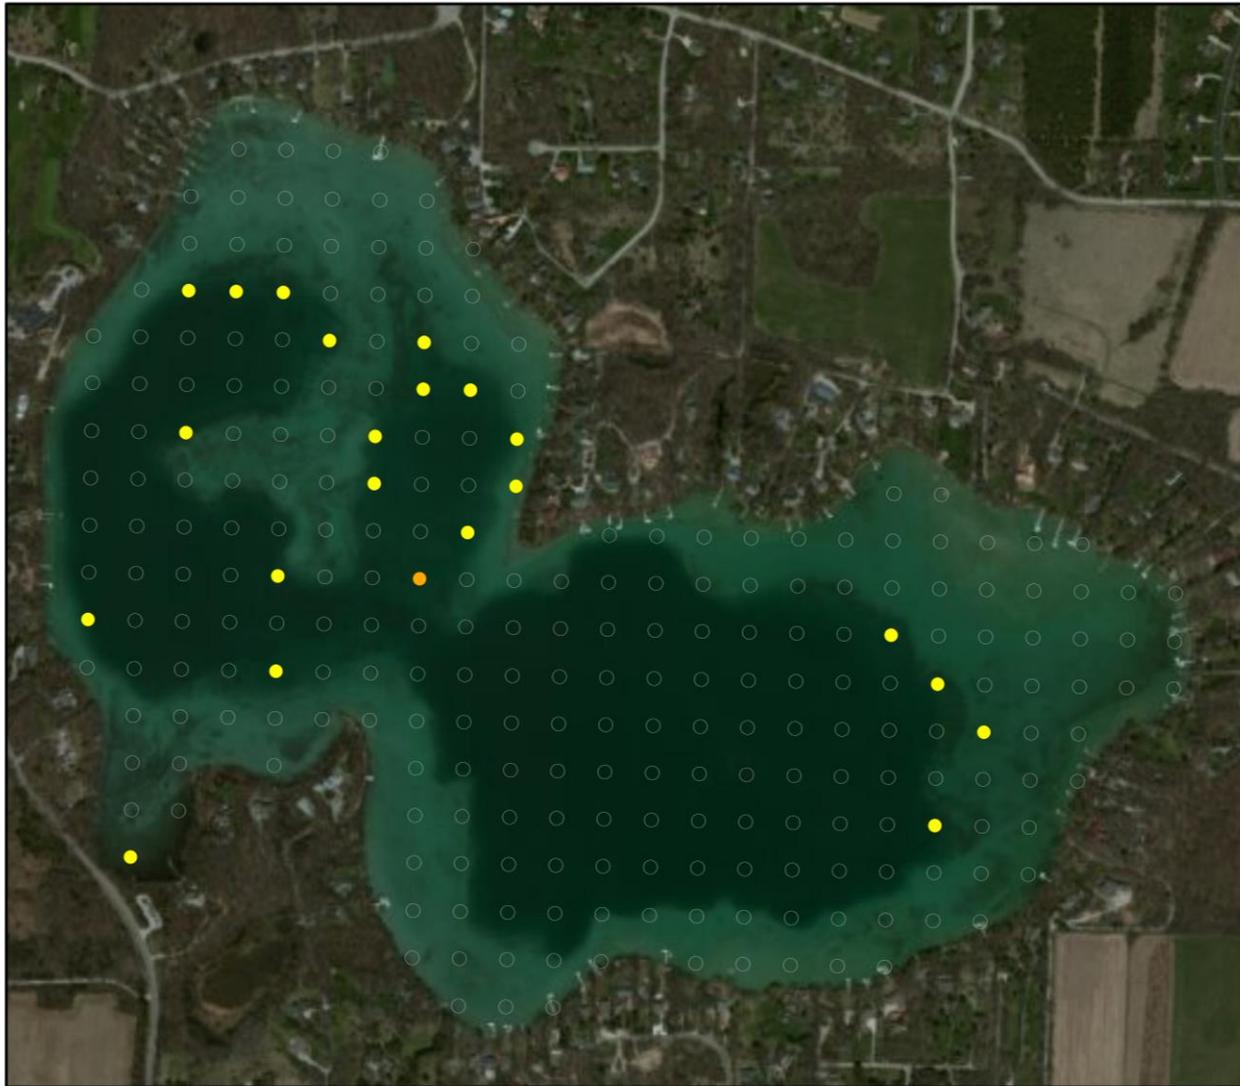
Spiny Naiad

Figure 5. Distribution of spiny naiad (*Najas marina*), on August 6, 2015 on Beaver Lake, Waukesha County, WI.

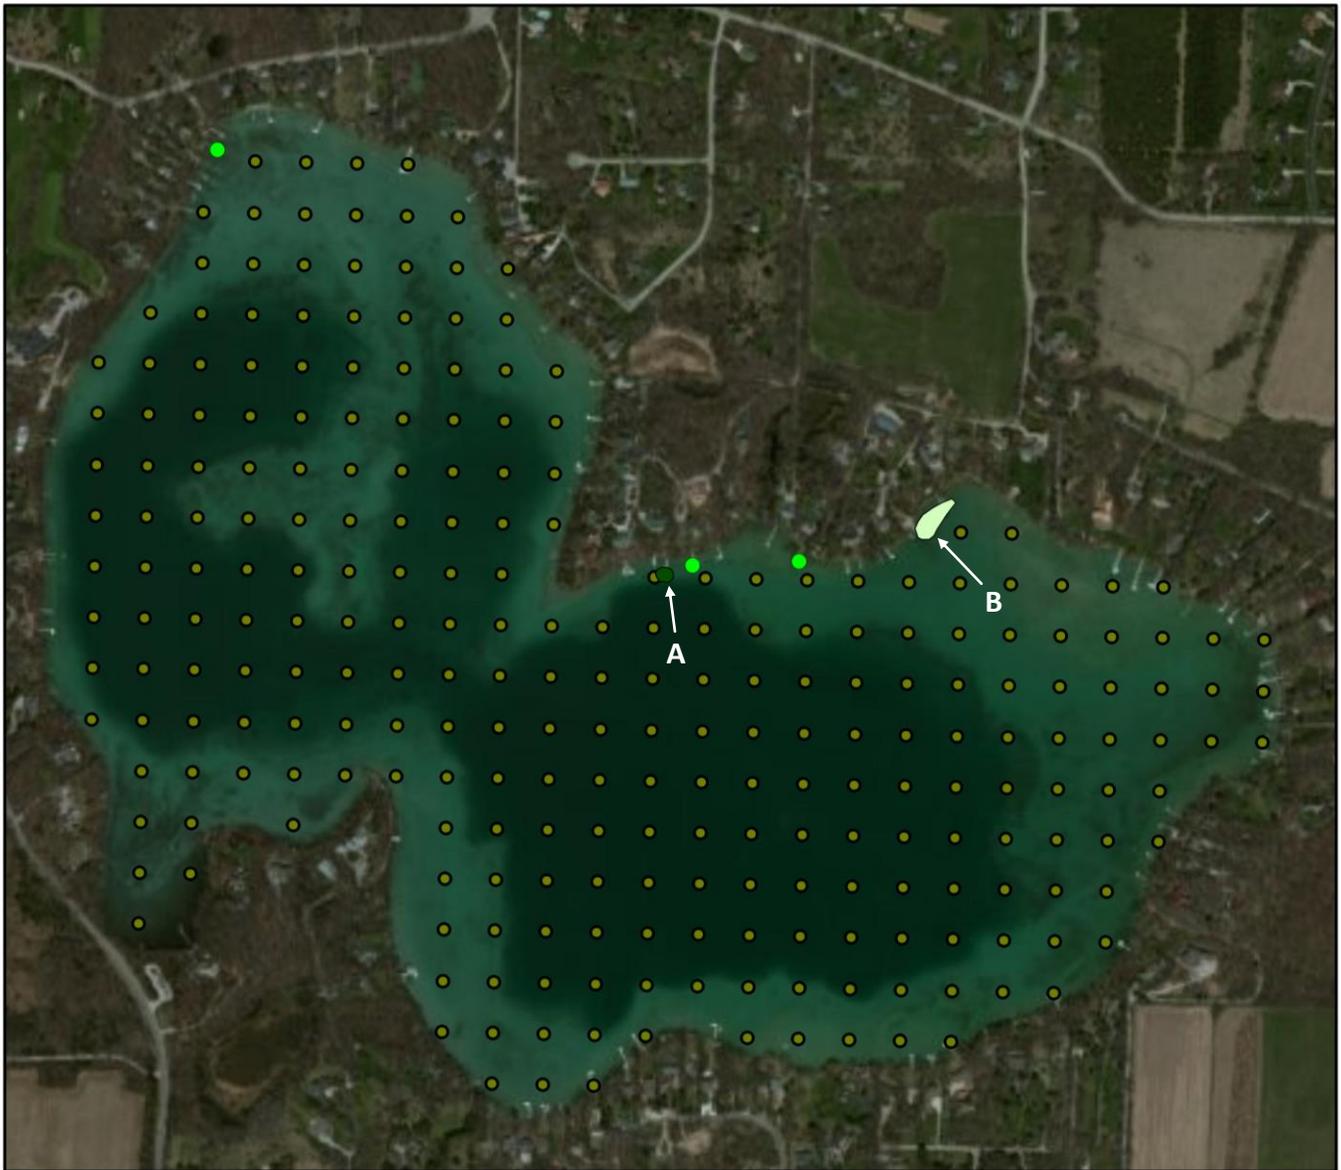
Fortunately for Beaver Lake, Eurasian watermilfoil was identified in only five locations during the August 6, 2015 survey (**Figure 6**). Three of the locations consisted of an individual plant or a small group of plants. Plant growth in these areas was not abundant enough to warrant herbicide treatment. Only one of the two beds contained dense plant growth. The two plant beds contained enough plant growth to warrant treatment. Starry stonewort was not identified in Beaver Lake at the time of this survey.

Figure 6. Distribution of Eurasian watermilfoil in Beaver Lake, Waukesha County, WI found during the August 6, 2015 mapping survey.

Annual chemical treatments have been the tool of choice for managing Eurasian watermilfoil in Beaver Lake in recent years. In the spring of 2016, a chemical treatment could again be utilized. Eurasian watermilfoil beds should be targeted using Navigate[®]. The application rate for milfoil ranges from 2.0 to 4.0 ppm. For small, isolated beds, the maximum labeled rate of 4.0 ppm (56.8 lbs/acre-ft) is recommended. The higher concentration requires less contact time to be effective.

Chemical treatments can provide seasonal relief from Eurasian watermilfoil, but may not provide long-term control at these small scales. Often these beds are found in the same locations from year to year. These treatments did however serve to prevent or slow the further spread of Eurasian watermilfoil throughout the lake. While this approach rarely leads to eradication, these treatments can serve as a means to prevent wide-spread expansion of Eurasian watermilfoil. **Table 1** provides a breakdown of estimated treatment costs for 2016.
