Beaver Lake
Eurasian Watermilfoil Manual Removal
&
General Lake Survey
Summer 2018

Prepared by
Robert C. Anderson, PhD & Katarina Volkmann

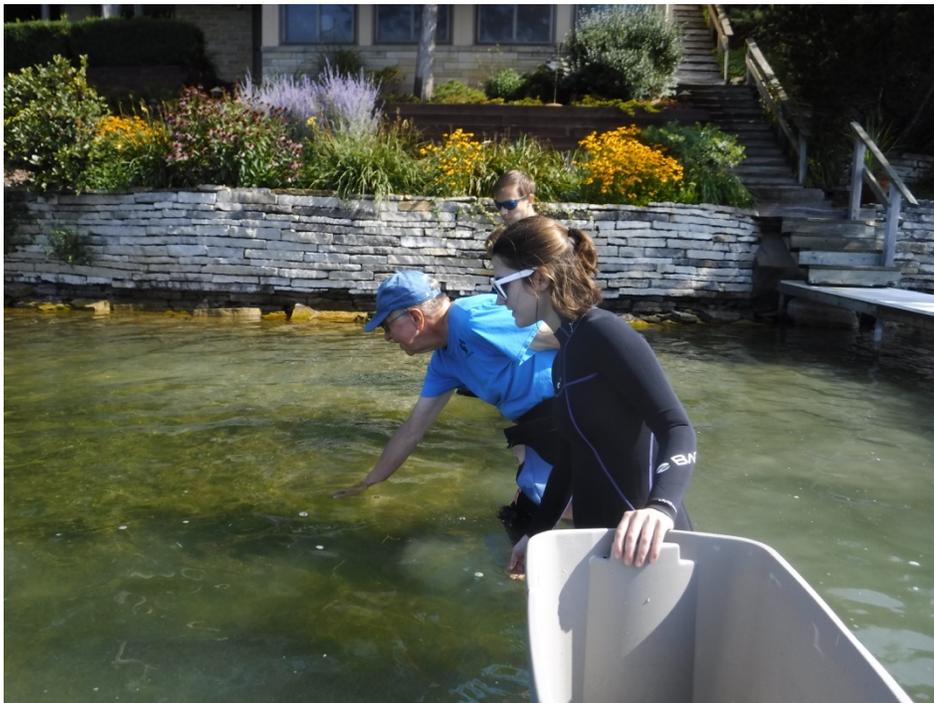
Manual removal of Eurasian watermilfoil was completed in two beds near the North central part of the lake. Plants were removed by hand pulling from the roots with care to prevent fragmentation. Those pulling the plants were followed closely by other collectors to retrieve any fragments and assure all Eurasian watermilfoil plants had been removed. Plants were placed in large floating tubs and taken to shore for disposal in upland compost piles (Figure 2).

Figure 2: Eurasian watermilfoil manual removal from nearshore waters of Beaver Lake, August 2018.

shore. Care was taken to remove the full plant including roots and to collect any fragments. Careful regular removal of recurring Eurasian milfoil plants should allow control of this invasive species without further chemical treatment.

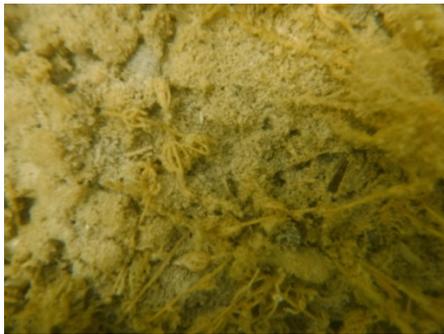
Visual surveys revealed that the aquatic plant community is dominated by muskgrasses (*Chara spp.*) (Figure 3), with occurrences of slender naiad (*Najas flexilis*) (Figure 4), spiny naiad (*Najas marina*) (Figure 5), a small number of pondweed (*Potamogeton spp.*) (Figures 6 & 7) and wild celery (*Vallisneria americana*) (Figure 8). In many areas vegetation was quite sparse and in some areas forming a low lying mat of vegetation (Figure 9). Few areas provided the diversity of plant species that would provide habitat structure to encourage development of a diverse aquatic community. A review of plant surveys performed by Casson and Associates 2012-2015

Figure 3: Beaver Lake muskgrasses. Figure 4: Slender naiad.

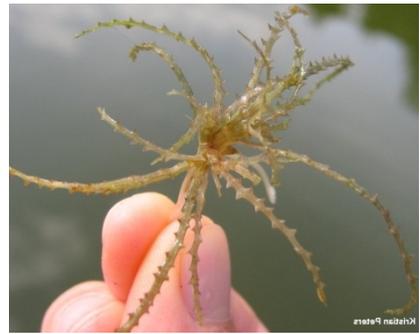
Figure 5: Spiny naiad.

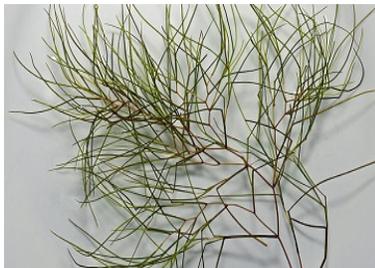
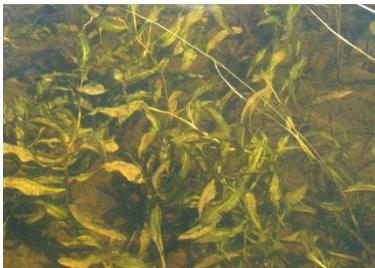
Figure 6: Sago pondweed. Figure 7: Variable pondweed.

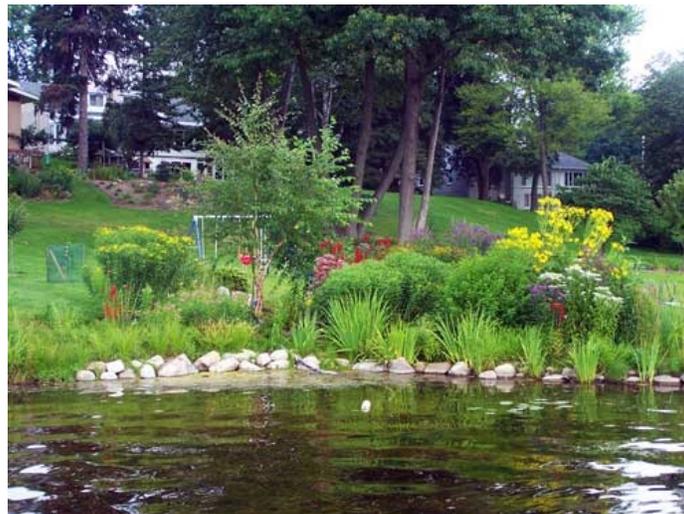
invertebrates can attach and hide. Near shore waters of a lake with a vibrant plant community of underwater and emergent plants (Figure 10) not only provides good habitat but helps to prevent erosion and absorbs excess nutrients which assist in keeping the water clear. This type of natural shoreline can add beauty to lakefront property enhancing value while improving the lake ecosystem (Figure 11).

Figure 11: Shoreline plant community (LLA 2018)

Establishment of a more diverse plant community can be encouraged as more lake property owners establish shoreline plant communities. This type of shoreline reduces sediment erosion caused by wave action and may encourage growth of a greater variety of aquatic plants.
