**STRUCTURAL INTEGRITY RESERVE STUDY**

***The Hillcrest No.4 Condominium Association, Inc.***  
*1000 Hillcrest Ct., Hollywood, FL 33021*

*Prepared by: Gregorio Batista, PE, CGC, and Kristian Cano*  
*Inspected on: March 14, 2025*  
*Prepared on: March 17, 2025*

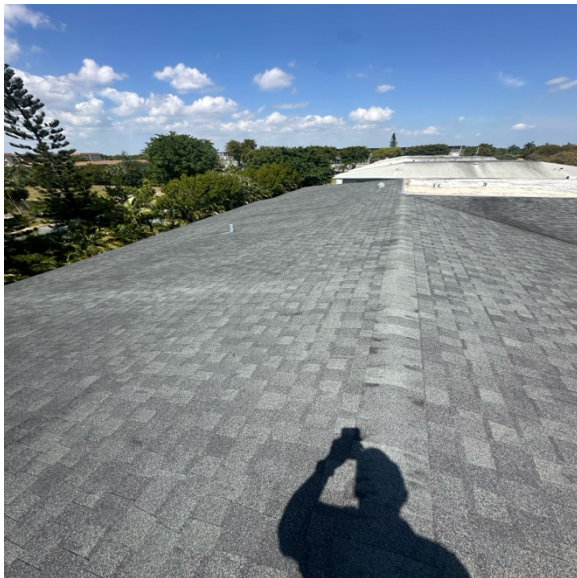
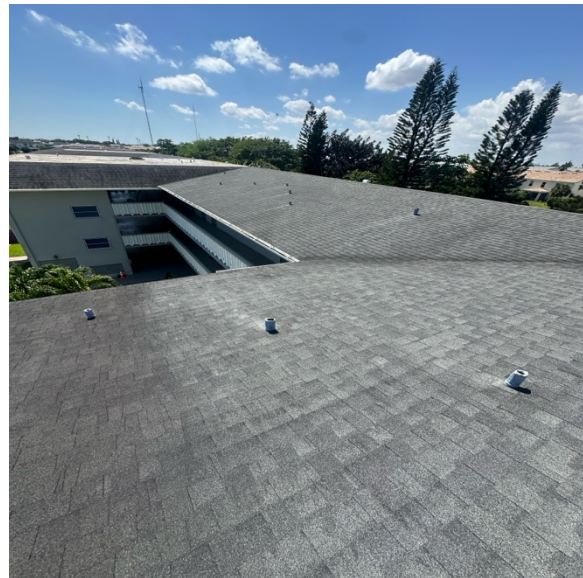
**Condition:** The roof is in satisfactory conditions.

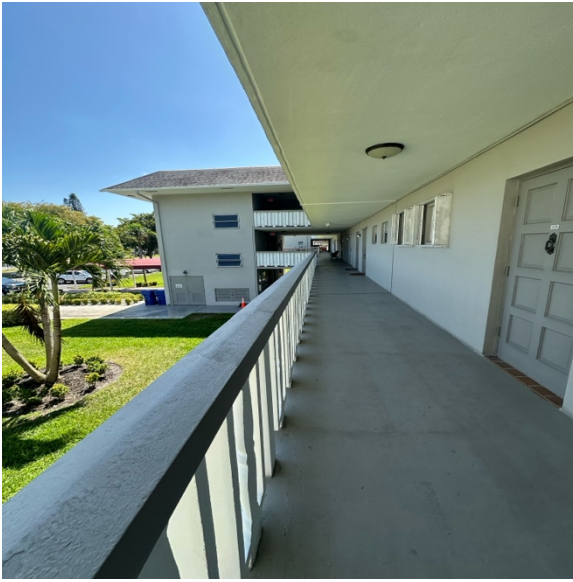
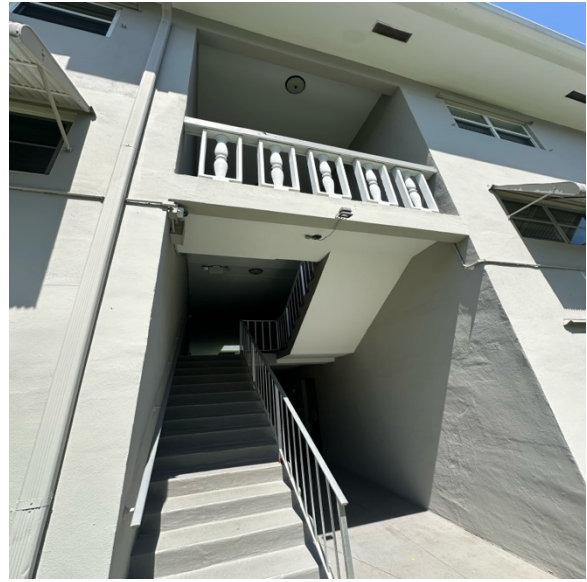
**Condition:** The concrete framing and floor systems is in satisfactory condition.

**Remaining Lifespan:** Although concrete is a very durable material, due to the location's proximity to the coast, spalling due to rebar corrosion usually manifests before the concrete naturally deteriorates. It is important to note that it is rarely possible to visually inspect and examine all the concealed construction, nor should be generally necessary. Our conclusions are based upon our experience and conditions examined in the exterior typical structural members of the building. Refer to the table presented at the end of this report.

**Estimated Cost of Replacement:** Concrete repairs are typically done on a unit-price basis and should be repaired as damages appear. Refer to the table presented at the end of this report for our recommendation based on our experience and the size of the building.

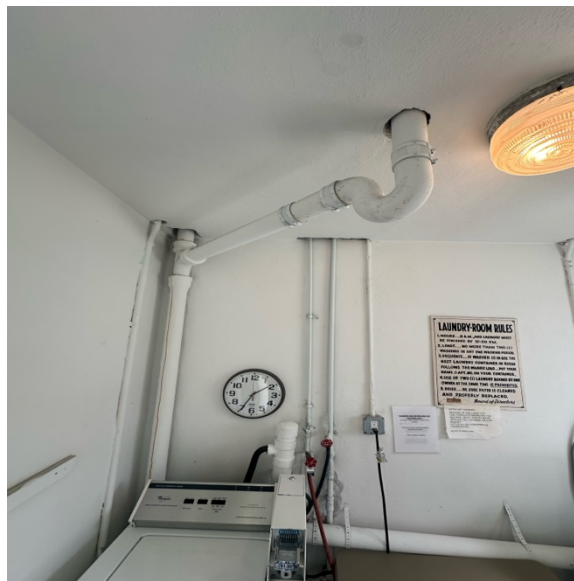
**Condition:** The plumbing system is in fair condition. It is important to note that it is rarely possible to visually inspect and examine all the concealed construction, nor should be generally necessary. Our conclusions are based upon our experience and deficiencies found in the visible and readily accessible areas.

**Estimated Cost of Replacement:** Plumbing lines and systems are typically not replaced in their totality but are repaired as items appear. See the table presented at the end of this report for our recommendation based on our experience and the size of the building.

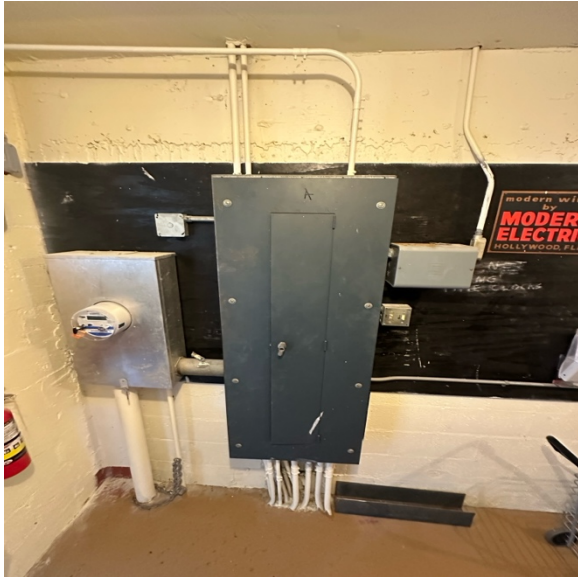
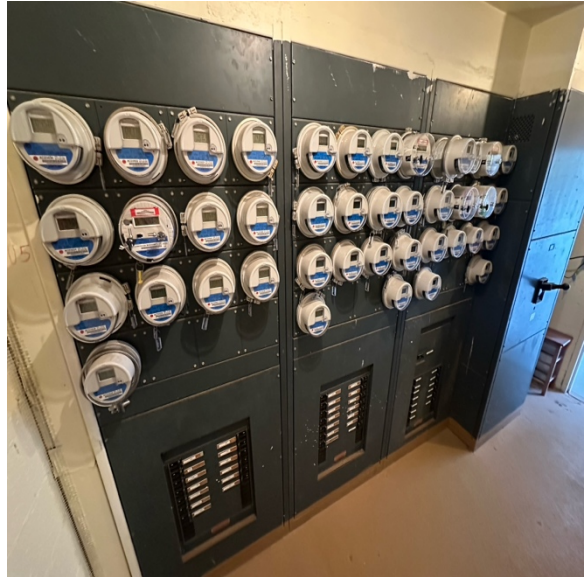
**Condition:** The electrical system(s) is in fair condition.

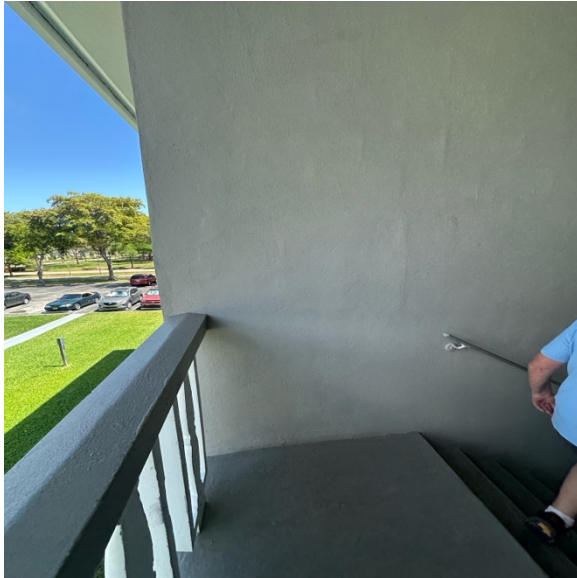
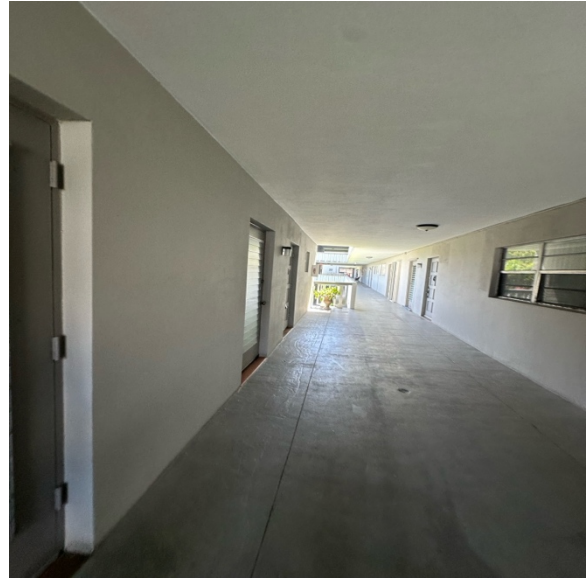
**Condition:** The exterior stucco is in satisfactory condition. It is important to note that our conclusions are based upon our experience and deficiencies found in the visible and readily accessible areas.

**Remaining Lifespan:** Although the stucco is a very durable material, due to the location's proximity to the shore, spalling due to rebar corrosion usually manifests before the stucco naturally deteriorates. Refer to the table presented at the end of this report.

**Estimated Cost of Replacement:** The removal and replacement of all the stucco finish is rarely required. It is typically repaired as required in the building for general maintenance. Therefore, we assume that 20% of all exterior surfaces are required to be replaced at once. See the table presented at the end of this report for our recommendation based on our experience and the size of the building. (The exact amount of area needing replacement will be discretionary based on the actual future conditions and the desired appearance).

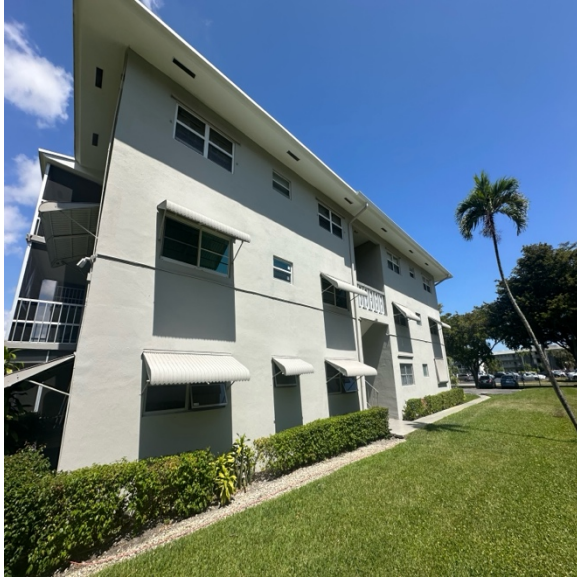
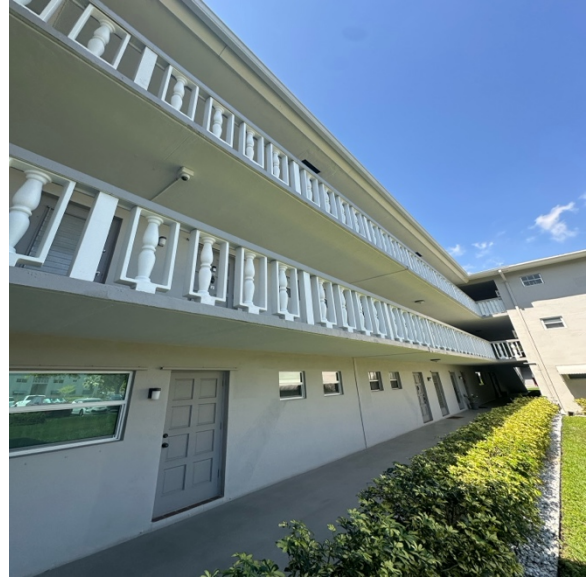
**Condition:** The surfaces appear to be in satisfactory condition.

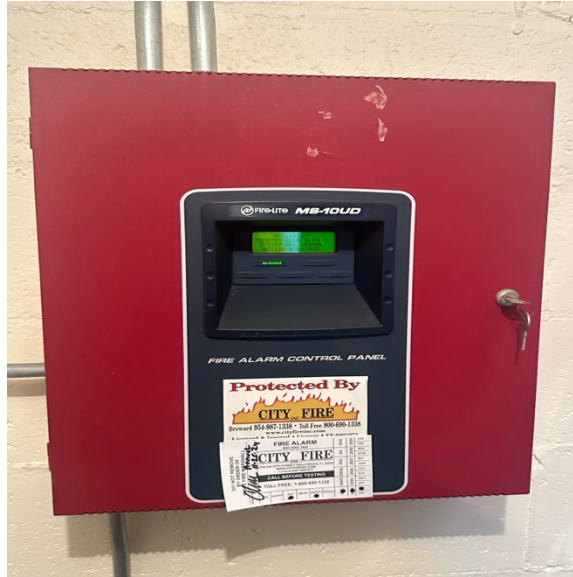
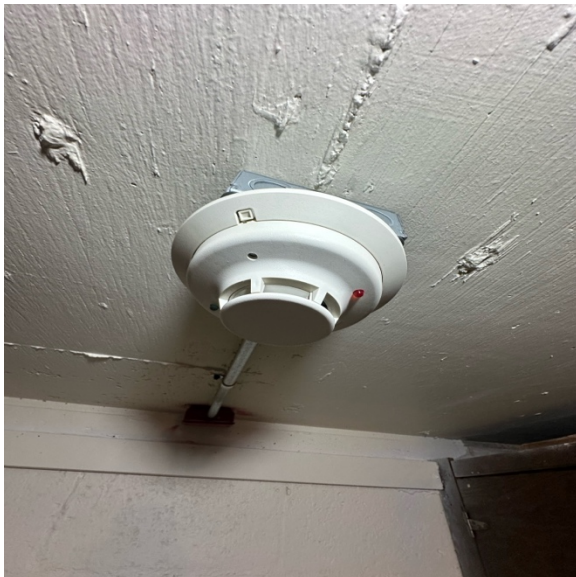
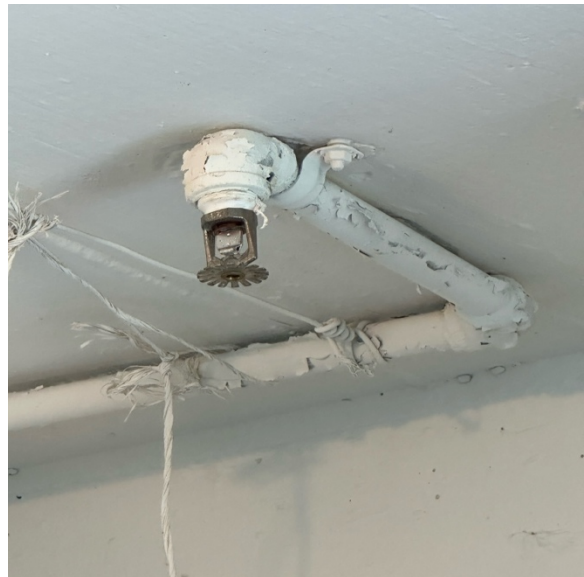
**Condition:** The fire protection systems appear to be in satisfactory condition.

**Estimated Cost of Replacement:** Fire protection systems such as the ones observed in the building are typically not replaced in their totality but are replaced as required. See the table presented at the end of this report for our recommendation based on our experience and the size of the building.

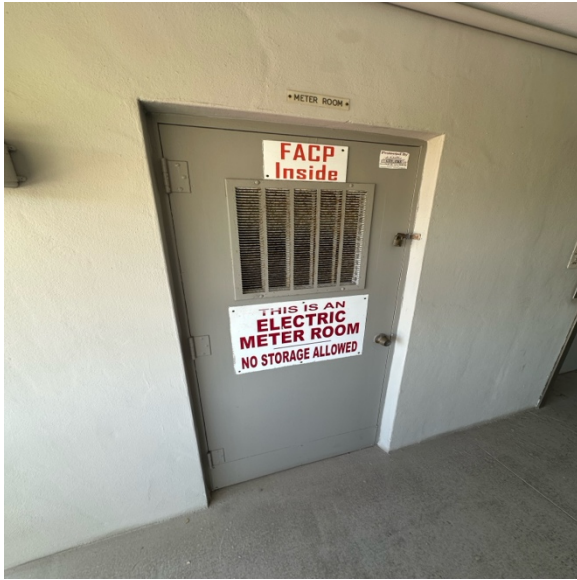
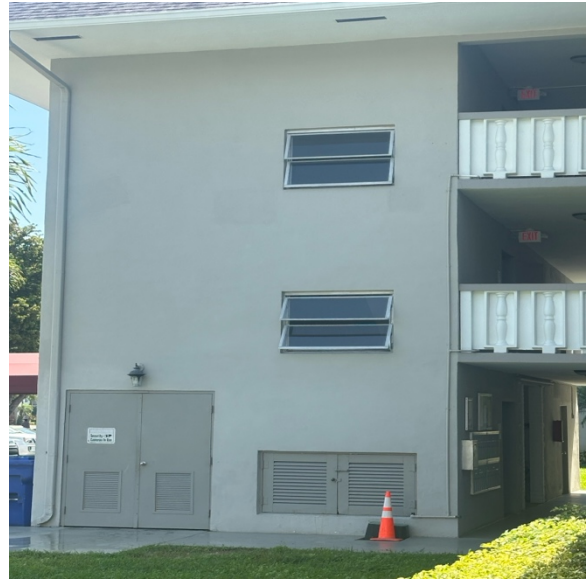
**Condition:** The common area windows and doors appear to be in satisfactory condition. The association is only responsible for the common areas. The units' windows and doors are the unit owner's responsibility.
