KINGSTON
AERIAL WITH FLUCFCS AND WETLANDS

**Old Corkscrew Plantation
FD-36-0284086-001**

**FORMAL DETERMINATION OF THE LANDWARD EXTENT OF WETLANDS AND
OTHER SURFACE WATERS**

**Final Report
for
Old Corkscrew Plantation
Formal Determination of the Landward Extent of Wetlands
and other Surface Waters of the State
(FD-36-0284086-001)**

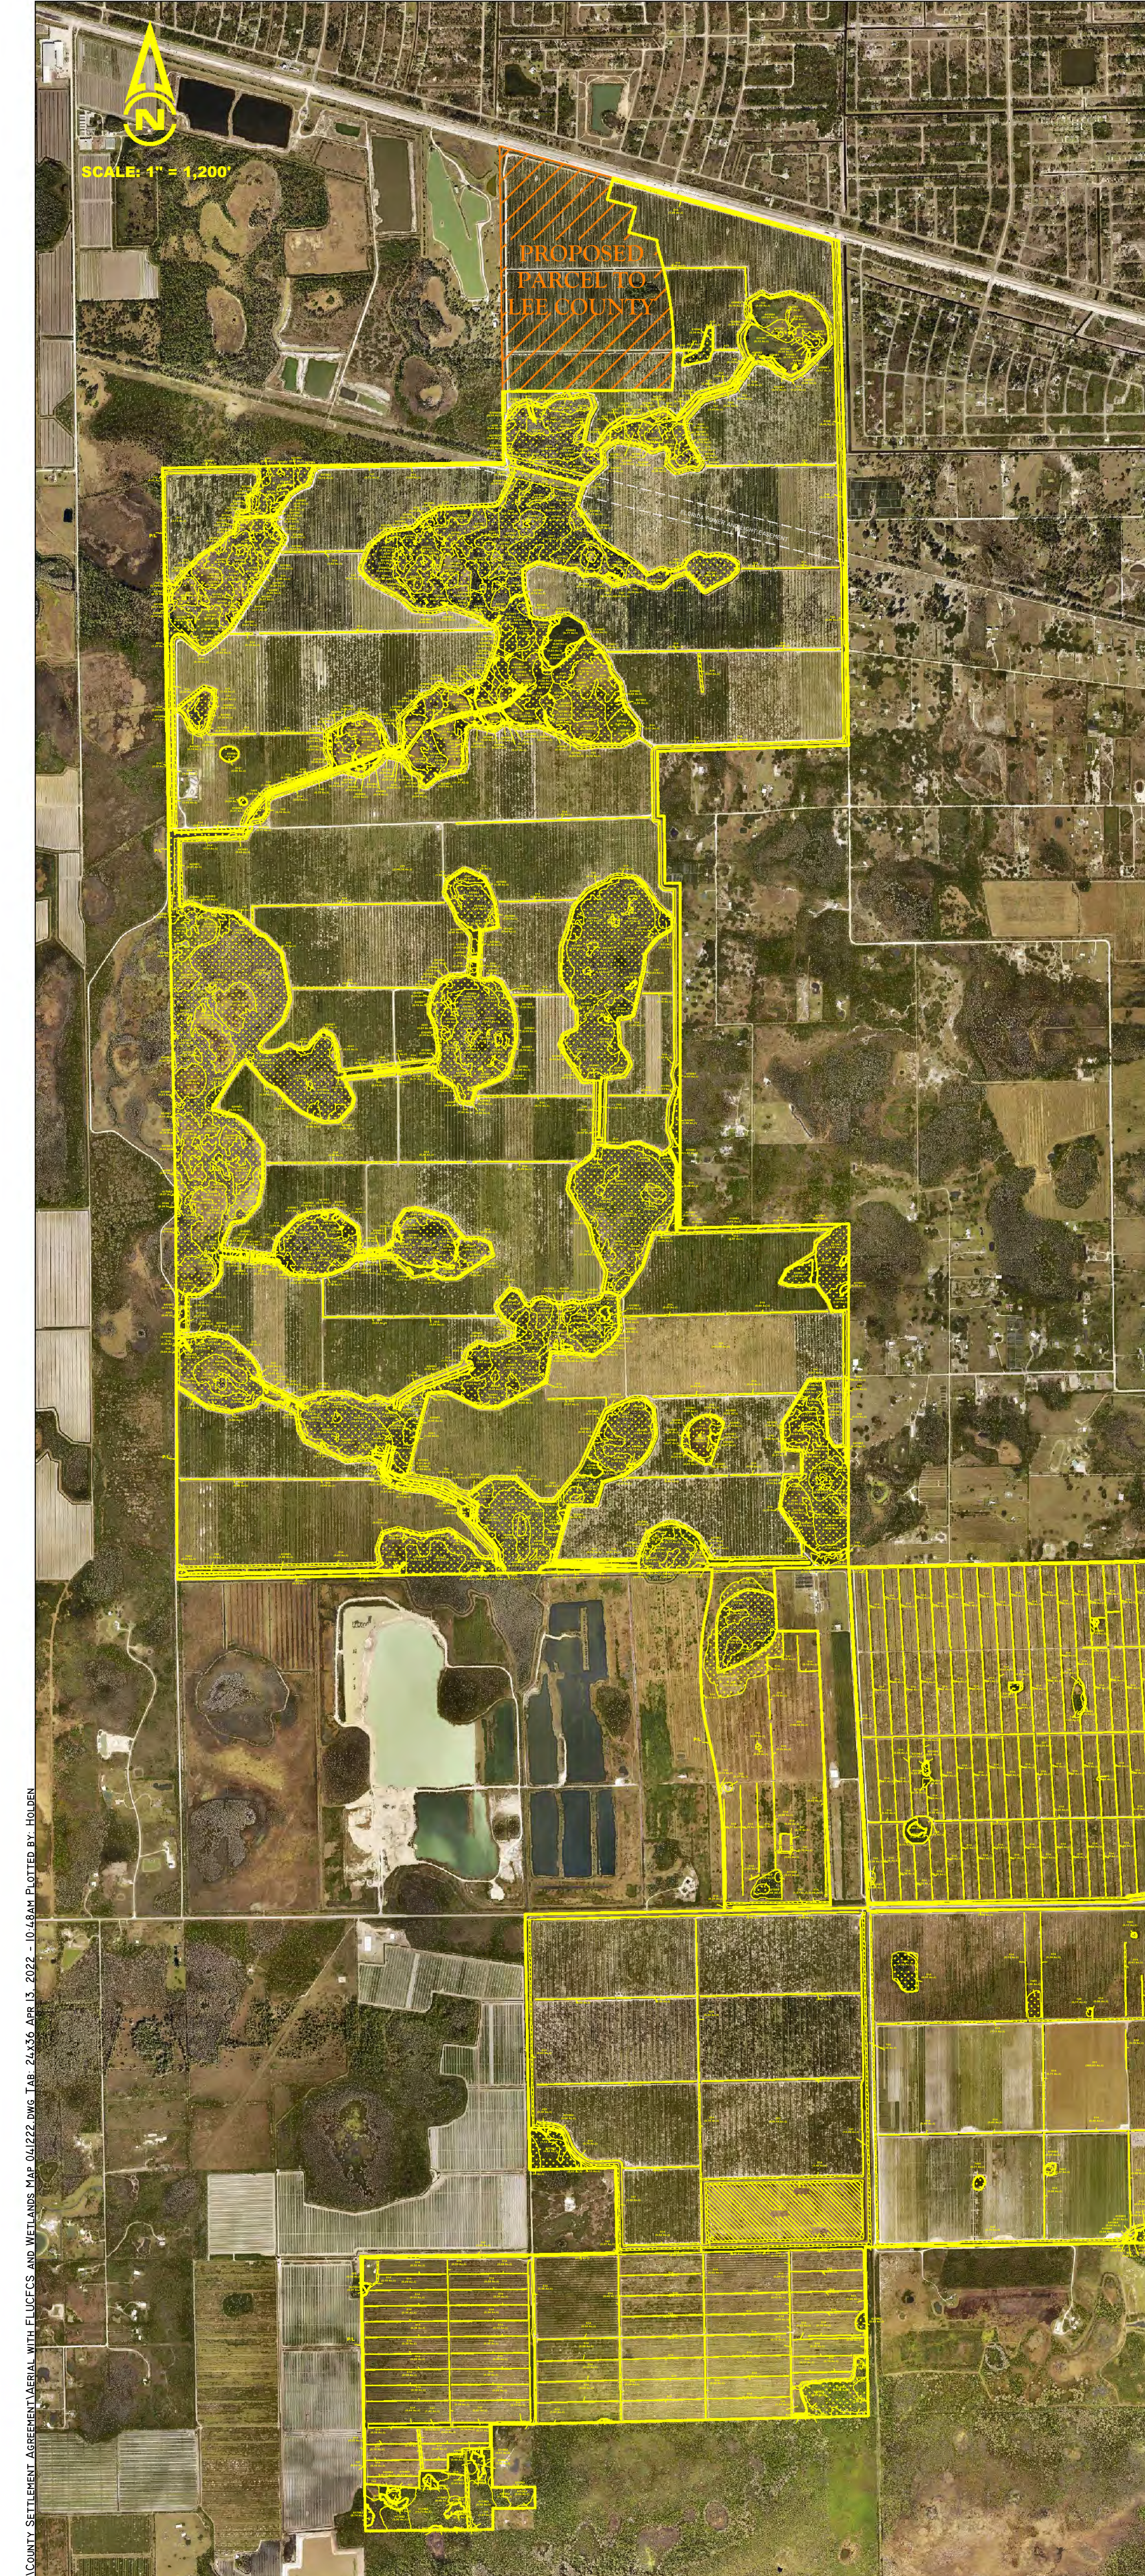
WETLAND AND OSW LINES SHOWN PER FDEP FORMAL WETLAND JURISDICTIONAL DETERMINATION NO.FD-36-0284086-001 ISSUED AUGUST 26, 2009.

FLUCFCS LINES ESTIMATED FROM 1"-300' AERIAL PHOTOGRAPHS AND LOCATIONS APPROXIMATED.

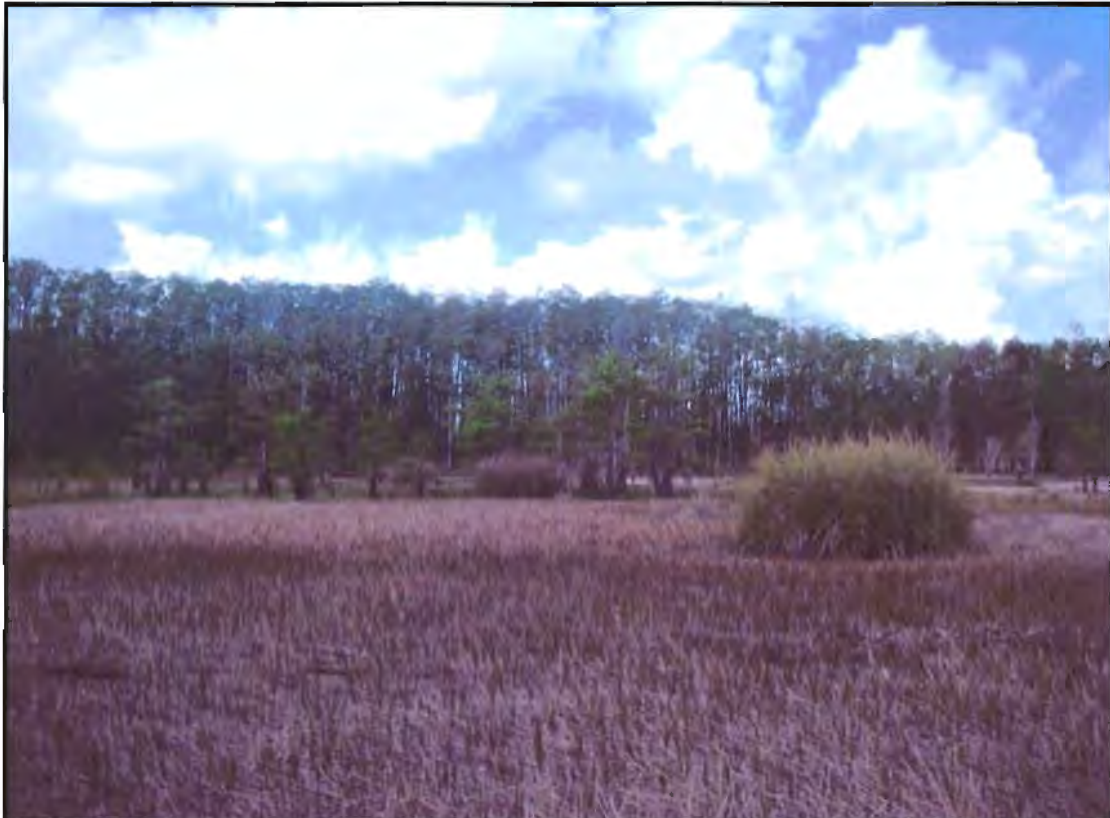
Figure 2. Typical wet prairie interior. Note the ground is carpeted by *Eleocharis sp.* and other obligate herbs.

Usually, the outer edge of the wetlands is dominated by shrub and forested wetlands, while the wetland interiors are frequently open marsh or wet prairie (Figure 2). The wetlands are contained within created berms with deep perimeter ditches outside of the berm (Figure 5). A series of culverts and agricultural pump stations connect the deep ditches on site to the wetland systems. The wetlands on site are generally of good to high quality (suggested UMAM scores typically 8 or above for community structure and water environment), except some areas where melaleuca (*Melaleuca quinquenervia*) and Brazilain pepper-tree (*Schinus terebinthefolius*) are major problems. The transition from wetland to upland was typically easily identified based on the change in vegetation (Figure 3).

Wet Prairie (Figure 2, 9)- About 35 acres of wet prairie communities occurred on site. Dominant plants included *Eleocharis* sp., *Rhynchospora* sp., *Xyris caroliniana*, and seaside heliotrope (*Heliotropium curravaseum*).

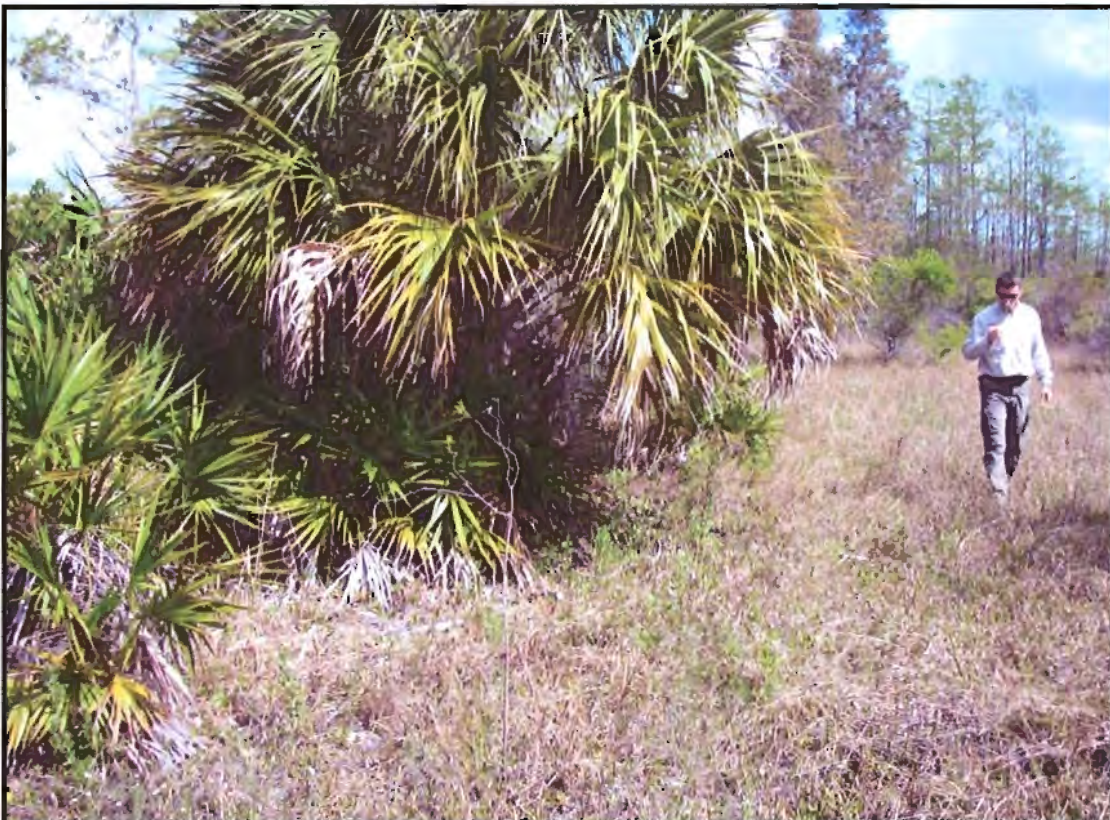
Figure 3. Typical upland/wetland ecotone on the Old Corkscrew Plantation site. The grasses and other herbaceous groundcover were typical of the interior of many of open wetlands on site.

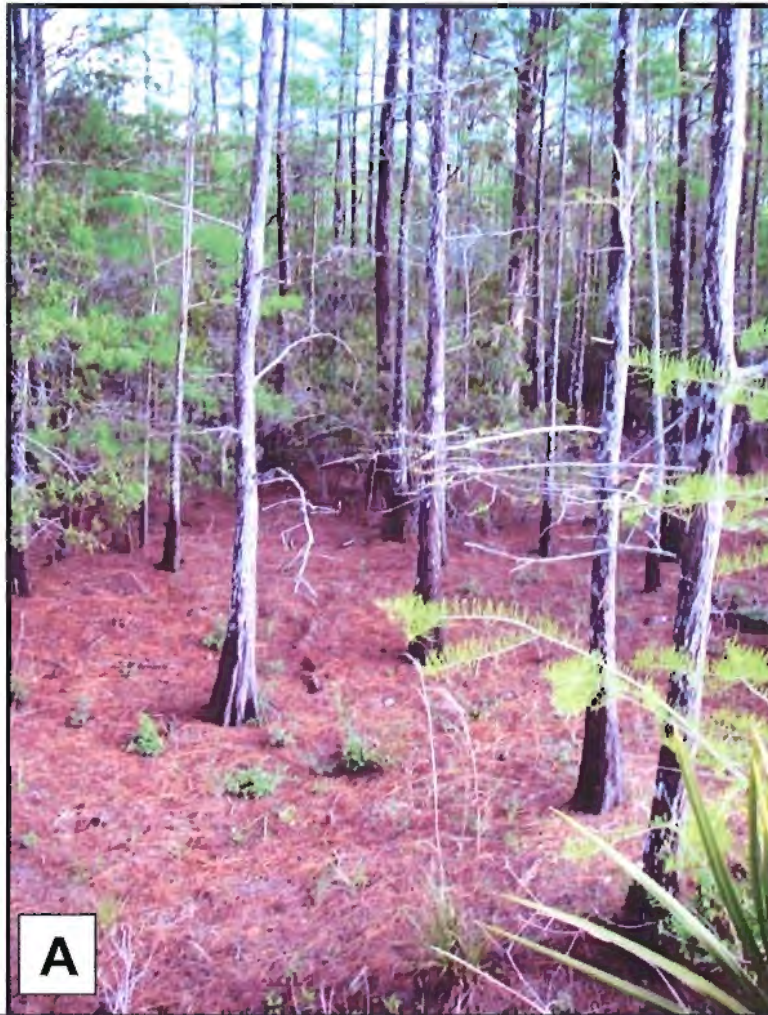
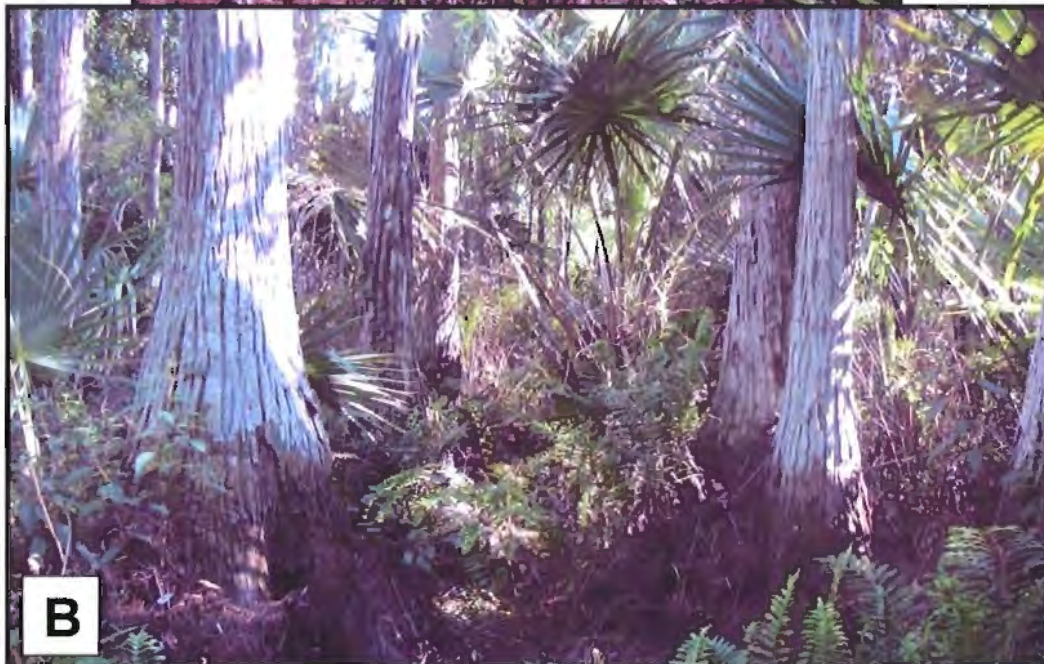
Figure 4. Typical cypress dome and strand wetland interior. In all cypress domes on site, there is a dominance of *Taxodium ascendens*, however depending on the hydroperiod, the groundcover was often substantially different. A. Short hydroperiod cypress dome with sparse understory. B. Long hydroperiod cypress dome with a dominant groundcover of *Blechnum serrulatum*, *Osmunda cinnamomea*, and *Boehmeria cylindrica*.

Cypress Swamp (Figure 4)- The Cypress Swamp community was the most common plant community on site. Over 620 acres of this community type was found. Dominant plants included pond cypress (*Taxodium ascendens*), sweetbay magnolia (*Magnolia virginica*), swamp bay (*Persea palustris*), myrsine (*Myrsine guianensis*), and wax myrtle (*Myrica cerifera*).

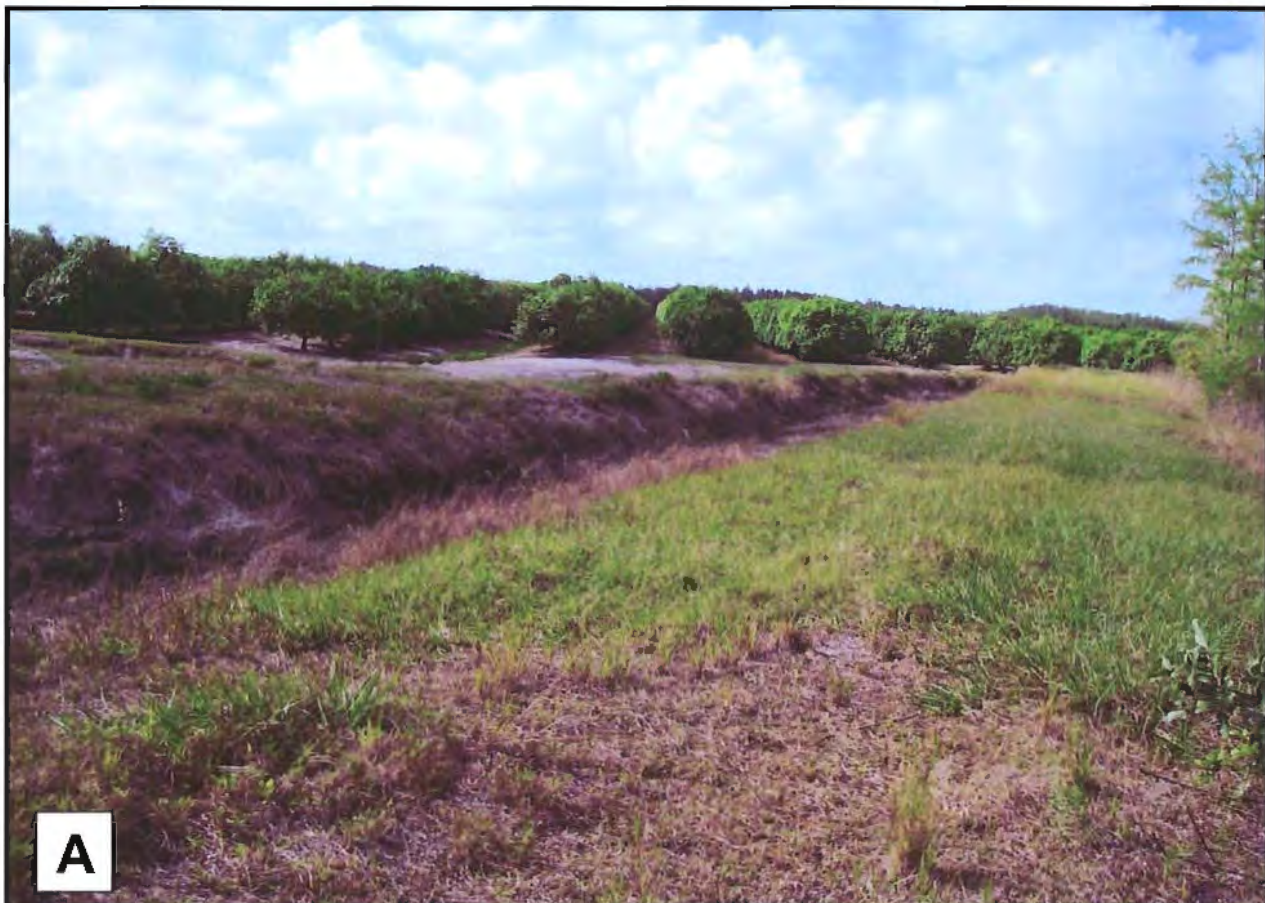
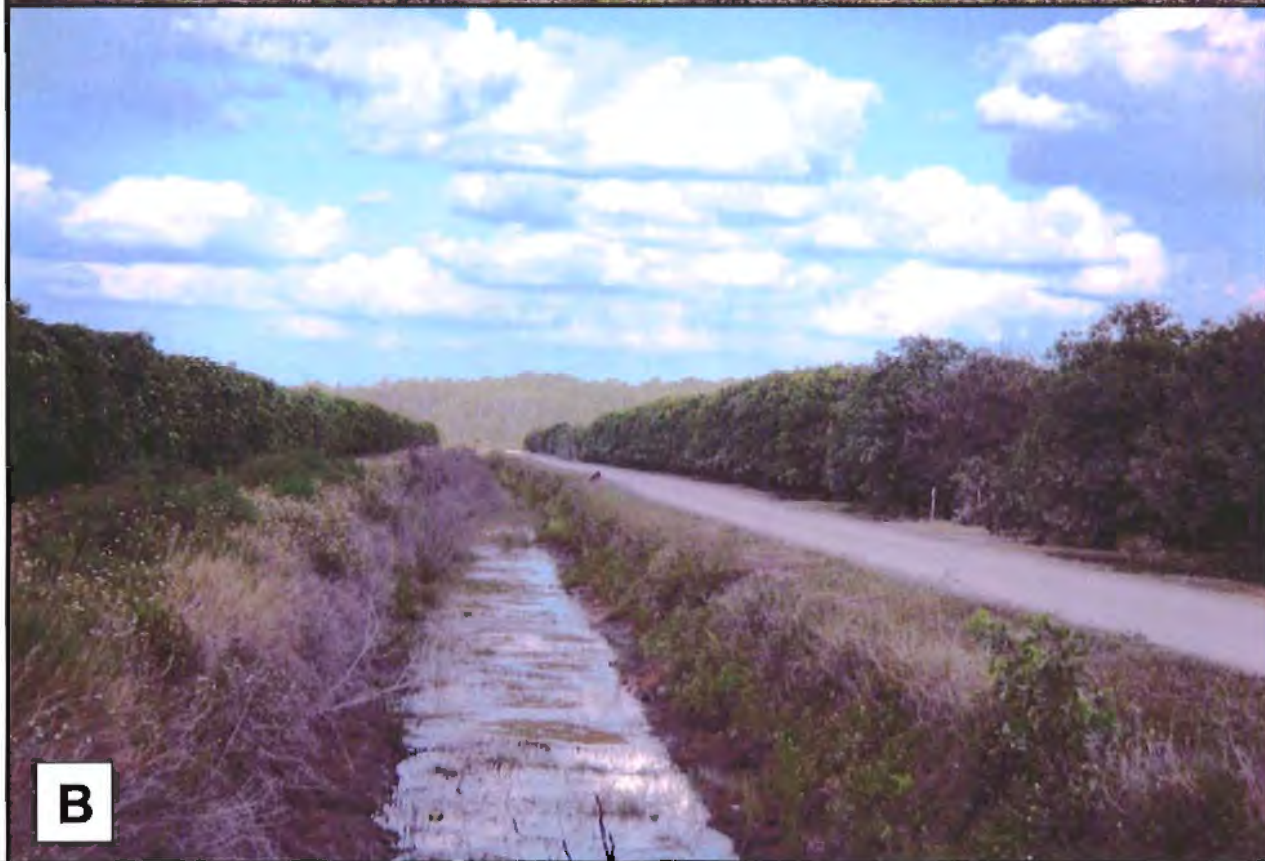
Figure 5. Typical artificially created ditches and berms on the Old Corkscrew Plantation site. A. View of one of the wetland rim ditches as seen standing atop the berm that forms the perimeter of most of the large wetland systems on site looking toward the orange grove. B. A ditch located along roads within the orange groves was smaller in diameter and depth than the wetland rim ditches.

Freshwater Marsh/Artificial Ditches (Figures 5, 18)- The Freshwater Marsh habitat occurred in the artificial ditches on site. Over 300 acres of this community type existed on site. The dominant plants were cattails (*Typha latifolia* and *Typha domengensis*), sawgrass (*Cladium jamaicense*), peruvian primrose willow (*Ludwigia peruviana*), bulltongue arrowhead (*Sagittaria lancifolia*), torpedo grass (*Panicum repens*), creeping primrosewillow (*Ludwigia repens*), *Lemna* spp., Bladderworts (*Utricularia* spp.), mosquito fern (*Azolla caroliniana*), *Centella asiatica*, *Hydrocotyle umbellata*, carolina willow (*Salix caroliniana*), and other floating and emergent aquatic and obligate plants.

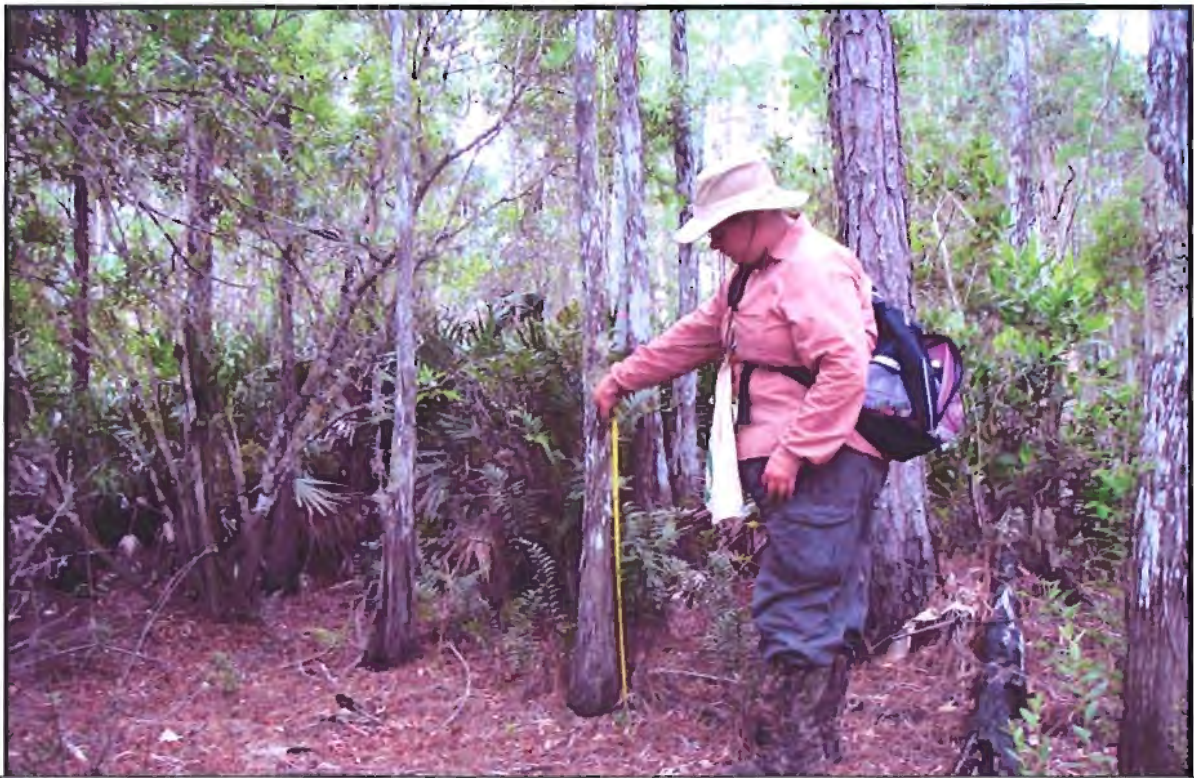
Figure 6. The author demonstrating the height of lichen lines near a palmetto island. When lichen lines consistently occurred above the elevation of the palmetto islands that occurred within the large wetland systems, these palmetto islands were not claimed as uplands, but as other surface waters of the state.

In some areas on site, hydrologic indicators suggested that the Ordinary High Water Line (OHWL) was a good deal higher than suggested by the vegetation (Figure 6). In these cases, the areas without hydrophytic vegetation, but with hydrologic indicators present indicating that the OHWL was above the topographic/vegetation break were identified as surface waters of the state. It is thought that this circumstance occurs; because during heavy rain events, the agricultural pumps are turned on, thus flooding areas that typically remain flooded. As long as the agricultural activity continues on site and the agricultural pumps remain, this situation will occur. Thus, these areas were identified as jurisdictional surface water areas. Several palmetto

islands, pine flatwoods areas, and one hardwood/conifer mixed forest area were identified as surface water areas due to this circumstance.

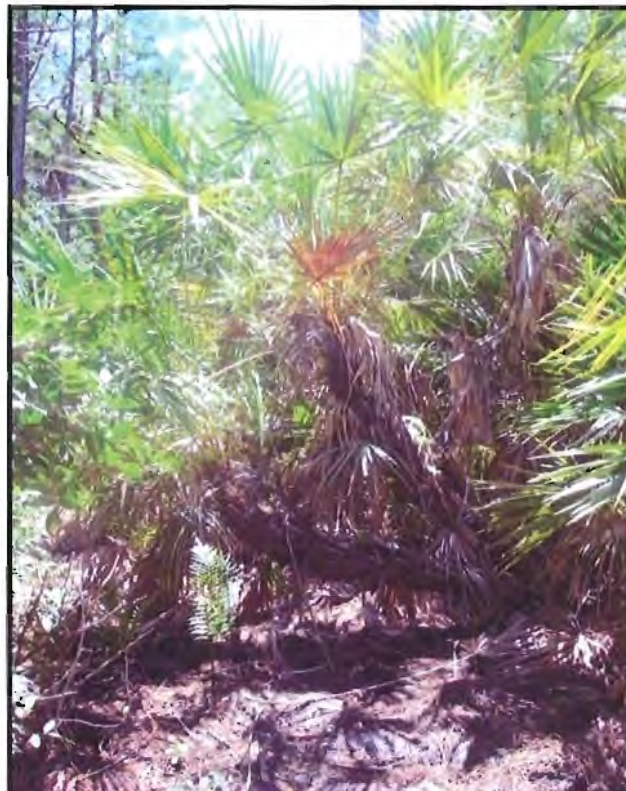
Figure 7. Large tree-like palmetto that occurring in one of the palmetto islands that were frequently located as upland islands within the large wetland systems.

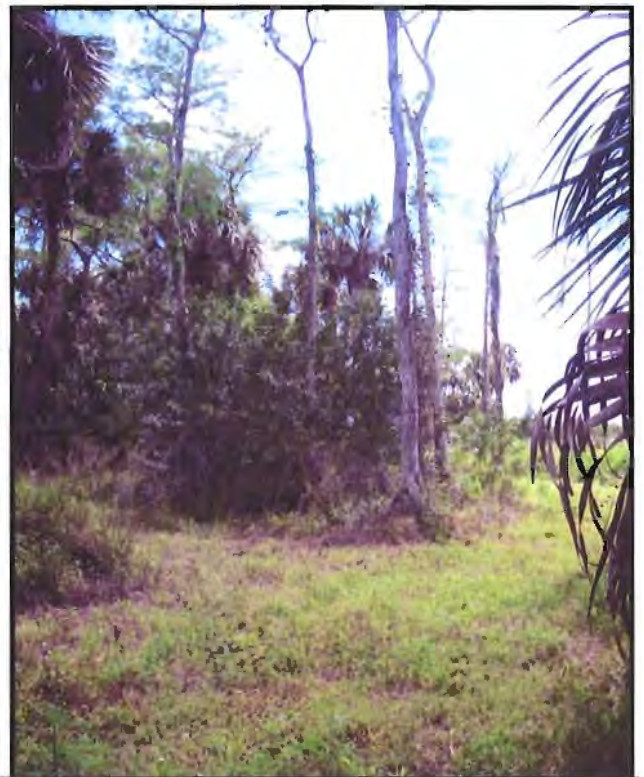
Figure 8. Hydrologically altered wetland. This small area appeared to be a wetland on aerial photographs, however closer inspection revealed that it was altered beyond minimum wetland criteria. Two such areas occurred on site.

A couple of areas were identified as being hydrologically drained areas (Figure 8). In these cases, though a canopy of pond cypress (*Taxodium ascendens*) may have persisted, the groundcover recruitment was primarily upland or facultative species and no contemporary hydrologic indicators or hydric soils were identified. In addition, in the two areas identified as being hydrologically drained (and thus non-jurisdictional), the canopy of pond cypress appeared to be stressed, showing a large amount of dying or dead wood and little to no leaf sprout.

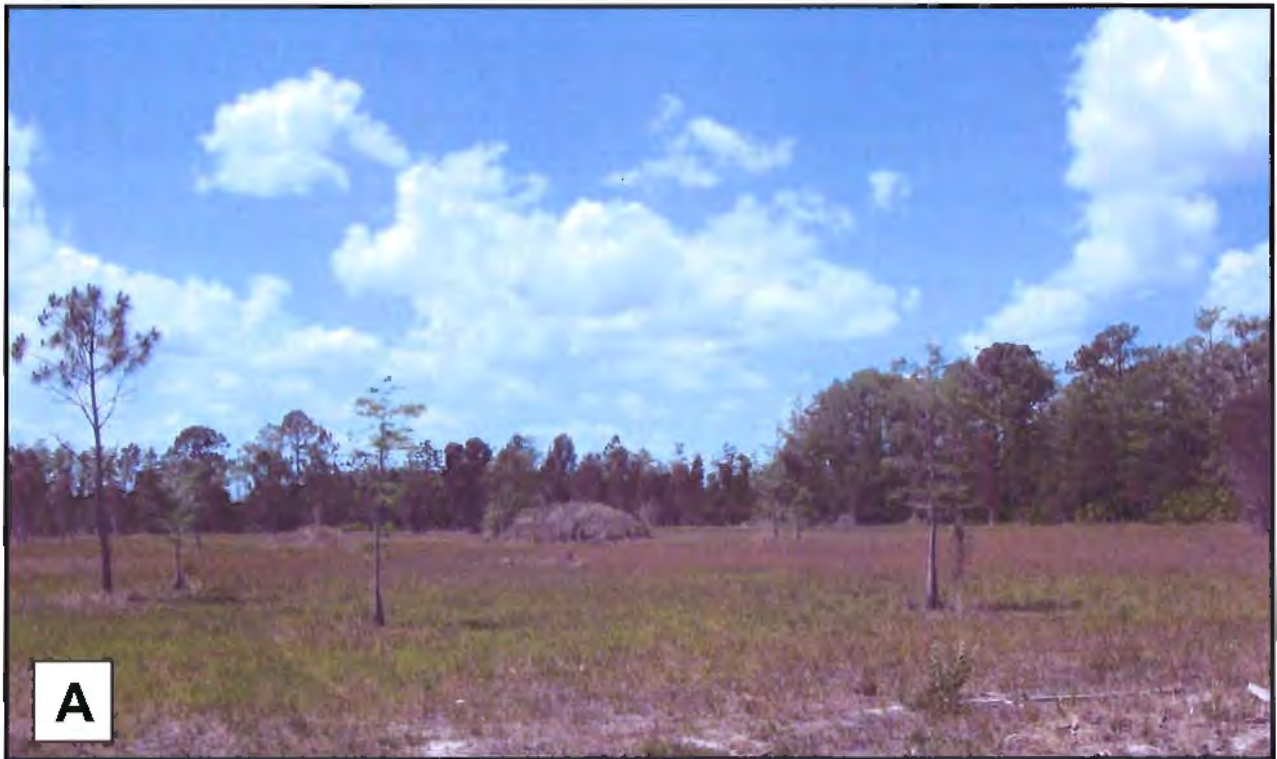
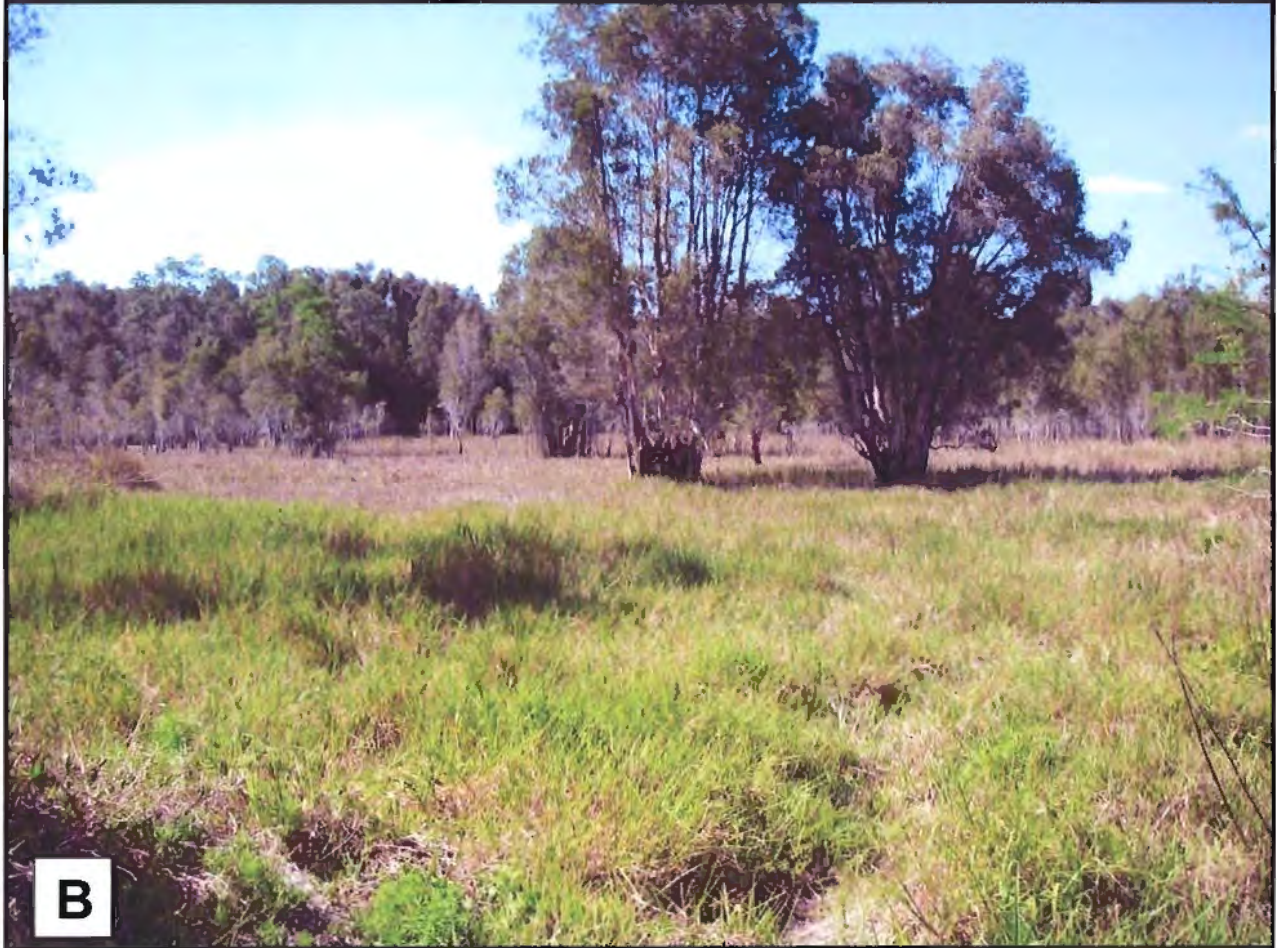
Figure 9. Wet prairie wetlands (also see Figure 2). A. Wetland plants such as *Xyris sp.*, *Rhexia sp.*, and *Polygala spp.* occurred in the wet prairie wetlands. B. Occasionally, dense grasses dominated the groundcover of the herbaceous marshes, especially in areas adjacent to ditches as pictured here.

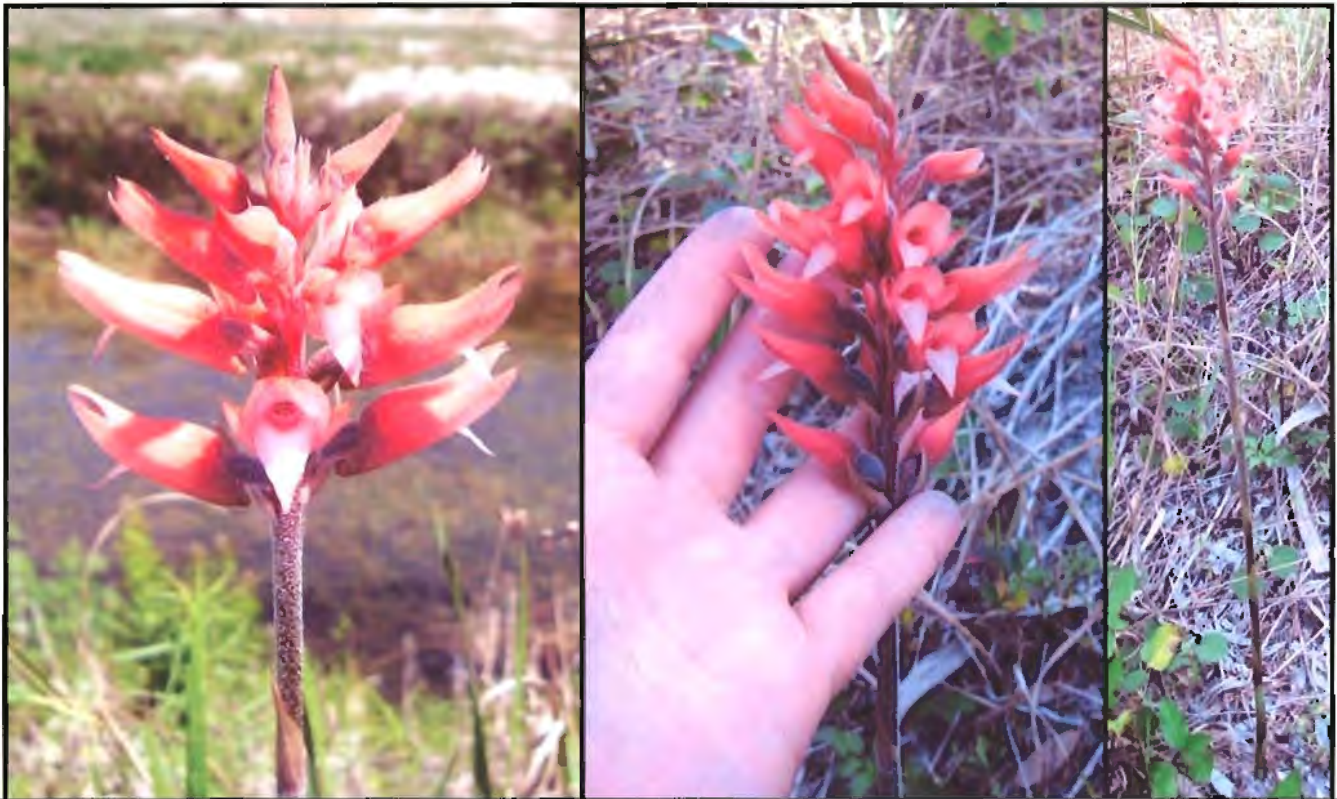
Figure 13. Notable Plant: *Sacoila lanceolata* (Orchidaceae). An orchid listed as state Threatened, *Sacoila lanceolata*, also known as "Leafless Beaked Ladytresses," occurred on spoil mounds and berms throughout the site.

In addition to wildlife, many interested plants were observed on site. At least one State Threatened species was identified (leafless lady tresses, *Sacoila lanceolata*) (Figure 17), as well as one commercially exploited species (Florida butterfly orchid, *Encyclia tampensis*) (Figure 16). In addition, some species of general interest were noted (Figures 14, 15).

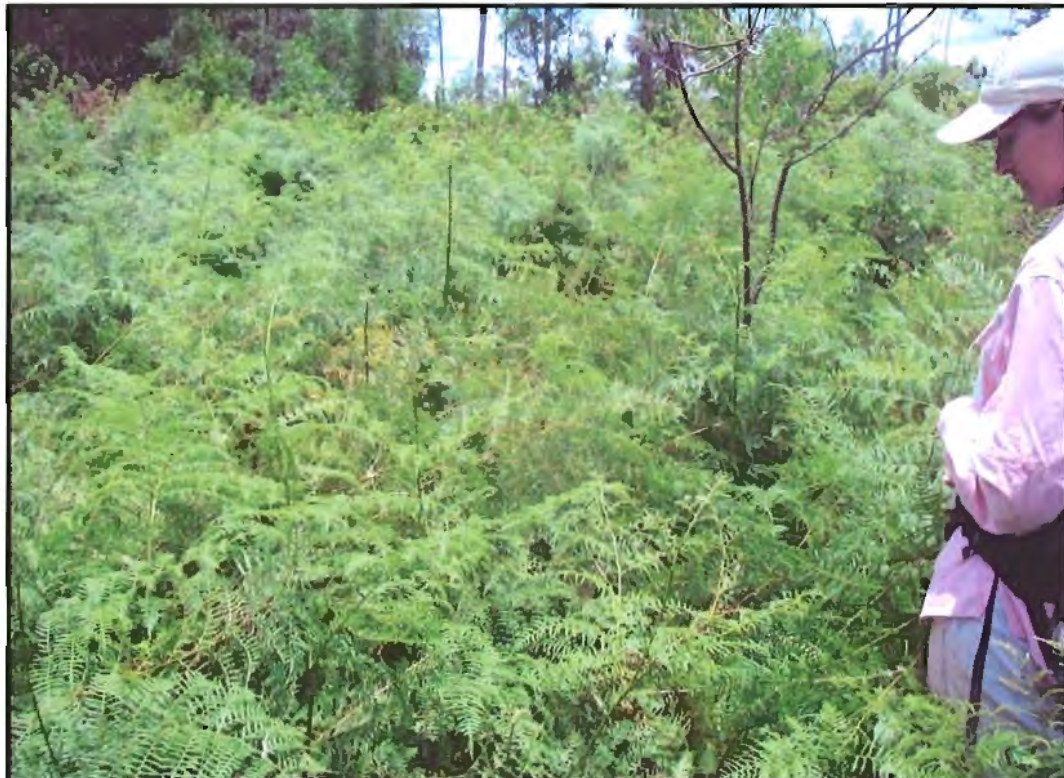
Figure 14. Notable Plant: *Pteridium aquilinum*. A dense thicket of *Pteridium aquilinum* was encountered on site, with plants shooting 6-7 feet up.

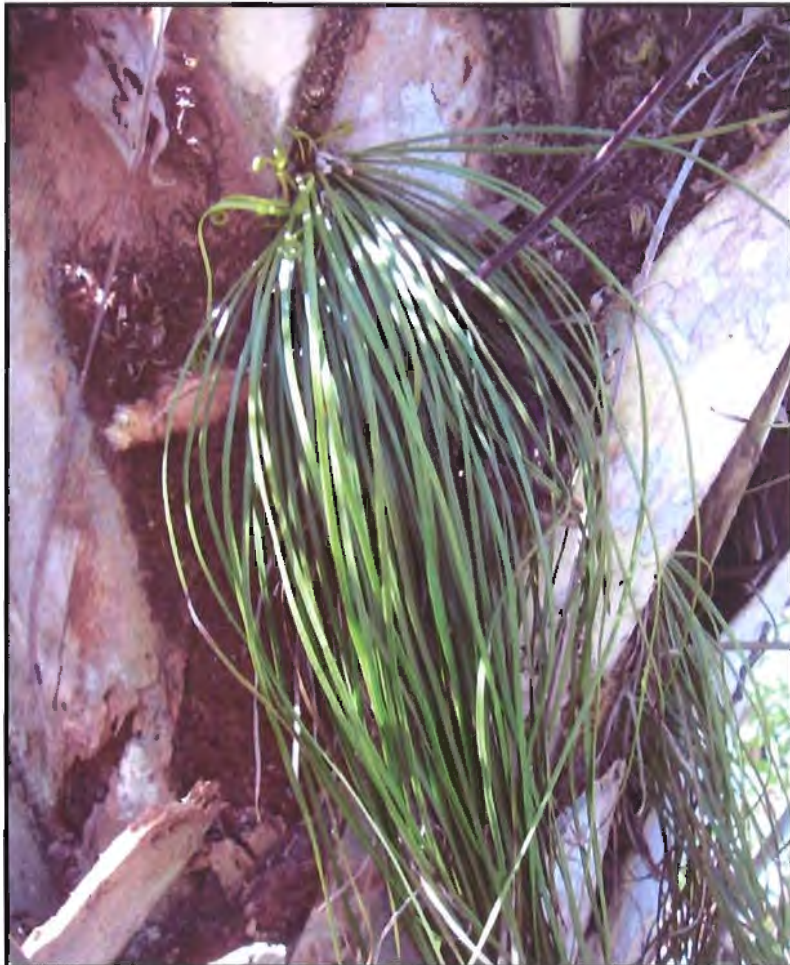
Figure 15. Notable Plant: *Vittaria lineata* (Vittariaceae). The unusual shoestring fern (*Vittaria lineata*) was found growing attached to *Sabal palmetto* in hammock areas.

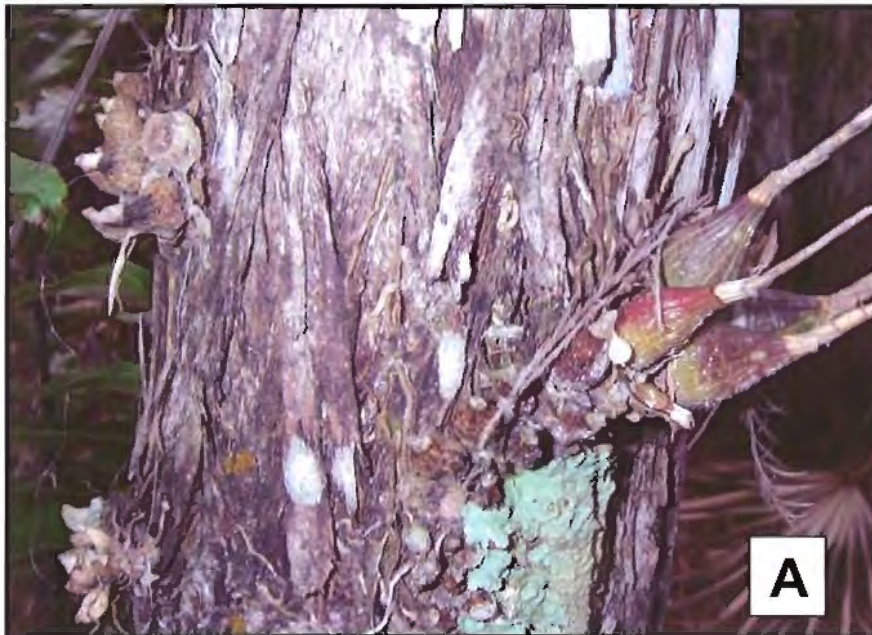
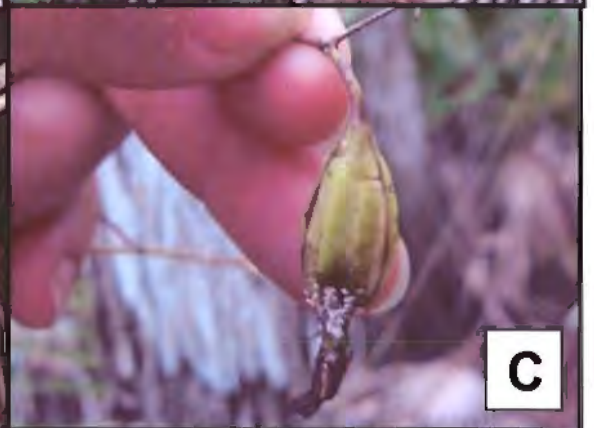
Figure 16. Notable Plant: *Encyclia tampensis* (Orchidaceae). This example of *Encyclia tampensis* (Florida Butterfly Orchid) was located attached to the trunk of *Taxodium ascendens*. A. Plant base. B. Long stem of plant. C. Detail of fruit.

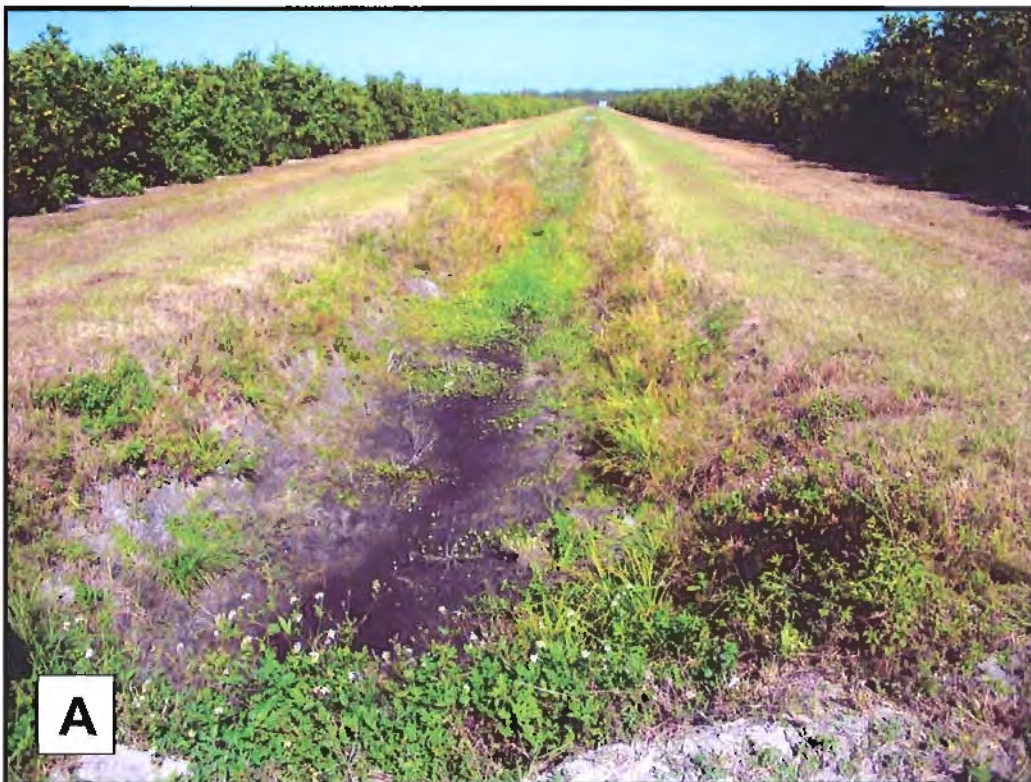
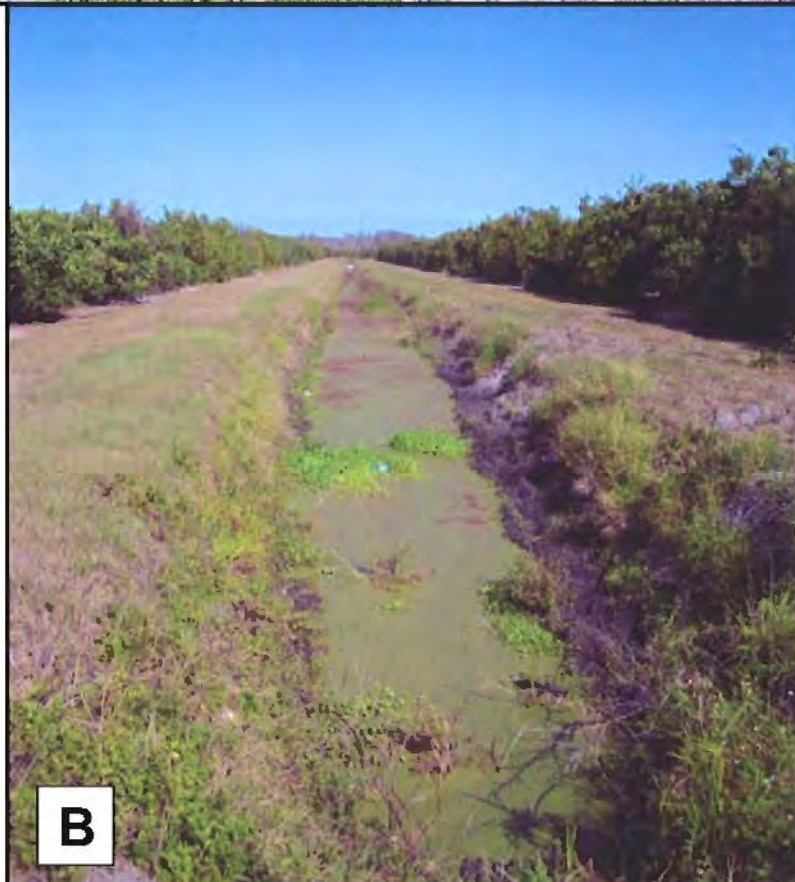
Figure 18. Ditches from Section 12. A. The ditch was identified as a wetland ditch. B. The ditch identified as other surface waters. Though floating aquatic vegetation was present, ditches identified as surface water ditches had little to no littoral zone with emergent vegetation.

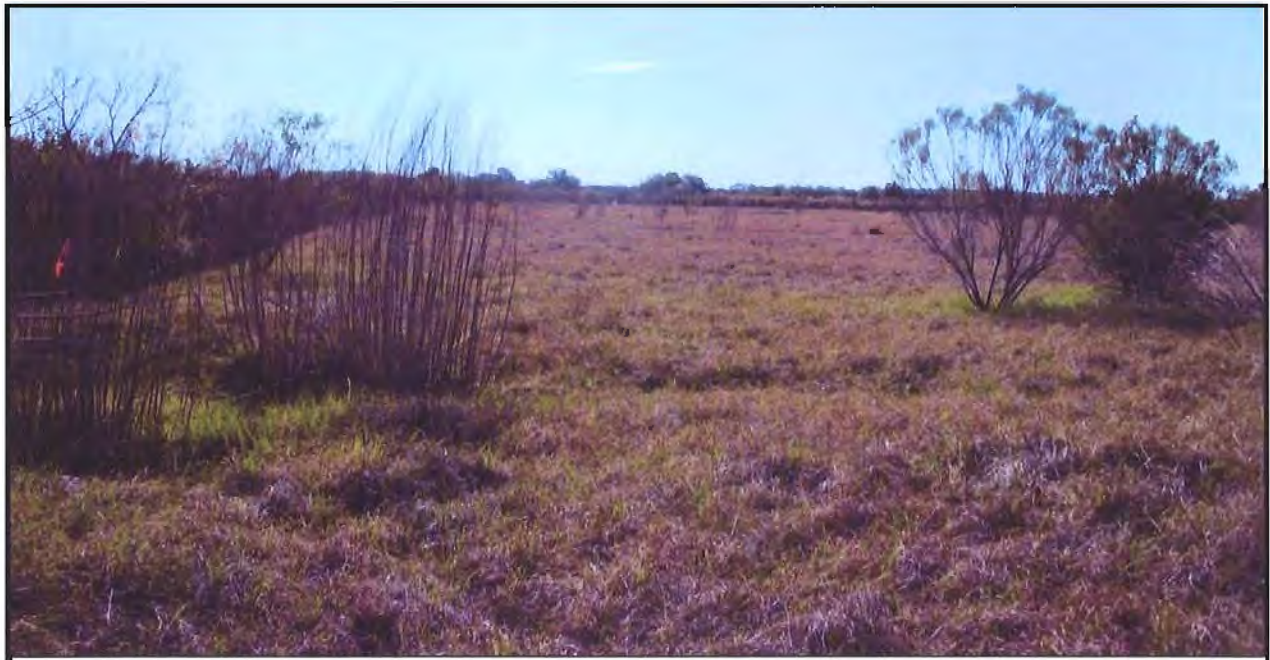
Figure 19. Point description location for point 772 TOB. Note wetland flag at left with *Salix caroliniana* in wetland. Note *Eupatorium* and *Baccharis halimifolia* to right with *Paspalum notatum* in groundcover.
