Atlanta Public Safety Training Center

Terracon Project No. 49217142

Re: Phase I Environmental Site Assessment

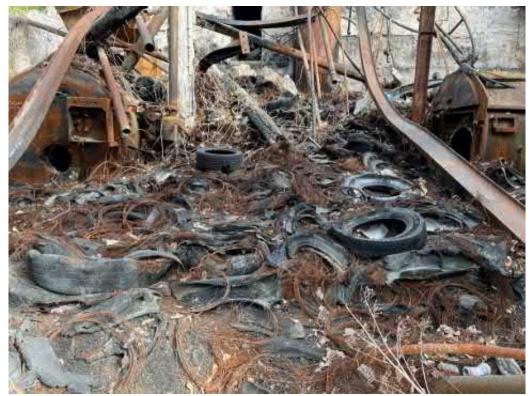
Photo 13: View of the burnt mound of tires, metal, and boilers located in the former boiler room/building on the northern portion of the site.

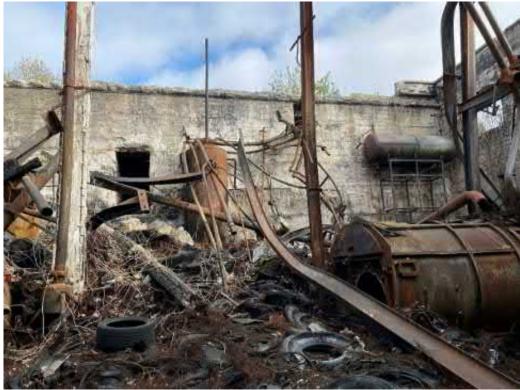
Photo 14: View of the burnt mound of tires, metal, and boilers located in the former boiler room/building located on the northern portion of the site.

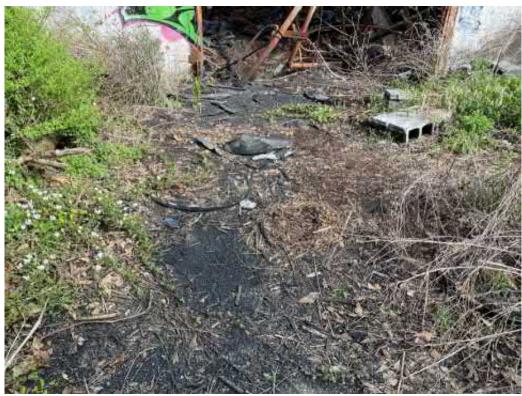
Photo 15: View of the stained soil and stressed vegetation observed on the exterior of the former boiler room/building.

- On-Site REC: There is potential for soil and groundwater impairment beneath the site as a result of the following: stained soil and stressed vegetation associated with the burnt tire activities conducted in the boiler room/building, the bulk storage of hundreds of un-labeled cans in building B1, the stained concrete and former remnants of the concrete fuel dispenser islands and piping observed in building B2, and the stained soil and discarded 55-gallon drums observed in building B3.

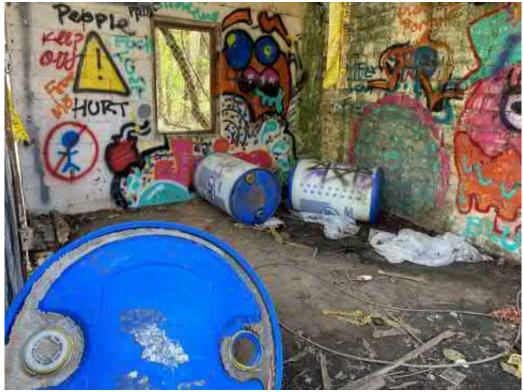
Photo 23: View of the 55-gallon Zep degreaser drums and stained concrete floor observed in building B2.

At the time of the Terracon site reconnaissance, the concrete blocks from the bottom of the fuel dispenser islands and additional piping were observed in the interior of building B2. Stained concrete flooring was observed beneath the concrete fuel dispenser blocks. Multiple empty 55-gallon drums of Zep degreaser, trash, and a personal portable gasoline tank were observed in building B2, near the concrete fuel dispenser blocks. Soil sampling beneath the dispenser blocks and additional piping has not been conducted based on information obtained from the GEPD. As such, it is likely that contamination exits underneath building B2 in the area of the fuel dispenser blocks which constitutes a REC associated with the site.

At the time of the Terracon site reconnaissance, the concrete blocks of the fuel dispensers and additional piping were observed in the interior of building B2. The ground surface beneath the concrete fuel dispenser blocks was observed to be concrete, and staining was observed on the floor of the building. Multiple empty 55-gallon drums of Zep degreaser, trash, and a personal portable gasoline tank were observed in building B2, near the concrete fuel dispenser blocks. Soil sampling beneath the dispenser blocks and additional piping has not been conducted based on information obtained from the GEPD. As such, it is likely that contamination exits underneath building B2 in the area of the fuel dispenser blocks which constitutes a REC associated with the site. The remaining interior portion of building B2 could not be observed due to the large amounts of building debris that has gradually collapsed/become dilapidated overtime. Other storage of petroleum products or hazardous substances could be stored under the debris in building B2.

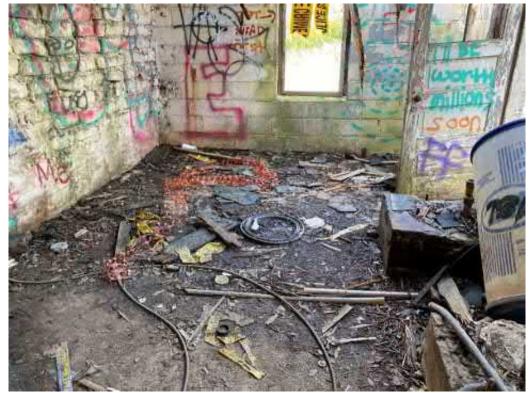
Photo 24: View of the stained concrete floor observed inside building B2.

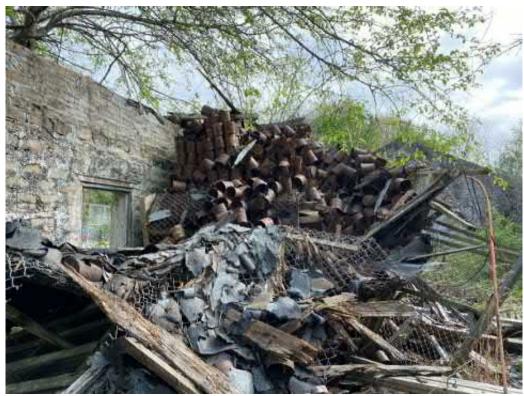
Photo 25: View of the hundreds of discarded metal cans (contents unknown) observed in building B1.

substances and for it to infiltrate the soil and enter groundwater, the hundreds of discarded containers constitute a REC associated with the site.

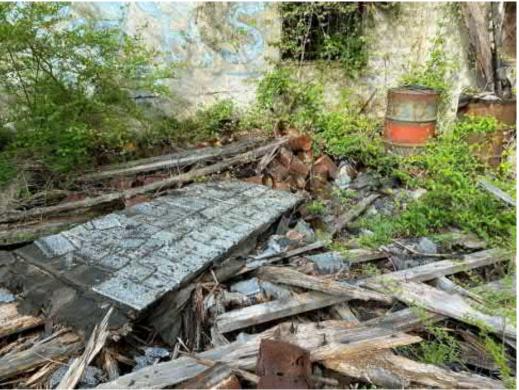
Photo 26: View of the hundreds of discarded metal cans, 55-gallon drums (contents unknown), and dilapidated building materials observed in building B1.

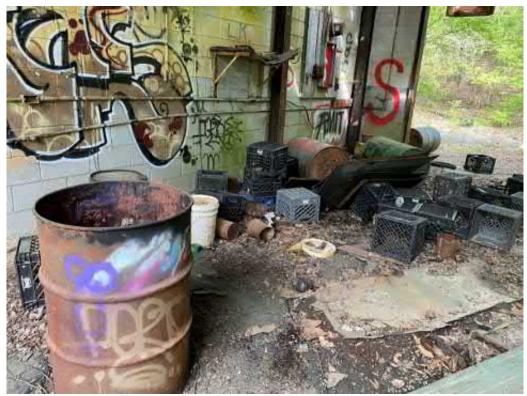
Photo 27: View of the discarded 55-gallon drums (former contents unknown) and stained soil observed in building B3.

Building B3 was observed to be an approximate 2,500-square foot structure constructed with CMU block walls and a flat metal roof deck. The former use of building B3 is unknown; however, the structure appears in aerial imagery from as early as 1966 when the former Prison Farm operated at the site. The building could have been used to store tractors/ farming equipment, and possible maintenance of tractors could have been conducted inside the building. Building B3 was not constructed on a concrete slab, and the floor was observed to consist of gravel overlying residual soil. Several rusted 55-gallon drums, small storage bins, and trash was observed scattered throughout building B3. Additionally, several large areas of stained soil were observed in building B3. The 55-gallon drums and stained soil observed in Building B3 constitutes a REC associated with the site.

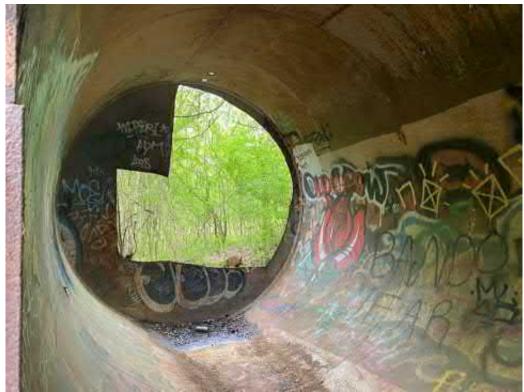
Photo 29: View of the interior of the empty 20,000-gallon AST observed on-site.

An empty approximate 20,000-gallon AST was observed near the northern/central portion of the site. The former contents and use of the AST are unknown, and no secondary containment was observed on the exterior of the AST. The inside of the AST can be accessed through cutouts on the end and side of the AST, which commonly are cut to prevent further use. No petroleum products were observed inside the AST. No significant staining or other visual evidence indicative of a release, such as stressed vegetation, was identified on the ground surface around the AST at the time of the site reconnaissance. Based on the lack of information regarding the former use and contents of the empty 20,000-gallon AST, this representants a significant data gap to the site.

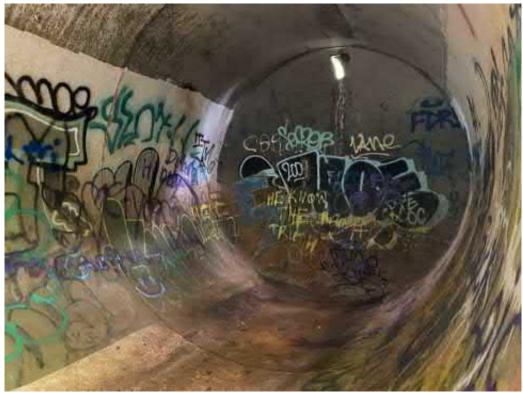
Photo 30: View of the interior of the empty 20,000-gallon AST observed on-site.

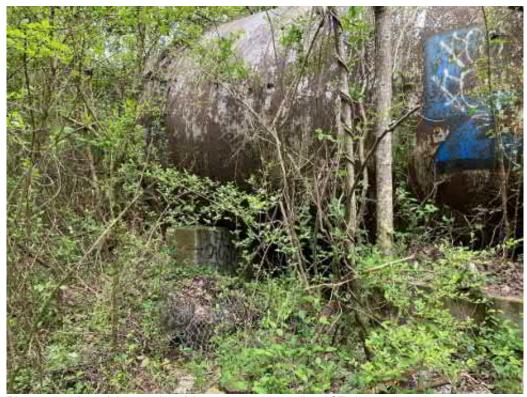
Photo 31: View of the exterior of the empty 20,000-gallon AST observed on-site.
