POOL REPAIR
& REJUVENATION

The **TOWNSEND** Story

CASE HISTORIES

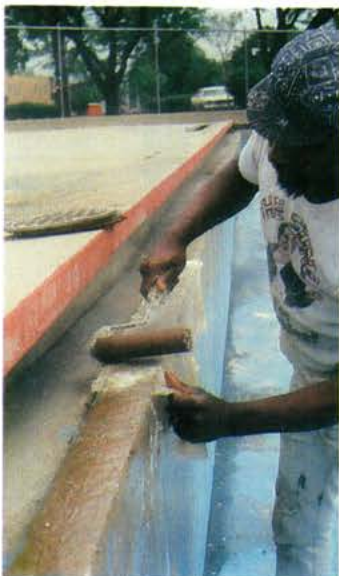
Cracks—Many pools have a multitude of fine cracks that are covered by paint each year. Leakage continues through these cracks as they open when the pool is filled. (Right)

Many pools have been patched and repatched. Patched areas become visible once an area has been sandblasted.

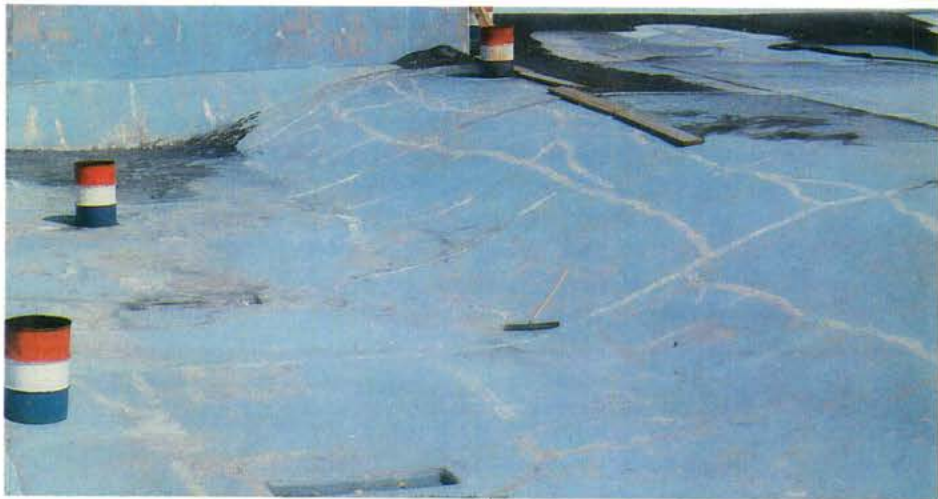
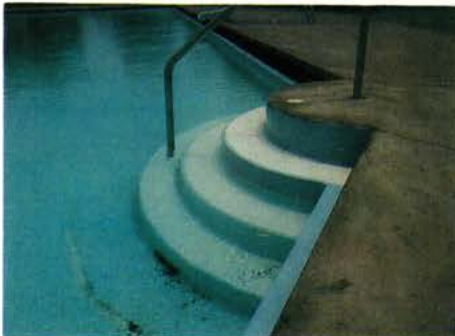
Hand lay-up—The use of the hand lay-up technique is often used in the areas that require close detail work. Hand lay-up allows for more application control to avoid overspray of resins and fibers onto areas that will not be laminated.

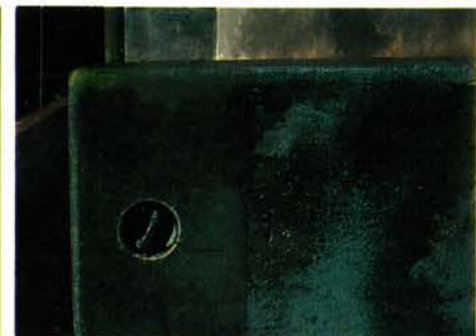
Steps—State codes require that steps be in a contrasting color. In addition, all steps, ledges, and laminated decks are skid proofed.

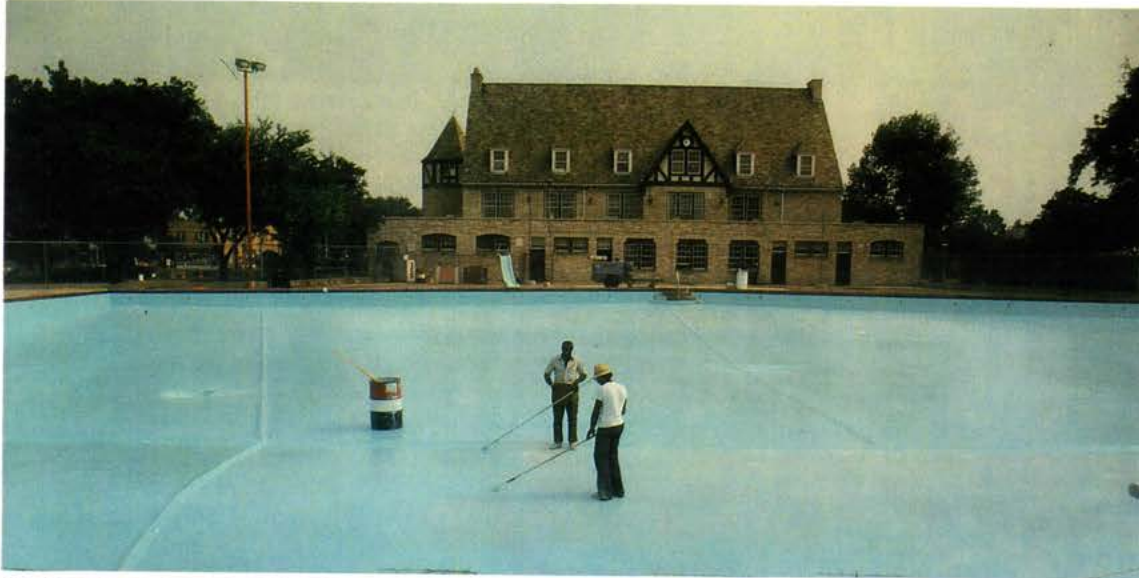
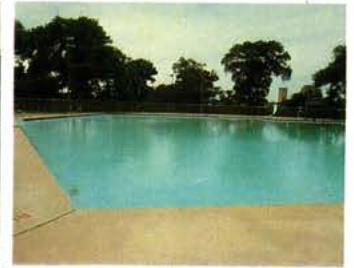
Pool inlets, drains, lights, etc; are thoroughly cleaned to remove overspray of resins, fibers and gel coats. If taped, tape is removed and tape residue is removed. This picture also shows a section of fiberglass laminate against the concrete surface.

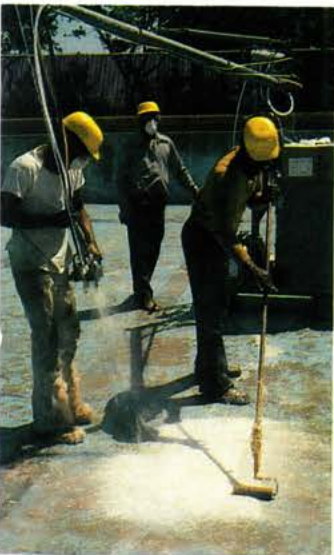
Forest Park was completed and filled after 24 hours of cure time, eliminating the 2-3 day wait that normally follows pool paints. (Above)

The final coat is sprayed on followed by a roll out to insure uniform and complete coverage. (Left)

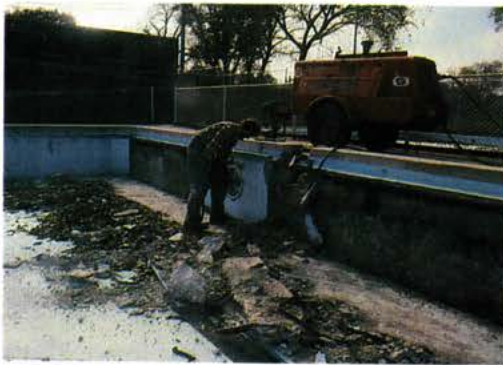
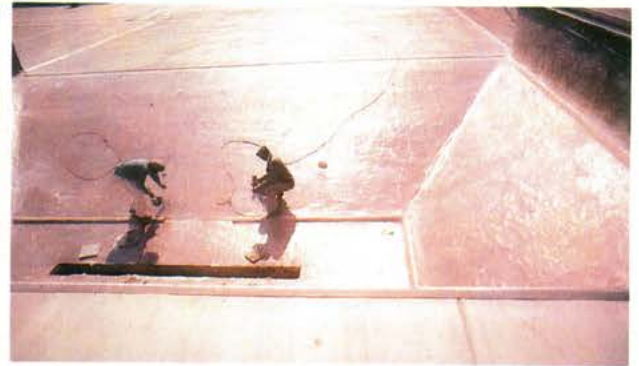
"P.I.P." stress pool being sanded and finished prior to inspection. (Above)

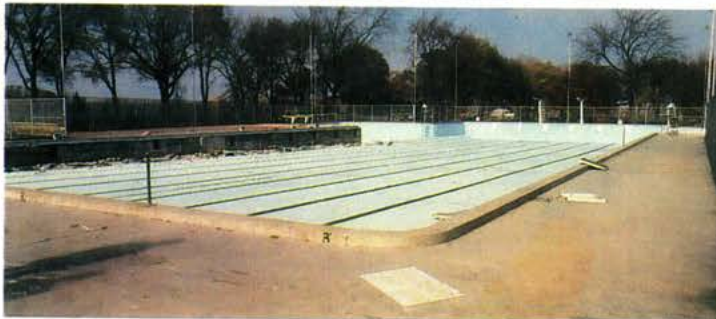
Secondary walls are removed back to the original concrete. Old lights are removed; and new stainless steel, aluminum, or concrete overflow gutters may be added and tied to the existing structure with reinforcing rods and new concrete walls. (Above center and left)

90% of the "P.I.P." pool stress material is installed with the spray-up technique. All materials are installed from 1/8"-1/2" thick (concrete), 1/32"-3/16" thick over metals in a neutral color to insure maximum visual inspection. All laminate is rolled to insure complete resin coverage. (Above)

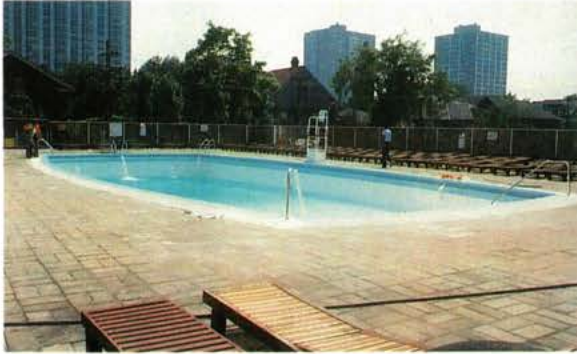
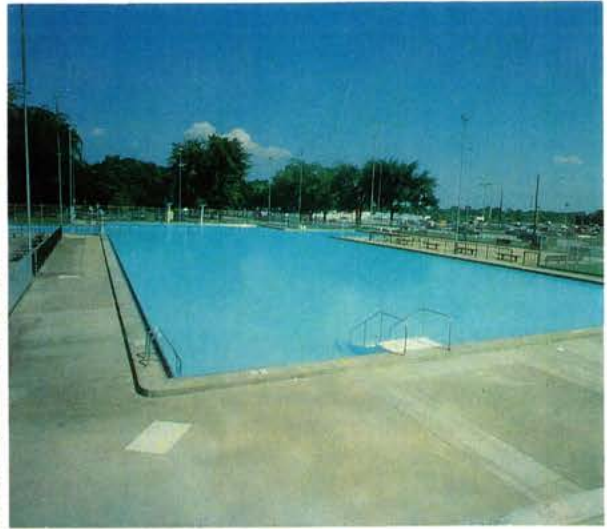
Wicker Park Swimming Pool located in Highland, Indiana. This 1.5 million gallon, "T" shaped pool received a "P.I.P." pool stress application up to but not including the stainless steel gutters. The material varied from 1/8" to 1/2" thick in high stress areas.

Suspended pool built over a hi-rise garage. Steps were prefabricated from fiberglass, set in place and laminated. The entire pool, including the overflow gutters and deck edge were laminated; overflow gutters and step risers were painted in a contrasting color.
