# Safety Benefits Inc.

Inspection of Community Playground  
Buffalo Gap SD  
7/11/2024

Safety Benefits, Inc. (SBI) was asked by the City of Buffalo Gap to conduct an inspection of a playground within the City. Todd and Tracie Everson (the inspectors) conducted this inspection. Both inspectors hold the designation of Certified Playground Safety Inspector through the National Recreation and Park Association. The playground was inspected using the recommendations in the Consumer Product Safety Commission Handbook for Public Playground Safety ("CPSC Handbook") as a guide.

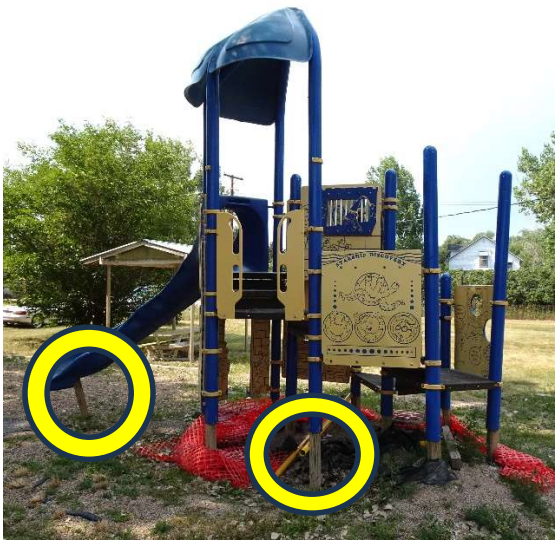
- The composite structure was manufactured by Landscape Structure and reportedly provided to Buffalo Gap by the City of Hermosa SD. Upon inspection it is clear that the manufacturer's design has been altered/modified. This is of concern as such modifications generally nullify any liability protections that may have been available from the manufacturer.

- PHOTO 1 The legs of the structure were cut off and 4x4 timbers used to anchor the structure to the ground. The slide is supported by a 4x4 timber as well.

- It is recommended that one of the following actions be taken:
  1. Remove this structure from the playground. If this course of action is taken, it is further recommended that it be effectively blocked from use until it is removed from the playground.

2. Contact the manufacturer for replacement parts and properly repair the structure. If this course of action is taken, it is further recommended that the structure be effectively blocked from use until it is repaired in compliance with the recommendations of the CPSC Handbook. If repaired and use is continued, the structure needs to be relocated as it is currently too close to the overhead power line.

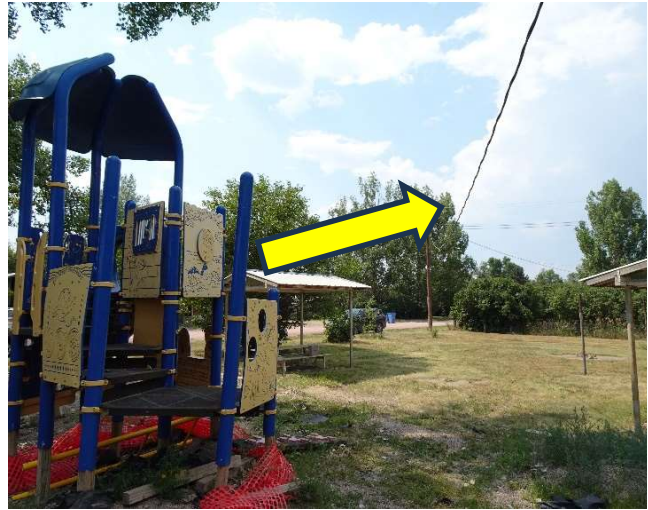
- PHOTO 2 The structure is too close to the overhead power line. A child could jump from the structure to the power line.
- PHOTO 3 The structure has broken pieces that could result in harm to a child.

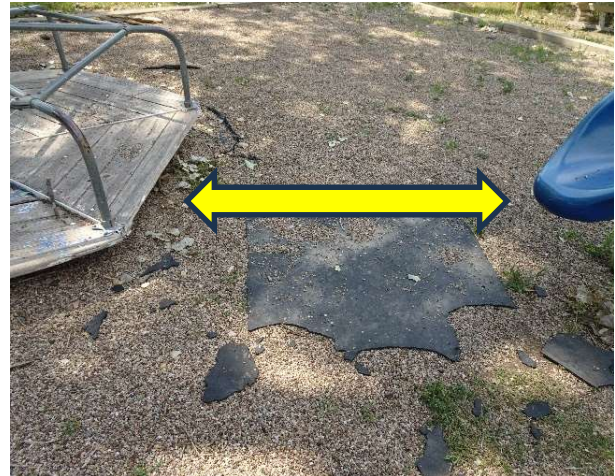
- The use zone should extend a minimum of 6 feet beyond the perimeter of the platform.

- PHOTO 4 The difference between the minimum and maximum radii of the platform was measured to be 9 inches in places.
- PHOTO 5 The use zone between the nearby slide exit and the merry-go-round is less than 6 feet.
- Inspection of the merry-go-round confirmed there is no means (governor, brake, etc.) to limit the peripheral speed of rotation.
- It is recommended that this merry-go-round be removed.

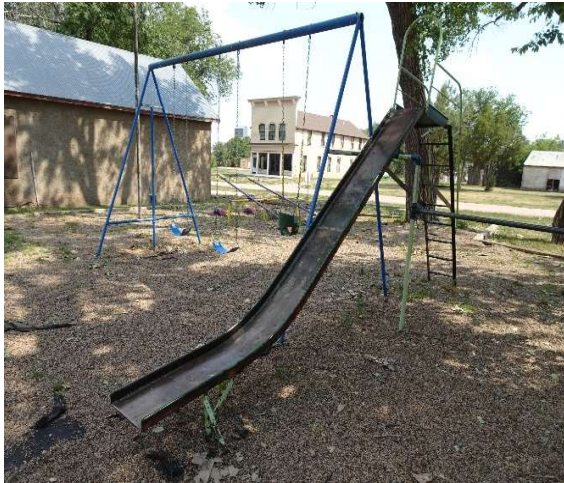
Regardless of the type of slide, avoid using bare metals on the platforms, chutes, and steps. When exposed to direct sunlight the bare metal may reach temperatures high enough to cause serious contact burn injuries in a matter of seconds. Provide shade for bare metal slides or use other materials that may reduce the surface temperature such as, but not limited to, plastic or coated metal.

- PHOTO 6 The slide is metal, but shade is provided by trees in the playground.
- PHOTO 7 The distance of 7.5 inches between the slide and swing structure presents an entrapment hazard.
- PHOTO 8/FIGURE 2 The angled bar on the slide support creates a partially bound angle resulting in an entrapment hazard.
- PHOTO 9 There are gaps between the platform and slide structure creating an entanglement hazard.
- PHOTO 9 The slide platform between the ladder and the slide is not horizontal.
- It is recommended that this slide be removed.

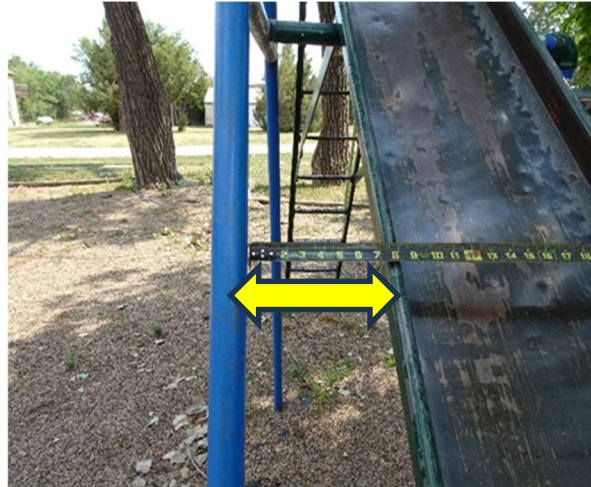
PHOTO 7

Head entrapment is a serious concern on playgrounds, since it could lead to strangulation and death. Certain openings could present an entrapment hazard if the distance between any interior opposing surfaces is greater than 3.5 inches and less than 9 inches.

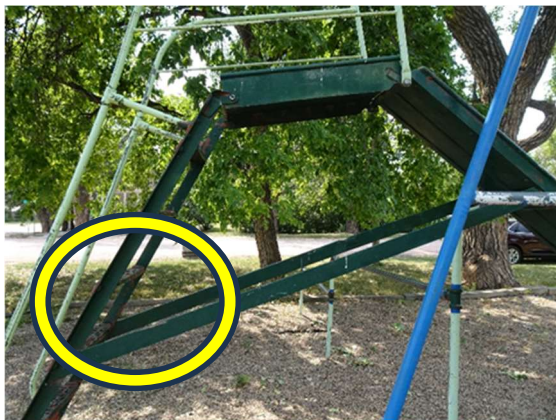
PHOTO 8

- Angles formed by two accessible adjacent parts should be greater than 55 degrees unless the lowest leg is horizontal or below horizontal.

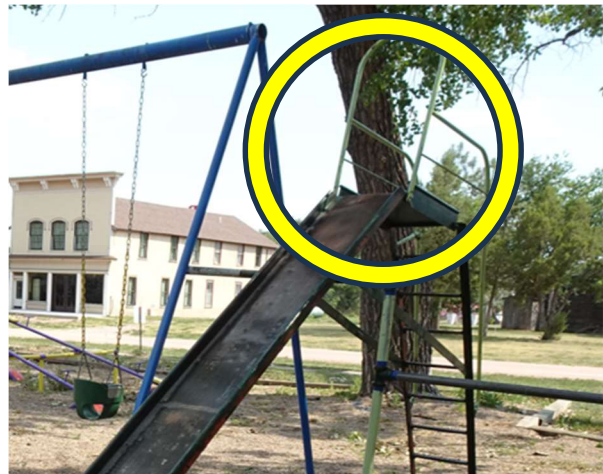
PHOTO 9

- Be horizontal.
- Not have any spaces or gaps that could trap strings, clothing, body parts, etc. between the platform and the start of the slide chute.

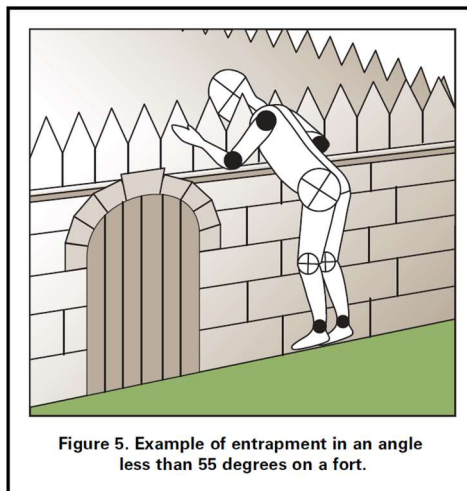
**FIGURE 2**

Children can become entrapped by partially bound openings, such as those formed by two or more playground parts (FIGURE 2).

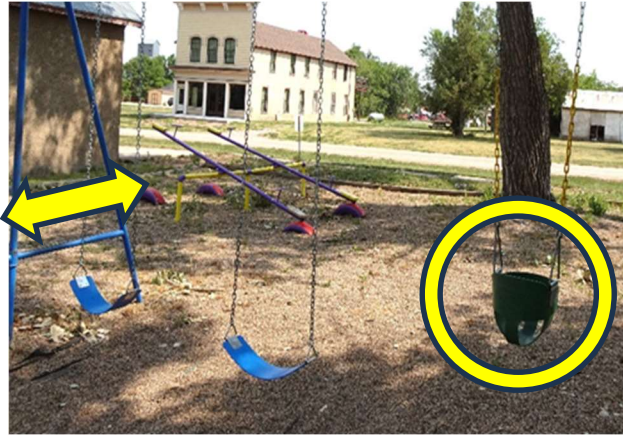
- PHOTO 10 There are more than 2 swings in the bay.
- PHOTO 10 There is a crossbar on the a-frame structure that may encourage climbing.
- PHOTO 10 The toddler swing is in the same bay as the school-age swings introducing a mixed use that is not recommended.
- It is recommended that the toddler swing be removed.

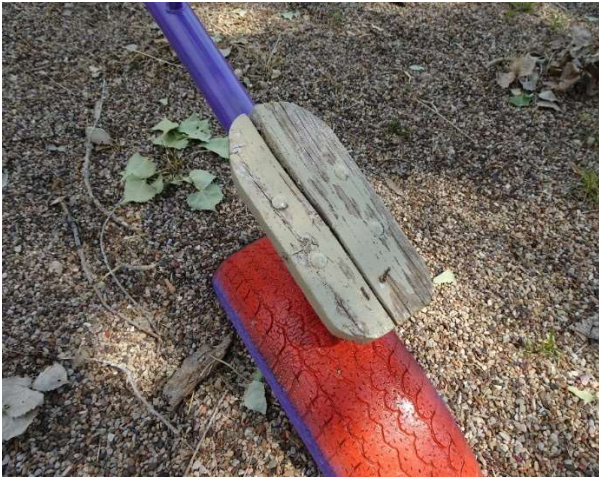
- PHOTO 11 The boards on this seat are chipped. It is recommended that the seat be repaired to prevent user injury.
- PHOTO 12 The hand holds on the seesaw create an impalement hazard. The handle could poke a child in the eye or temple causing serious injury. It is recommended that the handle be retrofitted or replaced to eliminate this hazard.

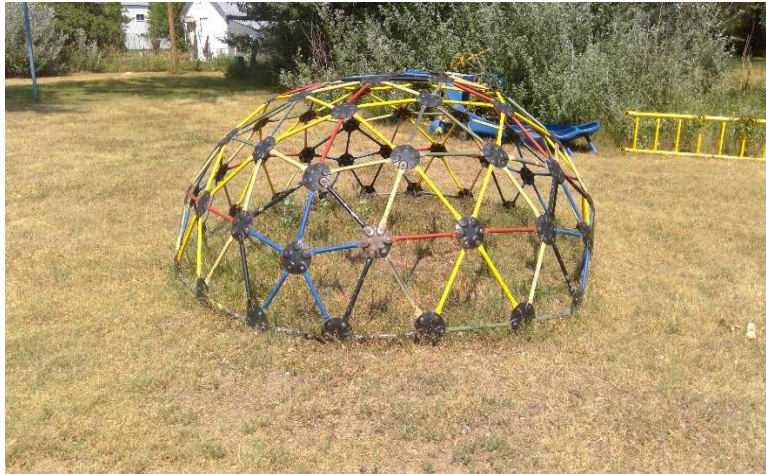
- PHOTO 13 The geodome sits on grass/dirt. It is recommended that proper surfacing material be installed beneath and in the use zone around the geodome.

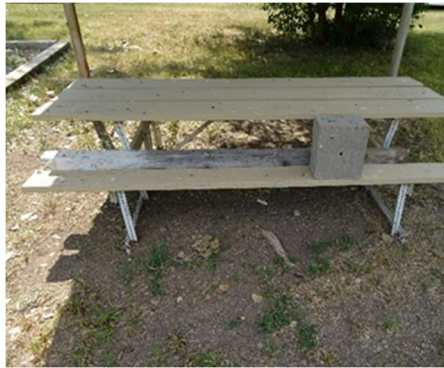
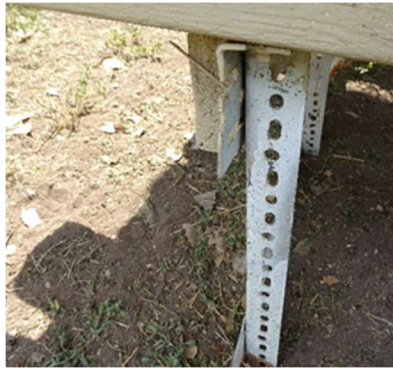
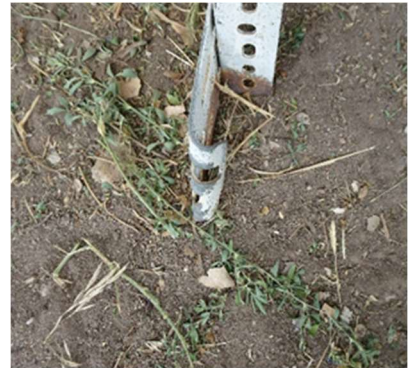
While not addressed in the CPSC Handbook, a picnic table adjacent to the playground area was inspected. There are multiple sharp edges on the picnic table where one could get injured. It is recommended that this picnic table be removed.
