Case Study #1

Install Date – 5/8/2024

Rheem – Vertical System – Garage – AC Power – Dispense Interval Seven Days (requested by customer)

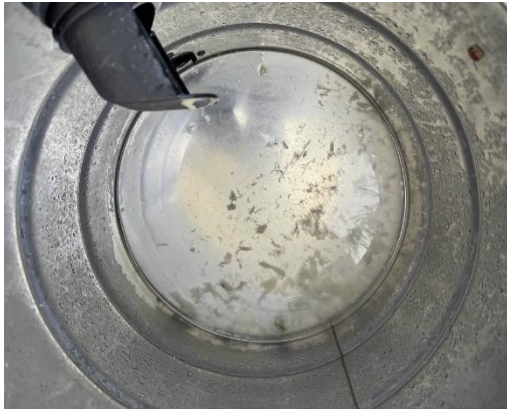
Vacuuming out the drain line – there was bacteria in a quantity that was surprising based on the drain line just being cleaned out a few weeks ago.

That is a large quantity of Zoogloea, so right away I am thinking his line was not vacuumed out or there is something else going on.

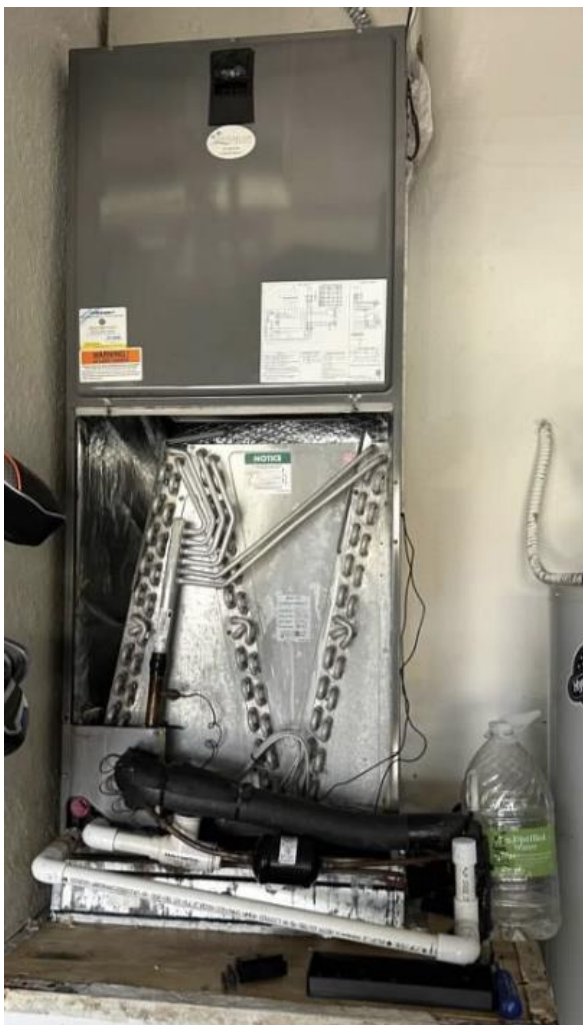
This system is an “N” configuration with one coil on the left side which dispenses into one drain trough, and the other two coils form a “V” and share a common drain trough.

Cutoff switch directly in a drain outlet.

Spare drain outlet (ideal for install).

The output drain line had good slope and no trap as the filter at the bottom slides out, so a trap is not physically possible.

The underground line forms a “natural” trap and suffices (but not optimal) as the system trap.

The drain line has a cleanout port on the far right, which is capped, and the drain line has a 90-degree elbow downturn into the platform.

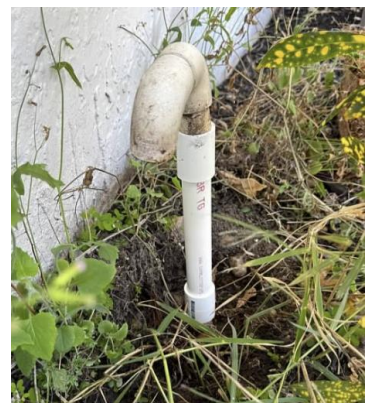
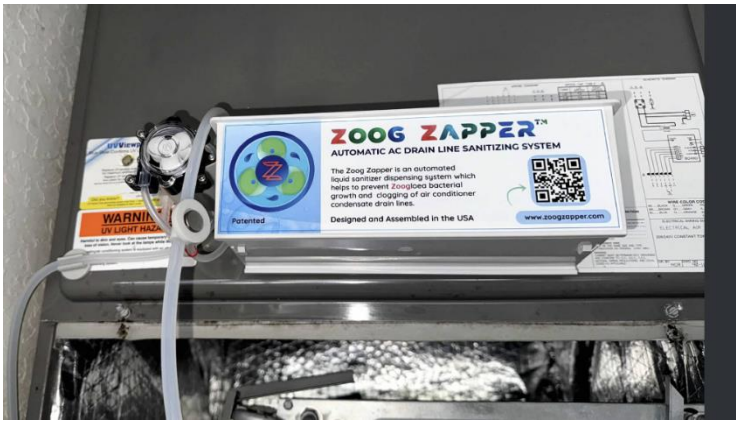
The Reservoir Holder was mounted on the upper cabinet to provide clearance in case the lower cabinet panel had to be removed in the future. The customer preferred the system being elevated.

This system had a spare drain outlet opening with a red plug as most Rheem air conditioners do.

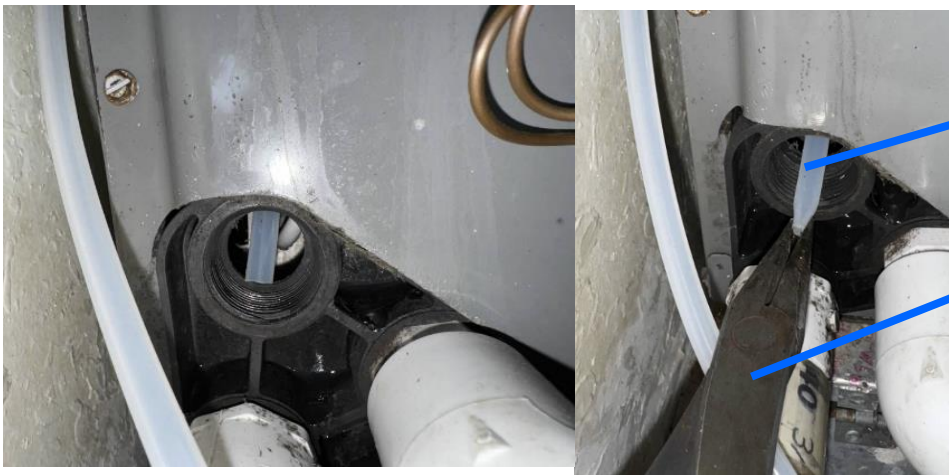
The plug was removed and the 380mm (15") dispense tube was lowered behind the stationary panel to the drain outlet, and the tube was pulled out with a needle-nose pliers

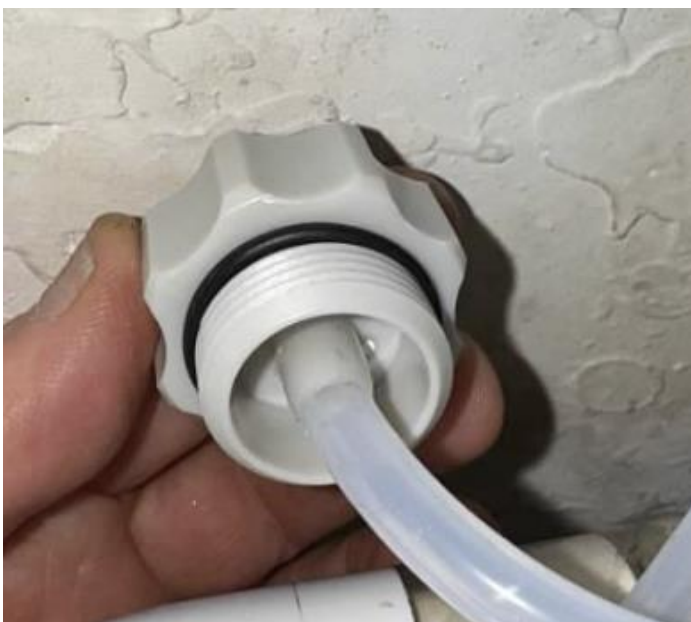
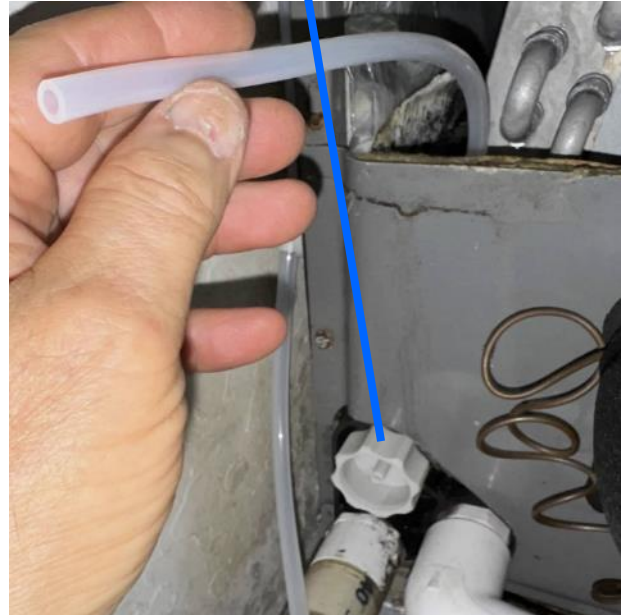
The Combo Fitting was connected to the dispense tubing on the threaded side of the fitting.

The Combo Fitting was screwed all the way into the drain port until the fitting stops.

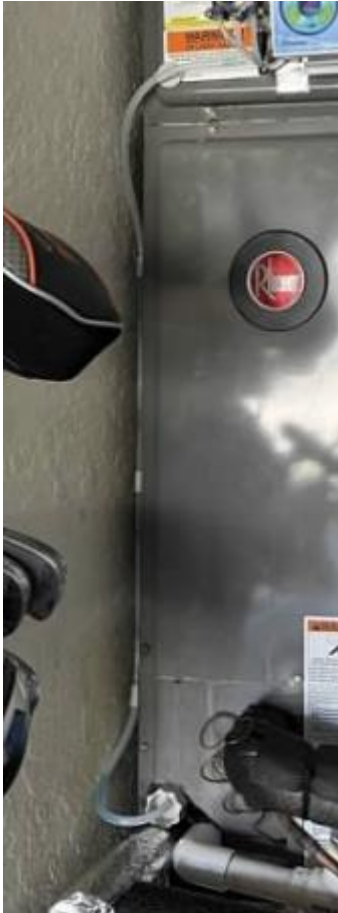
The dispense tubing from the pump was run on the SIDE of the cabinet so the tubing would not interfere with the cover.

The tubing was connected to the Combo Fitting.

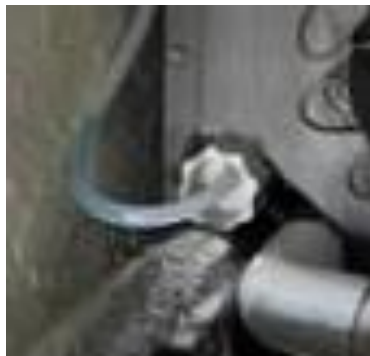
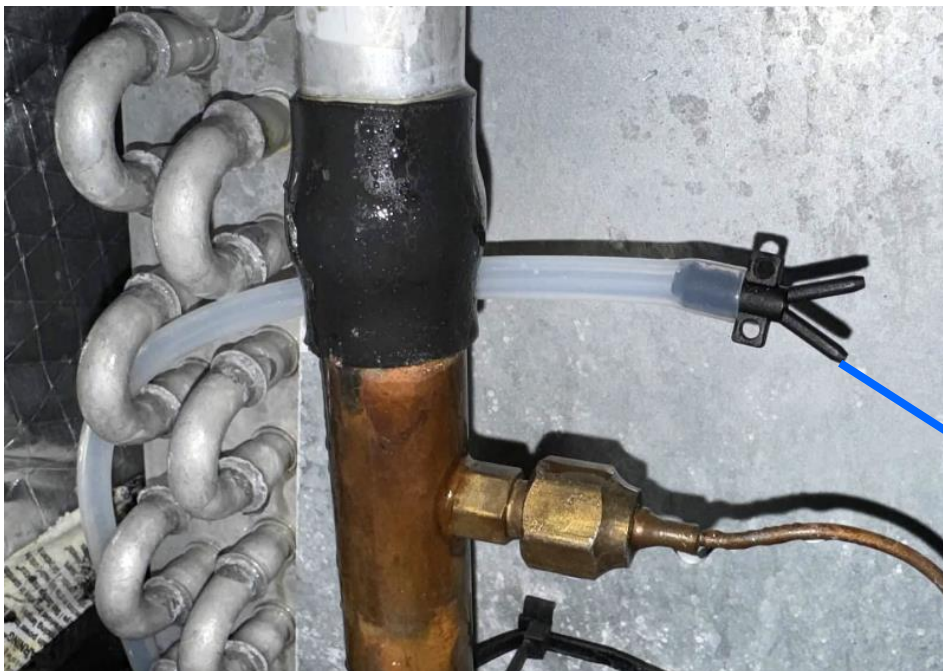
The dispense tubing was threaded through the coil aluminum tubes to anchor the dispense tubing, and the dispense tubing is brought to the center of the unit.

The two-port manifold was connected. (there is a shadow behind the manifold from the flash of the camera)

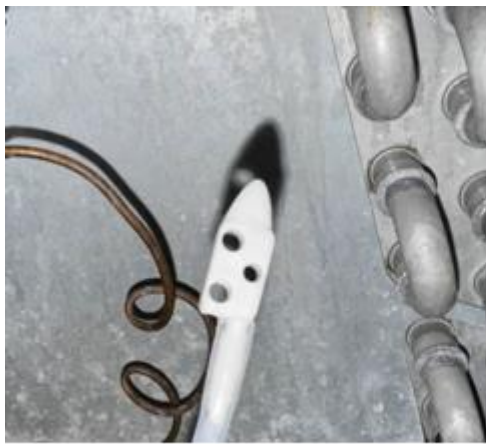
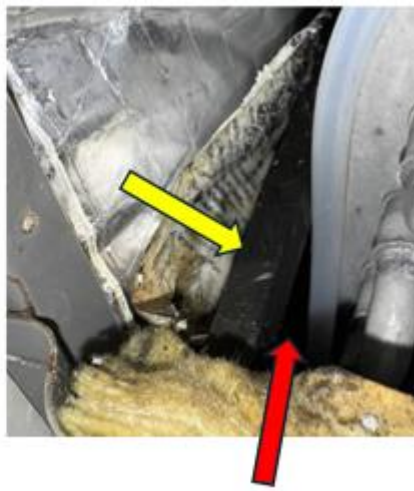
The left coil dispense tube was placed on top of the left coil. The placement wire was used to reach all the way to the back of the drain pan. The drain pan (yellow arrow) had a height side wall of about 2.5" which is perfect for placement of the Single-Port Nozzle (red arrow):

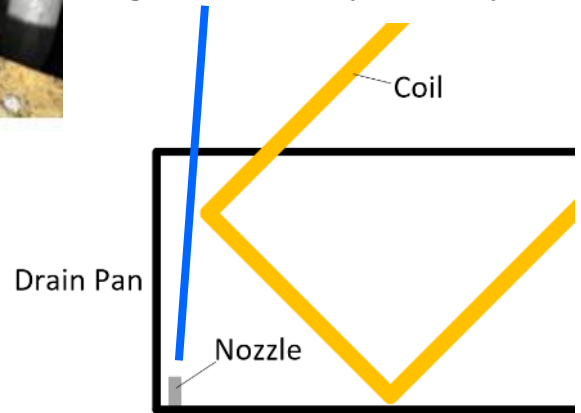
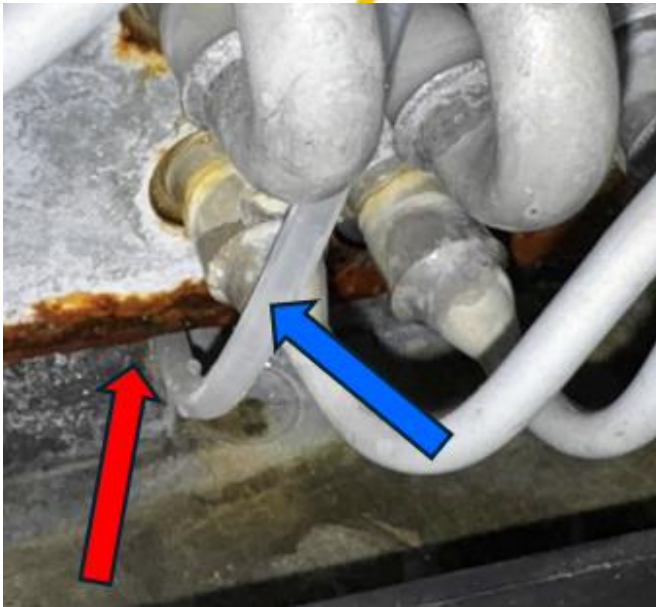
The second dispense tube (Blue arrow) was slid under the two coils in the common drain trough (Red arrow):

The nozzle was able to be inserted by hand and the placement wire was not required.

No wire ties were used to secure the tubing, so no chance to over-squeeze the tubing.

The 4mm (1/8") tubing was threaded through the coils to secure the tubing and connected to the two-port nozzle:

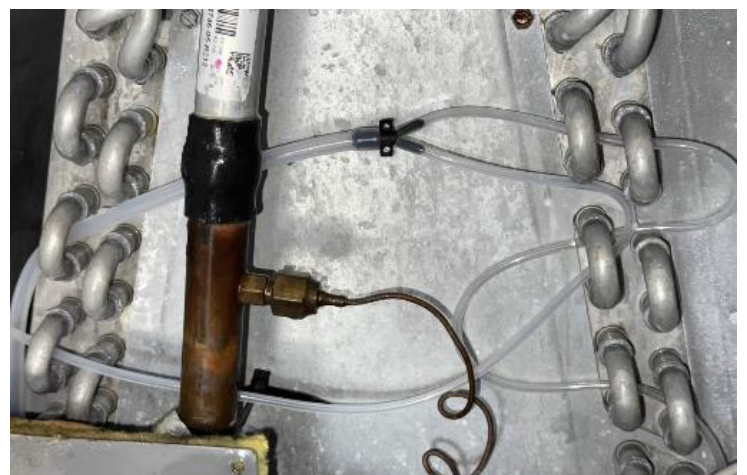
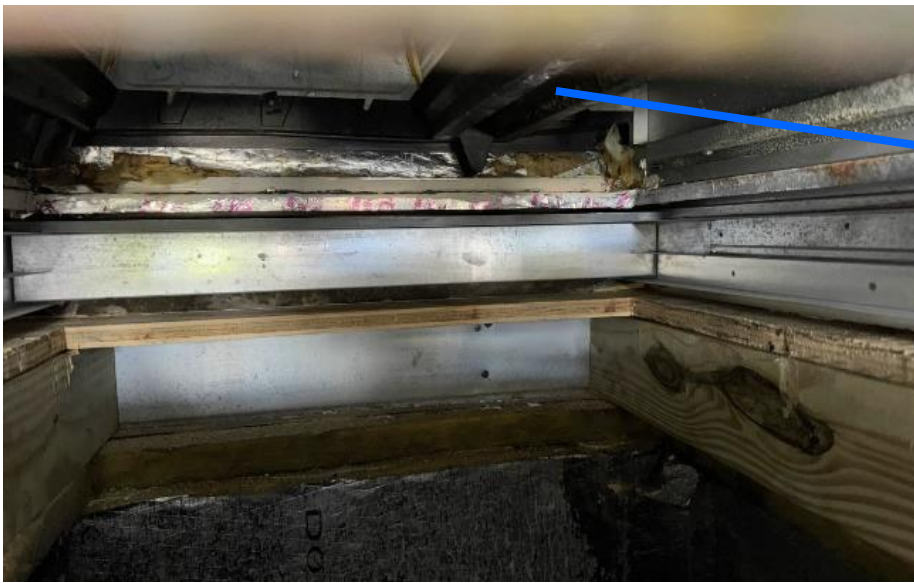
After placement, the filter opening provided visual access from underneath the system that the nozzle and dispense tube were secure in the drain trough and had not popped out while being inserted.

The nozzle and tube would be visible hanging from the trough if the tube dislodged while sliding in.

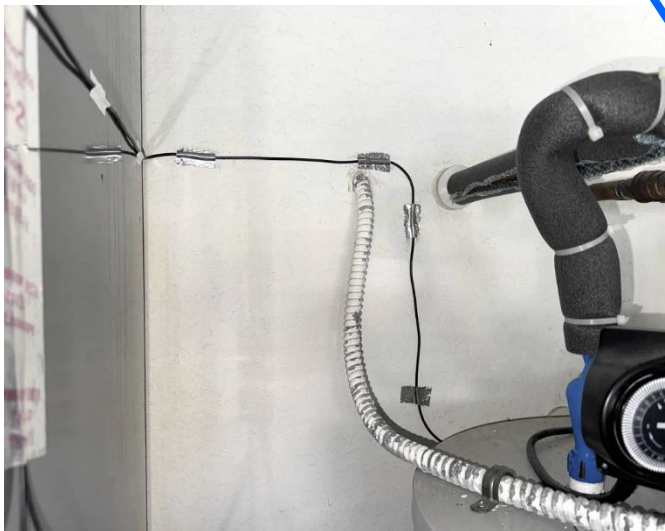
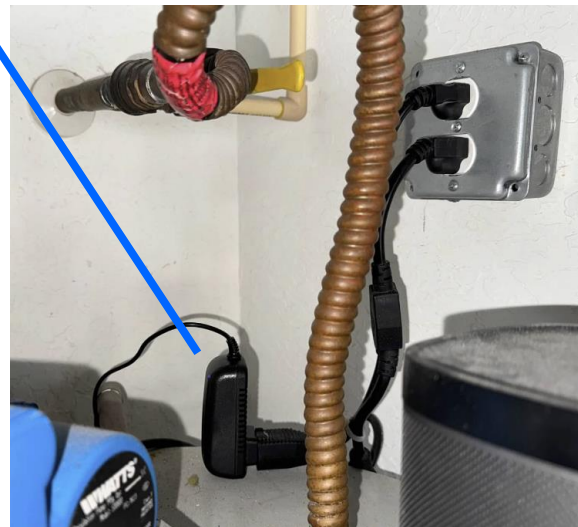
Power is from the AC Power adapter. The adapter was plugged into a “splitter” cord available by the water heater to the right of the AC unit.

Cut pieces of Aluminum tape were used to secure the cable.

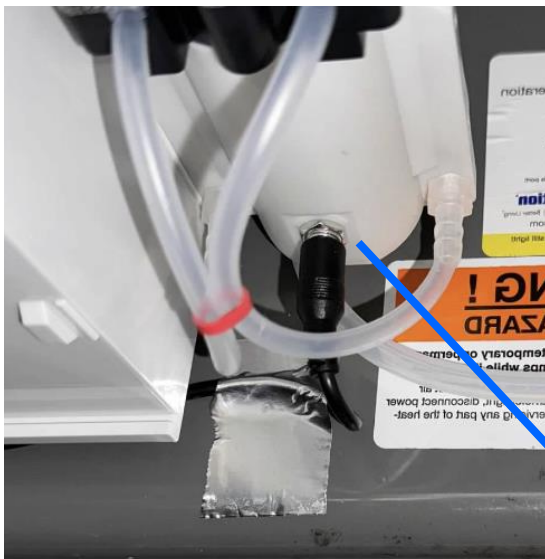
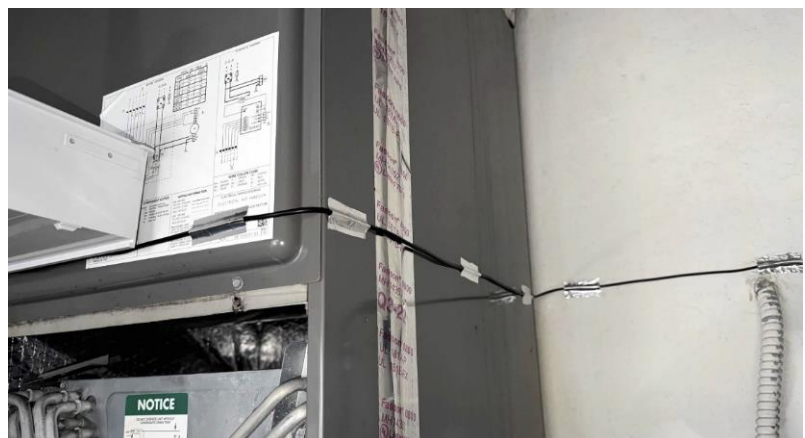
Make sure the power plug is inserted all the way in as in the picture.

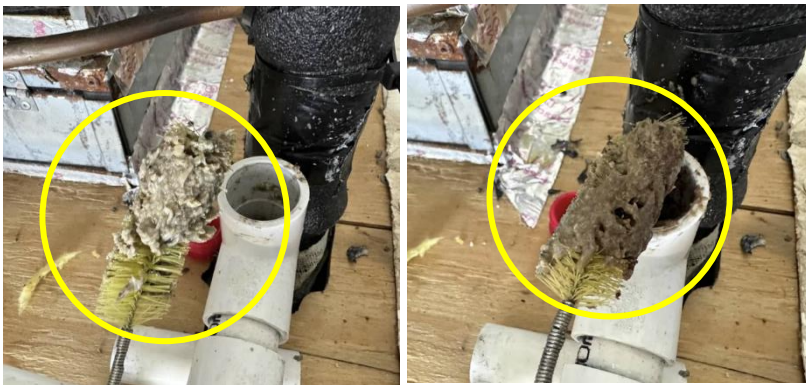
Looking into the drainpipe through the cleanout tube to observe the sanitizer flowing into the pipe, I could see bacteria down the pipe. Really?

This pipe is a vertical drop straight down into the platform and eventually routed outside.

I then took a brush which is on a long spring and pushed the brush into the drainpipe --- and the brush only went down about 8 inches (maybe there is a 90-degree elbow there?).
