Case Study #2

Install Date – 5/6/2024

Manufacturer – Carrier - Horizontal System – Attic – AC Power – Dispense interval fifteen days (default)

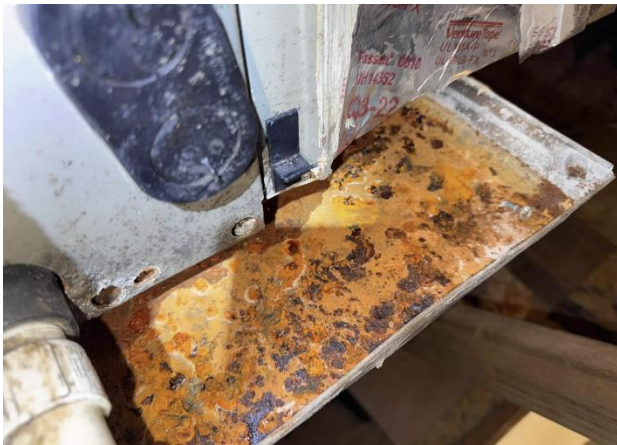
Vacuumed the drain line. Since this is an attic installation there was only a small amount of condensate due to the slope of the attic drainpipe, then a vertical drop from the attic down to the exit port. There was some Zoogloea at the exit port couplings and some Zoog visible on the ground.

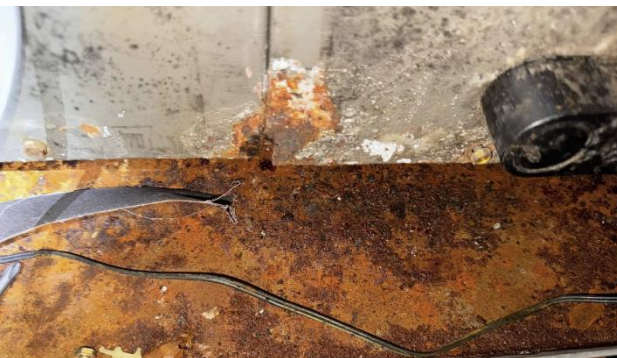
The secondary drain pan is very rusted.

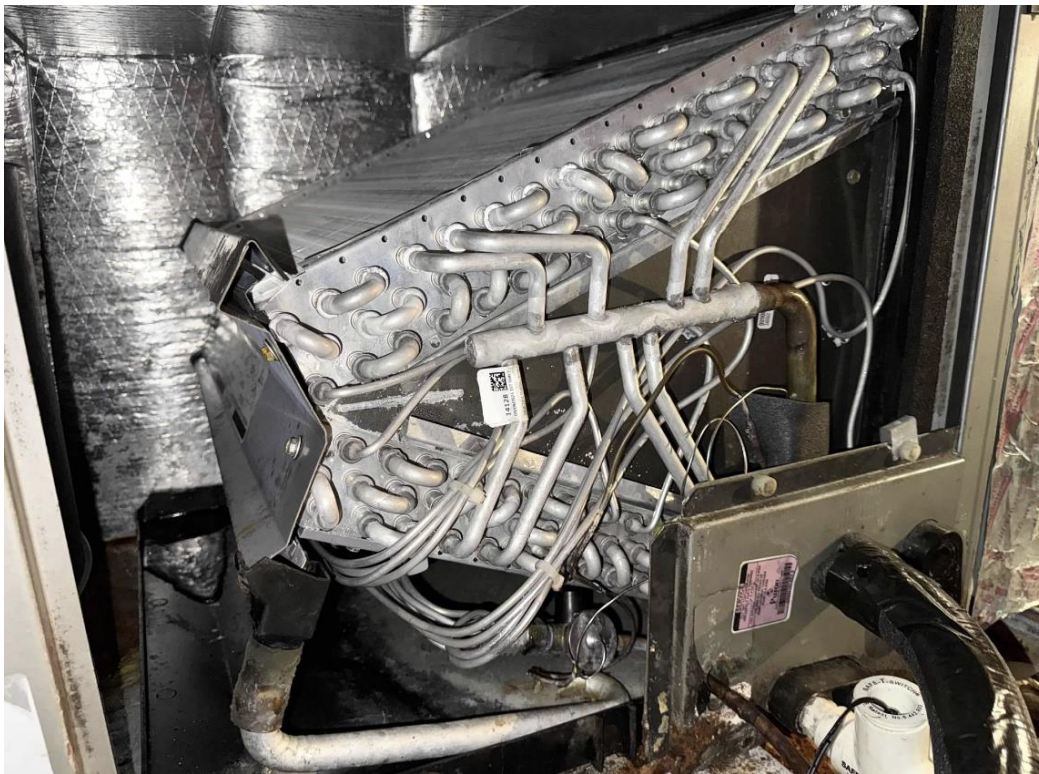
The sides of the panels have excessive rust.

Looks like a water “issue” here...?

Took off the right panel – all aluminum evaporator coil:

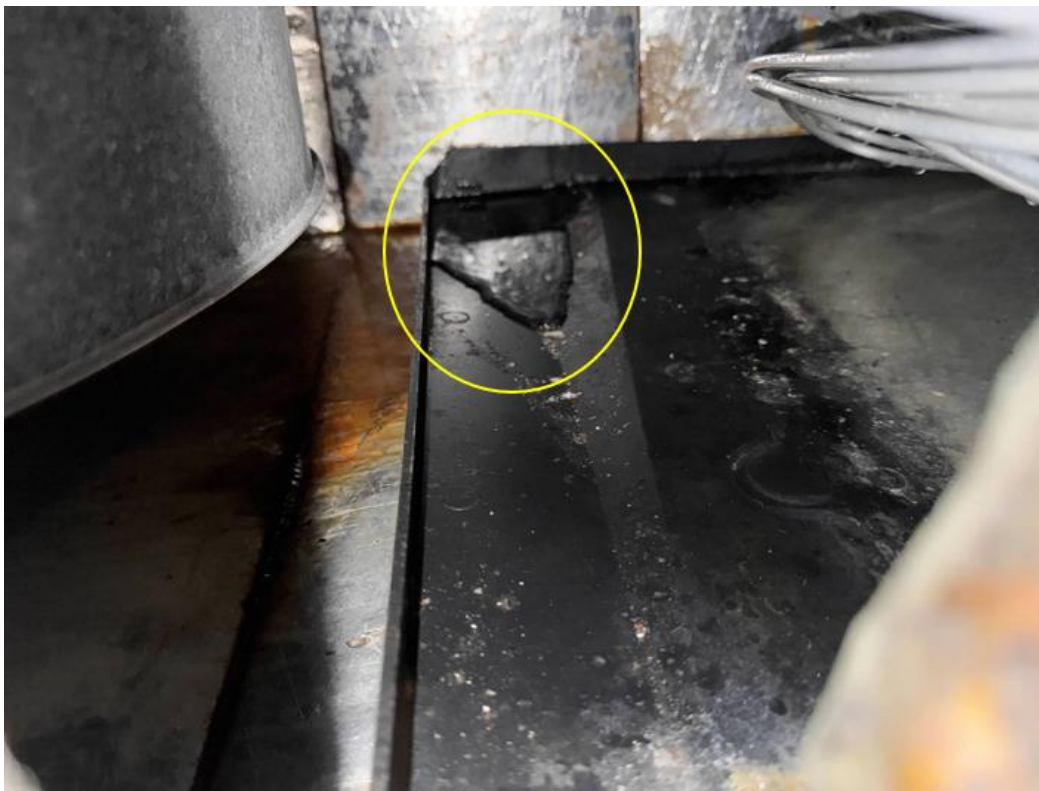
I notice the back left corner of the drain pan has standing water? (yellow circle):

My assumption is that the pitch of the drain pan/cabinet is incorrect, and water is overflowing the left back corner of the drain pan and spilling down to the floor of the cabinet.

Based on the assumption that the system is not pitched properly, I placed a 1” PVC pipe cap under the back left corner of the drain pan to raise the pan to increase the pitch, this reduced the water in the far-left corner.

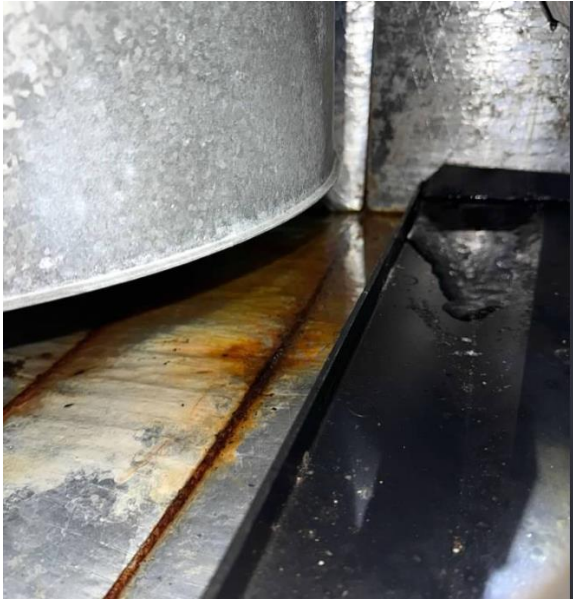
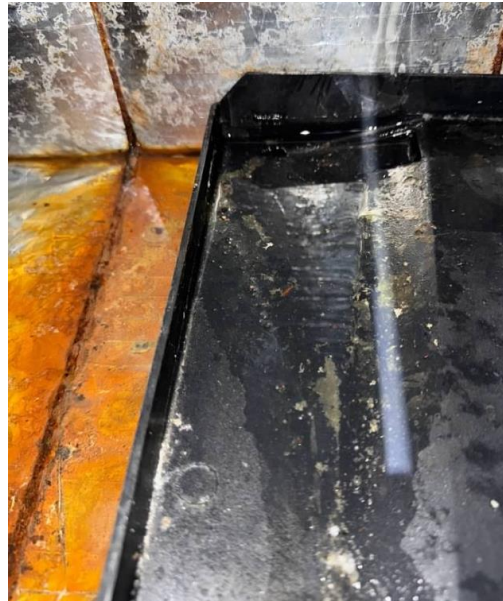
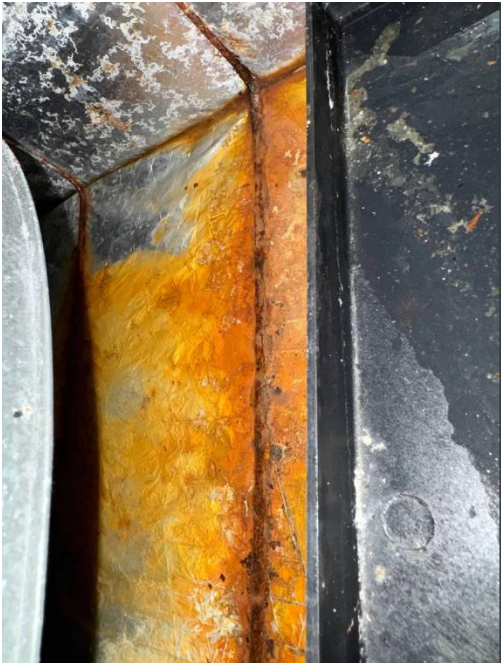
Looking to the left of the drain pan, the floor of the unit has **standing water**, about $\frac{1}{4}$ " deep.

Notice the metal bars are rusted!

The water on the floor is below the blower, and this could/would explain why the ceiling vents all had water exiting and soaking the ceiling causing the paint to fall off. The blower is sucking up water and blowing water out the vents (all the vents on this system had peeling paint).

Pictures of the installation were given to the customer so the AC company could be contacted to come and orient the cabinet to make sure the pan is tilted properly. The existing water on the cabinet floor was vacuumed out best I could, and the rest will evaporate now that condensate should no longer be overflowing the drain pan.

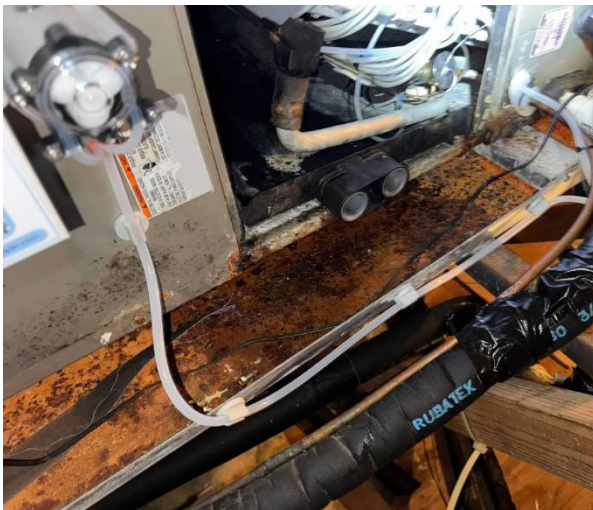
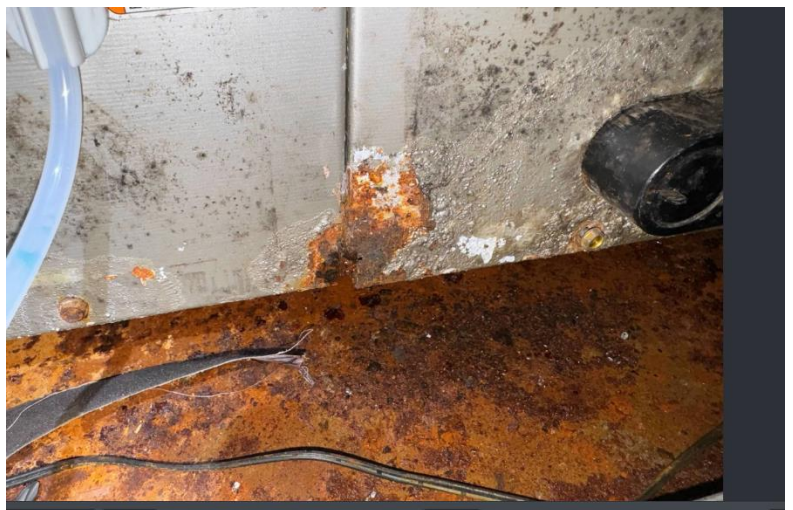
The water on the cabinet floor also drains/seeps out continuously from the gaps in the cabinet seams and is causing rusting in the secondary drain pan and on the unit:

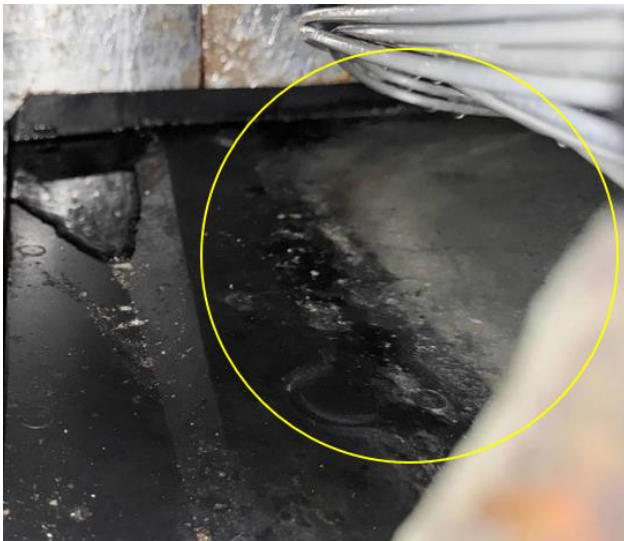
Also, there was a large amount of bacteria on the drain pan, more of a film of bacteria.

Looking closer, the drain pan contained a large “puddle” of water – so instead of the condensate flowing out of the drain pan, the water is always residing in the drain pan (yellow circle):

The bacteria covered the drain pan from the circle all the way to the drain trough on the far right and to the drain outlet. This area also was submerged in condensate – the “puddle”.

There should not be standing water in the drain pan and again the assumption is the drain pan is not pitched properly.

I also modified the hangers to increase the overall pitch of the cabinet, which did help to reduce the puddle size, but did not eliminate the puddle. There was a limit on how far the lower front right corner could be lowered as there were straps supporting the ductwork. On the backside of the cabinet, I raised the adjusting nuts until I ran out of thread, which was about a ½” increase only in height.

The unit needs to be set properly for even better drainage, but at least the system will now not overflow the drain pan and the condensate puddling should be minimized in the pan.

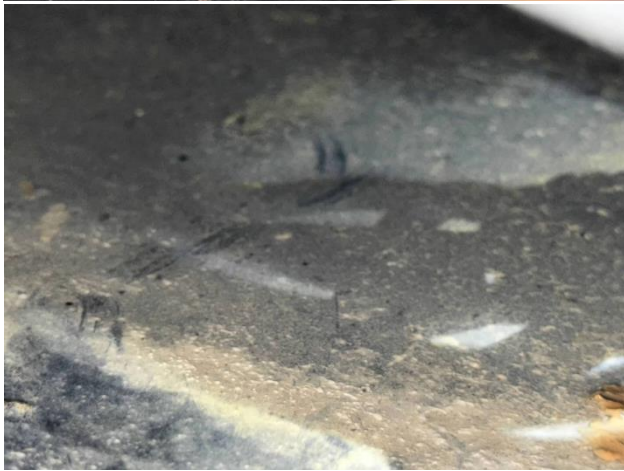
This picture shows the bacteria and there is actually water covering the bacteria, but it's difficult to discern the water.

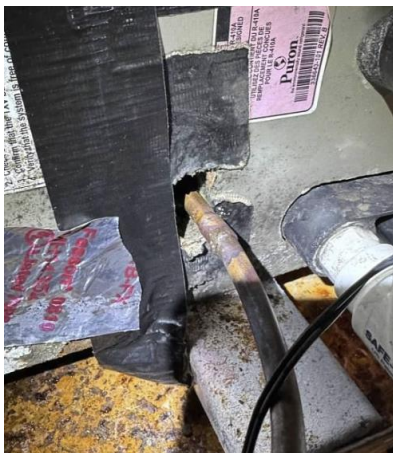
The Zoog Zapper was placed on the cabinet on the left panel:

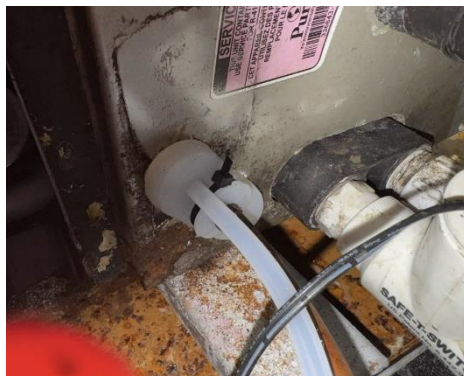
The entry point of the dispense tubing was the standard oval opening with the rubber plug, except there was no rubber plug – just a hole.

On a unit that was recently serviced. You would think that a consciousness tech would seal the hole with aluminum tape...

The rubber grommet was used (a previous version of the plug was used which is white urethane, the new version is black rubber).

The grommet is designed to cover the oval whole completely.

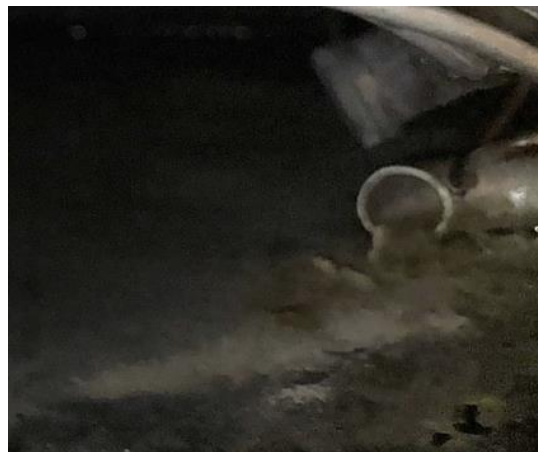
This unit has a tube from the coil connection plate down to the drain pan, and there was Zoogloea growing at the exit of the tube.

The decision on nozzle placement was to put one tube with the Single-Port nozzle into the channel of the connection plate.

The nozzle was slid in by hand to the end of the channel/trough.

The Steramine will flow through the entire channel and down into the tube which should prevent the bacterial growth at the exit of the tube.

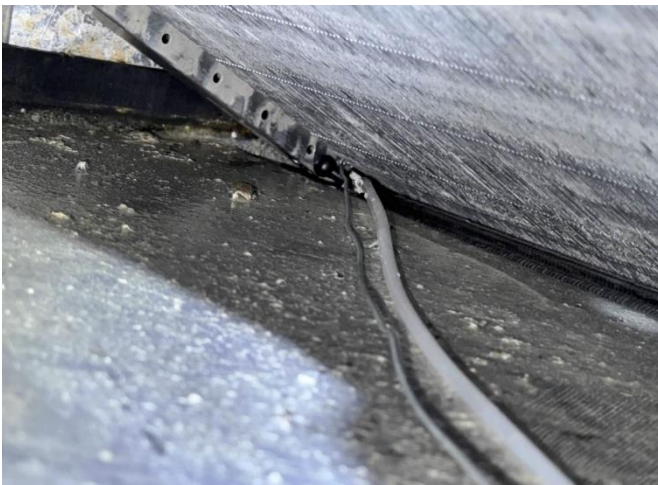
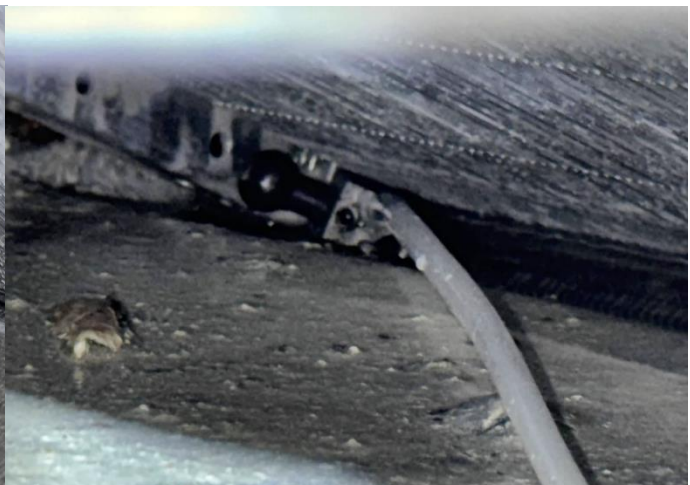
The second nozzle location was in the far-right back corner of the drain pan and the Double-Port Nozzle was used since there is some condensate in the drain pan with the puddle. The Double-Port Nozzle is less prone to submersion by the design of the nozzle.

The placement wire was needed to reach to the far back corner.

This completed installation of the two nozzles.

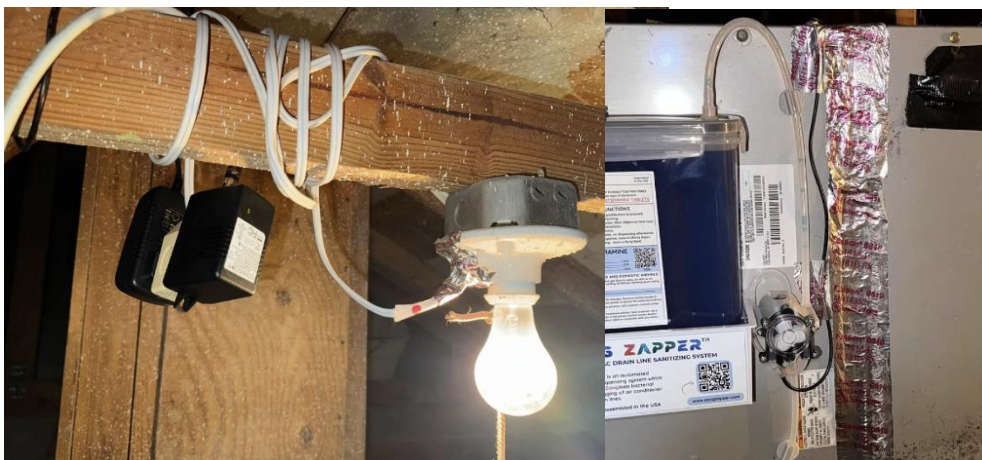
Power – there was an attic light that had an AC outlet built in, but the outlet already had an AC power adapter plugged in. A two-prong extension cord was used so the existing AC adapter and the new AC Power adapter for the Zoog Zapper could both be connected to AC power.

Aluminum tape was added to the extension cord plug to make sure the cord would not easily come out of the socket.

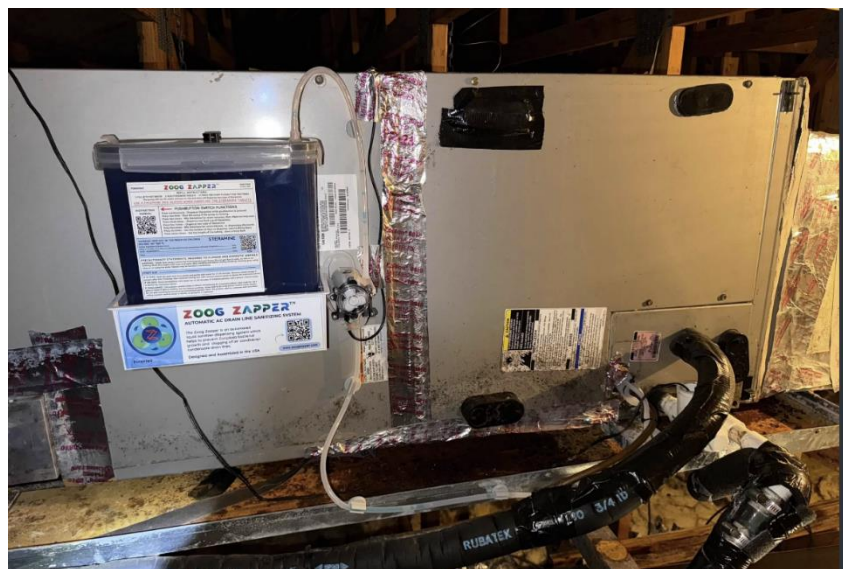
The right panel was re-installed.

The dispense tubing was routed along the secondary drain pan using the magnetic tube holders.
